## APPENDIX A – SITE PHOTOGRAPHS

### Construction Evidence

## External Audit

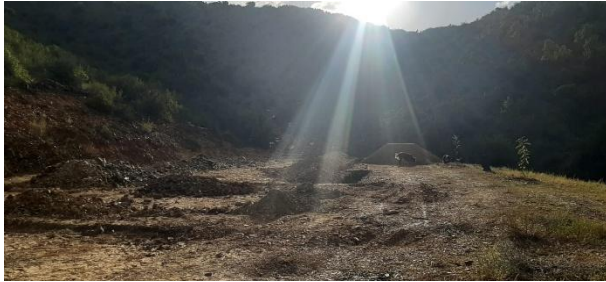
Site preparation

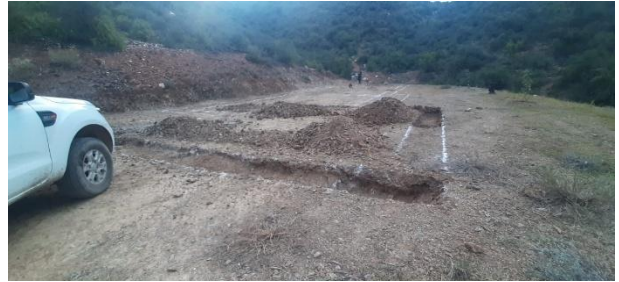
Platform/site layout demarcated with chalk.

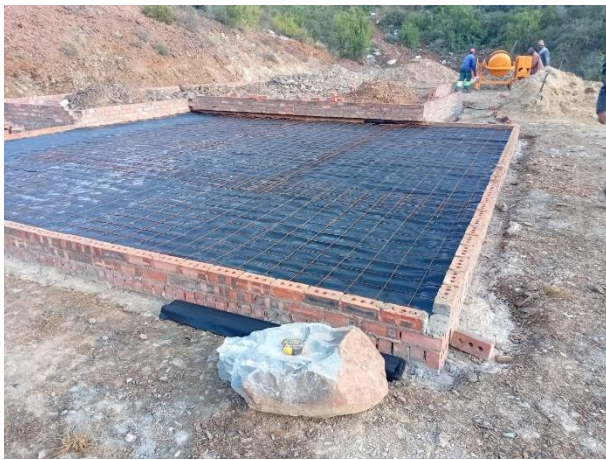
Prepared foundation with brick formwork and steel reinforcement grid.

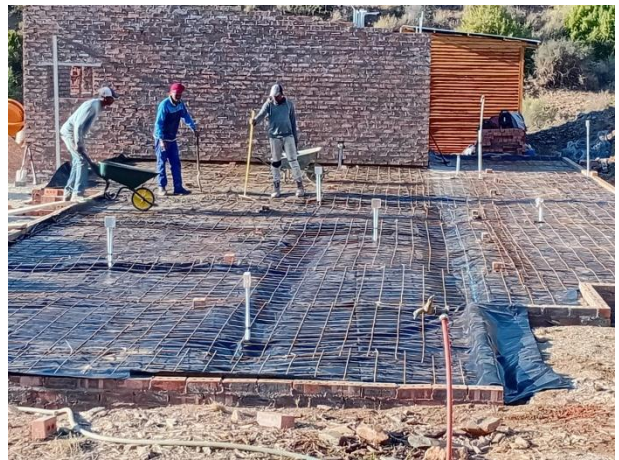
Prepared foundation with brick formwork and steel reinforcement grid.

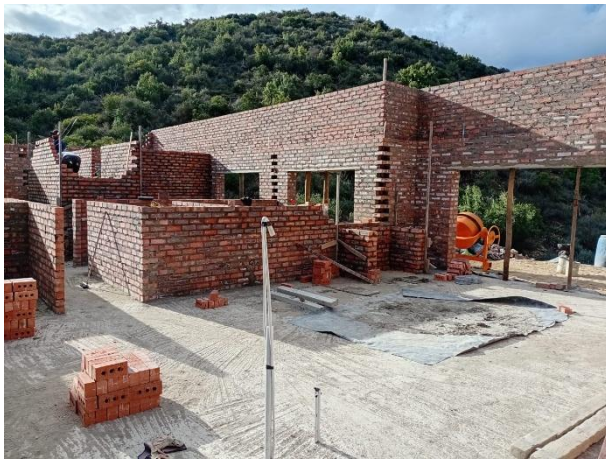
Brickwork progressing steadily.

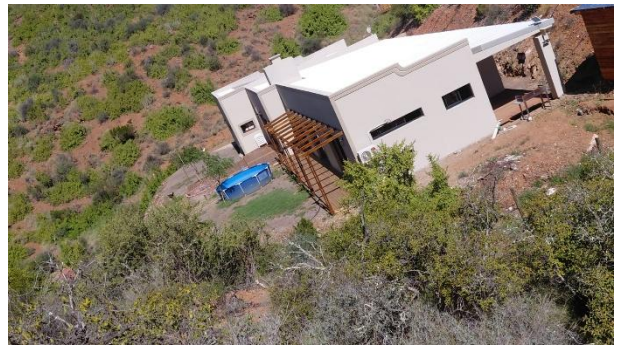
Completed residence.

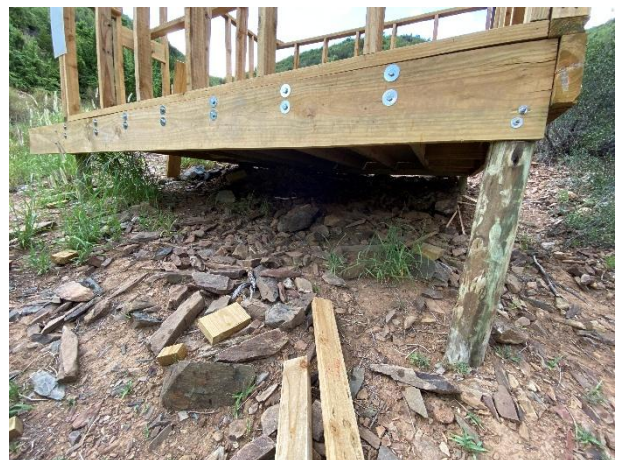
Chicken coop deck on stilts. Condition of the natural vegetation.

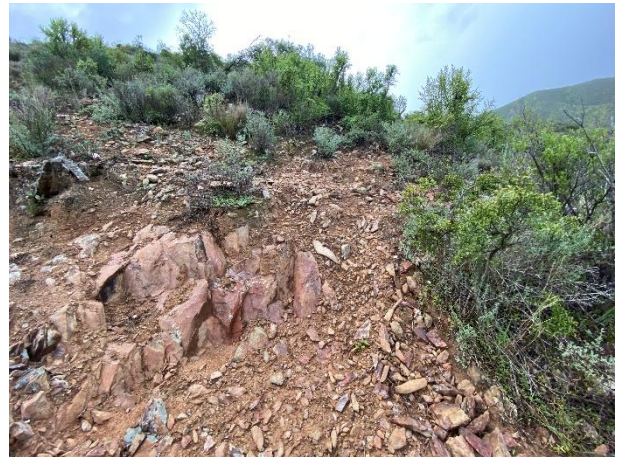
Animal trek at 33°29.6099' S; 21°36.9852' E to be rehabilitated.

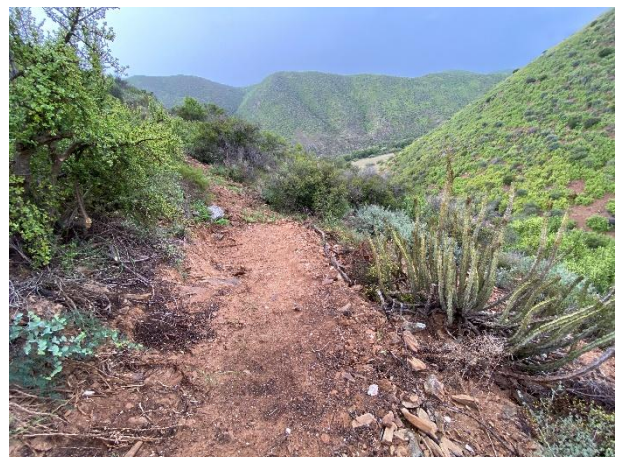
Animal trek at 33°29.6209' S; 21°36.9574' E to be rehabilitated.

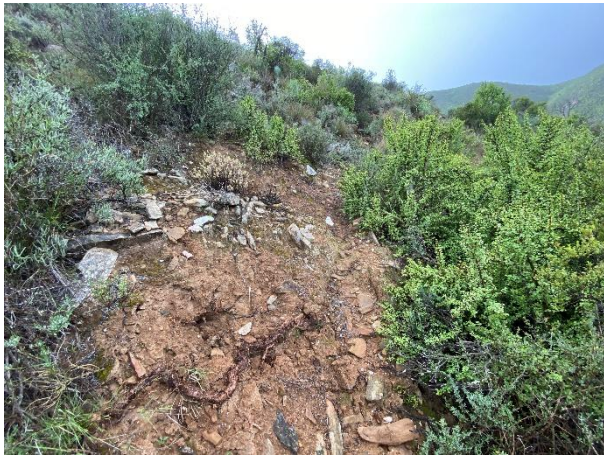
Vegetation along the animal paths will gradually regrow and close over time.

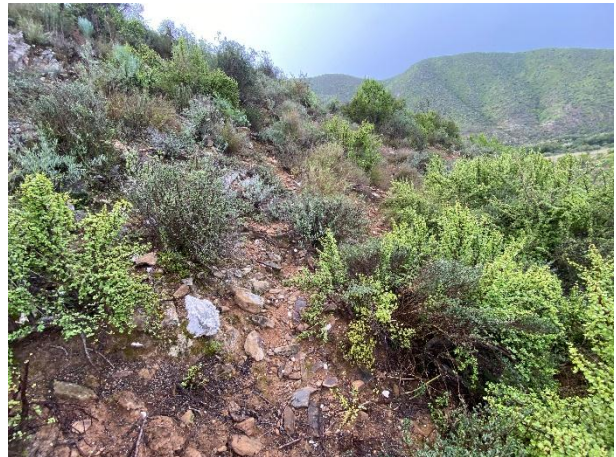
Vegetation along the animal paths will gradually regrow and close over time.

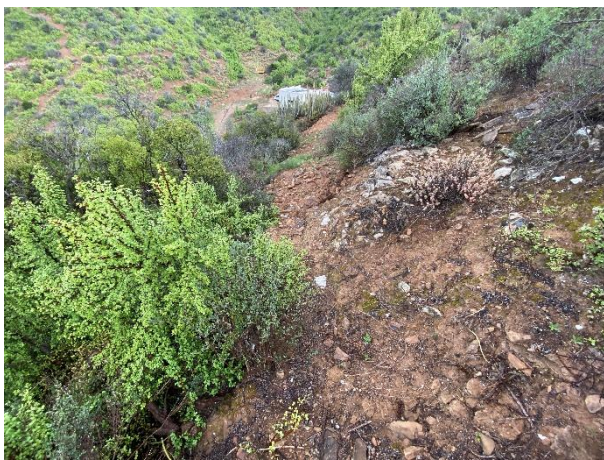
Vegetation along the animal paths will gradually regrow and close over time.

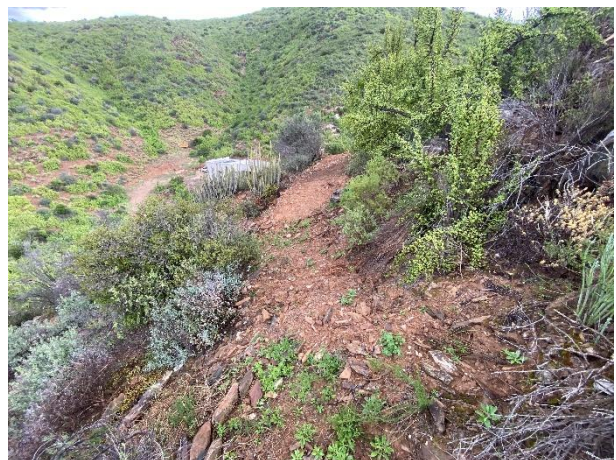
Vegetation along the animal paths will gradually regrow and close over time.
