# THE PROPOSED RIVERBANK MAINTENANCE AT SAN MARINO, ERF 586, KEURBOOMSTRAND, PLETTENBERG BAY.

ANNUAL OPERATIONAL EXTERNAL ENVIRONMENTAL  
AUDIT REPORT IN TERMS OF REGULATION 34 OF THE  
NEMA EIA REGULATIONS, 2014 (AS AMENDED).

DEA&DP AMENDED EIA REF. NO. 16/3/3/1/D1/6/0014/20  
NEAS AMENDED REF. NO. WCP/EIA/0000960/2021

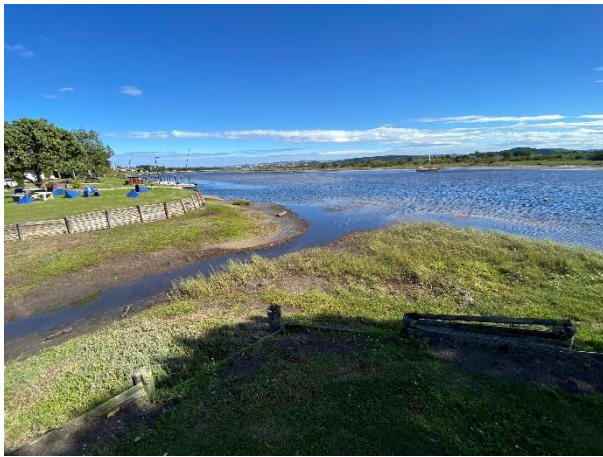
Stormwater outlet channel north of the slipway.

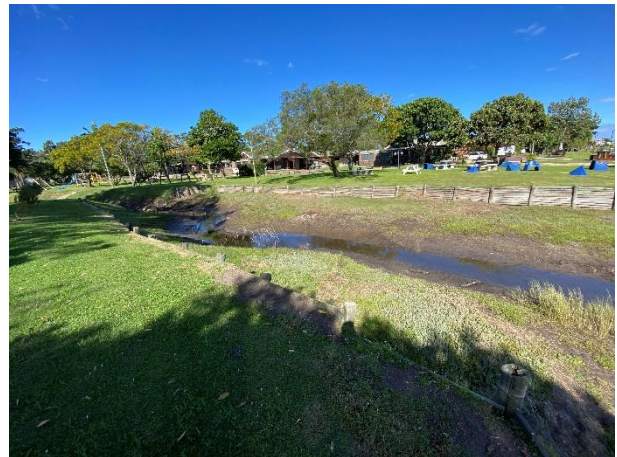
Condition of the stormwater channel outlet into the Keurboom River Estuary towards San Marino.

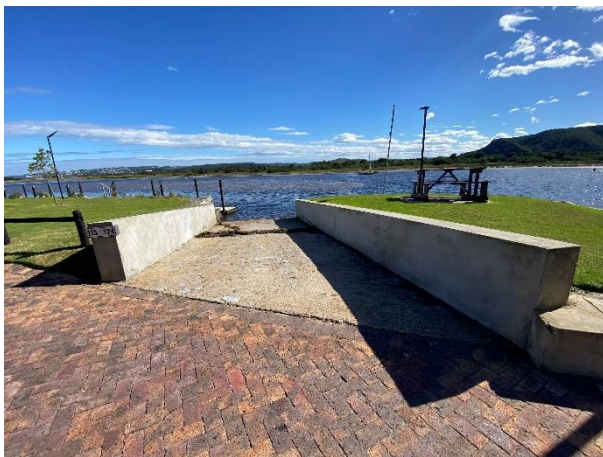
Condition of the slipway from the roadside.

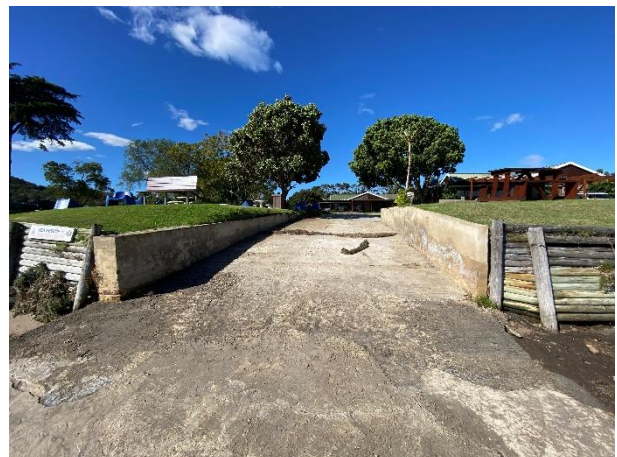
Condition of the slipway.

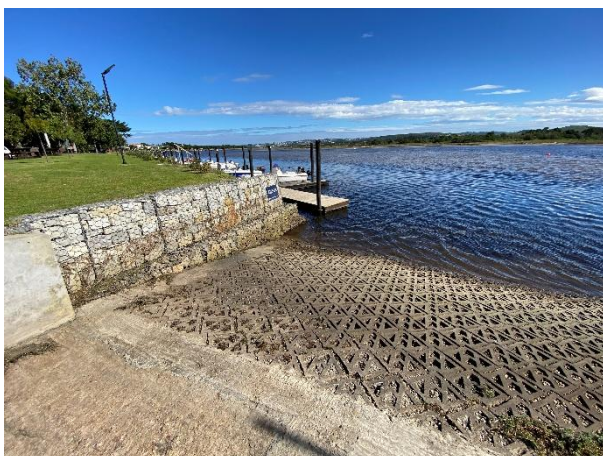
Condition of the slipway grassblocks.

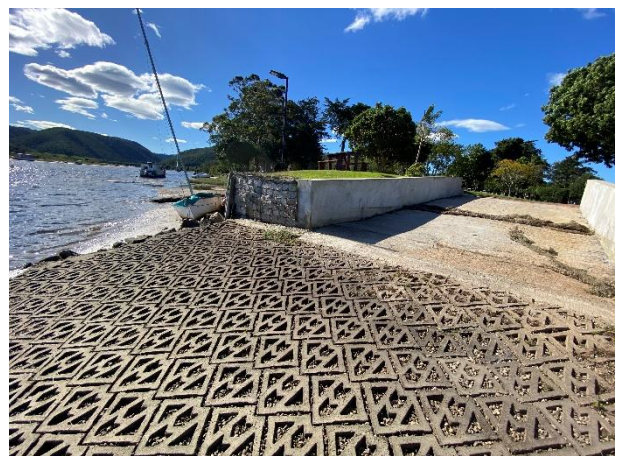
Condition of the slipway grassblocks.

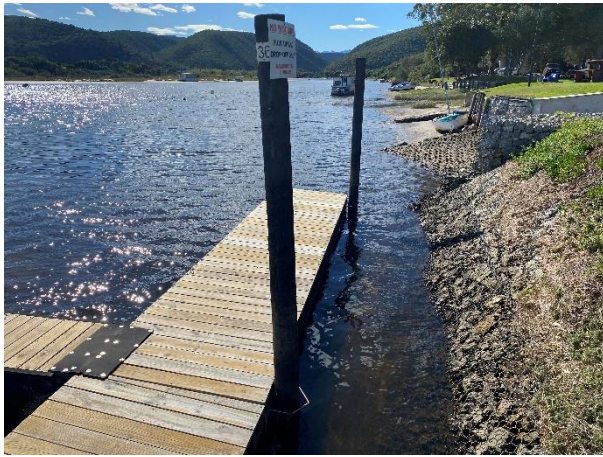
The northern end of the jetty showing the completed layers of the reno-matresses and established bank.

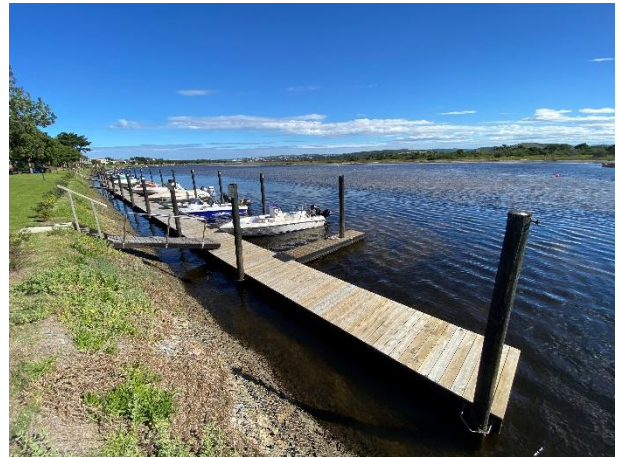
The banks and jetty as seen from the north.

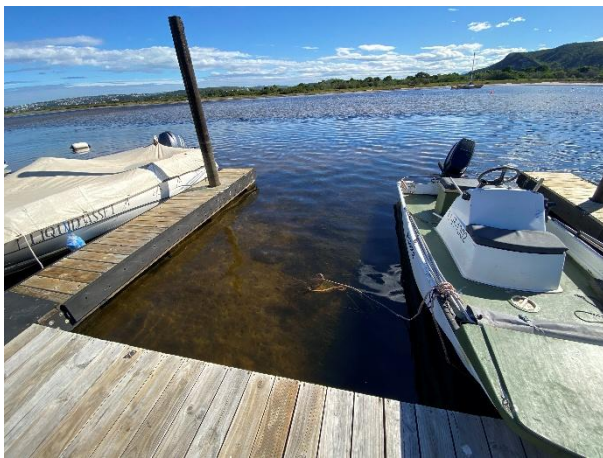
Established *Zostera* along the base.

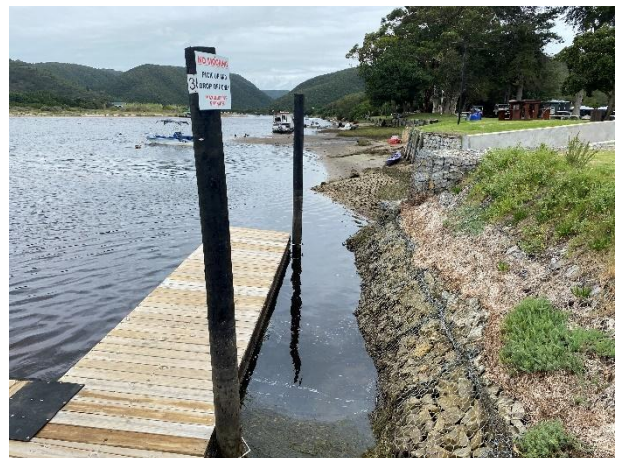
The mooring poles nearest to the slipway as seen towards the north.

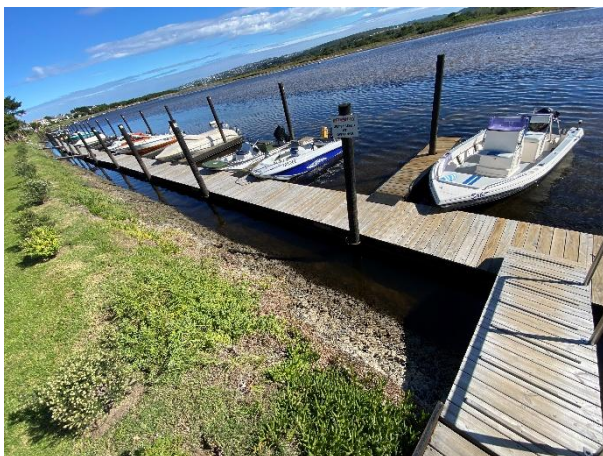
Completed jetty showing the gang-plank, jetty and fingers as seen towards the south.

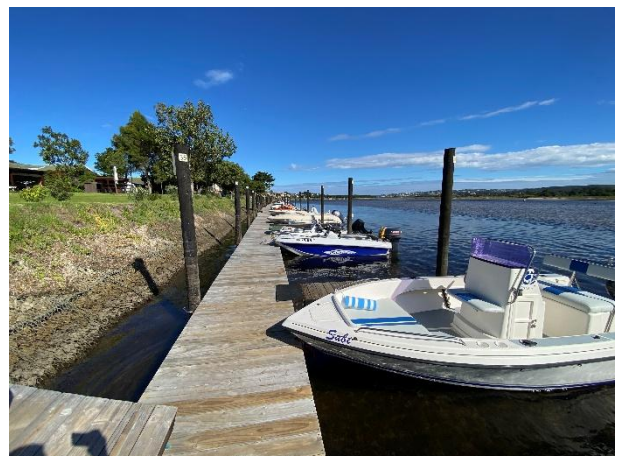
Completed and operational jetty as seen towards the south.

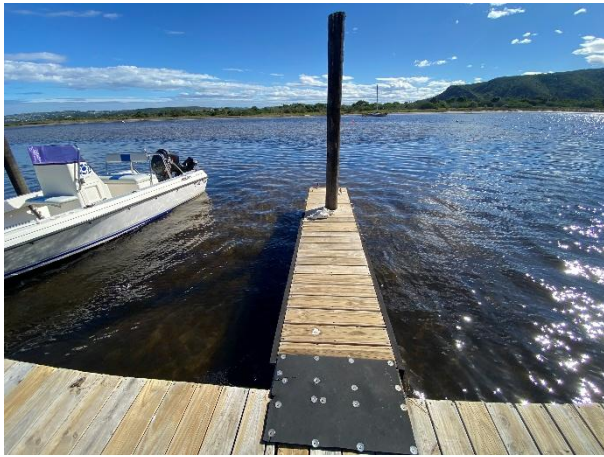
Attached floating jetty and the 4-meter-long by 0.7-meter-wide mooring finger.

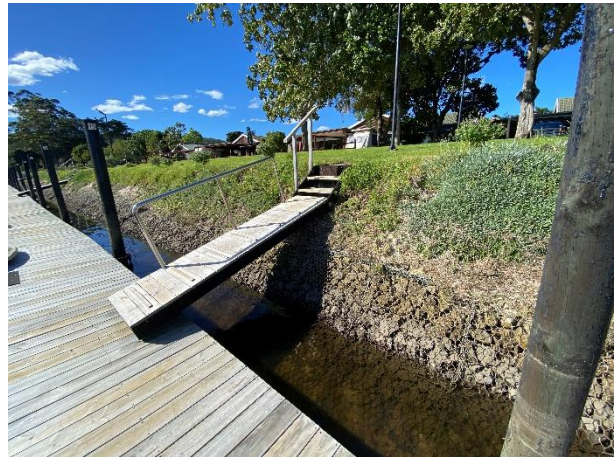
Condition of the jetty showing the gang-planks on low tide as seen towards the north.

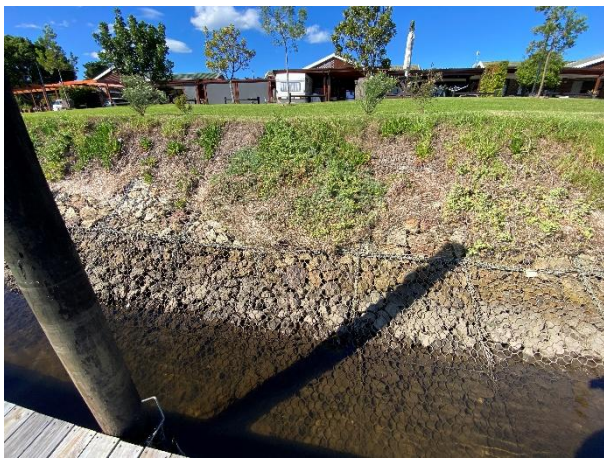
Reno-mattress toe at the bottom of the riverbank.

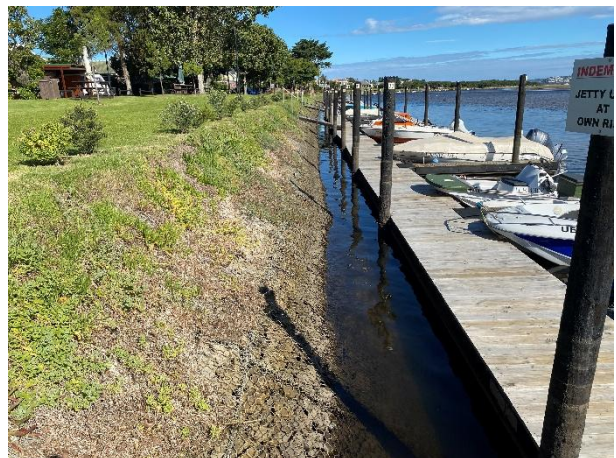
Rehabilitation of the riverbank.

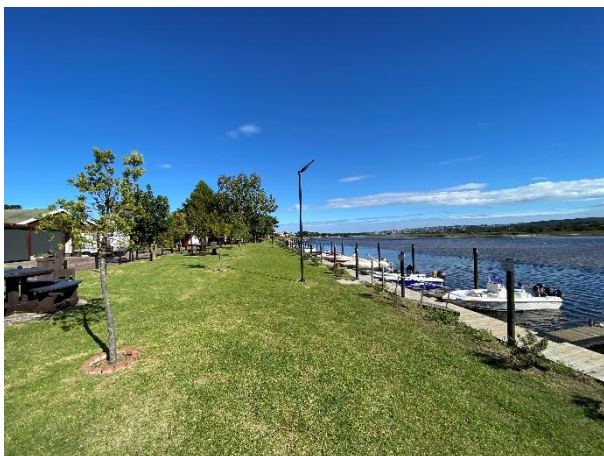
Current condition of the rehabilitation riverbank.

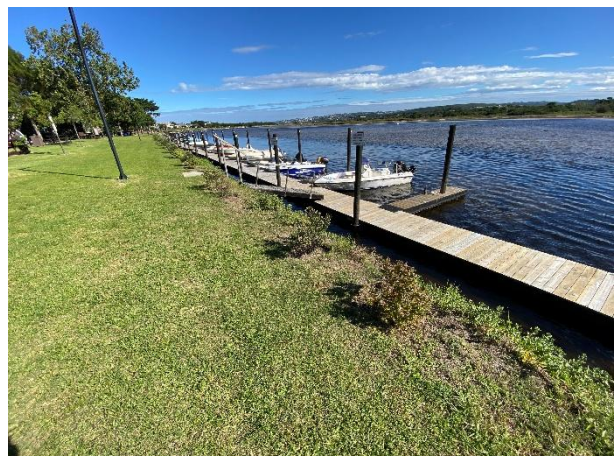
Current condition of the rehabilitation riverbank.
