## APPENDIX A – SITE PHOTOGRAPHS

## External Audit

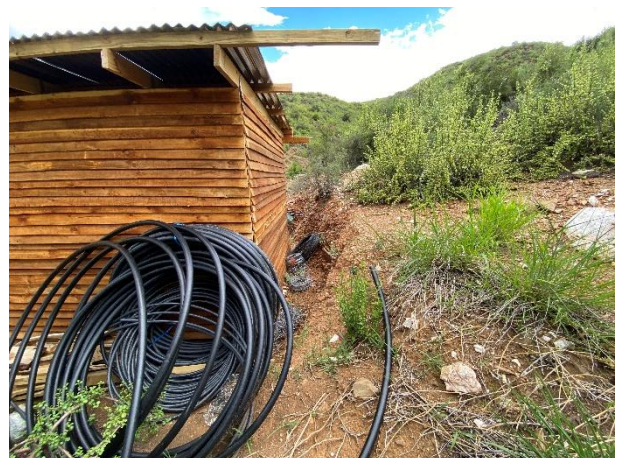
Condition surrounding the outhouse adjacent to the main house.

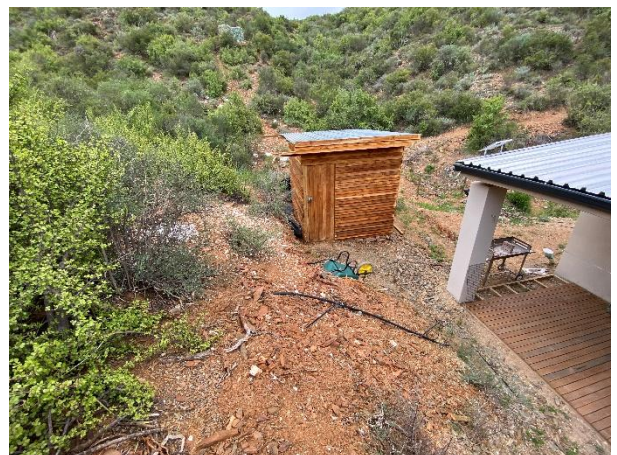
Condition surrounding the outhouse adjacent to the main house.

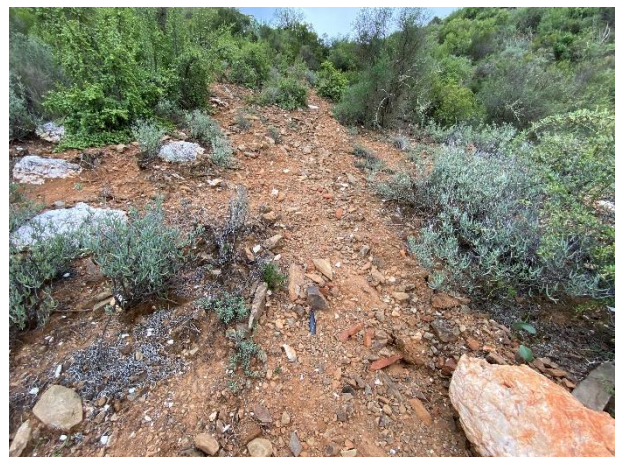
Condition of the footpaths towards and surrounding the water tank.

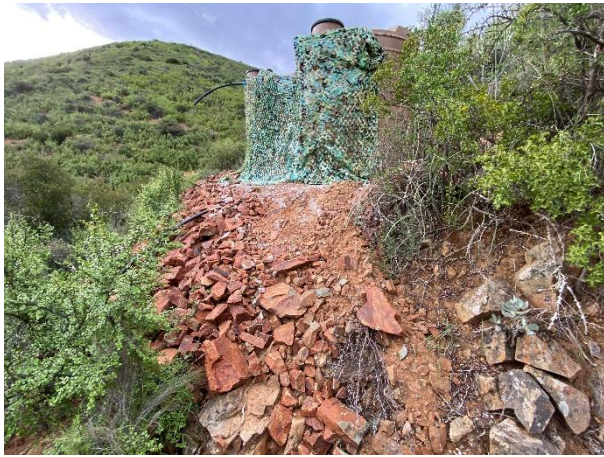
Condition of the water tank towards the northwest.

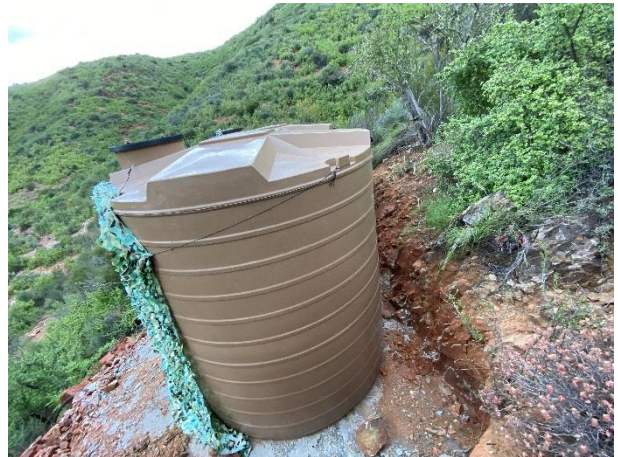
Condition of the water tank towards the northwest.

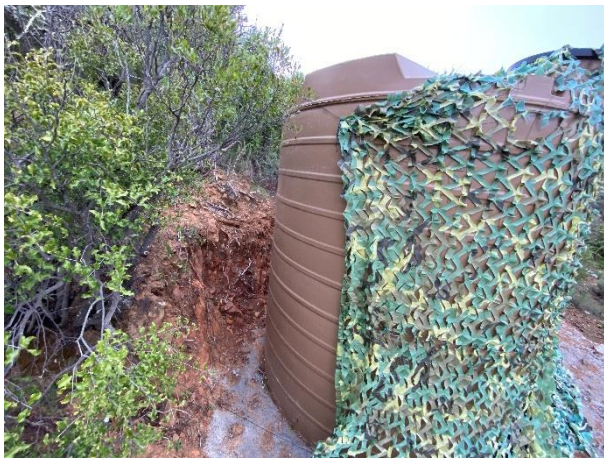
Condition of the water tank towards the northwest.

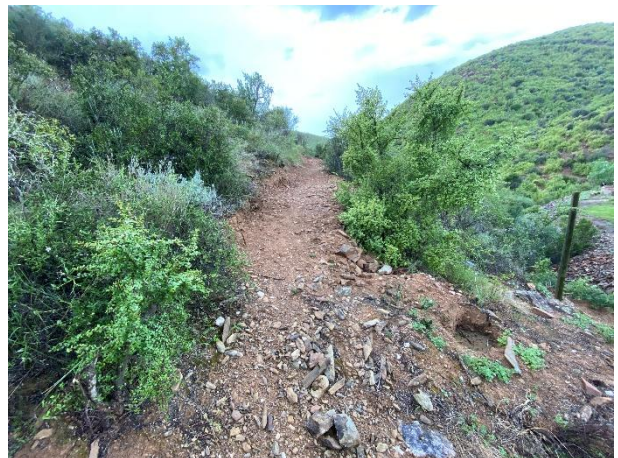
Condition of the footpaths towards the water tank.

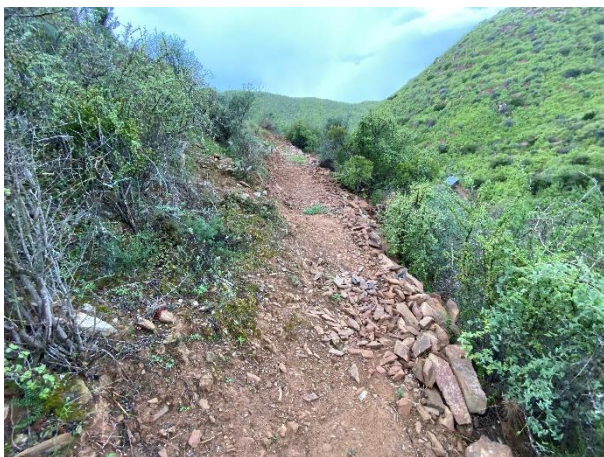
Animal trek at 33°29.6300' S; 21°36.9590' E to be rehabilitated.

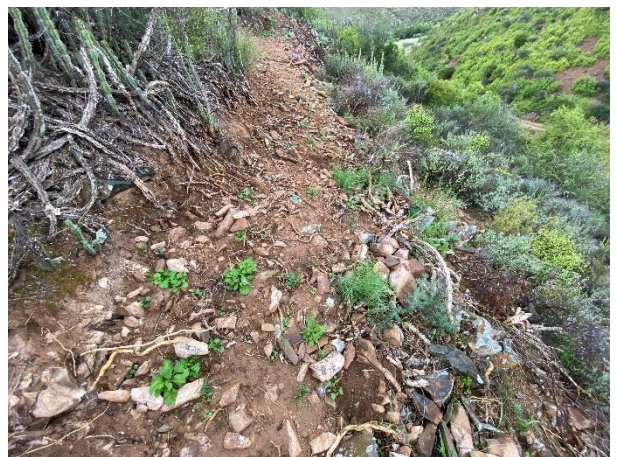
Animal trek at 33°29.6258' S; 21°36.9680' E to be rehabilitated.

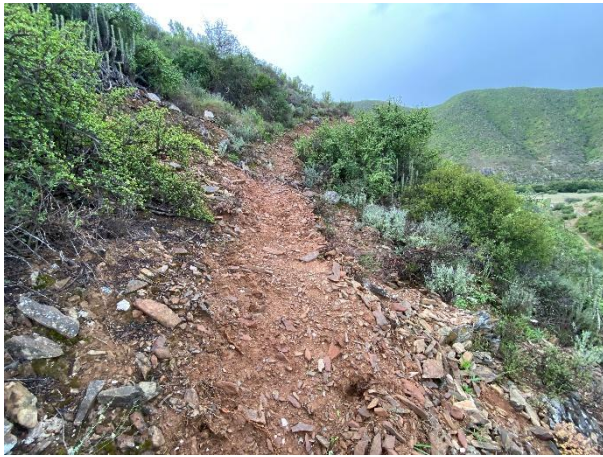
Animal trek at 33°29.6174' S; 21°36.9775' E to be rehabilitated.

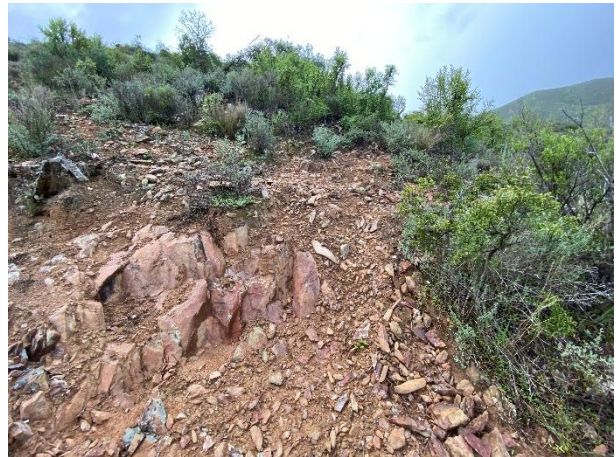
Animal trek at 33°29.6099' S; 21°36.9852' E to be rehabilitated.

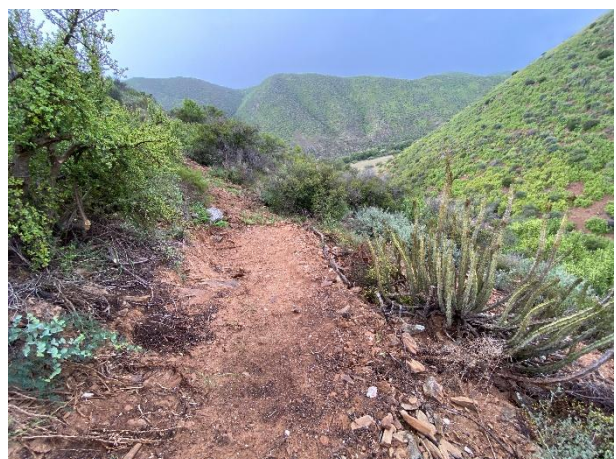
Animal trek at 33°29.6209' S; 21°36.9574' E to be rehabilitated.

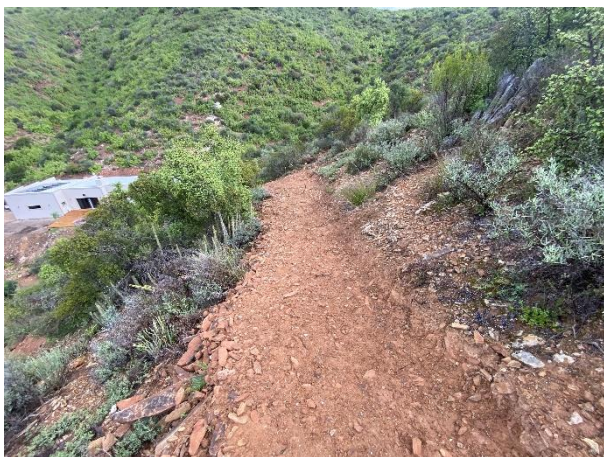
Animal trek at 33°29.6082' S; 21°36.9724' E to be rehabilitated.

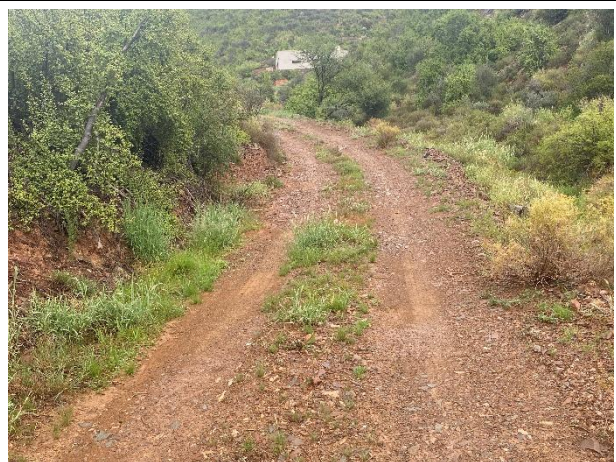
Condition of the access road at the entrance of the site.

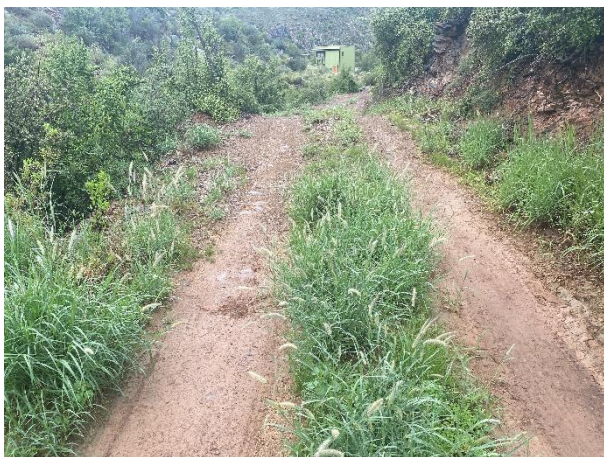
Condition of the access road at the entrance of the site.

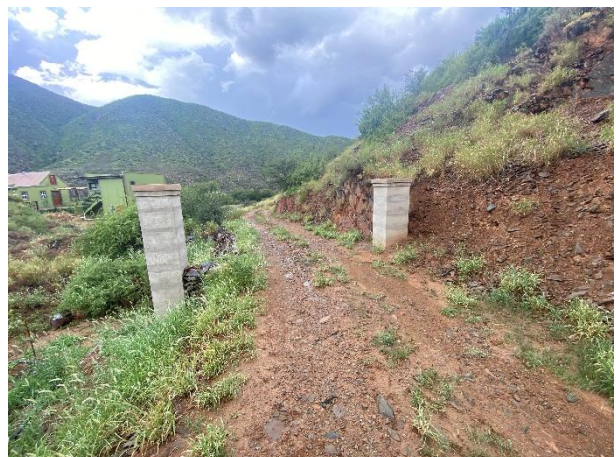
Condition of the access road at the entrance of the site.
