## APPENDIX A – SITE PHOTOGRAPHS

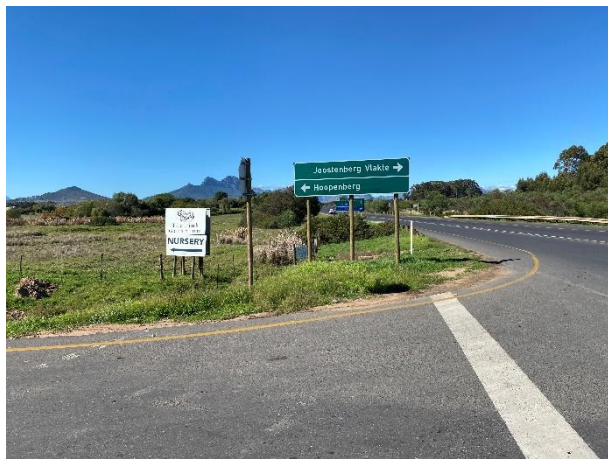
The intersection of Klipheuwel Road (R304) and Protea Road.

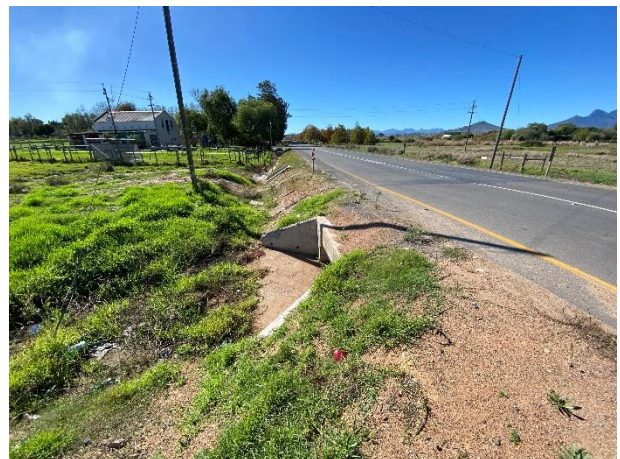
At the western end of Protea Road where stormwater culverts are installed adjacent to the road shoulder.

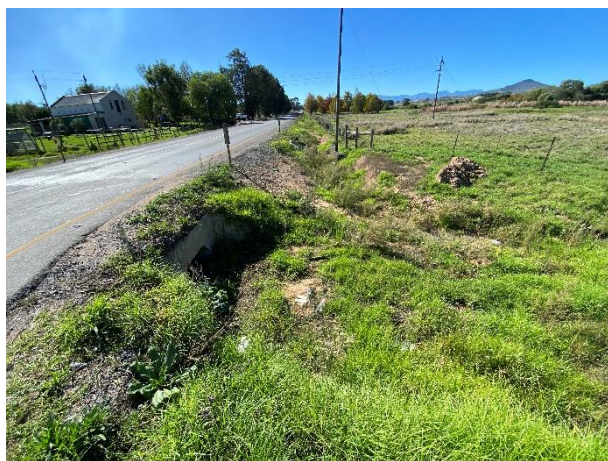
At the western end of Protea Road where stormwater culverts are installed adjacent to the road shoulder

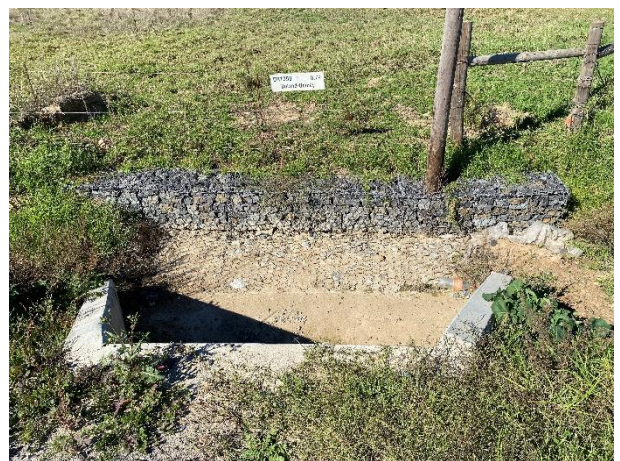
Newly upgraded stormwater culvert.

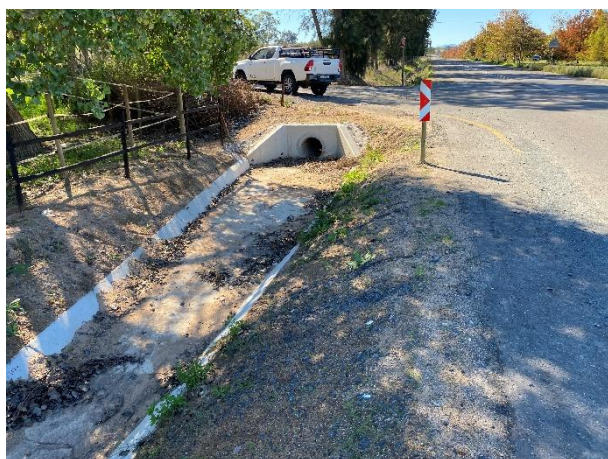
Installed stormwater side drains.

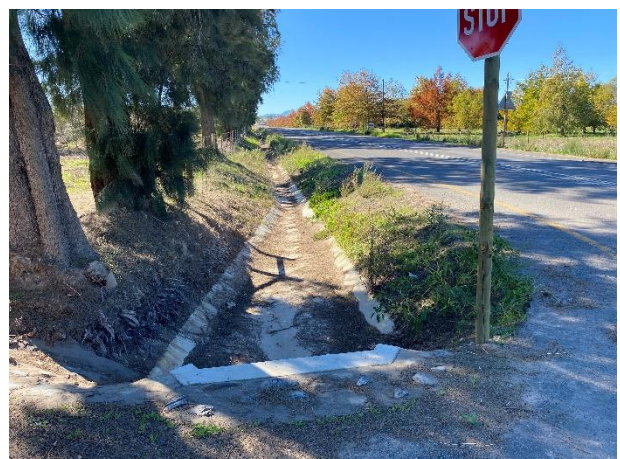
Installed stormwater side drains.

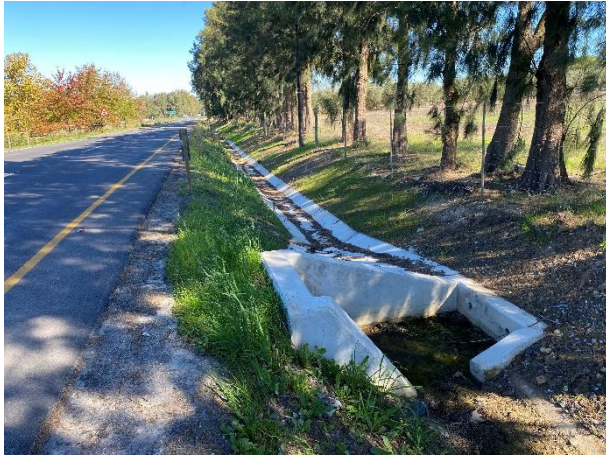
Installed stormwater side drains and inlet structure.

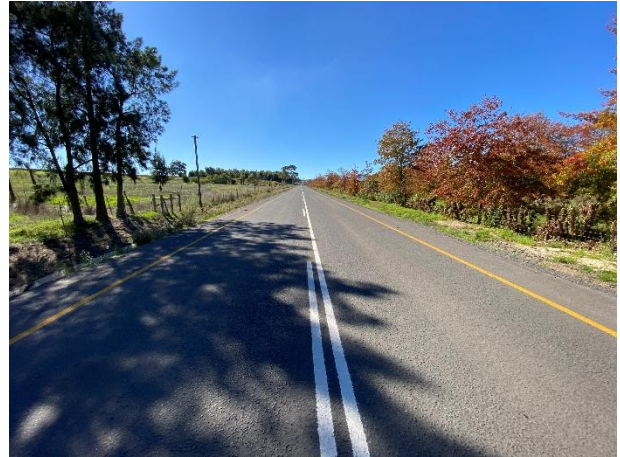
Condition of Protea Road, successfully resurfaced.

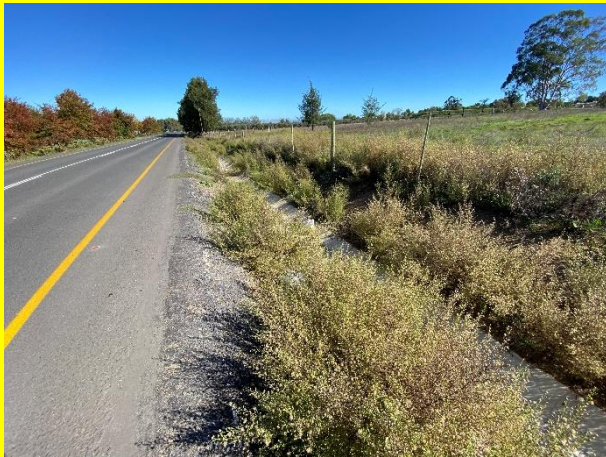
Stinkwort (*Dittrichia graveolens*) observed establishing along the road reserve, requiring ongoing management.

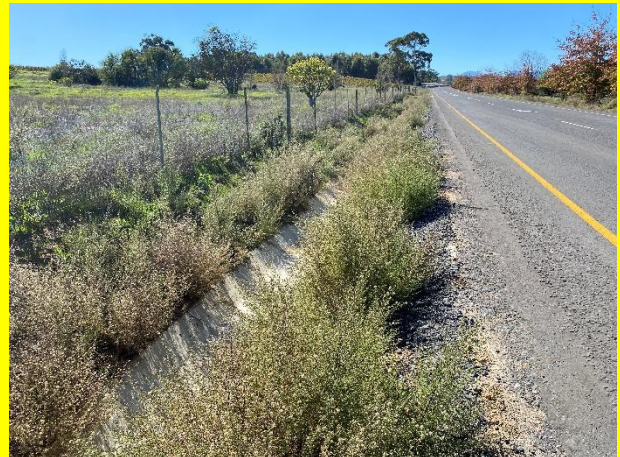
Stinkwort (*Dittrichia graveolens*) observed establishing along the road reserve, requiring ongoing management.

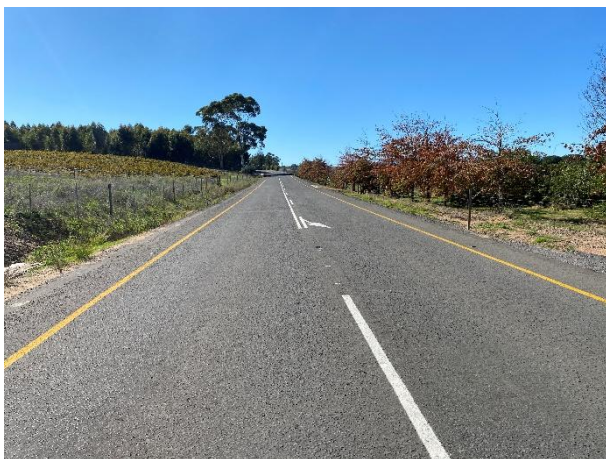
Condition of Protea Road, successfully resurfaced.

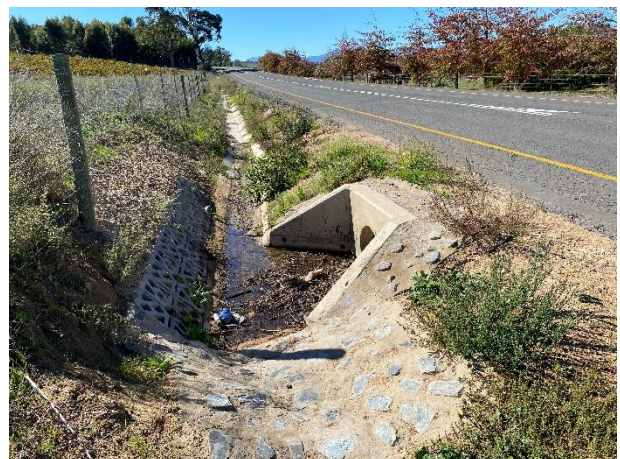
Stormwater outlet structure successfully installed.

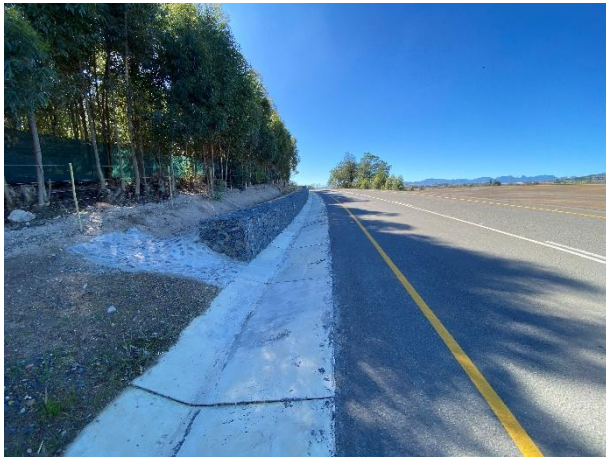
Installed gabion retention wall along the previous cuttings along the Protea Road.

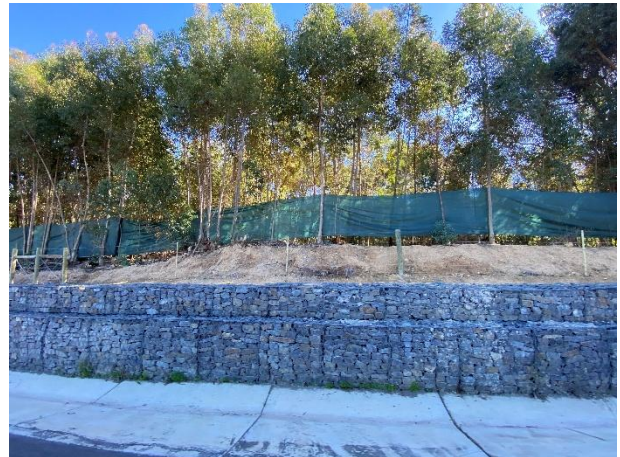
Installed gabion retention wall along the previous cuttings along the Protea Road.

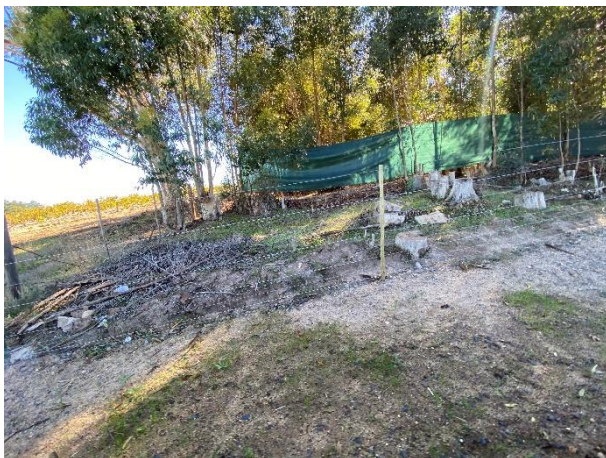
Reinstated fencing along the development route.

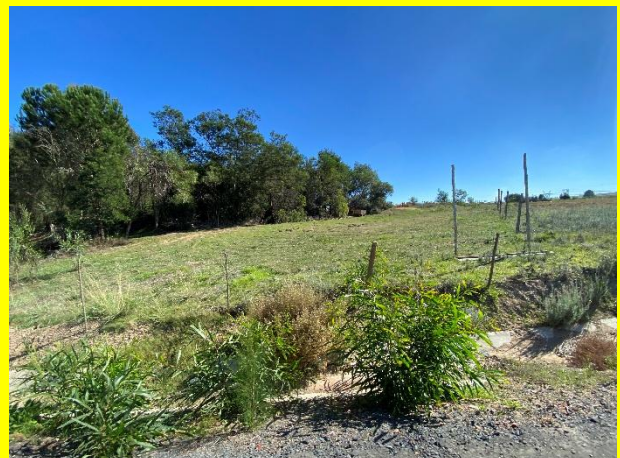
Golden Wreath Wattle observed establishing along the road reserve, requiring ongoing management.

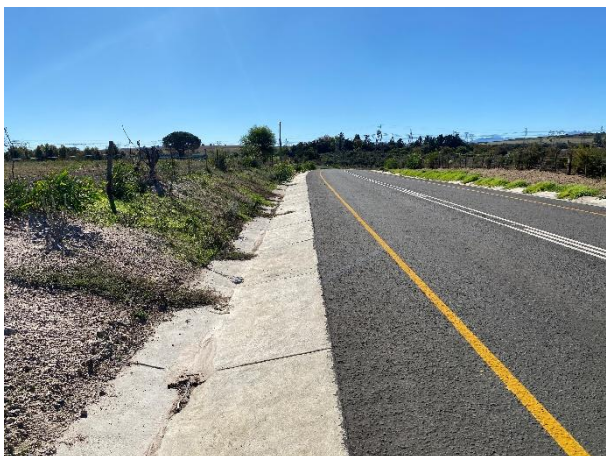
Installed stormwater side drains.

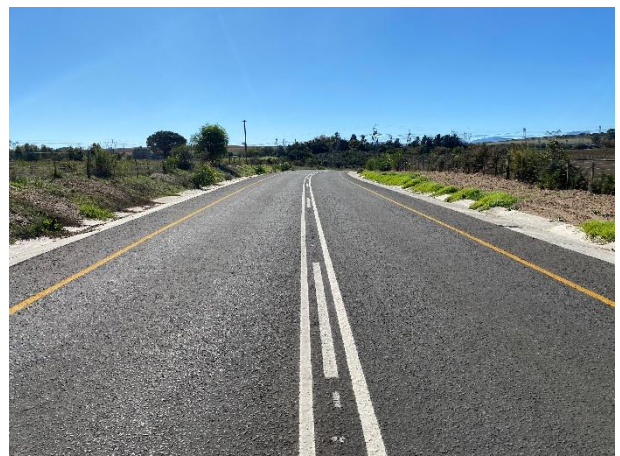
Condition of Protea Road, successfully resurfaced.

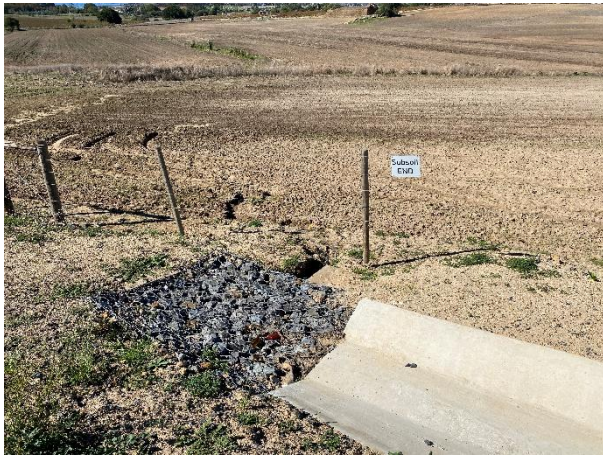
Gabion mattress installed.

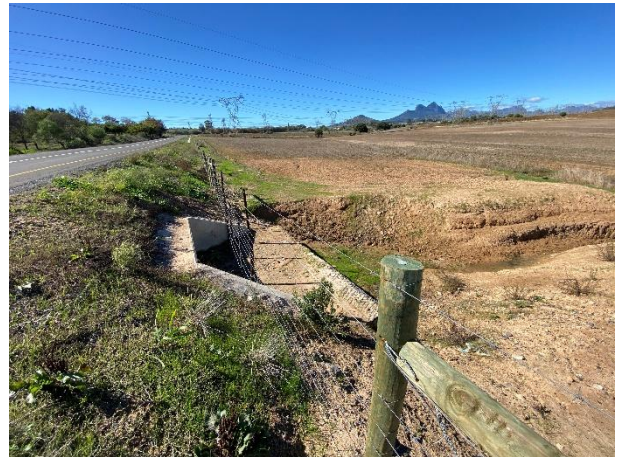
Stormwater outlet structure successfully installed.

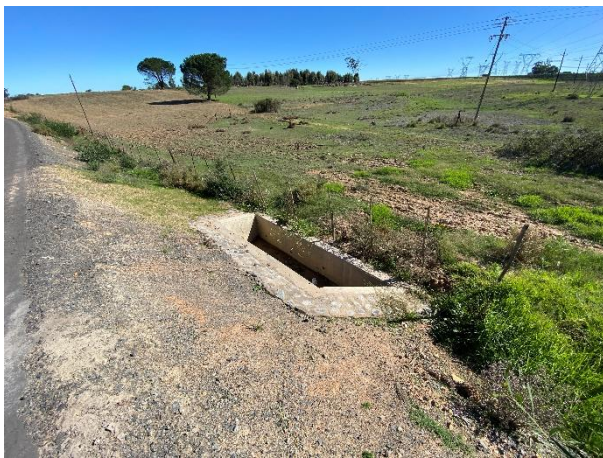
Stormwater inlet structure successfully installed.

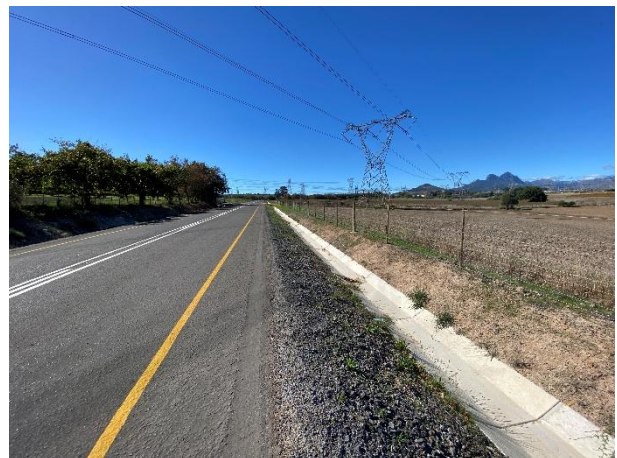
Stormwater side drains installed along the road reserve.

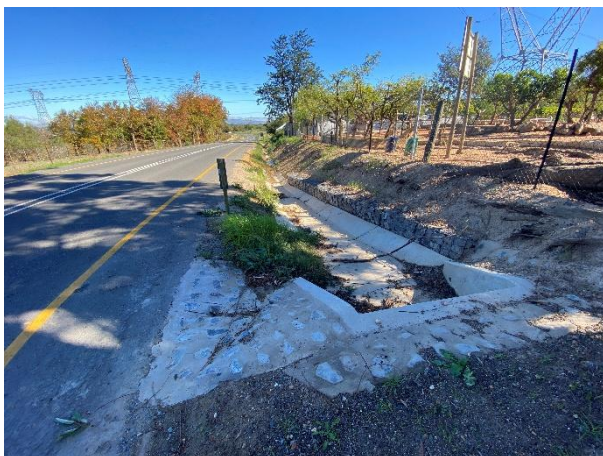
Stormwater side drains installed along the road reserve as seen towards the west.

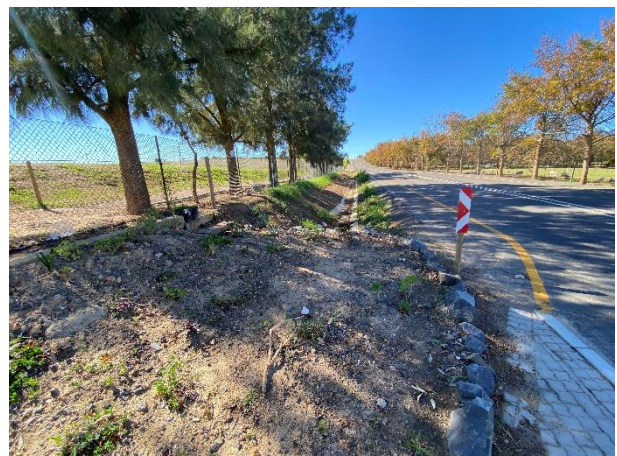
Rehabilitation of the road reserve in progress.

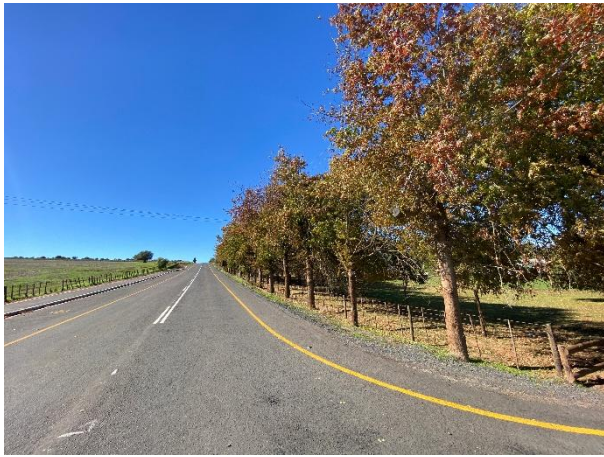
English oak trees trimmed along the road reserve towards the west near the Joostenberg Primary School.

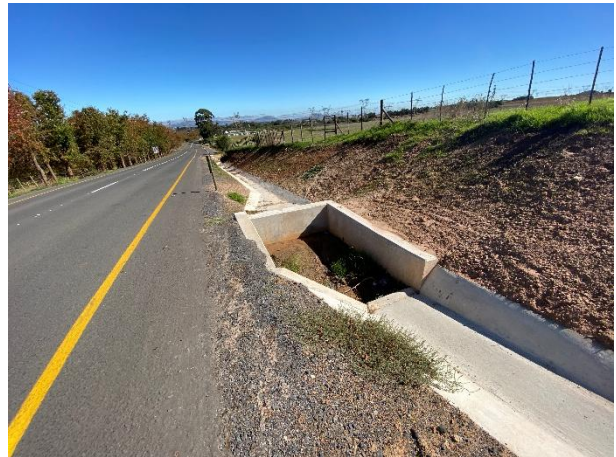
Upgraded stormwater inlet structure.

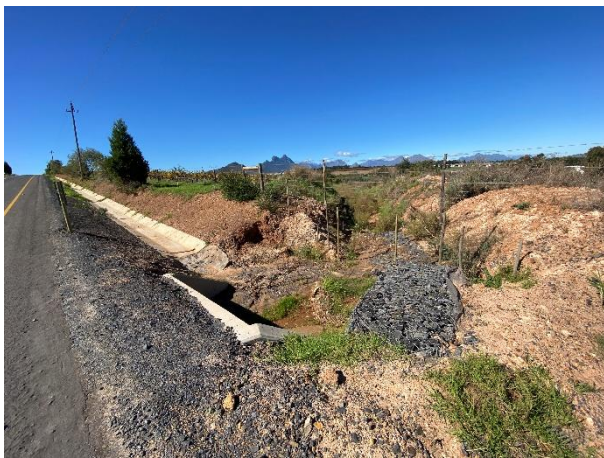
Upgraded stormwater outlet structure with installed gabion mattresses.

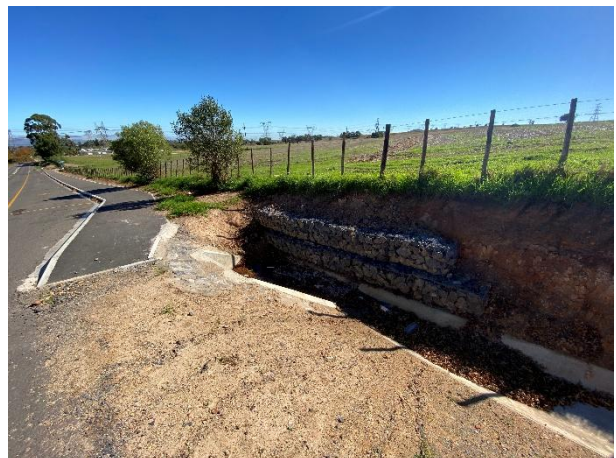
Excavated stormwater side drain channels successfully installed with gabion retaining walls.

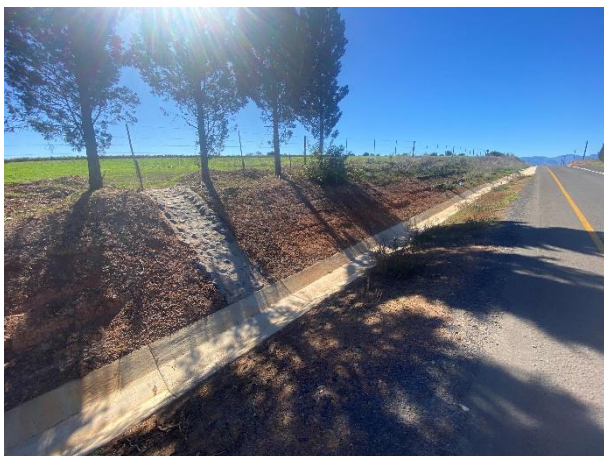
Recently constructed concrete-lined roadside stormwater drainage channel and slope stabilisation.

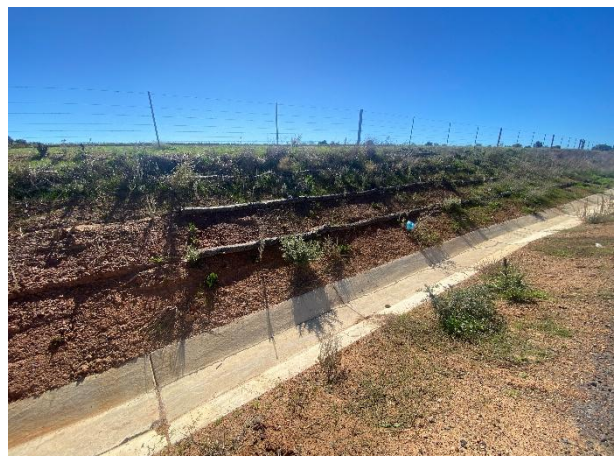
Hessian sausage erosion controls installed for roadside slope rehabilitation.

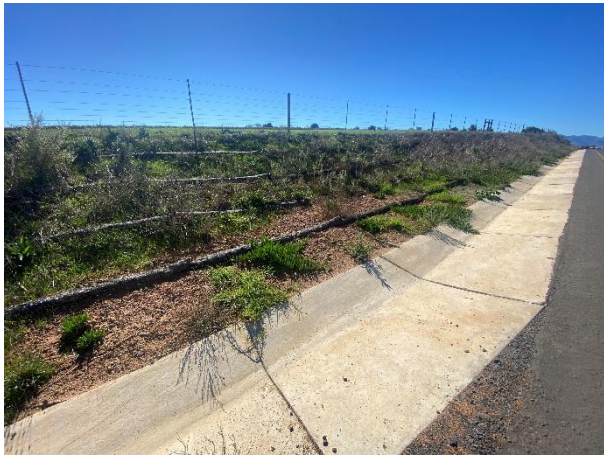
Hessian sausage erosion controls installed for roadside slope rehabilitation.

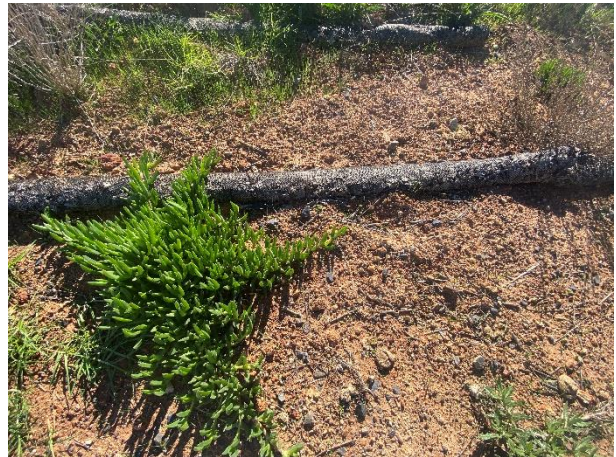
Revegetation established along rehabilitated roadside embankment slopes.

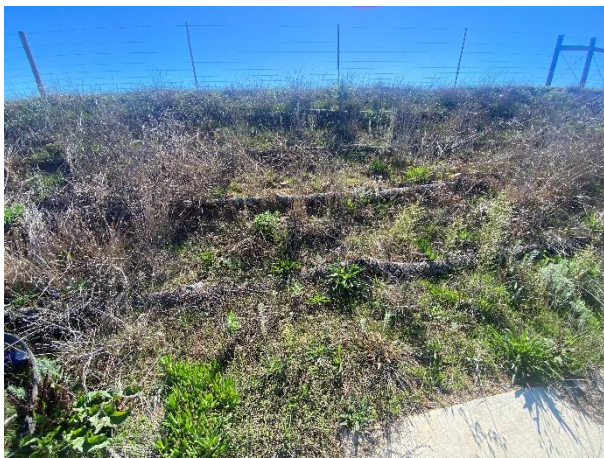
Revegetation established along rehabilitated roadside embankment slopes.

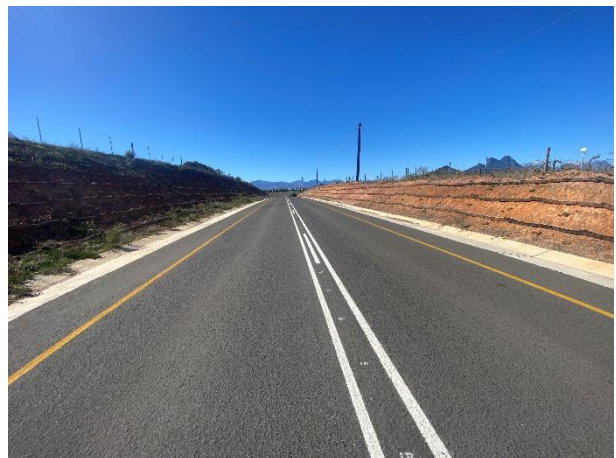
Hessian sausage erosion controls installed for roadside slope rehabilitation.

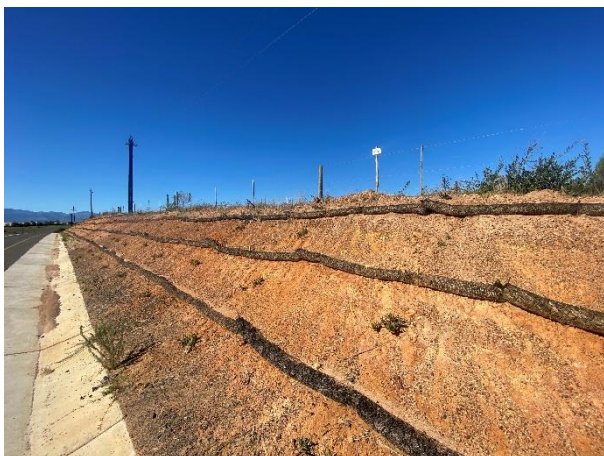
Hessian sausage erosion controls installed for roadside slope rehabilitation.

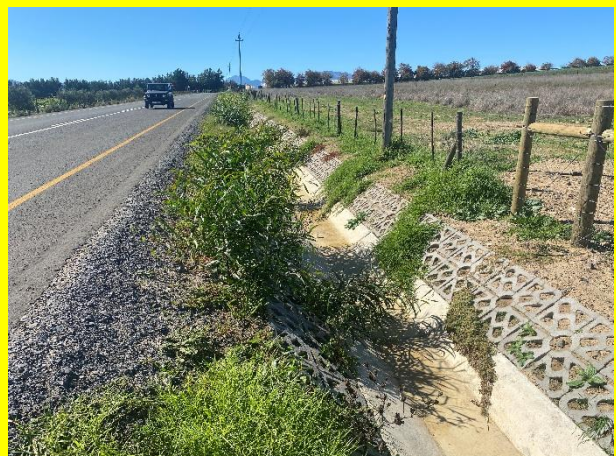
Golden Wreath Wattle observed establishing along the road reserve and stormwater channel.

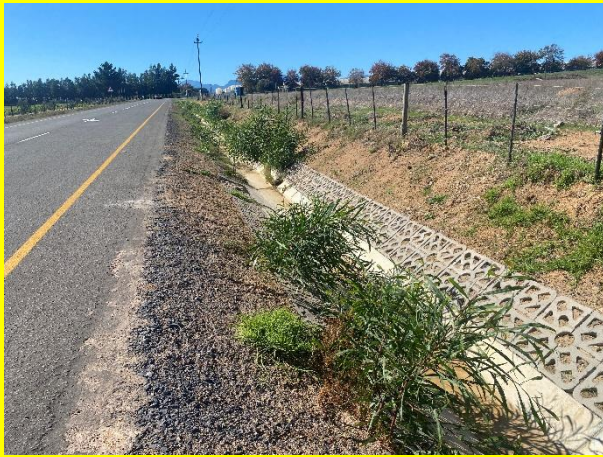
Golden Wreath Wattle observed establishing along the road reserve and stormwater channel.

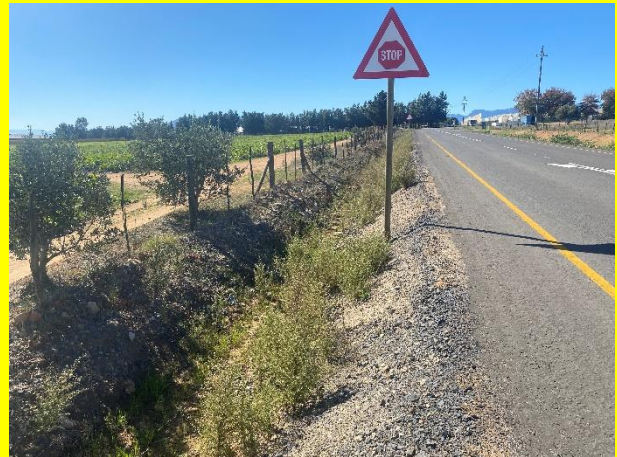
Stinkwort (*Dittrichia graveolens*) observed establishing along the road reserve, requiring ongoing management.

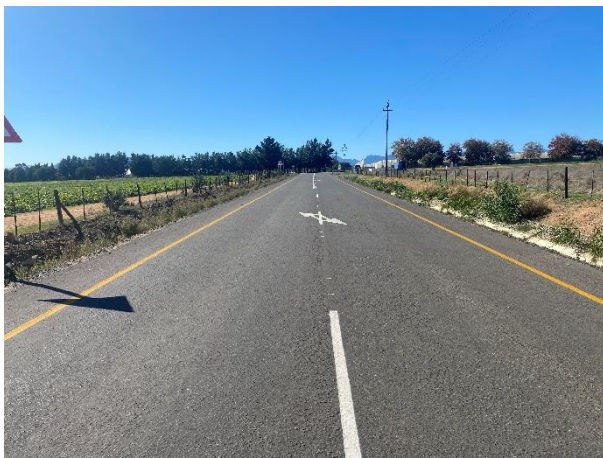
Condition of Protea Road, successfully resurfaced eastern end at the start of the contract.

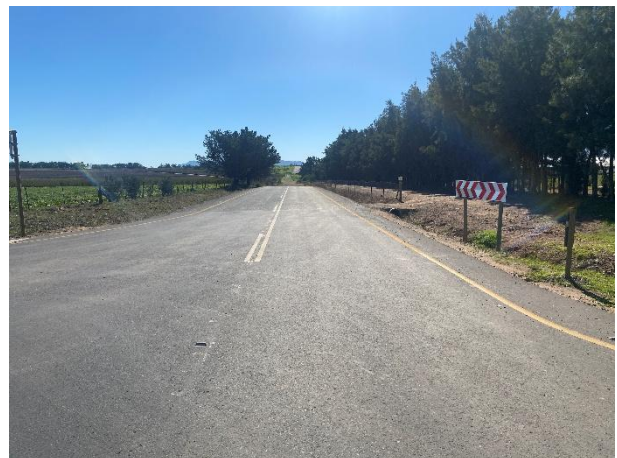
Condition of Protea Road, successfully resurfaced eastern end at the start of the contract.

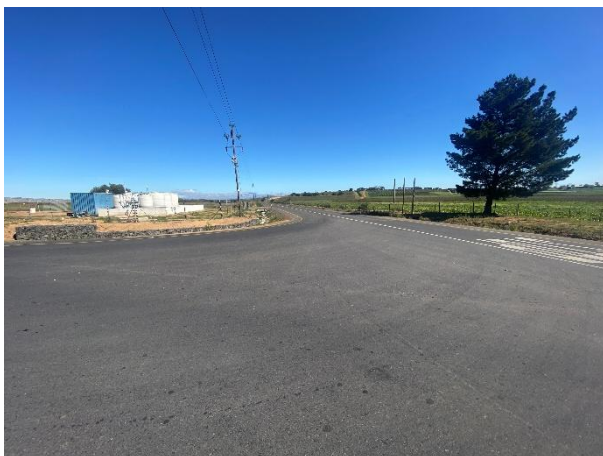
Condition of Protea Road, successfully resurfaced eastern end at the start of the contract.

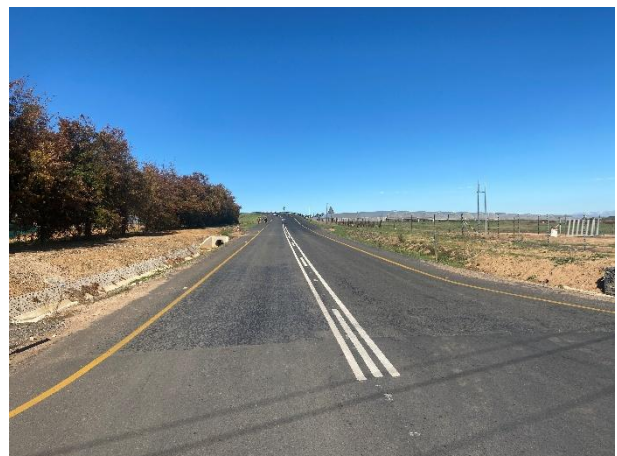
Condition of Protea Road, successfully resurfaced eastern end at the start of the contract.
