**THE UPGRADE OF PROTEA AND MAINTENANCE TO WAARBURGH ROAD NEAR  
JOOSTENBERG VLAKTE, WESTERN CAPE**

Contract No: C1049.03

**FORMAL ECO AUDIT REPORT**

31 May 2024

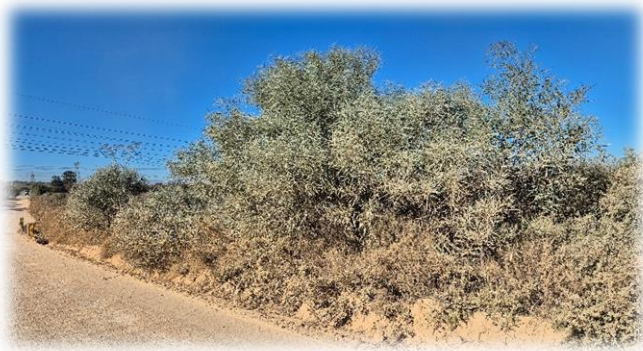
No alien clearing was done to date.

The contractor was advised to please first conduct alien clearing prior to the stripping of the topsoil to prevent alien vegetation within the stockpiled topsoil.

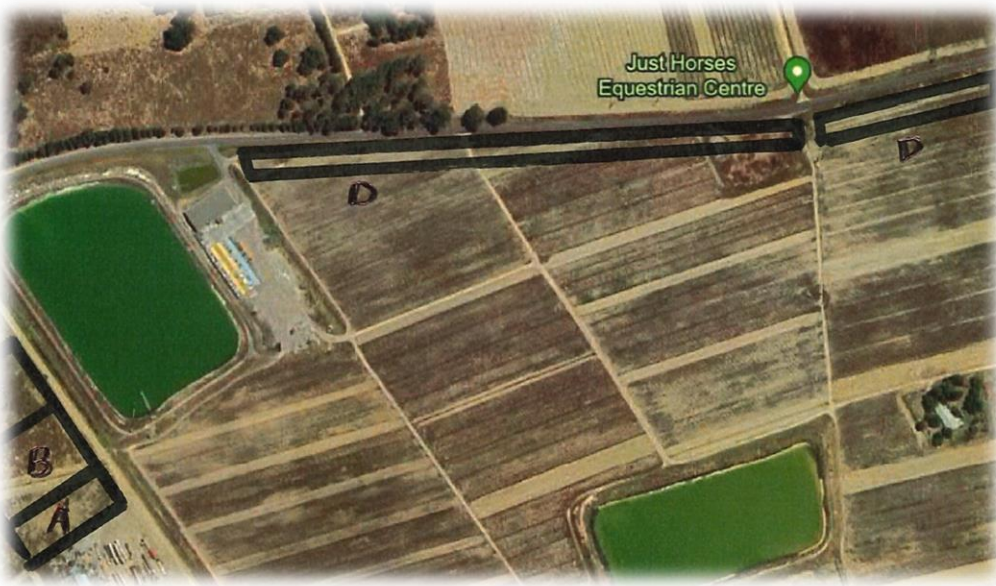
| Spoil Area No. | Comment | ECO Recommendation |
|---|---|---|
| 1. | <p><b>Spoil Area 1 along DR1098 at Approx km11.5 (berm)</b></p> <p>Existing ploughed farmland. The proposal is to create a berm for the farmer along the road with material cut from the road upgrade, only natural material is allowed in the berm and no rubble may be used in the berm.</p> <p>GPS Coordinates: 33°49'19.42"S 18°45'39.74"E</p> | <p>The ECO do not object to area being used as spoil area as the area is existing ploughed farmland. No indigenous vegetation is proposed to be cleared and no watercourses are nearby.</p> <p>Permission letter, prior to spoiling, and happy letter, after spoiling, is</p> |

| | | required from property owner. |

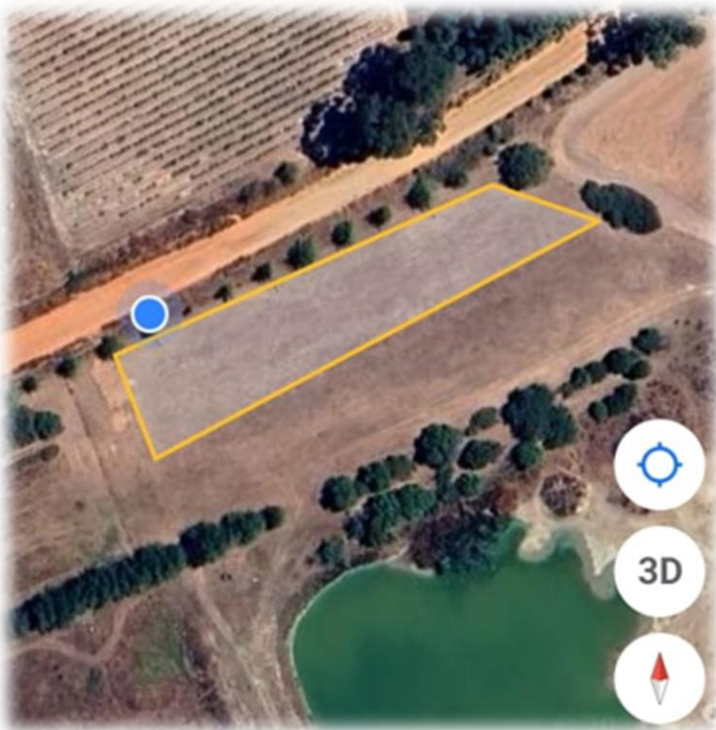
| 2. | <p><b>Spoil Area 2 along DR1098 at Approx km8.3</b></p> <p>Existing farmland with only short grass present, it is unsure if the site was lawfully cleared in the preceding 10 years, but no evidence of indigenous vegetation was noted during the visit. The proposal is to spoil clean material removed from the cuttings and to spread the existing topsoil over the area. Only the area should be used as indicated below.</p> <p>GPS Coordinates: 33°48'51.18"S 18°47'40.53"E</p> | <p>According to google earth it is unsure of the site was cleared in the preceding 10 years. No indigenous vegetation was available during the visit as seen on the photograph. Only the area should be used as seen left.</p> <p>Permission letter, prior to spoiling, and happy letter, after spoiling, is required from property owner.</p> |

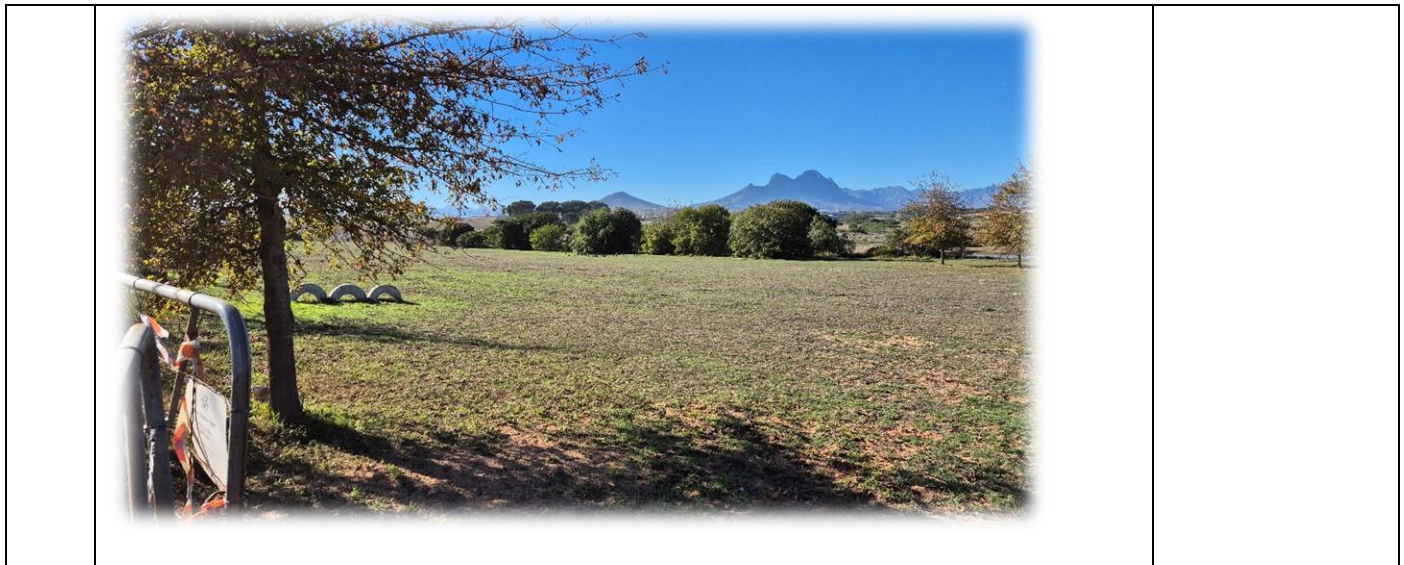
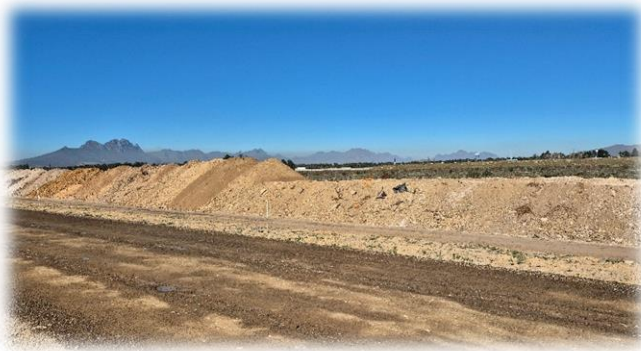
- Spoiling has commenced at Spoil Area 1 for the berm.

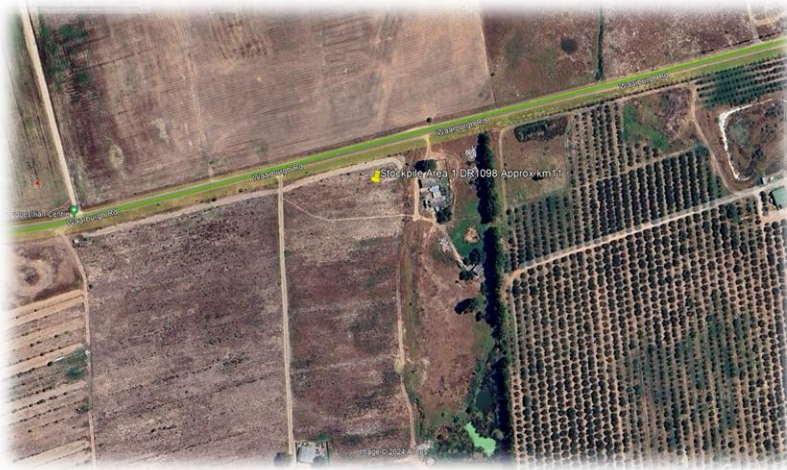
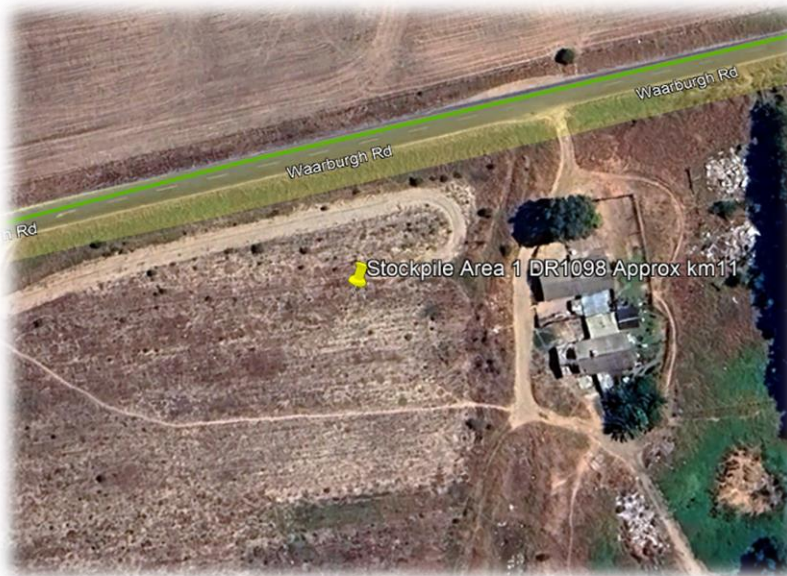
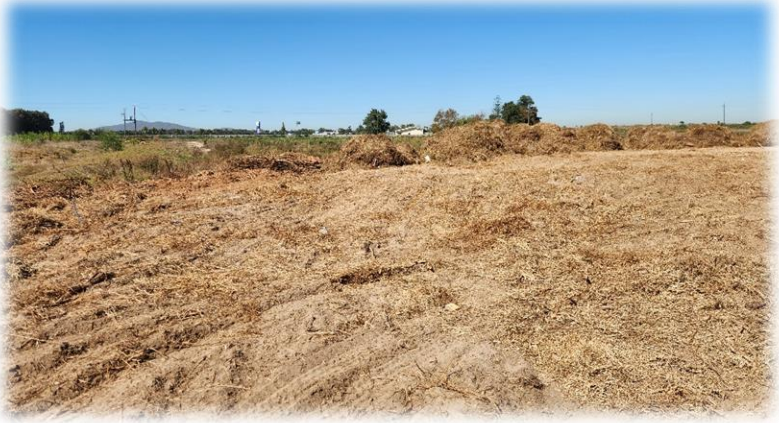
| Stockpile Area No. | Comment | ECO Recommendation |
|---|---|---|
| 1. | <b>Stockpile Area 1 on DR1098 at approx. km11 (LHS)</b><br><br>Existing farmed area. | Permission letter, prior to stockpiling, and happy letter, after stockpiling, |

According to google earth, the area has recently been used for farming (plough land)

The contractor already used the area during the 1<sup>st</sup> ECO visit and area was not scanned prior to the start of using the area.

is required from property owner.

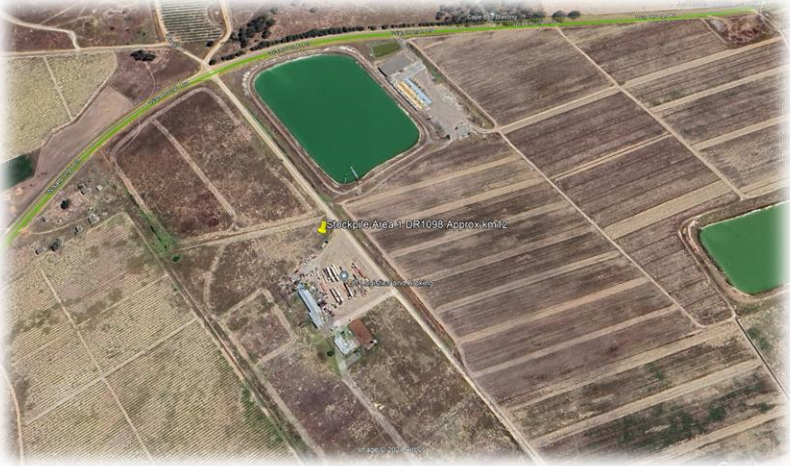
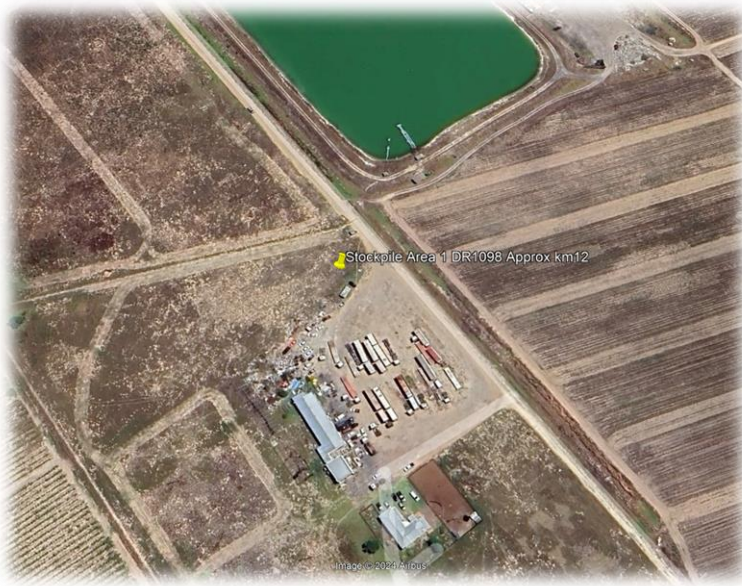
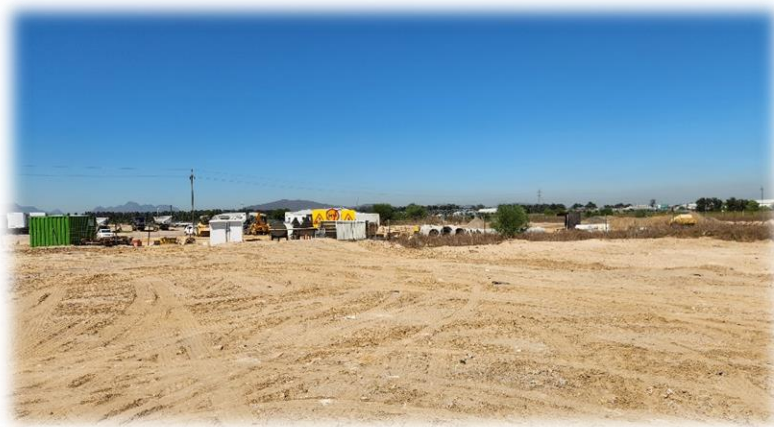
| <p>2.</p> | <p><b>Stockpile Area 2 on DR1098 at approx. km12 (LHS)</b></p> <p>Existing disturbed area, highly invested with alien vegetation. According to google earth the area was recently cleared.</p> <p>The contractor already used the area during the 1<sup>st</sup> ECO visit and area was not scanned prior to the start of using the area.</p> | <p>Permission letter, prior to stockpiling, and happy letter, after stockpiling, is required from property owner.</p> |

The contractor is advised to please inform the ER and ECO of potential stockpile areas prior to the start of using the area.

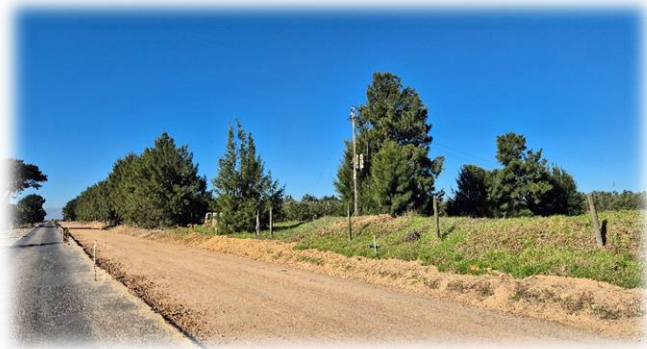
Topsoil has been stripped at a few locations along the site and currently stockpiled at Stockpile Area 1 and 2 above.

It is important to keep record of where topsoil from different sections is stockpiled to ensure the correct topsoil is returned to the same area.

If topsoil is windrowed and kept next to the where the works take place, no damage is allowed to the topsoil. This is to prevent high hydroseeding cost at the end of construction.

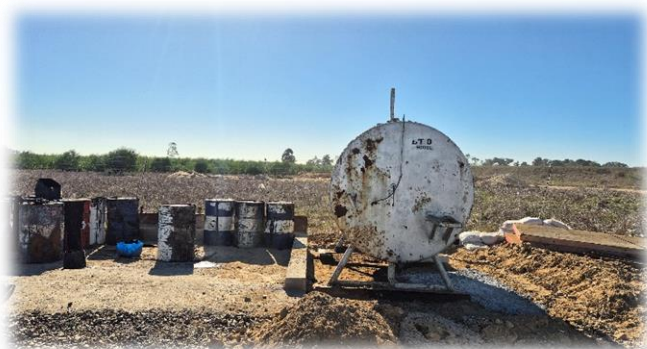
Stockpile Area 2 has been identified to be used as bitumen handling area. The contractor is advised to please ensure impermeable area is created underneath the bitumen tanks to prevent bitumen spills.

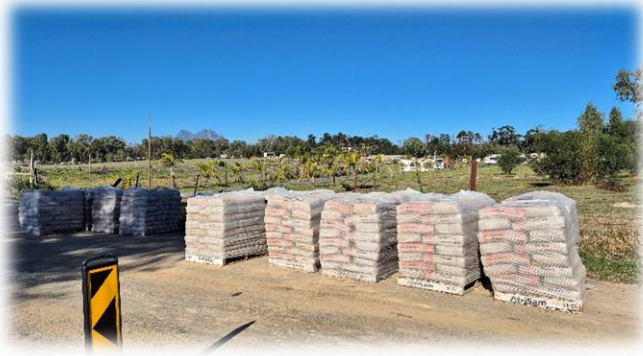
No batching or pouring of concrete was done during the audit. Stabilization of the subbase on certain section has been done to date. The contractor was advised to please pick up empty cement bags on the day they were used to prevent them from blowing around on site.

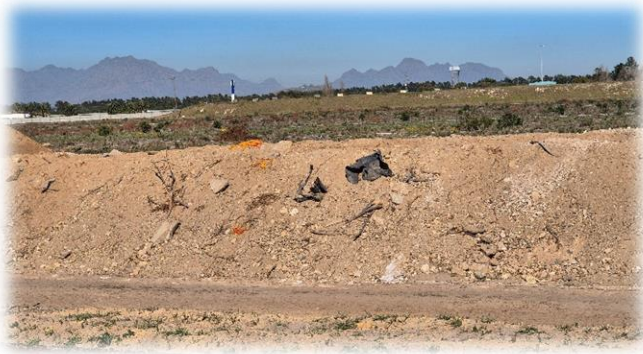
| | Finding | Close Out Recommendation |
|---|---|---|
| 1. | <p><b>Litter</b></p> <p>Litter was noted in the berm mentioned below</p> | <p>The contractor was advised to please remove the litter from the berm as only clean material may be used for the berm.</p> |

Litter was noted in the berm mentioned above, the contractor was advised to please remove the litter from the berm as only clean material may be used for the berm.

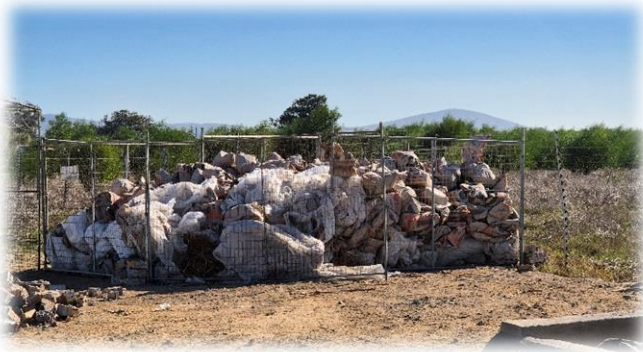
A litter structure was noted at Stockpile Area 2. The contractor is advised to please place empty cement bags into the large white bags or black bags, this is to prevent cement leaching from the bags during rain.

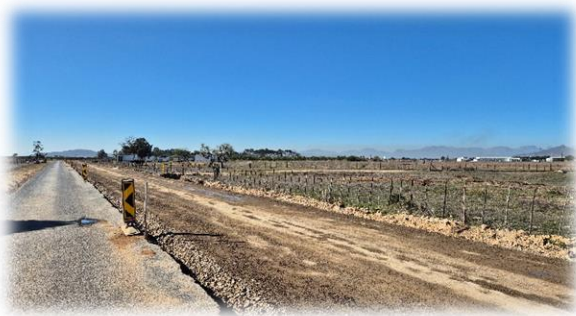
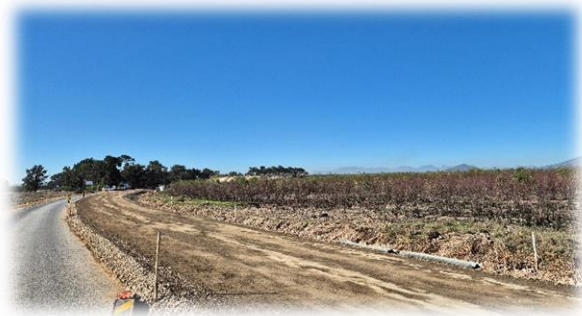
Layer works have commenced on the 1<sup>st</sup> sections of the road and progressing well as well as the temporary widening for the bypass to allow half width construction of the road.
