**THE UPGRADE OF PROTEA AND MAINTENANCE TO WAARBURGH ROAD NEAR  
JOOSTENBERG VLAKTE, WESTERN CAPE**

Contract No: C1049.03

**FORMAL ECO AUDIT REPORT**

## GENERAL FINDINGS DURING SITE VISIT ON THE 24<sup>TH</sup> OF JUNE 2024

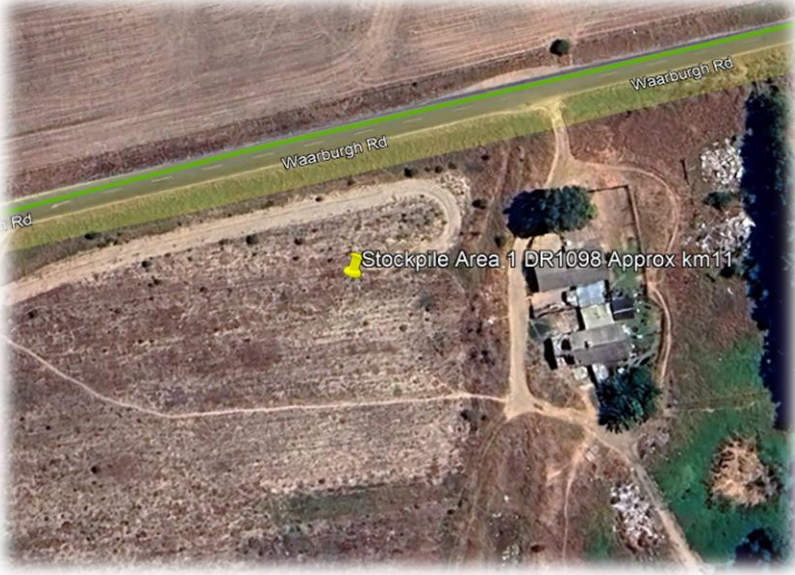
| Stockpile Area No. | Comment | ECO Recommendation |
|---|---|---|
| 1. | <p><b>Stockpile Area 1 on DR1098 at approx. km11 (LHS)</b></p> <p>Existing farmed area.</p> <p>According to google earth, the area has recently been used for farming (plough land)</p> <p>The contractor already used the area during the 1<sup>st</sup> ECO visit and area was not scanned prior to the start of using the area.</p> | <p>Permission letter, prior to stockpiling, and happy letter, after stockpiling, is required from property owner.</p> |

The contractor is advised to please inform the ER and ECO of potential stockpile areas prior to the start of using the area.

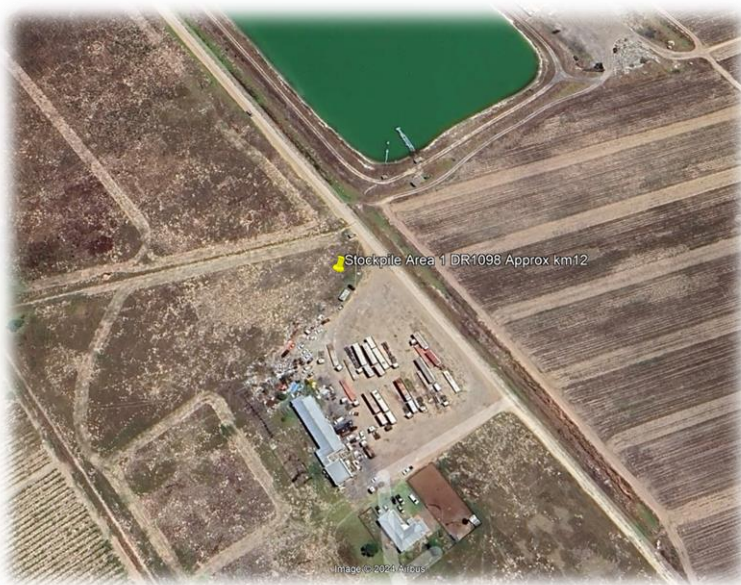
| 2. | <p><b>Stockpile Area 2 on DR1098 at approx. km12 (LHS)</b></p> <p>Existing disturbed area, highly invested with alien vegetation. According to google earth the area was recently cleared.</p> <p>The contractor already used the area during the 1<sup>st</sup> ECO visit and area was not scanned prior to the start of using the area.</p> | <p>Permission letter, prior to stockpiling, and happy letter, after stockpiling, is required from property owner.</p> |

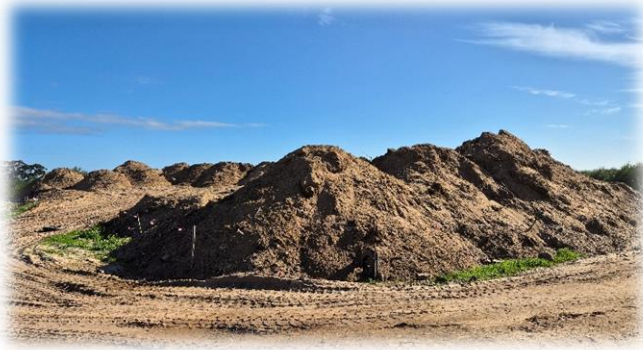
Topsoil has been stripped at a few locations along the site and currently stockpiled at Stockpile Area 1 and 2 above.

It is important to keep record of where topsoil from different sections is stockpiled to ensure the correct topsoil is returned to the same area.

If topsoil is windrowed and kept next to the where the works take place, no damage is allowed to the topsoil. This is to prevent high hydroseeding cost at the end of construction.

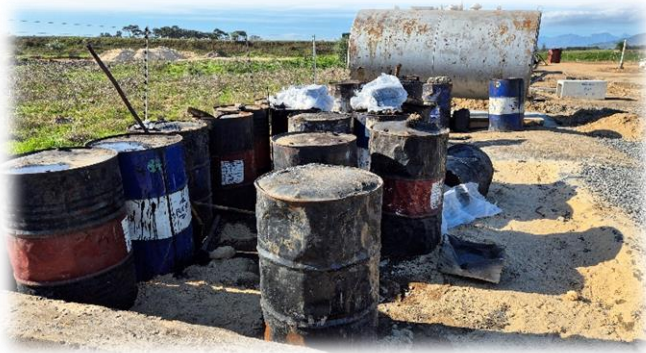
Stockpile Area 2 has been identified to be used as bitumen handling area. The contractor is advised to please ensure impermeable area is created underneath the bitumen tanks to prevent bitumen spills.

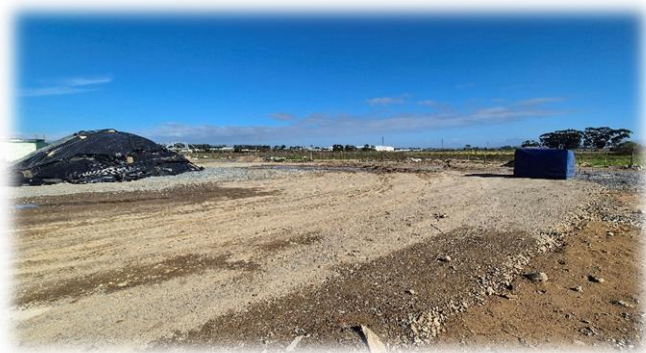
A hard stand area was created for the pre-coating of the seal stone and is sufficient.

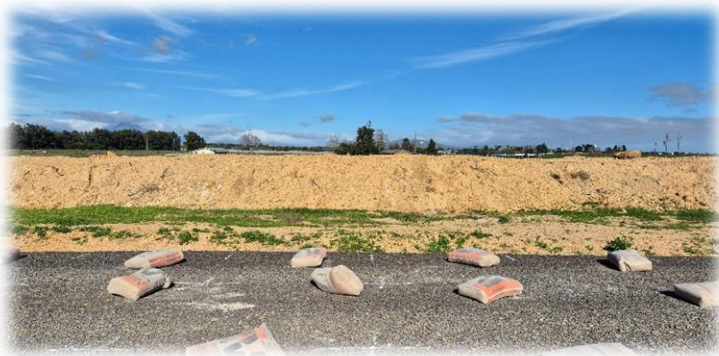
No batching or pouring of concrete was done during the audit. Stabilization of the subbase on certain section has been done to date.

The contractor was advised to please pick up empty cement bags on the day they were used to prevent them from blowing around on site.

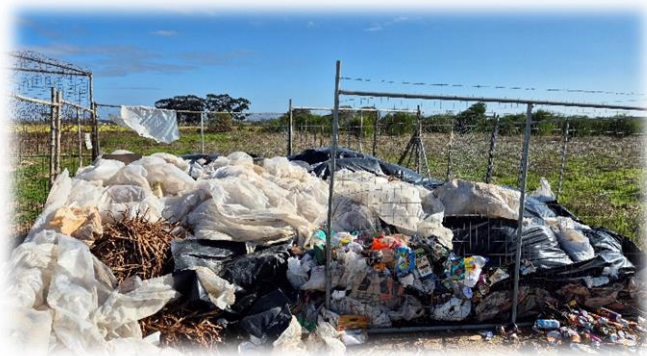
A litter structure was noted at Stockpile Area 2. The contractor is advised to regularly please remove litter from the litter structure to be disposed at a registered landfill site. Please forward proof of appropriate disposal to the ECO and ER.

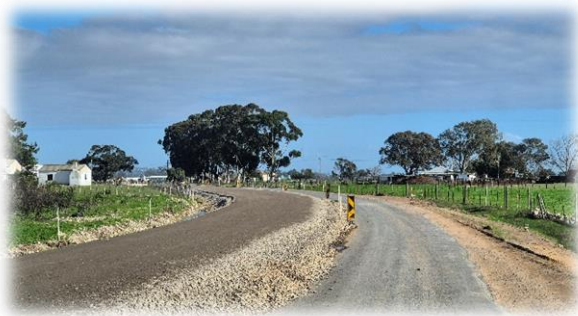
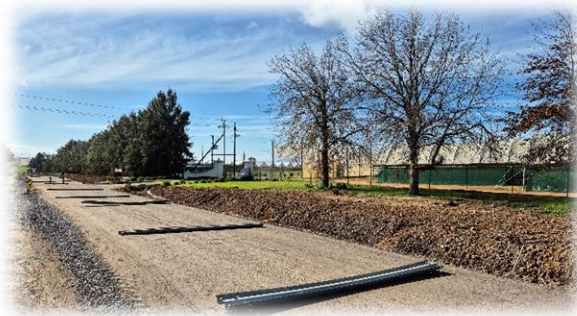
Layer works have commenced on the 1<sup>st</sup> sections of the road and progressing well as well as the temporary widening for the bypass to allow half width construction of the road.
