**THE UPGRADE OF PROTEA AND MAINTENANCE TO WAARBURGH ROAD NEAR  
JOOSTENBERG VLAKE, WESTERN CAPE**

Contract No: C1049.03

**FORMAL ECO AUDIT REPORT**

9 September 2024

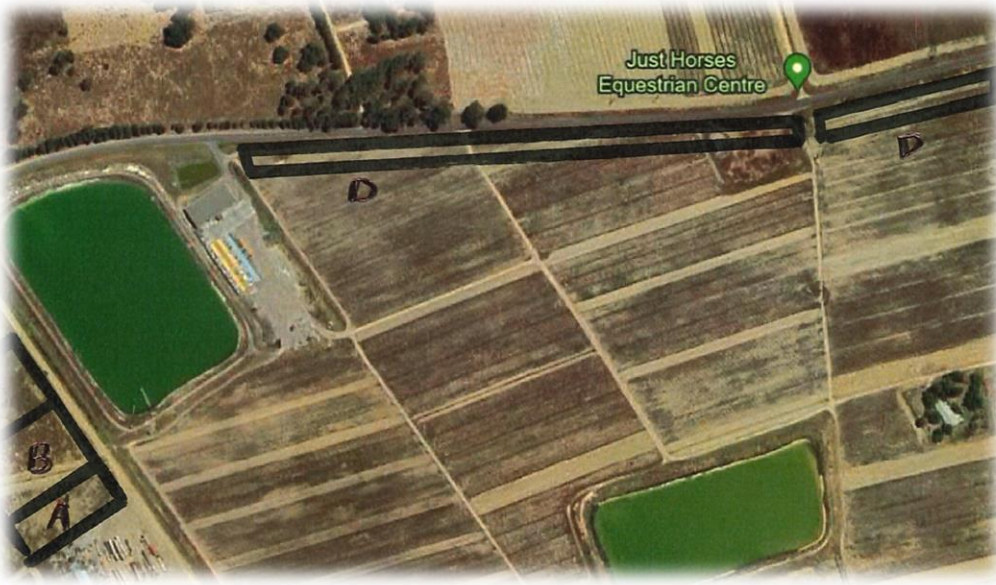
| Spoil Area No. | Comment | ECO Recommendation |
|---|---|---|
| 1. | <p><b>Spoil Area 1 along DR1098 at Approx km11.5 (berm)</b></p> <p>Existing ploughed farmland. The proposal is to create a berm for the farmer along the road with material cut from the road upgrade, only natural material is allowed in the berm and no rubble may be used in the berm.</p> <p>GPS Coordinates: 33°49'19.42"S 18°45'39.74"E</p> | <p>The ECO do not object to area being used as spoil area as the area is existing ploughed farmland. No indigenous vegetation is proposed to be cleared and no watercourses are nearby.</p> <p>Permission letter, prior to spoiling, and happy letter, after spoiling, is required from property owner.</p> |

- Spoiling has commenced at Spoil Area 1 for the berm.

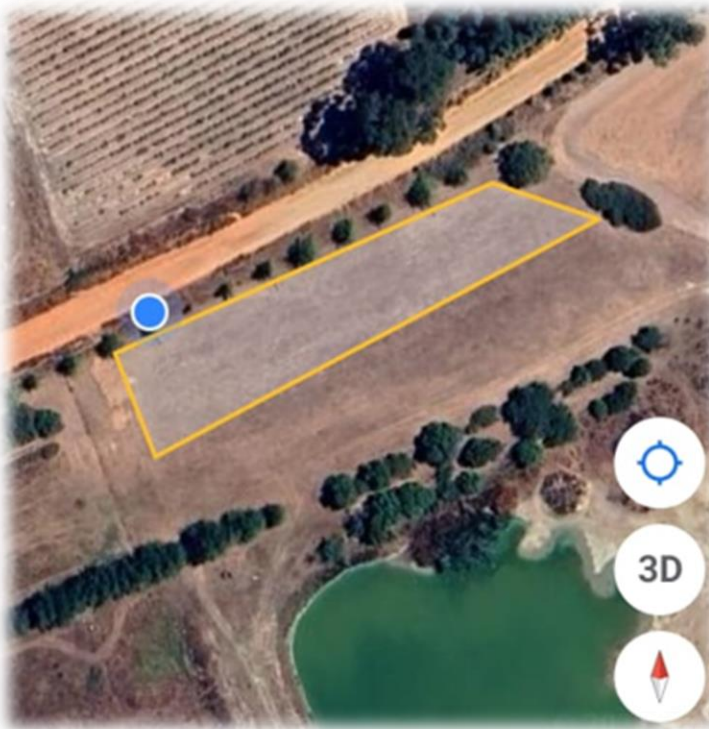
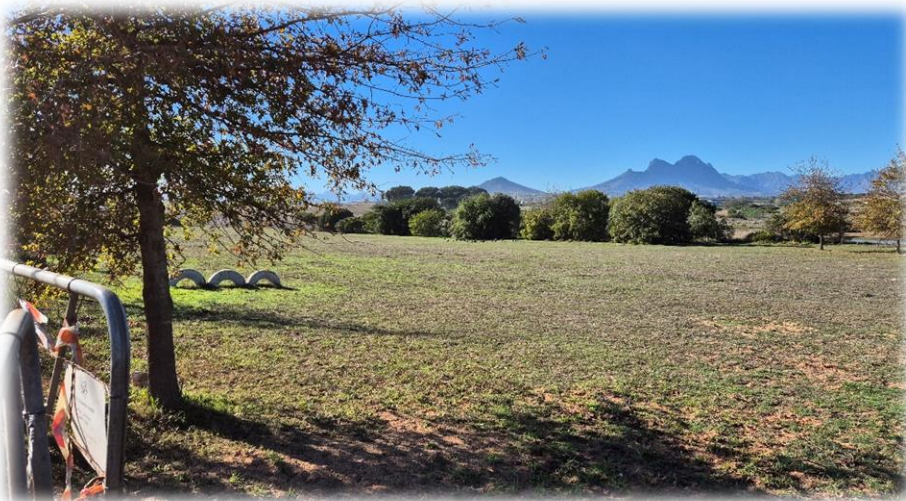
Existing farmland with only short grass present, it is unsure if the site was lawfully cleared in the preceding 10 years, but no evidence of indigenous vegetation was noted during the visit. The proposal is to spoil clean material removed from the cuttings and to spread the existing topsoil over the area. Only the area should be used as indicated below.

was cleared in the preceding 10 years. No indigenous vegetation was available during the visit as seen on the photograph. Only the area should be used as seen left.

Permission letter, prior to spoiling, and happy letter, after spoiling, is required from property owner.

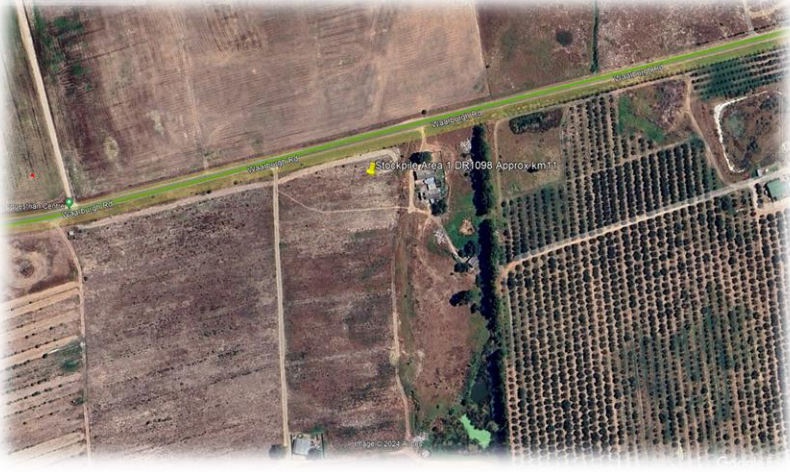
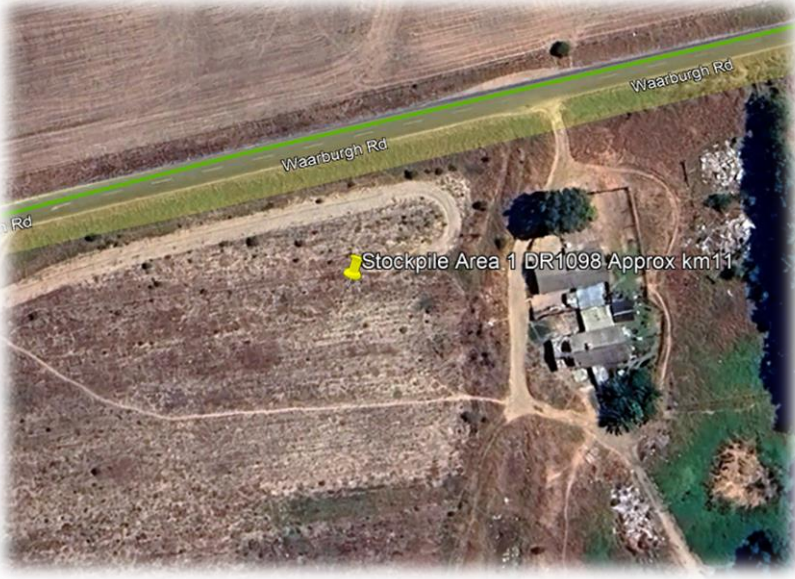
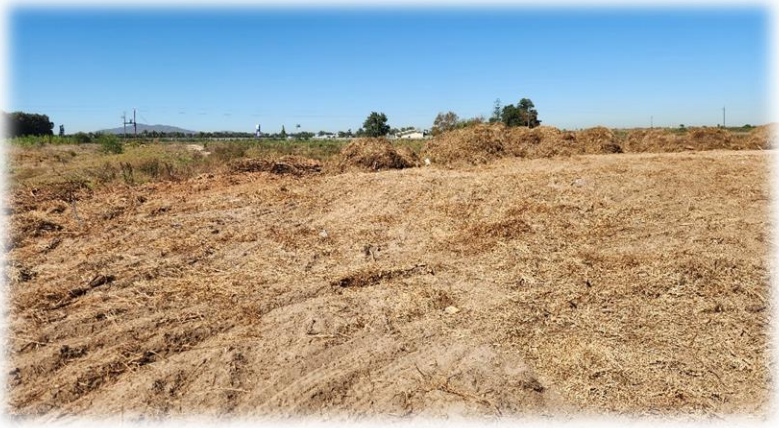
| Stockpile Area No. | Comment | ECO Recommendation |
|---|---|---|
| 1. | <p><b>Stockpile Area 1 on DR1098 at approx. km11 (LHS)</b></p> <p>Existing farmed area.</p> <p>According to google earth, the area has recently been used for farming (plough land)</p> <p>The contractor already used the area during the 1<sup>st</sup> ECO visit and area was not scanned prior to the start of using the area.</p> | <p>Permission letter, prior to stockpiling, and happy letter, after stockpiling, is required from property owner.</p> |

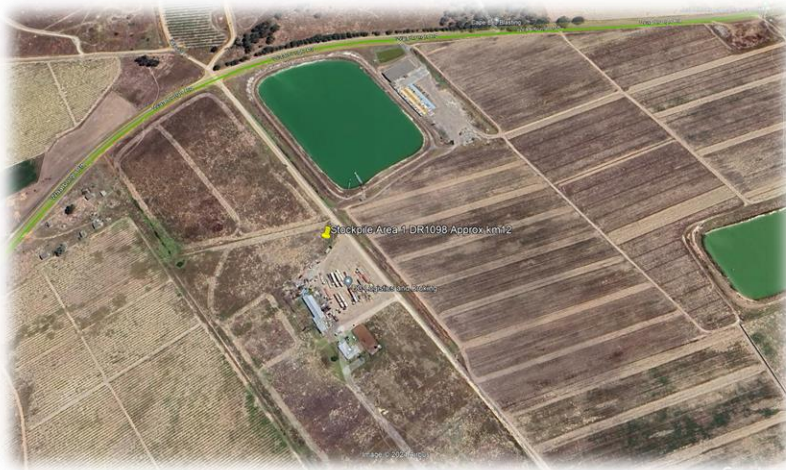
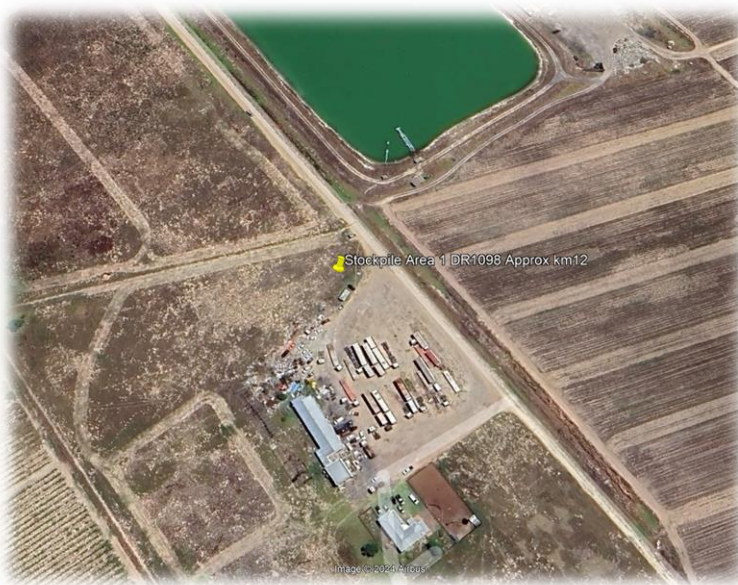
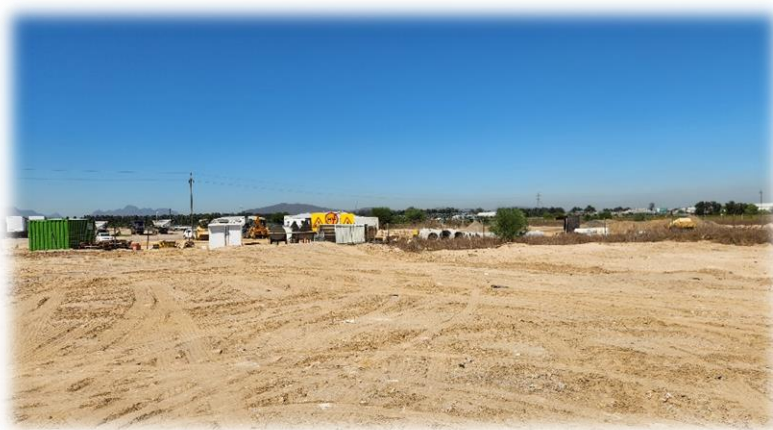
| <p>2.</p> | <p><b>Stockpile Area 2 on DR1098 at approx. km12 (LHS)</b></p> <p>Existing disturbed area, highly invested with alien vegetation. According to google earth the area was recently cleared.</p> <p>The contractor already used the area during the 1<sup>st</sup> ECO visit and area was not scanned prior to the start of using the area.</p> | <p>Permission letter, prior to stockpiling, and happy letter, after stockpiling, is required from property owner.</p> |

The contractor is advised to please inform the ER and ECO of potential stockpile areas prior to the start of using the area.

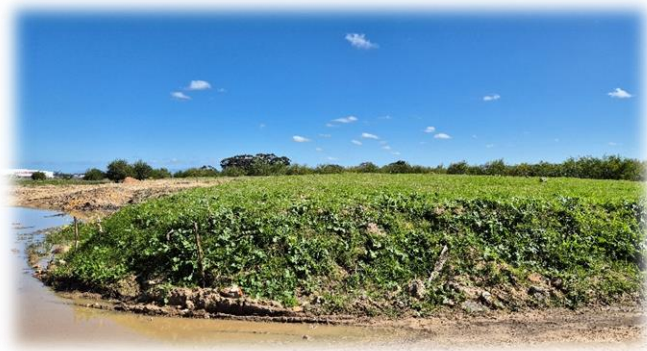
Topsoil has been stripped at a few locations along the site and currently stockpiled at Stockpile Area 1 and 2 above.

It is important to keep record of where topsoil from different sections is stockpiled to ensure the correct topsoil is returned to the same area.

If topsoil is windrowed and kept next to the where the works take place, no damage is allowed to the topsoil. This is to prevent high hydroseeding cost at the end of construction.

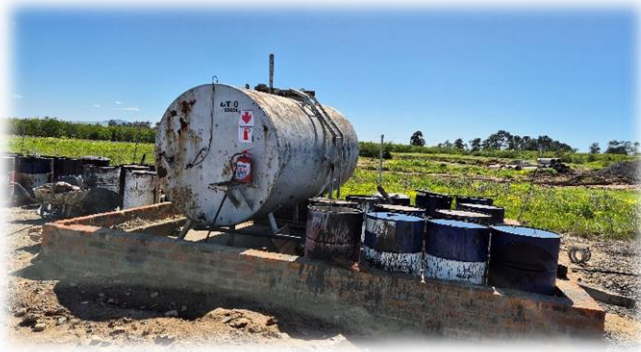
Stockpile Area 2 has been identified to be used as bitumen handling area. The contractor is advised to please ensure impermeable area is created underneath the bitumen tanks to prevent bitumen spills, the bunded wall underneath the tanks has been completed. The contractor confirmed verbally that the bunded area could store 10% more than the capacity of the tank.

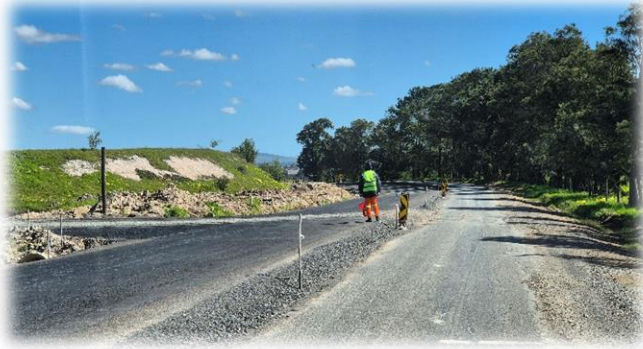
The road surface at the Klipheuwel Intersection was clean during the audit, please ensure that areas to the stockpile and spoil sites are kept clean from mud/sand to prevent the material being a danger to traffic.

The road surface was clean during the audit.

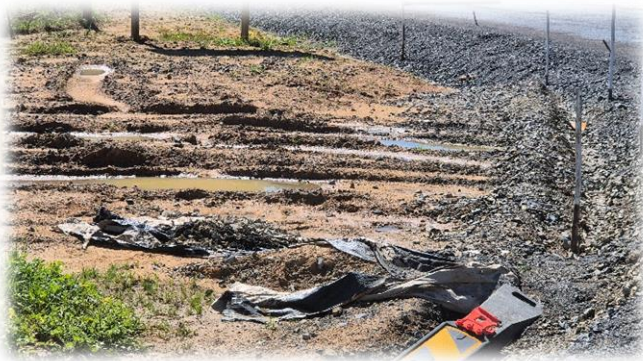
| | Finding | Close Out Recommendation |
|---|---|---|
| 1. | <p><b>Litter</b></p> <p>Bitumen paper was noted during the audit.</p> | <p>The contractor was advised to please remove bitumen paper on the day bitumen was sprayed.</p> |

Bitumen paper was noted during the audit, the contractor was advised to please remove bitumen paper on the day bitumen was sprayed.

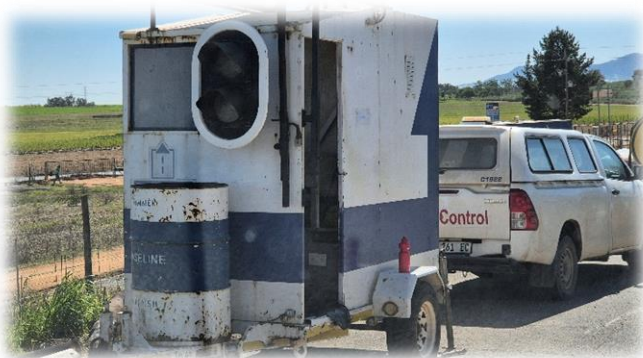
Bins were noted at the closures.

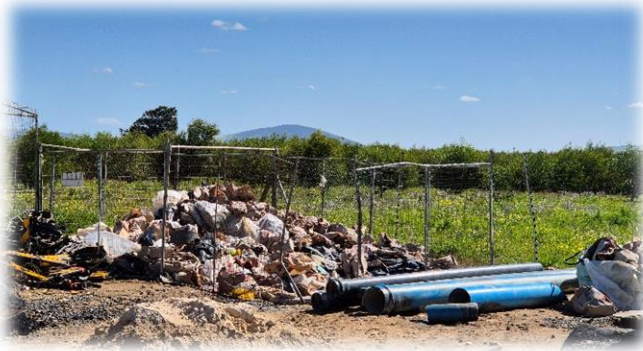
A litter structure was noted at Stockpile Area 2. The contractor is advised to regularly please remove litter from the litter structure to be disposed at a registered landfill site. Please forward proof of appropriate disposal to the ECO and ER.

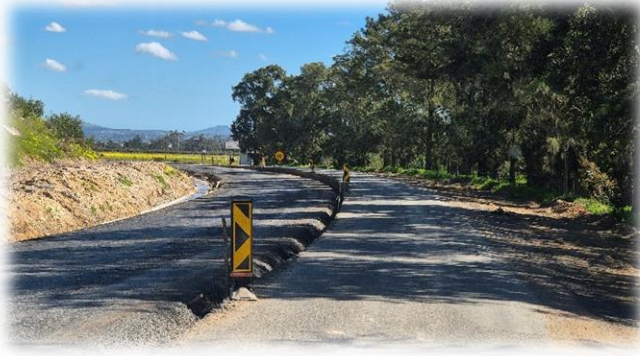
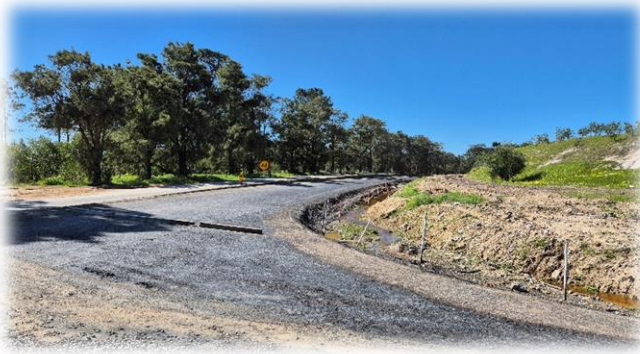
Layer works have commenced on the 1<sup>st</sup> sections of the road, progress was very slow during July due to the rainy conditions and underway again.
