## APPENDIX A – SITE PHOTOGRAPHS

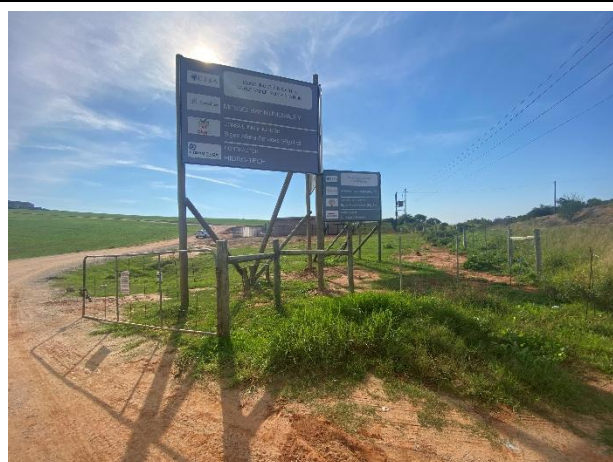
Signage in place at the entrance of the site off the R102.

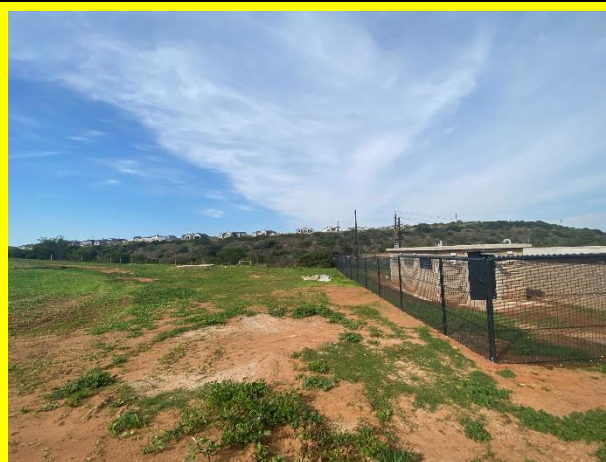
Hydroseeding surrounding the pump station in progress, minor builders' rubble to be removed.

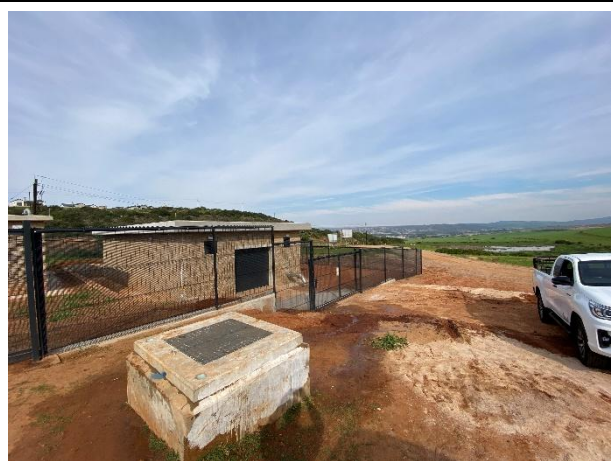
Pump station has been fully fenced in with ClearVu fencing.

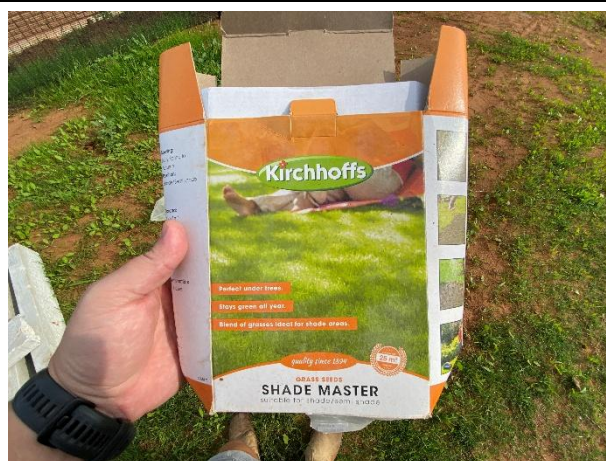
Mixed grass seeds used for rehabilitation within the pump station.

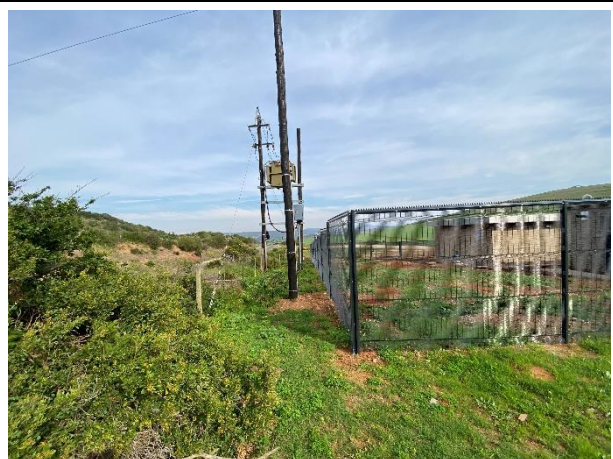
Condition of the constructed pump station along the R102 towards the south

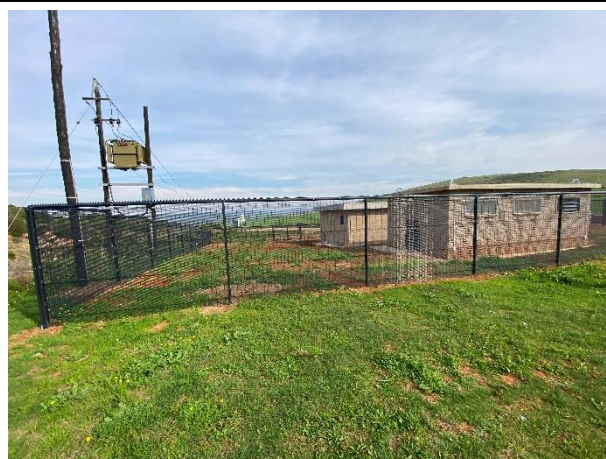
Condition of the constructed pump station and fencing along the R102 towards the south.

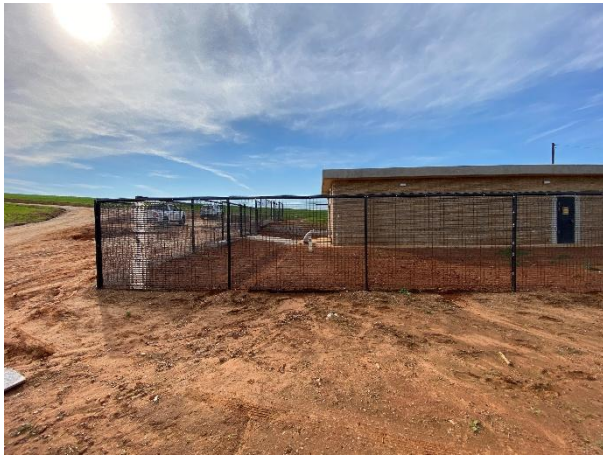
Condition of the constructed pump station and fencing as seen towards the northeast.

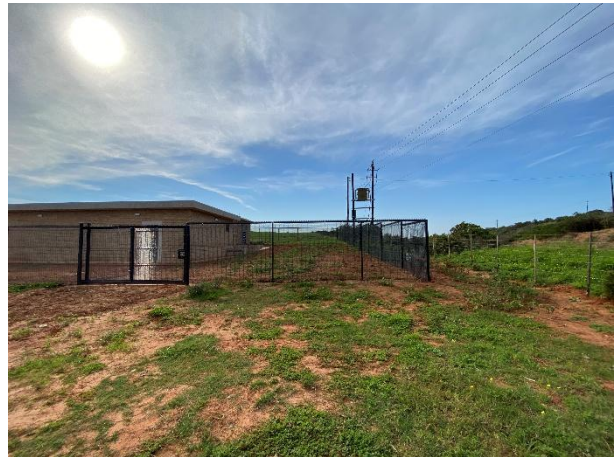
Condition of the constructed pump station and fencing along the R102 towards the north.

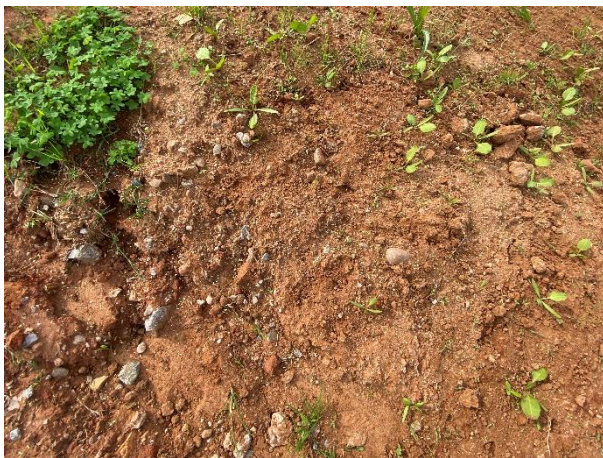
Hydroseeding within the pump station completed.

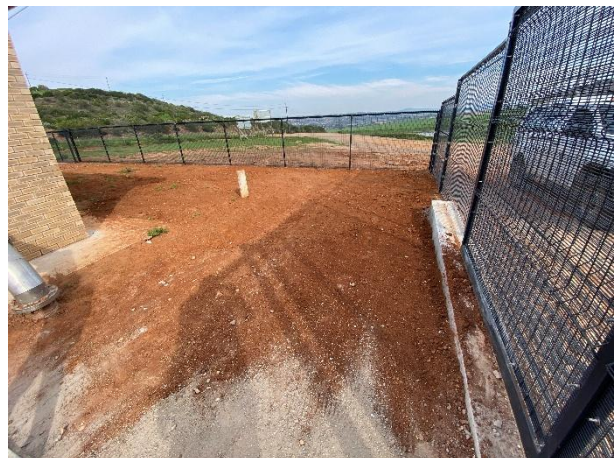
Fully rehabilitated site camp area within the pump station boundary, soil ripped, and topsoil reused. Drainage channel created for stormwater dispersal.

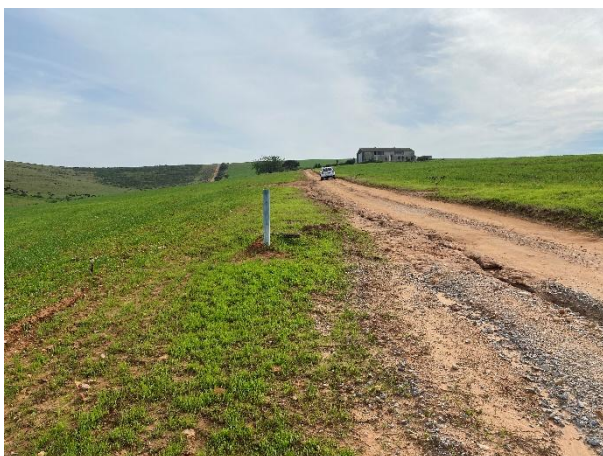
Road and surrounding agricultural fields towards the reservoir.

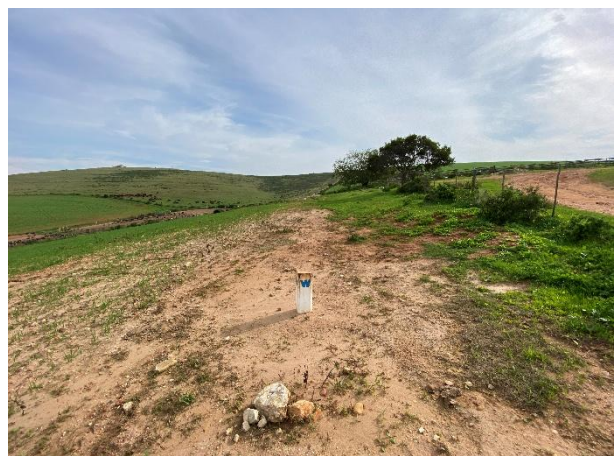
Installed gravity pipeline network and surrounding vegetation regrowth towards the northwest.

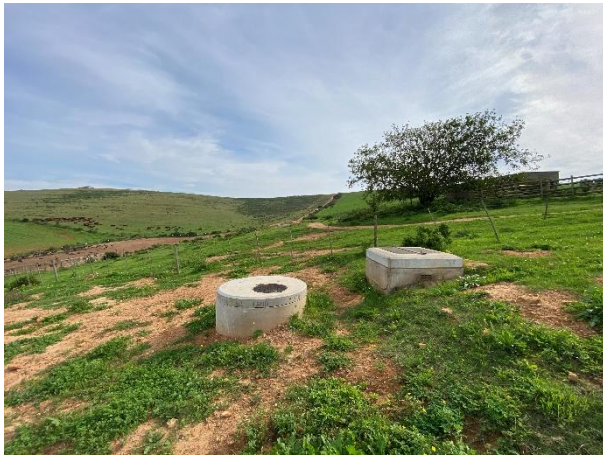
Installed gravity pipeline network and associated manhole infrastructure adjacent to the farm shed.

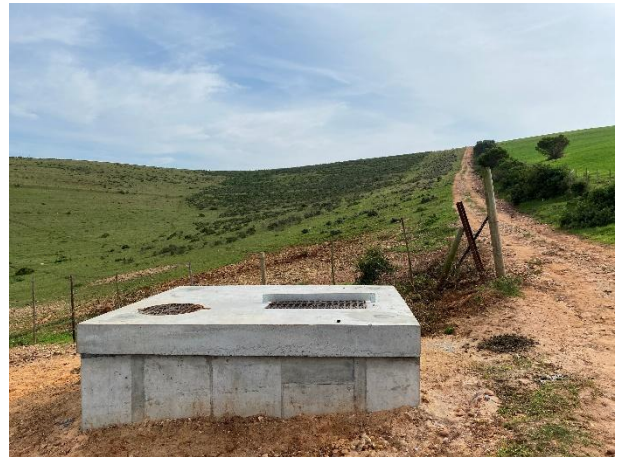
Installed gravity pipeline network and associated manhole infrastructure adjacent to the farm shed.

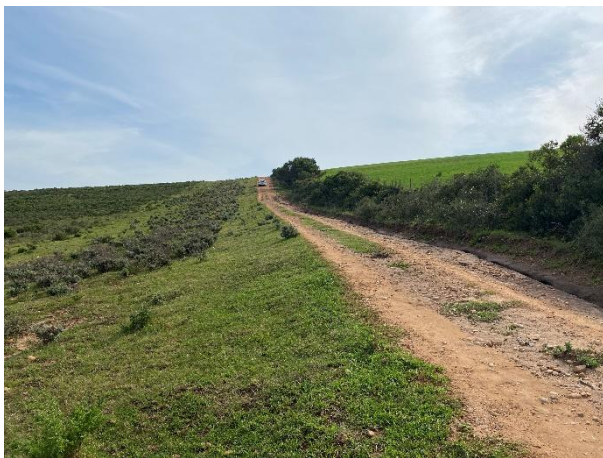
Condition of the existing farm tracks and surrounding vegetation.

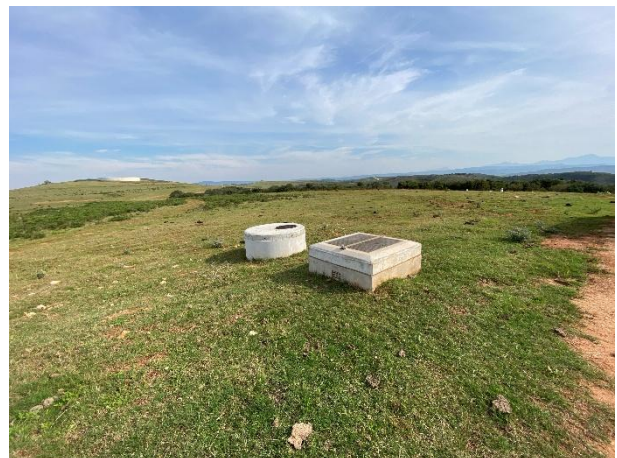
Installed gravity pipeline network and associated manhole infrastructure towards the northwest.

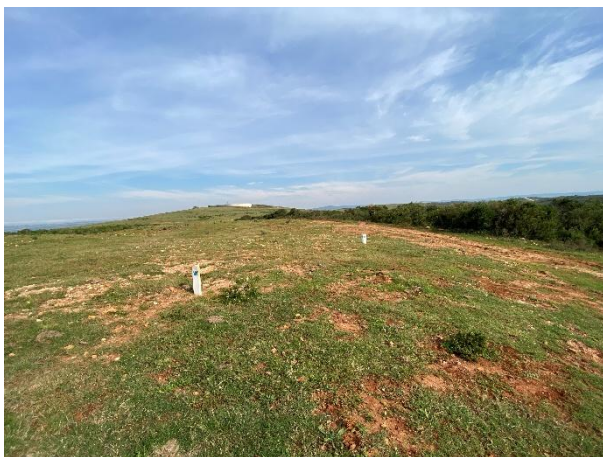
Installed gravity pipeline network towards the southwest, natural vegetation along the western boundary intact.

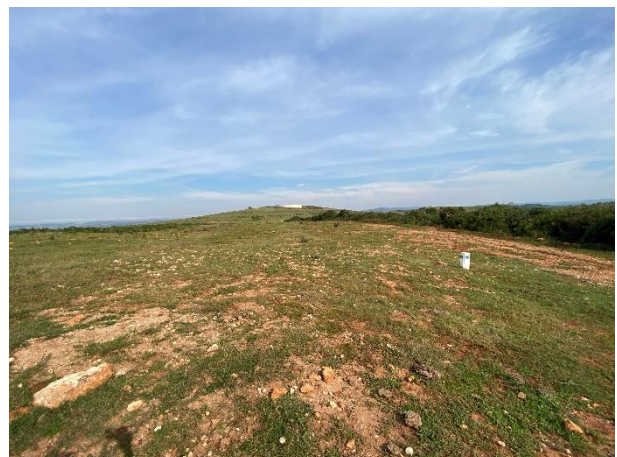
Installed gravity pipeline network towards the southwest, natural vegetation along the western boundary intact.

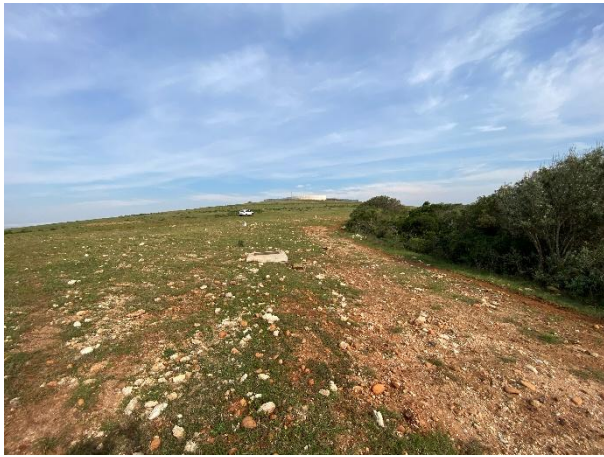
Installed gravity pipeline network towards the southwest, natural vegetation along the western boundary intact.

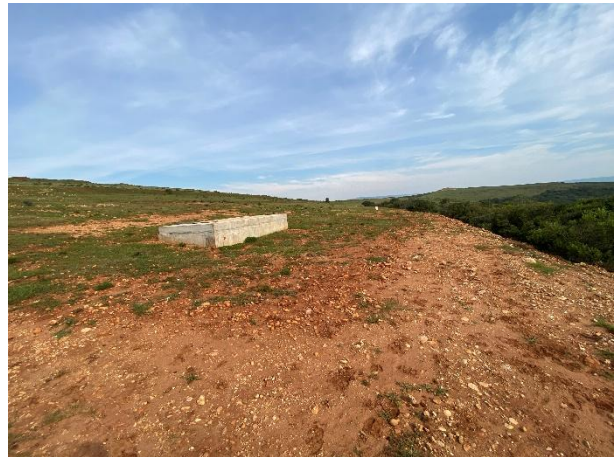
Installed gravity pipeline network and associated infrastructure towards the southwest.

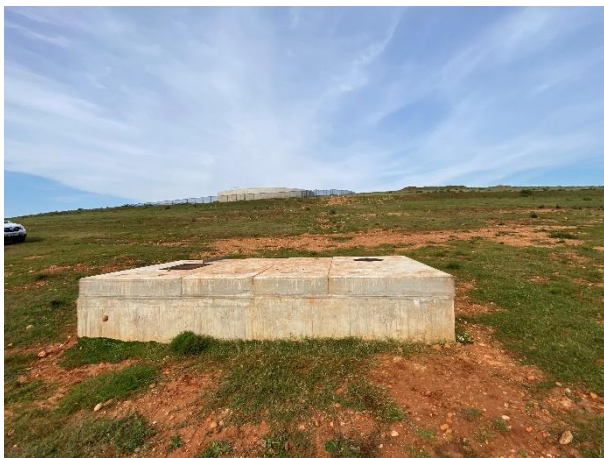
Condition of the associated potable water network infrastructure towards the southwest.

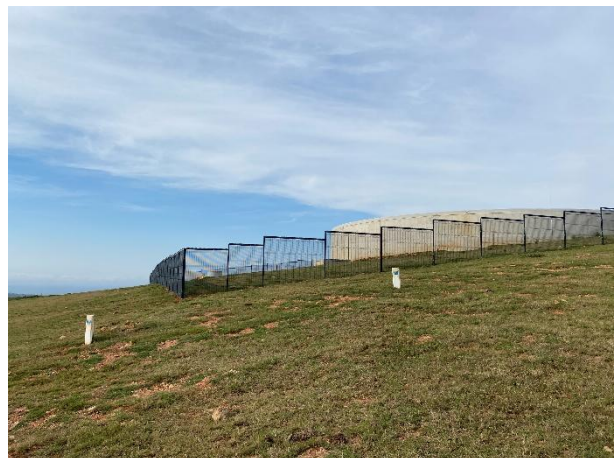
Connection of the gravity-fed pipeline network to the existing 7 Ml reservoir as seen towards the southwest.

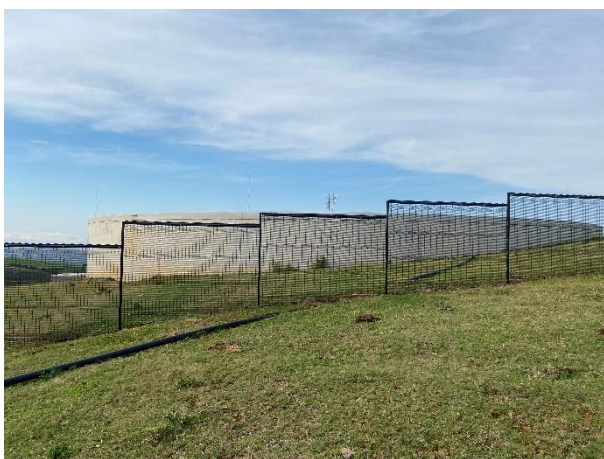
Existing 7 Ml reservoir fully fenced with ClearVu fencing as seen towards the southeast.

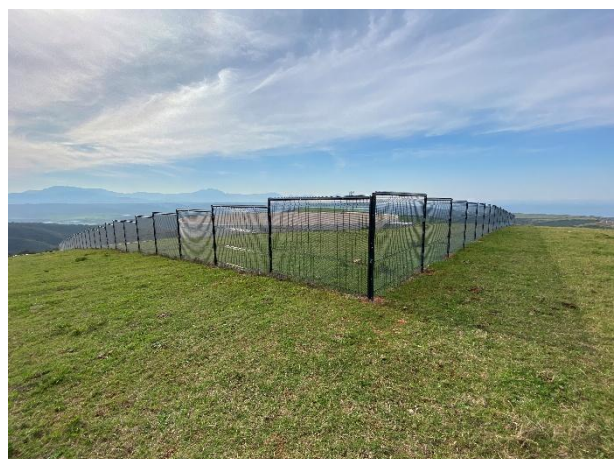
Existing 7 Ml reservoir fully fenced with ClearVu fencing.

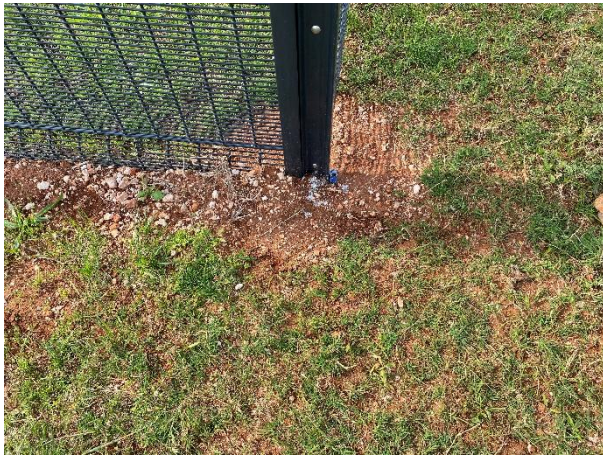
Surveyor peg for the fence installation.

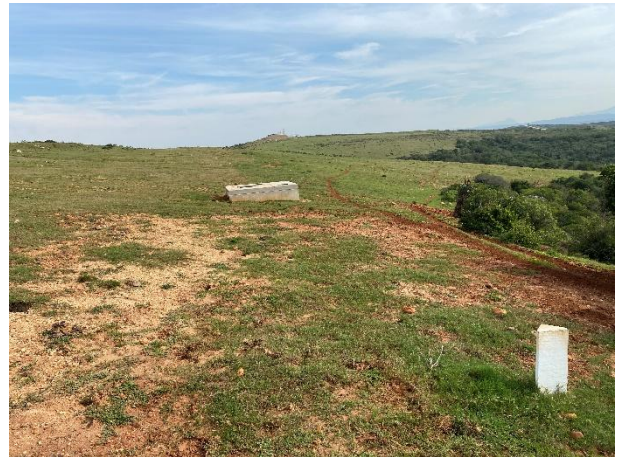
Installed gravity pipeline network and associated infrastructure towards the 1 Ml reservoir servicing Monte Christo Retirement Village.

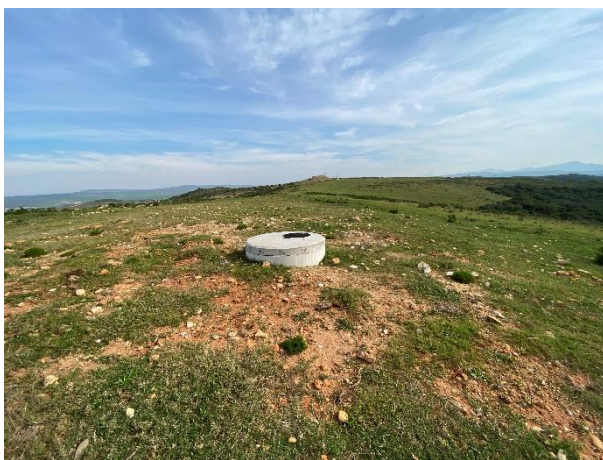
Installed gravity pipeline network and associated infrastructure towards the 1 Ml reservoir

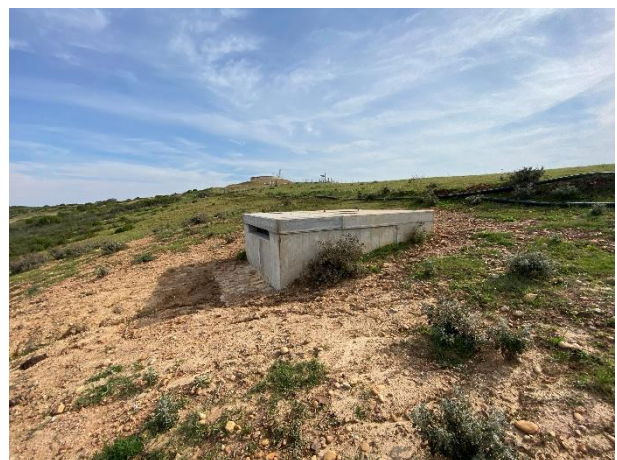
Installed gravity pipeline network and associated infrastructure towards the 1 Ml reservoir

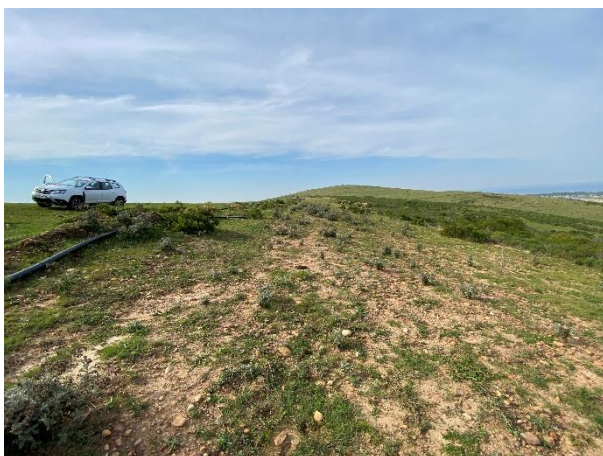
Installed gravity pipeline network and associated infrastructure towards the southeast.

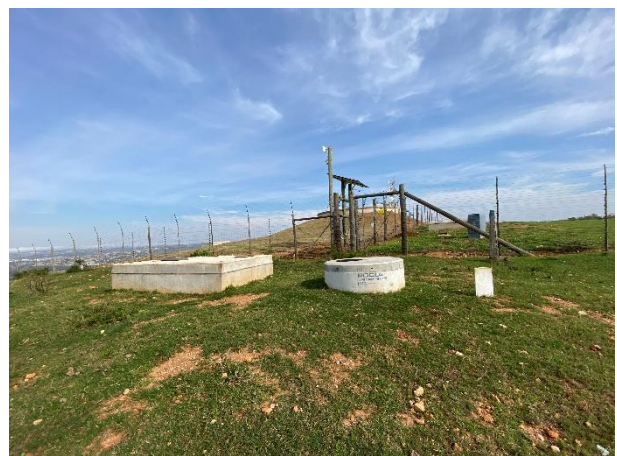
Installed gravity pipeline network and associated infrastructure towards the 1 Ml reservoir.

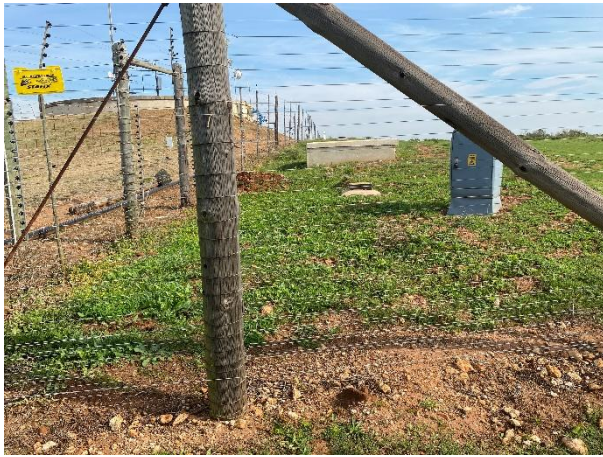
Fencing in place surrounding the 1 Mℓ reservoir servicing Monte Christo Retirement Village.

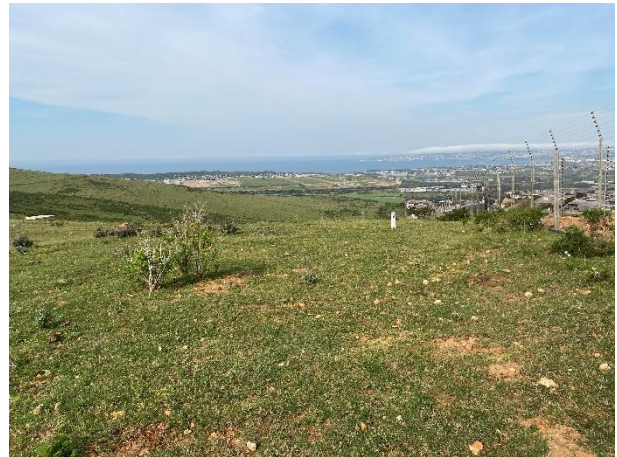
Installed gravity pipeline network connection from the 1 Mℓ reservoir towards the southeast.

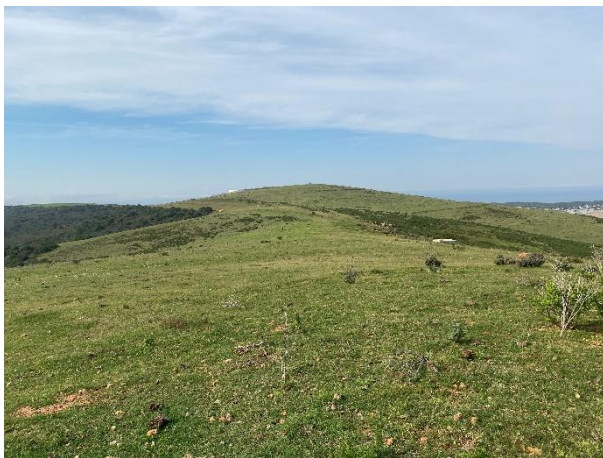
Installed gravity pipeline network connection from the 1 Mℓ reservoir towards the southeast.

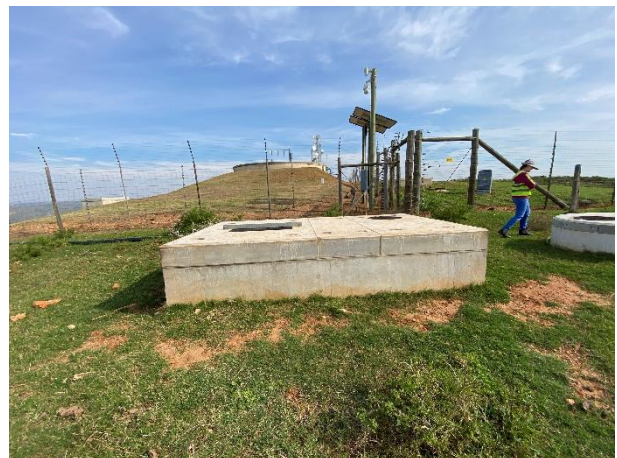
Installed gravity pipeline network and associated infrastructure towards the 1 Mℓ reservoir.

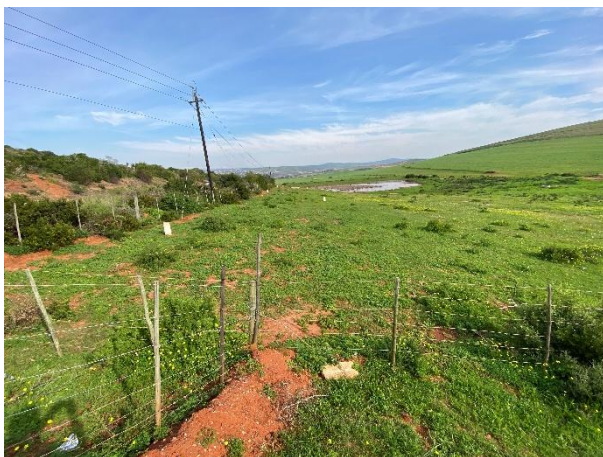
Installed gravity pipeline network along the R102 towards the southwest. Adequate vegetation regrowth.

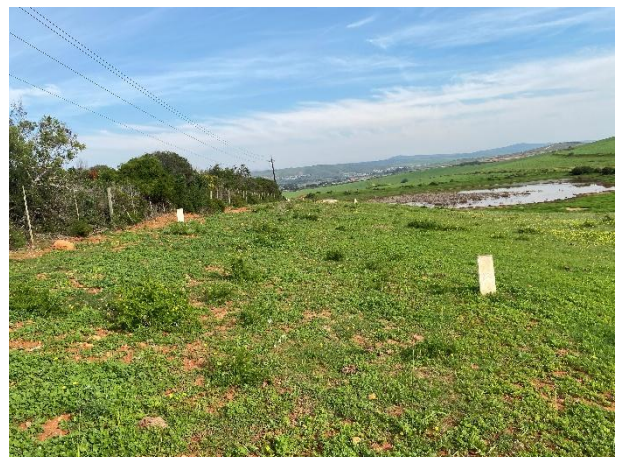
Installed gravity pipeline network along the R102 towards the southwest. Adequate vegetation regrowth.

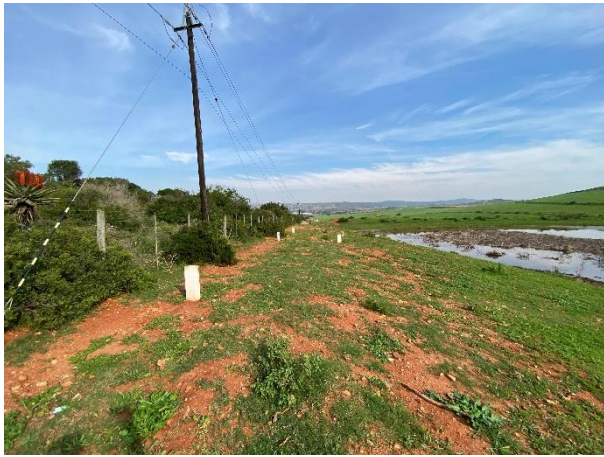
Installed gravity pipeline network along the R102 towards the southwest. Adequate vegetation regrowth.

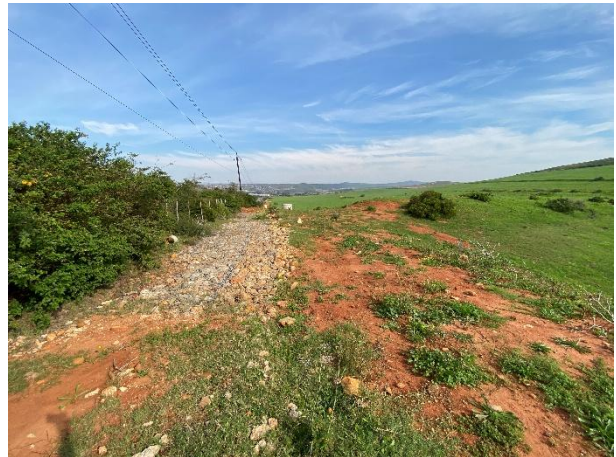
Installation of gabion mattresses along the pipeline route.

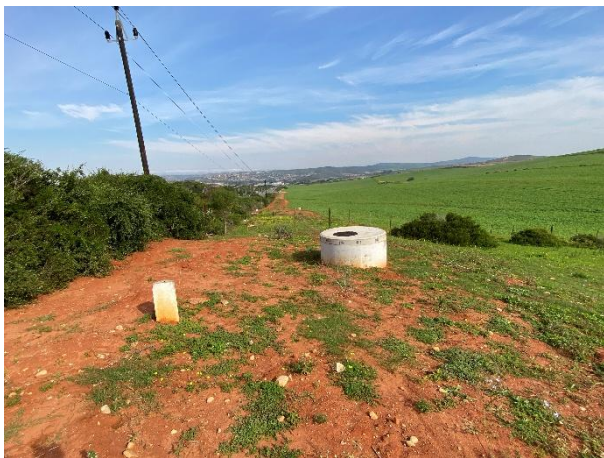
Installed gravity pipeline network and associated manhole infrastructure along the R102 towards the southwest.

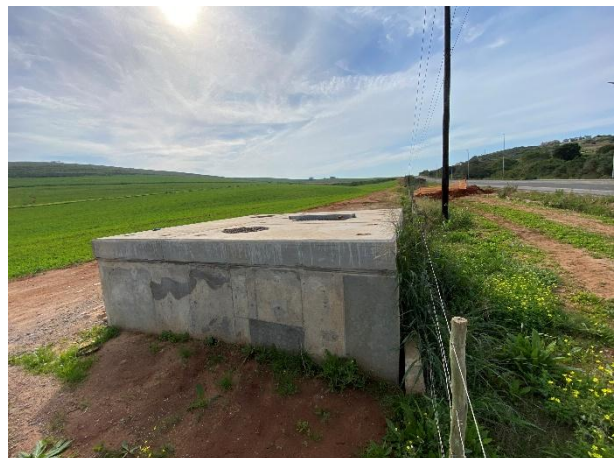
Installed gravity pipeline network and associated infrastructure along the R102 towards the southeast.

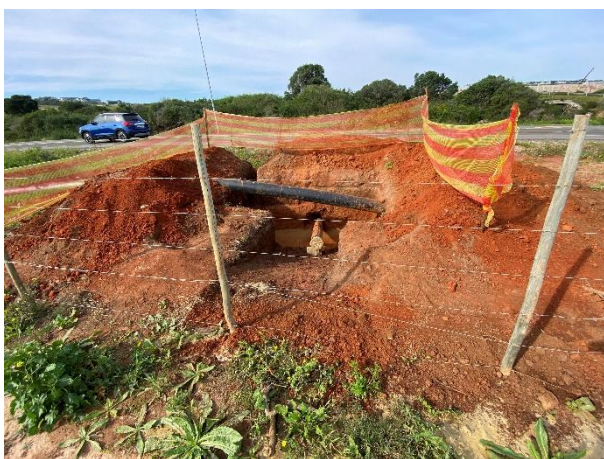
T-piece connection point adjacent to the R102.

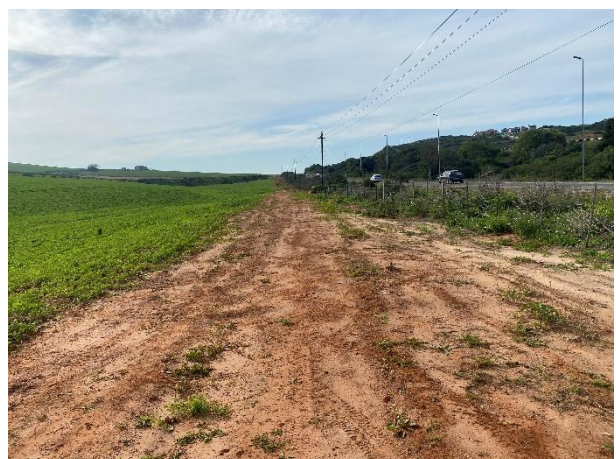
Condition of the existing farm trek towards the north along the R102.
