## REHABILITATION PLAN FOR A 1280m<sup>2</sup> PORTION OF REMAINDER VAALEVALLEI, 219, MOSSEL BAY

| <b>Hilland reference</b> | MOS25/1262/21 |
| <b>Date</b> | 12 September 2025 |

### **Rehabilitation plan portion of remainder farm 219 Vaalevallei**

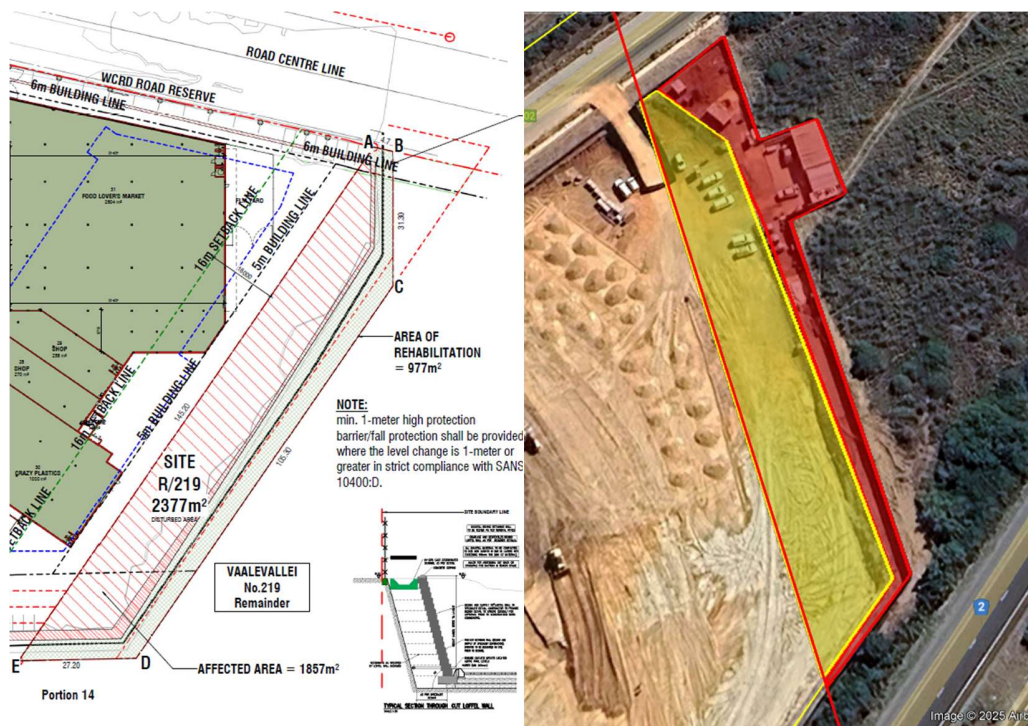
The area above the retaining wall is proposed for rehabilitation (area in red), while the area below and including the retaining wall will form part of a S24G rectification application (area in yellow).

The rehabilitation area will need to include the temporary contractors site office and parking area (total rehabilitation area of approximately 1280m²). The contractor's site office area was approved in terms of the EMP as an area of 295m² extending over the boundary and onto the neighbouring property (see method statement and approved plan at the time). This specifically kept disturbance of the area temporary and under the NEMA threshold 300m² at the time. The use of the incorrect boundary line, now requires the temporary site camp rehabilitation to be included in this rehabilitation plan.

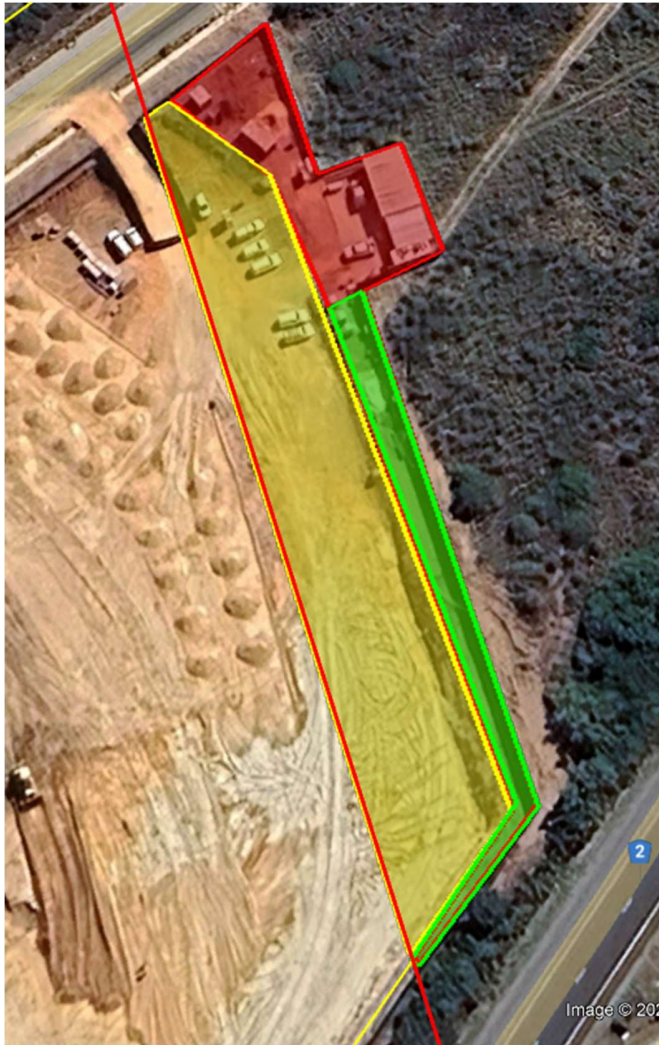
As part of the area is still in use, the rehabilitation is proposed in two phases:

- Phase 1 (Green) 480m<sup>2</sup> to be undertaken immediately on approval of the rehabilitation plan
- Phase 2 (Red) 800m<sup>2</sup> to be undertaken in March 2026 as the construction phase reaches finality and the contractor can move their office off site.

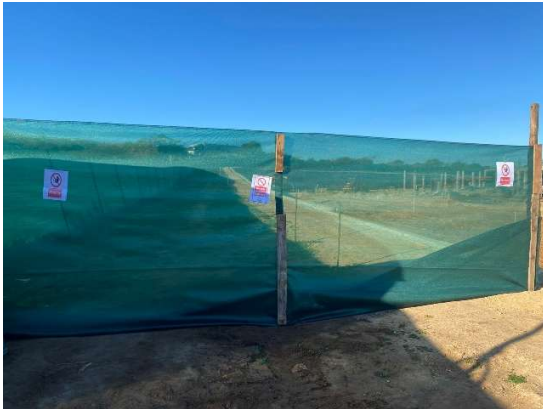
Photo of the rehabilitation area above the retaining wall – where work and access has been restricted.

The fact that the boundary line had been incorrectly surveyed and pegged on site was unfortunate. The area between the retaining wall and the no-go demarcation fencing can be easily rehabilitated to its prior condition as there has not been significant irreversible disturbance.

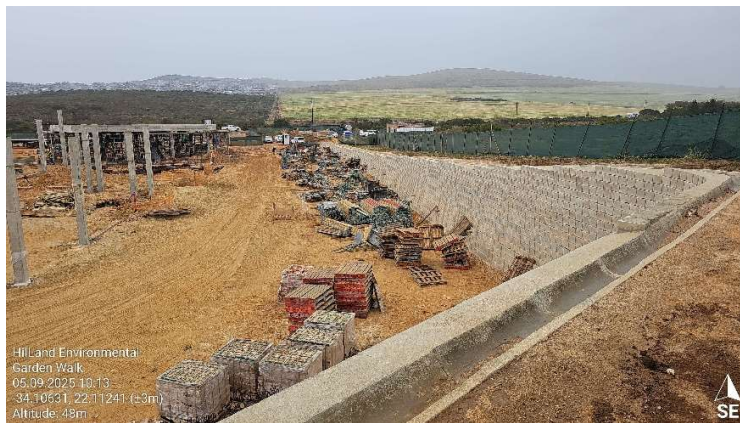
Photo of the area below the retaining wall where a S24G rectification application will be made to retain the area already cleared of vegetation.

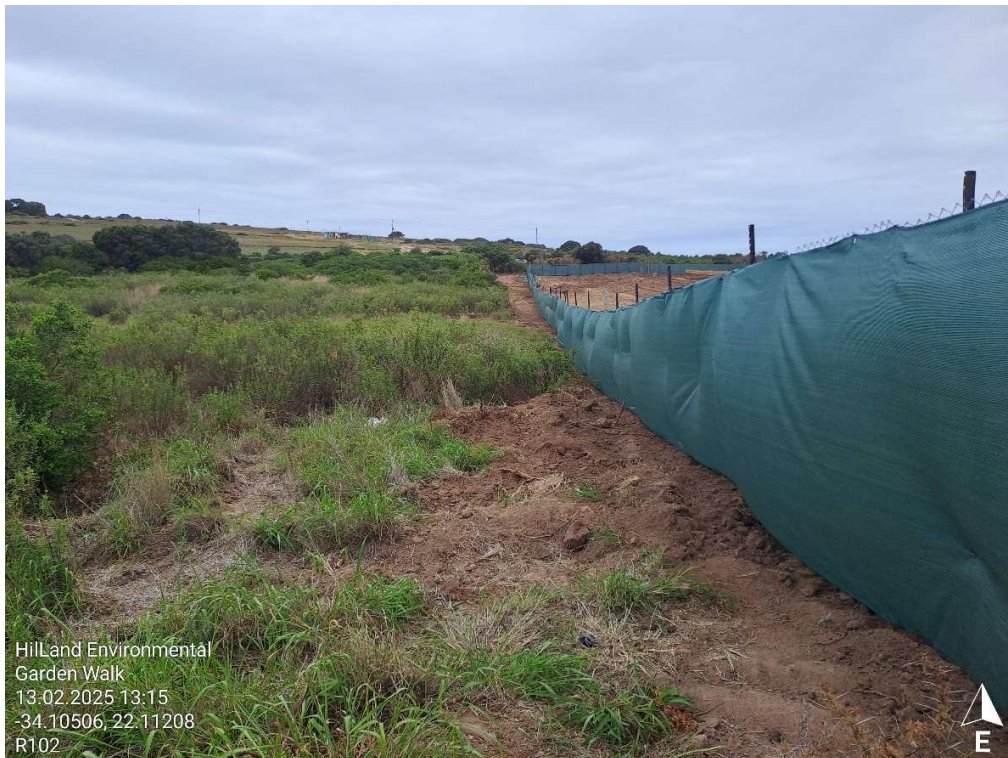
Status of the vegetation on the property immediately after clearing. The shade net was installed to demarcate the property boundary and no-go area. The vegetation to the left is an accurate representation of the status of the vegetation in the area that was physically cleared to the right of the shade cloth fence.

Species present – various grasses (*Paspalum*, *Digitaria*, *Eragrostis*), weed species (*Conyza*, *Solanum*), Alien species (*Acacia cyclops*), pioneer thicket species (*Helichrysum petiolare*, *Searsia lucida*, *Osteospermum moniliferum*)

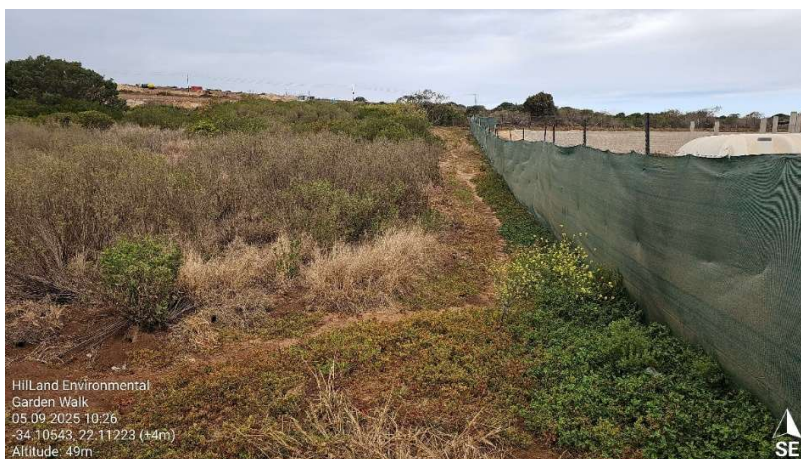
Current status on the agricultural land to the east of the shade netting, showing the topsoil mostly vegetated along the fencing with grasses and pioneer species *Tetragonia* and mustard (agricultural crop remnant).

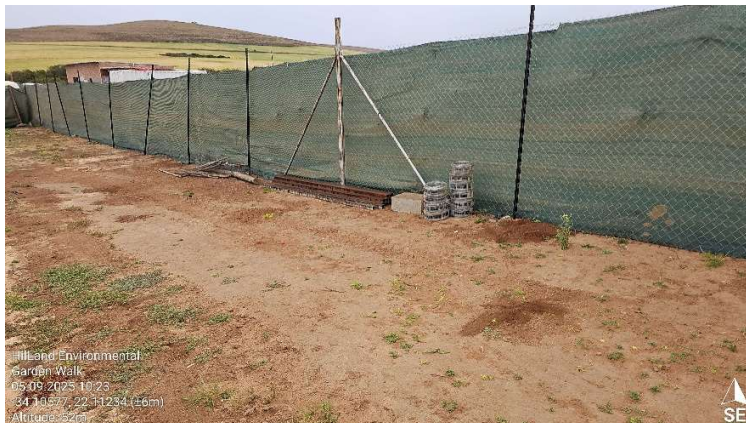
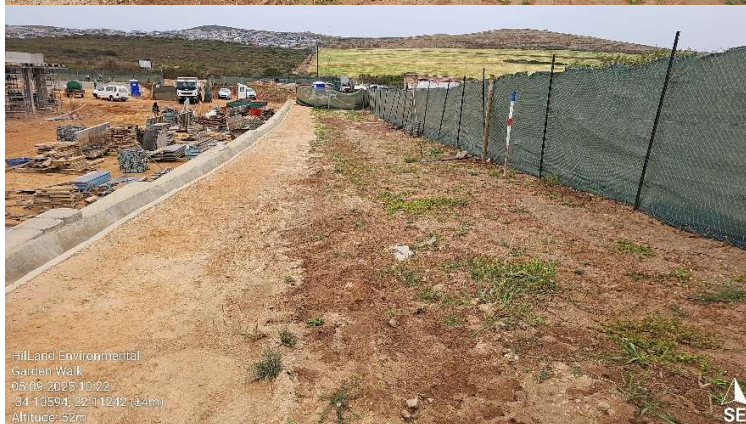
Status of the vegetation on the inside of the fencing. Showing an area that has been compacted and disturbed, with limited regrowth due to the compaction and disturbance. Note that there is significant rodent activity on both sides of the fence in the form of fresh burrows. This will impact any seeding activities and must be kept in mind when sowing seed.

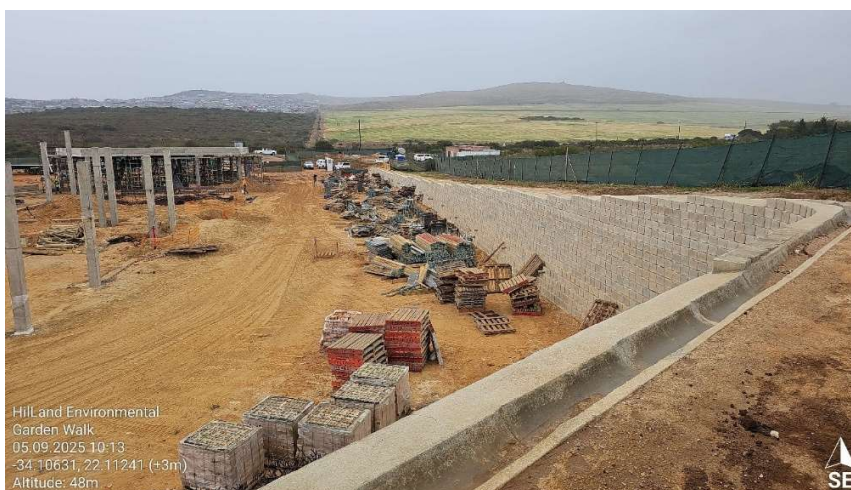
Area above the retaining wall to be rehabilitated. Area below the retaining wall to remain in use as a road in terms of the S24G.

- Remove alien species or weeds (*Acacia* spp.) prior to planting.
- Rip / loosen compacted soils (>300 mm depth) to improve infiltration.
- Return 20cm of topsoil to the area from the topsoil stockpile site. Try to follow the natural topography to create some habitat diversity in the form of undulations, swales, rises etc.

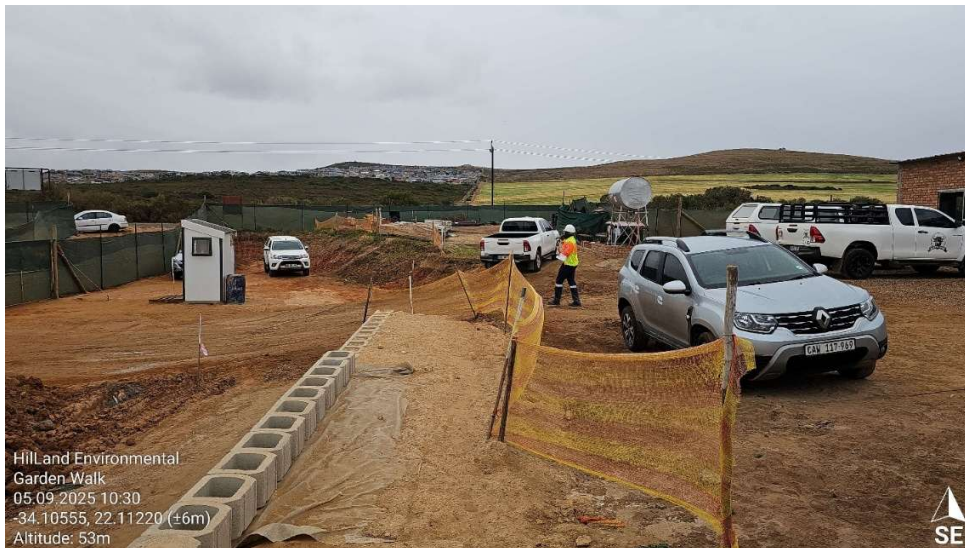
Area in and around the site camp will have to be rehabilitated once construction is complete and all temporary structures are removed.

- **Phase 1 (September – December 2025):** Site preparation, alien clearing, soil ripping, topsoil replacement and shaping and planting of the area above the retaining blocks.
- **Phase 2 (March – May 2026):** Site preparation, alien clearing, soil ripping, topsoil replacement and shaping and planting of the area around the contractors site camp offices.
