## ENVIRONMENTAL COMPLIANCE MONITORING REPORT NO.09

OUTENIKUASBOSCH, FARMS OUTENIKUASBOSCH 149 AND HARTENBOSCH  
217, HARTENBOS

**CIVIL SERVICES INSTALLATION (PHASE 10)**

**ENVIRONMENTAL MONITORING REPORT NO 9  
SEPTEMBER 2021**

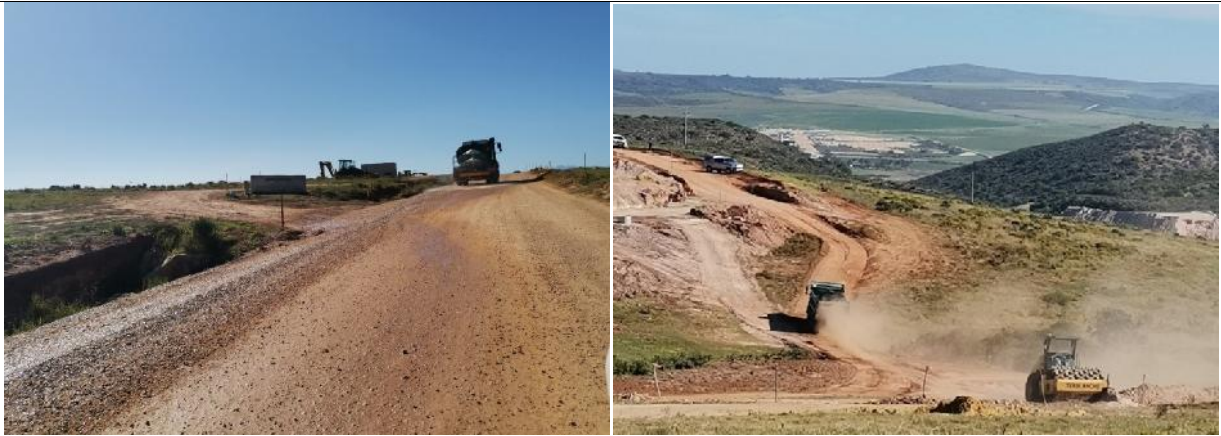
2021.09.08 – Water is sprayed on the road leading to phase 10 to minimize the dust.

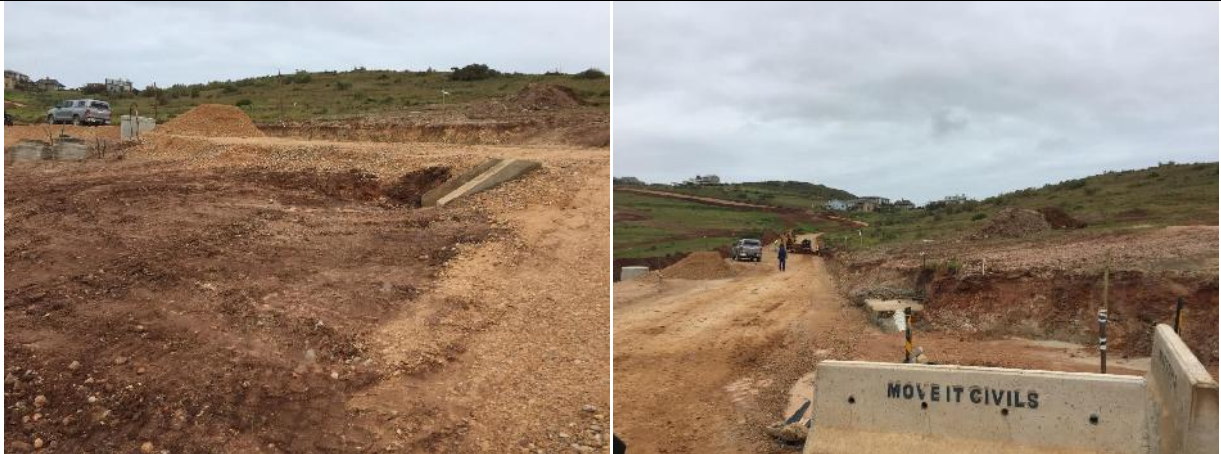
2021.09.30 – Ongoing construction of the civil services in phase 10 – topsoil replaced back (on top).

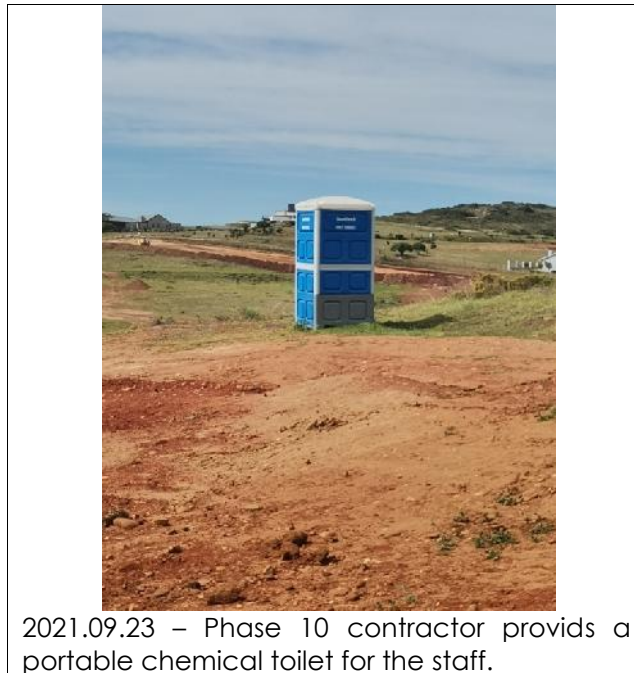
- Toilet facilities are available on site during civil services installation.

A fenced off area must be created within the camp site for refuse and waste management as indicated above. ECO to inspect for compliance.

- Adequate litter bins are to be provided at the site camp; littering should be covered in regular "toolbox" talks with all staff members.

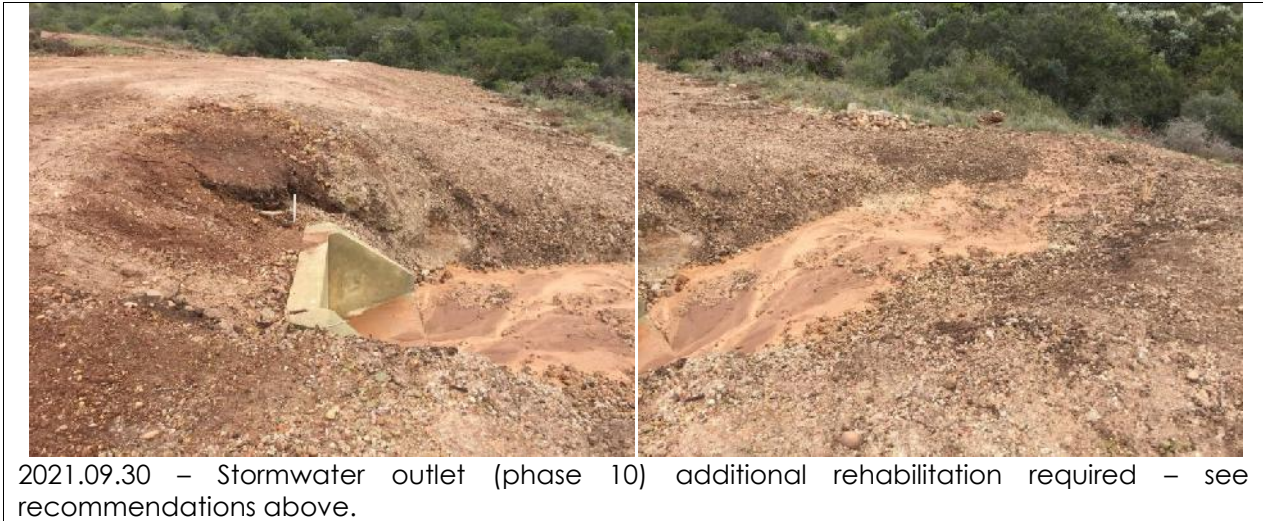
The following rehabilitation recommendation relates to the completed stormwater outlet structures within phase 10:

- Create small soil or stone berms across to slow the flow of the surface water;
- Sow the indigenous grass seed mixture on the side slopes and above the structure areas;
- Mulch filled onion bag (or similar) pegged along the contours, to the side slopes (where steep)
- Estate Management - ongoing maintenance of the stormwater outlets are to be done.

Equal parts of: **2g/m<sup>2</sup>** Kweek grass (*Cynodon dactylon*) seed and **2g/m<sup>2</sup>** Oulandsgras/Weeping Love Grass (*Eragrostis curvula*) seed (approximately **4g/m<sup>2</sup>**) that is to be sown over loosely raked soil.
