## ENVIRONMENTAL COMPLIANCE MONITORING REPORT NO.15

OUTENIKUASBOSCH, FARMS OUTENIKUASBOSCH 149 AND HARTENBOSCH  
217, HARTENBOS

**CIVIL SERVICES INSTALLATION (PHASE 10)**

**ENVIRONMENTAL MONITORING REPORT NO 15  
APRIL 2022**

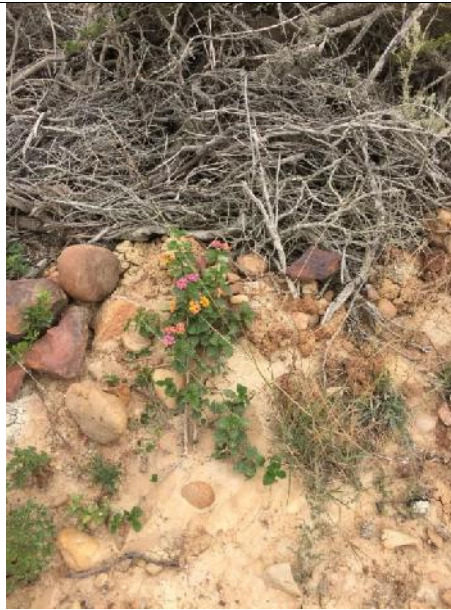
- *Lantana camara* was spotted in phase 10 near the stormwater outlet structure (between erf 7349 & 7350)

2022.04.01 – Lantana to be eradicated.

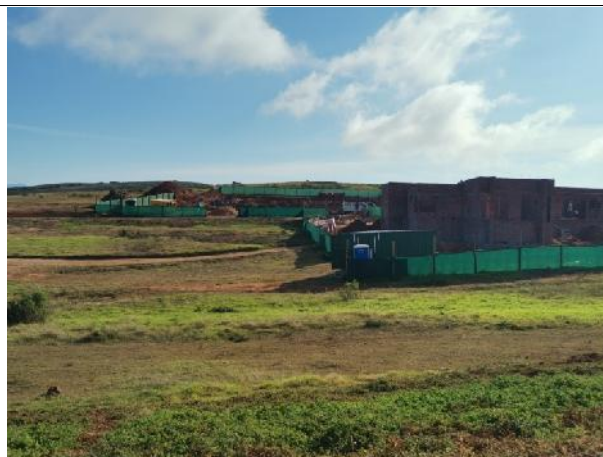
2022.04.13 – Construction of Erven in Phase 10.

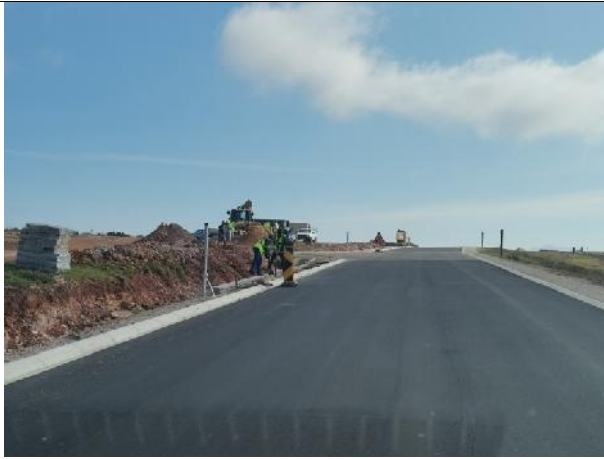
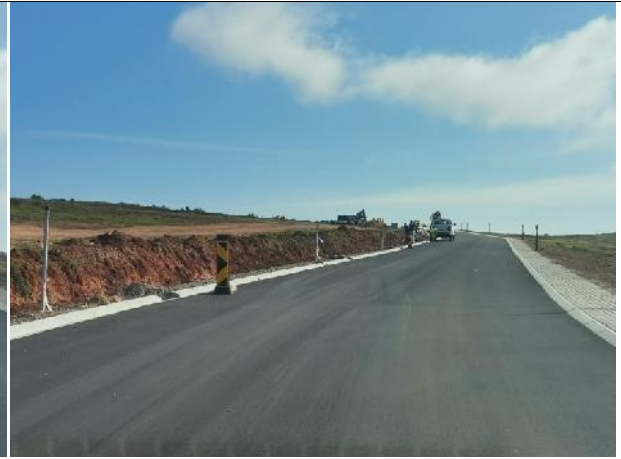
2022.04.13 – Construction of Mafunyane Street is near completion.

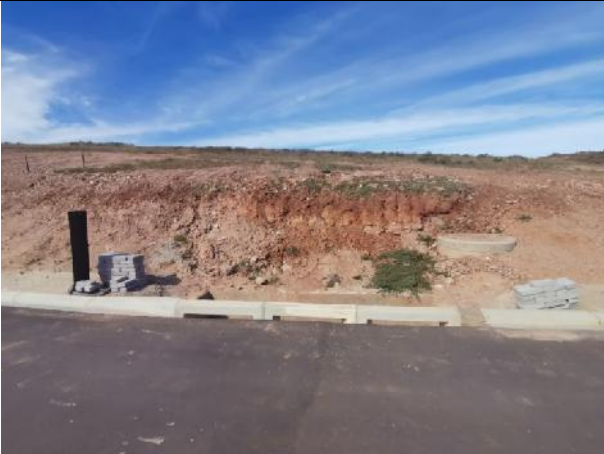
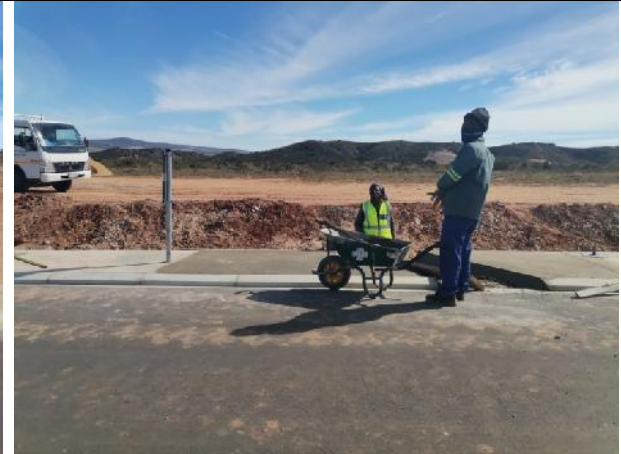
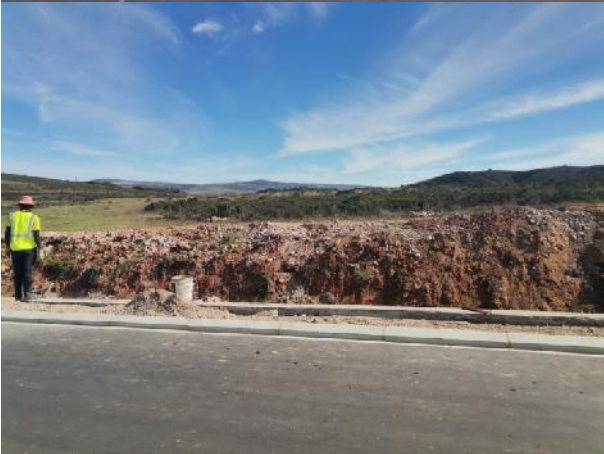
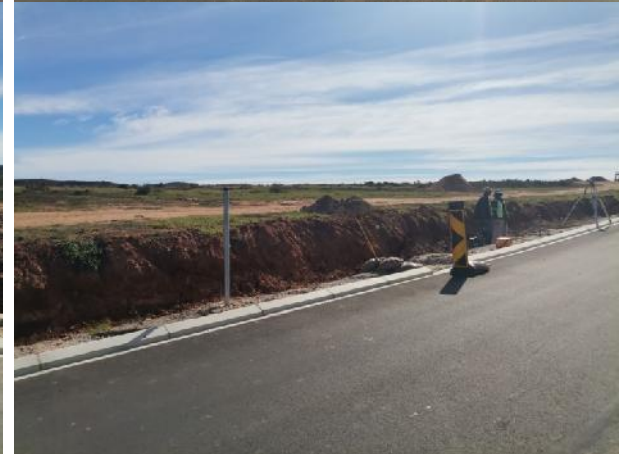
2022.04.20 – Stormwater channel of Mafunyane Street is in progress

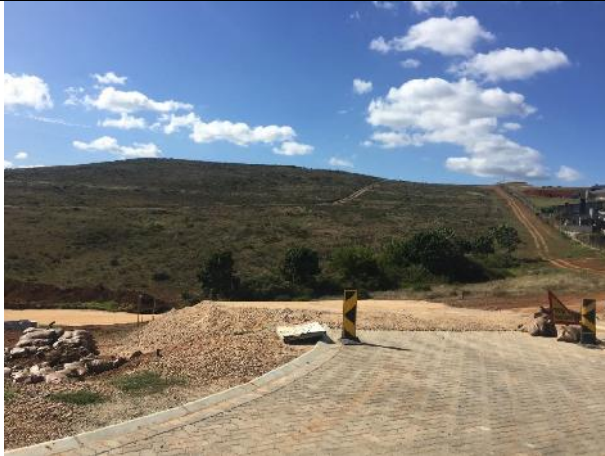
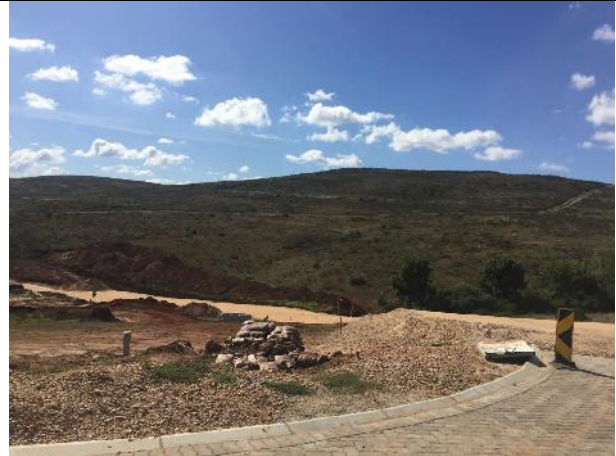
Construction of the internal access road to future phases has started – No environmental issues noted.

2022.04.29 – Tie in of the internal road to the future development phases access road has started.

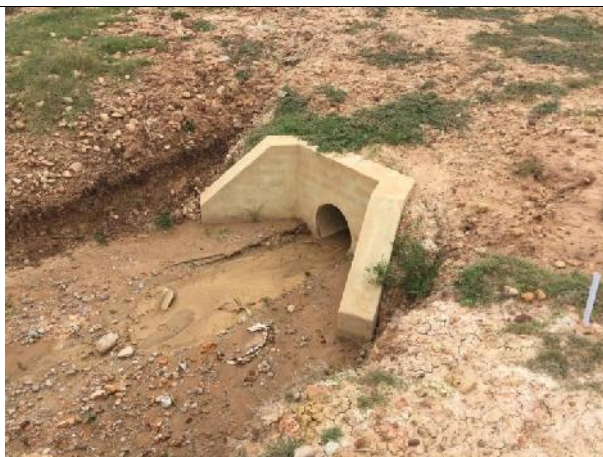
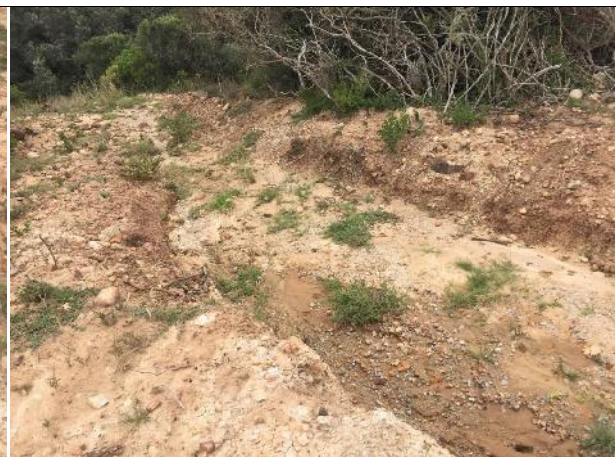
2022.04.01 – Stormwater outlet (phase 10) additional rehabilitation recommended (see Section 7) - **the estate management is continuing with rehabilitation**

- Create small soil or stone berms across to slow the flow of the surface water;
- Sow the indigenous grass seed mixture on the side slopes and above the structure areas;
- Mulch filled onion bag (or similar) pegged along the contours, to the side slopes (where steep)
- Estate Management - ongoing maintenance of the stormwater outlets is to be done.

Equal parts of: **2g/m<sup>2</sup>** Kweek grass (*Cynodon dactylon*) seed and **2g/m<sup>2</sup>** Oulandsgras/Weeping Love Grass (*Eragrostis curvula*) seed (approximately **4g/m<sup>2</sup>**) that is to be spread over loosely raked soil.

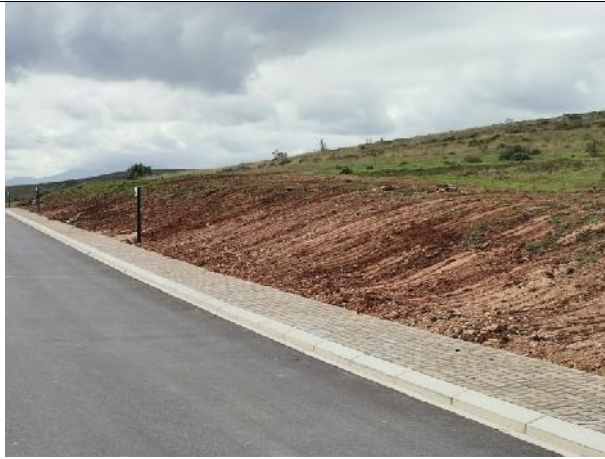
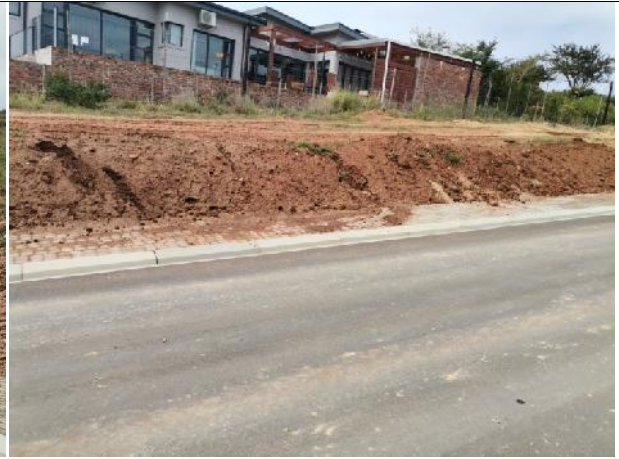
2022.04.08 - The steep road verges are to be shaped with horizontal grader lines to prevent vertical erosion and then seeded with the indigenous grass seed mixture.

The steep road verges are to be shaped with horizontal grader lines to prevent vertical erosion and then seeded with the indigenous grass seed mixture.

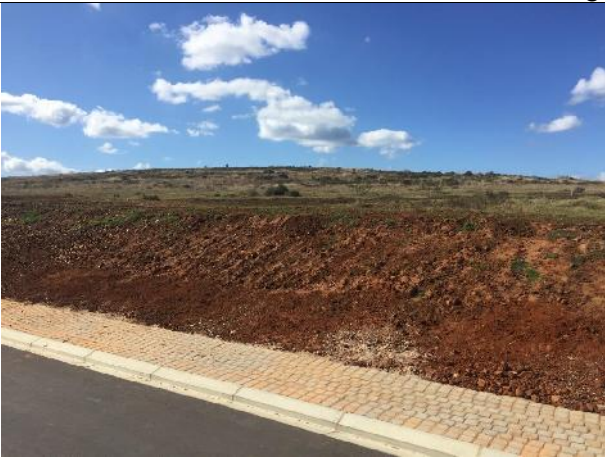
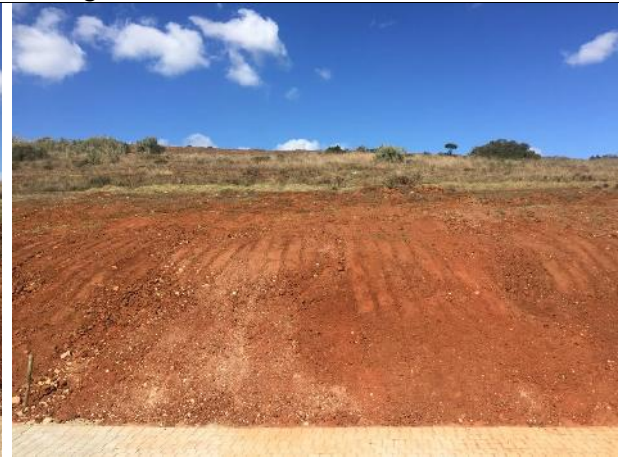
2022.04.29 – Vertical shaping was done as opposed to horizontal. HOA must now monitor the slopes for signs of soil erosion until the grass is established.

The contractors are aware of the environmental requirements and are complying. It is advised that the contractors (civil and home building) do regular toolbox talks with all staff members with special focus on **littering and cigarette** butt disposal. The **building** contractors are also reminded to ensure that the No-Go demarcation and safety netting is maintained to ensure that no animals get injured. The civil contractor of Phase 10 is near completion and rehabilitation work is in progress. Shaping of steep slopes must be done with horizontal and not vertical grader marks.
