**ENVIRONMENTAL COMPLIANCE MONITORING REPORT NO.20**

**OUTENIKUASBOSCH, FARMS OUTENIKUASBOSCH 149 AND HARTENBOSCH  
217, HARTENBOS**

**CIVIL SERVICES INSTALLATION (PHASES 4 & 11 & 13)**

**October 2022**

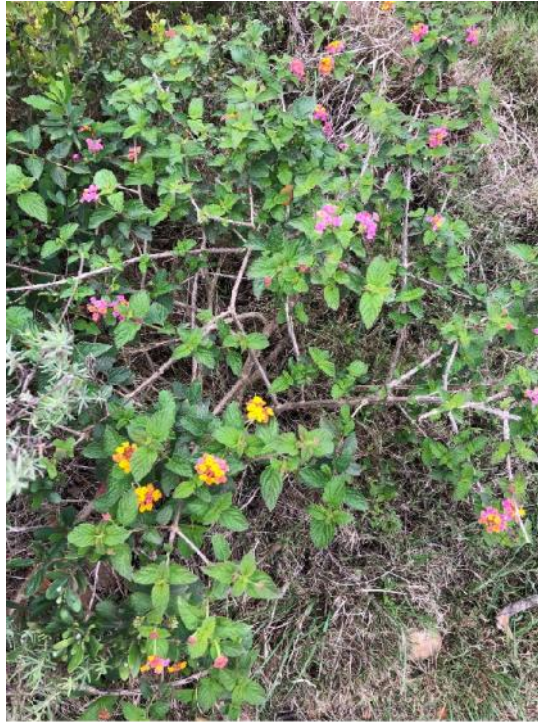
- *Alien invasive plant species as a result of construction (all phases) activity must be removed. The developer/management team must ensure ongoing alien plant eradication – **lantana camara** was noted between phases 11 and 13*

Lantana must be eradicated – Developers responsibility

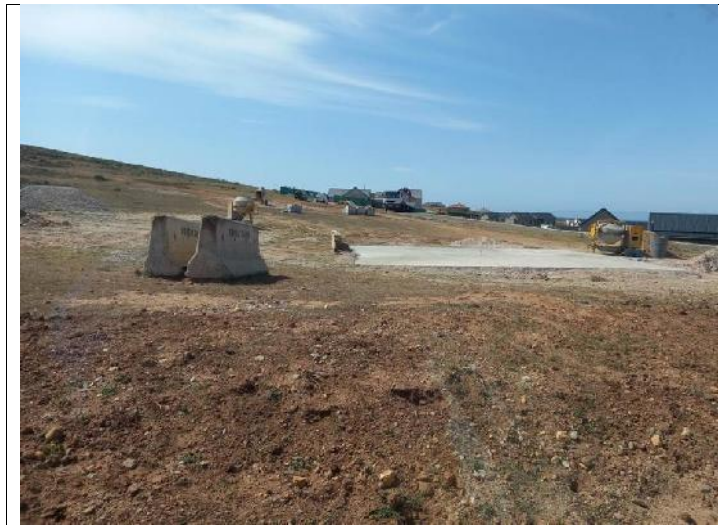
Construction site camp must be demarcated – cement slab processing area

- Civil construction – the cement mixing area for phases 4, 11 & 13 was discussed and agreed, no further encroachment of the mixing area is to occur.
- Home construction – cement mixing is to be contained within the disturbance footprint and on a non-permeable layer (wooden sheet/plastic etc) to prevent soil contamination.
- **Ready-mix trucks are not allowed to be washed on site.**
- **The cement slab processing area must be demarcated to prevent further encroachment into natural areas.**

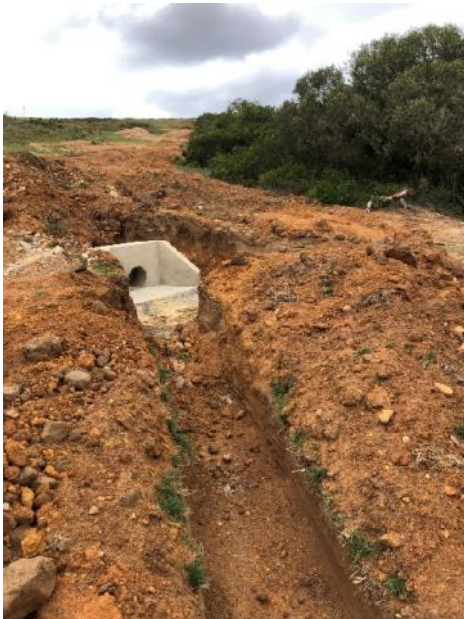
Silt fence required at the stormwater outlets

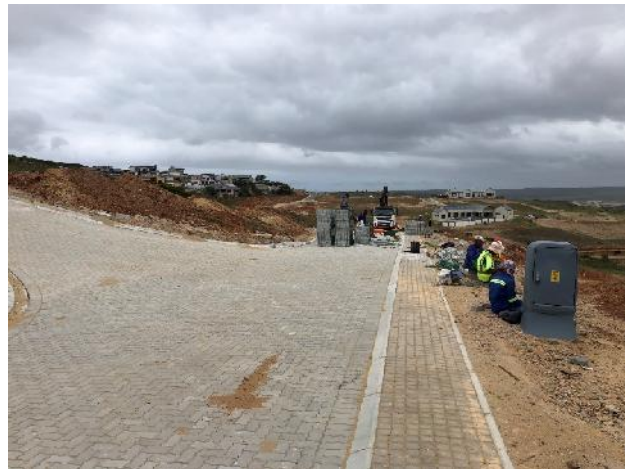
Construction site – phases 11 & 13

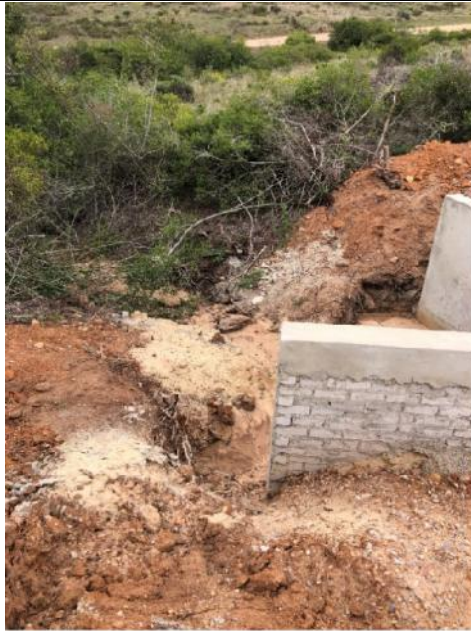
Silt fence and shaping of the stormwater outlet required on top

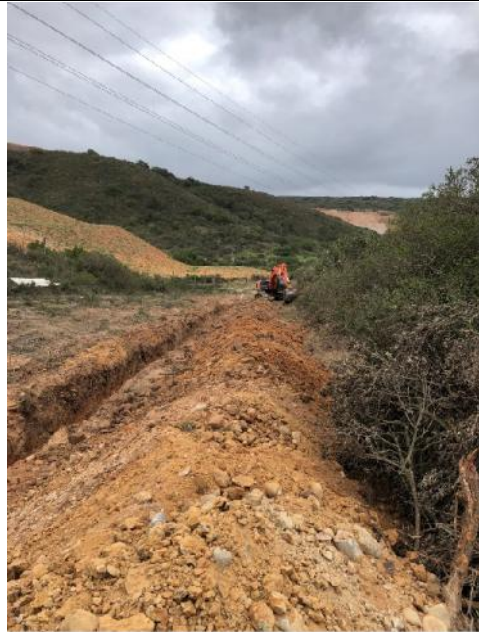
Trench – when closing, topsoil must be

Construction and installation of services for **phases 4, 11 & 13** are ongoing. Topsoil and subsoil must be stored separately, topsoil on one side and subsoil on the other side of the trench.

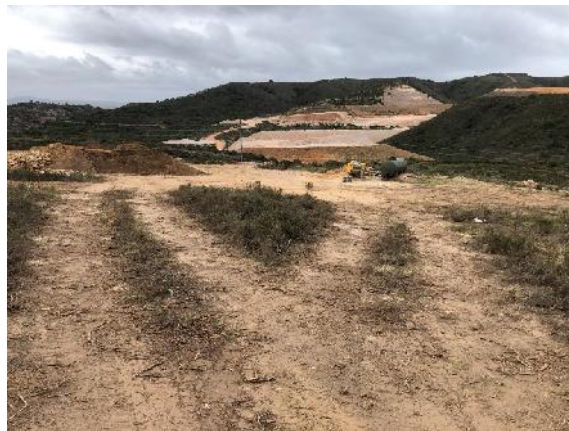
Single construction routes be used and maintained

The contractor will be responsible for the rehabilitation of all disturbed areas (including temporary construction haul routes) at the end of construction and before handing the services back to the developer/HOA.

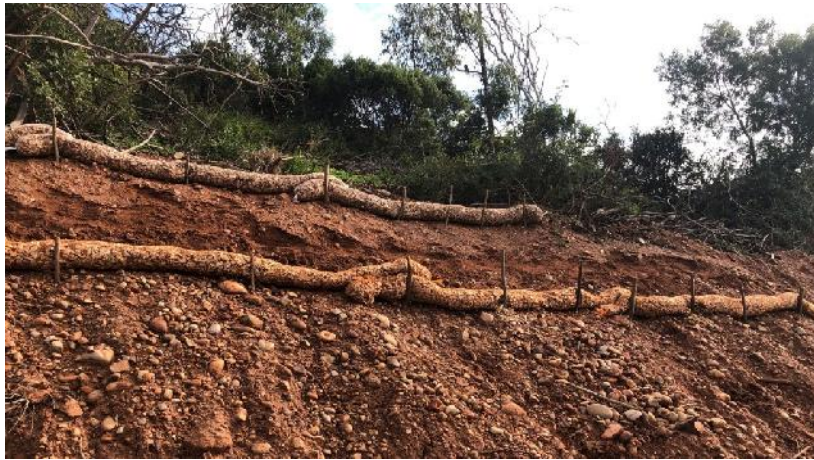
*Example of mulch filled sausages*

Additionally, the contractor can use mulch filled sausages staked horizontally to the steeper slopes along the roads to further curtail soil erosion.
