### ENVIRONMENTAL COMPLIANCE MONITORING REPORT NO.27

OUTENIKUASBOSCH, FARMS OUTENIKUASBOSCH 149 AND HARTENBOSCH  
217, HARTENBOS

**MOS23/455/106**

**ENVIRONMENTAL MONITORING REPORT NO 27**  
**September 2023**

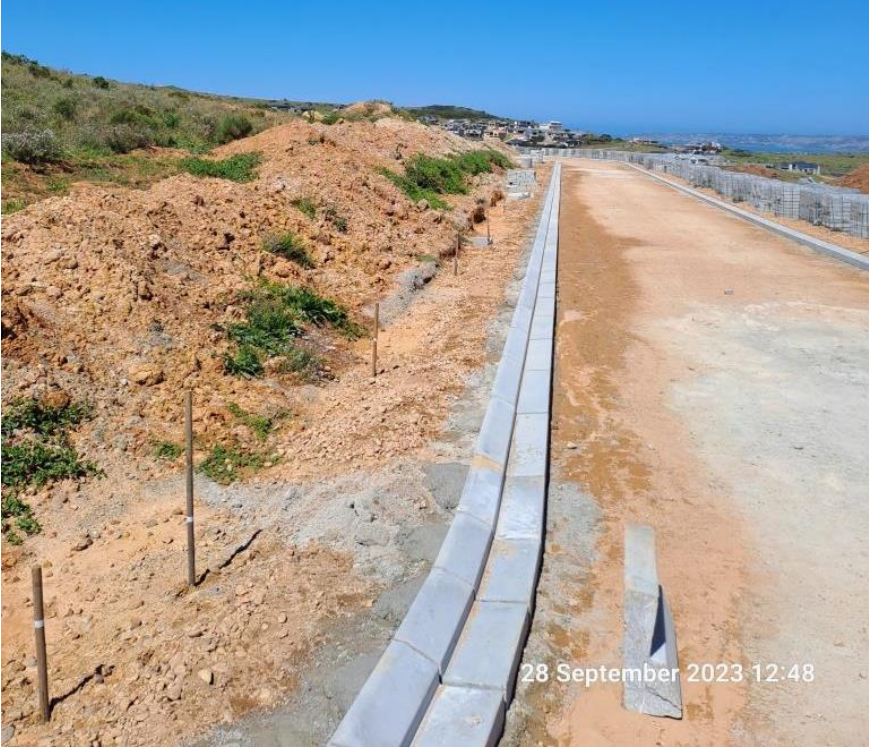
| Phase | Photographic record | Comment and requests |
|---|---|---|
| 12 & 14 | | <p>Construction footprint was pegged by the surveyour.</p> <p>Topsoil and subsoil stockpiled next to the road.</p> |

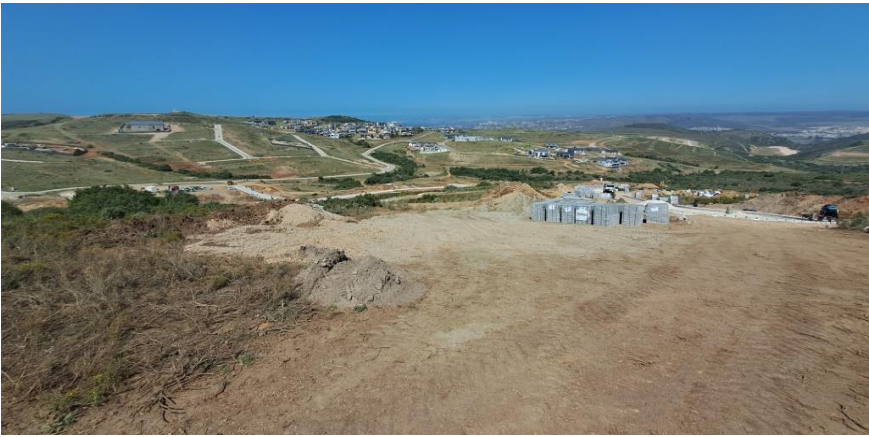
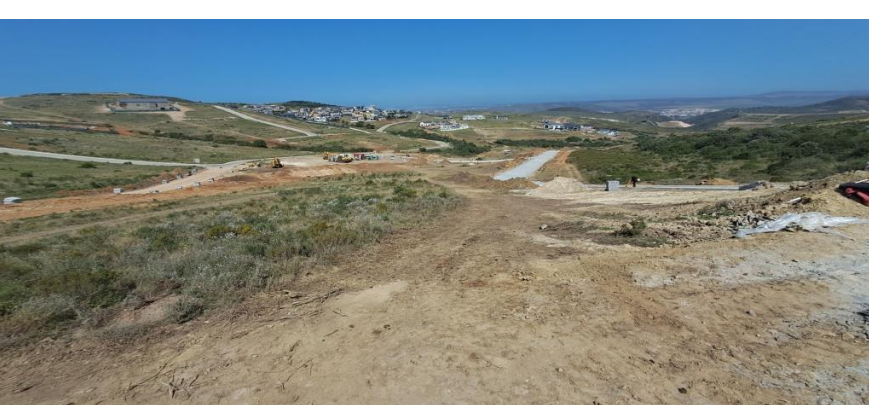
| Phase | Photographic record | Comment and requests |
|---|---|---|
| | | <p>Construction material stockpiled on developable erf.</p> |

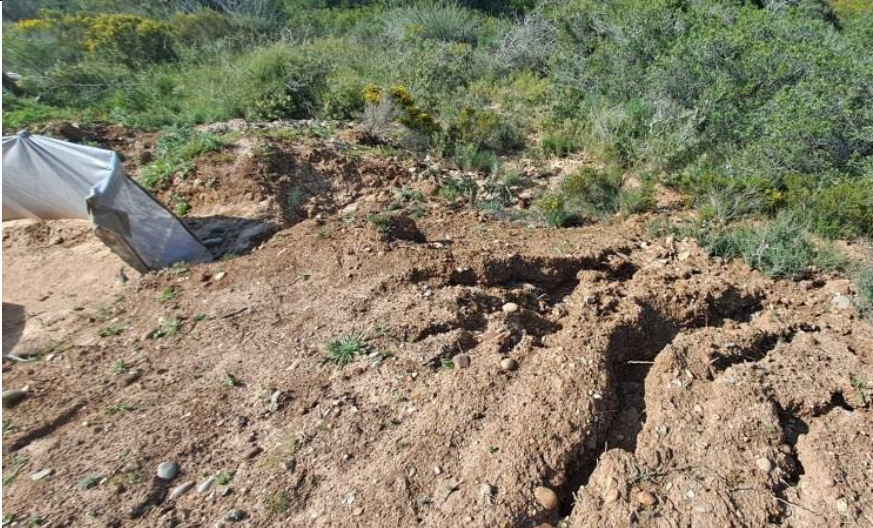
| 14 | | <p>Soil erosion protection required.</p> <p>This will have to be rehabilitated and erosion protection must be installed and maintained.</p> |

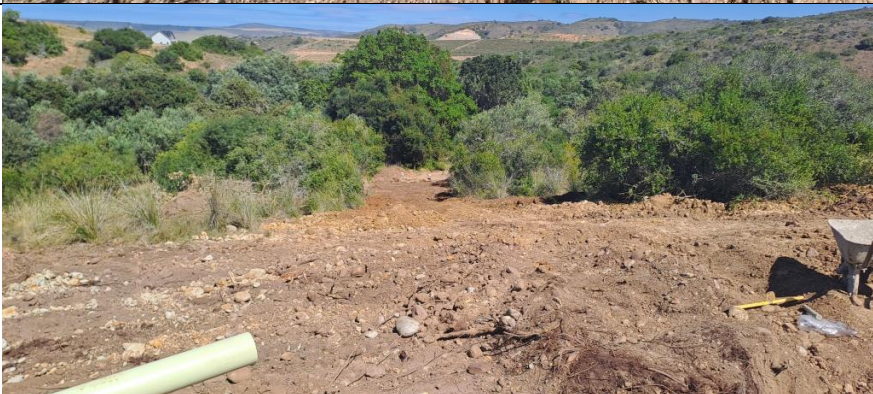
| 12 | | <p>Installation of the phase 12 sewer connection to the main sewer infrastructure without any additional disturbance beyond the demarcated route.</p> |

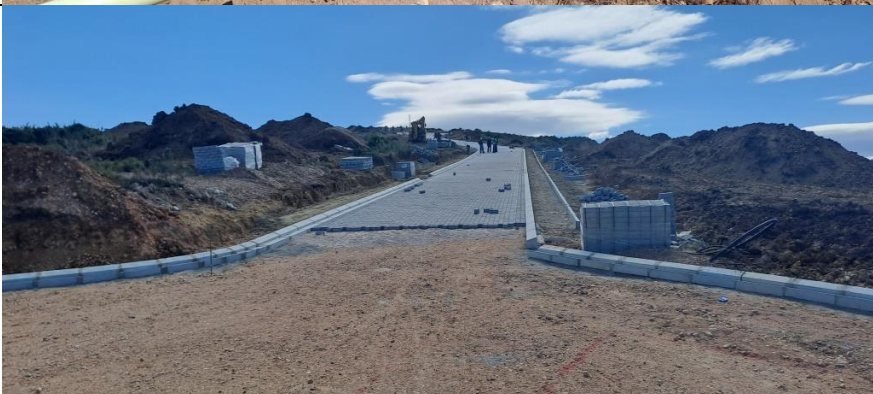
| 14 | | <p>Topsoil is stockpiled neatly next to work done to use in rehabilitation.</p> |

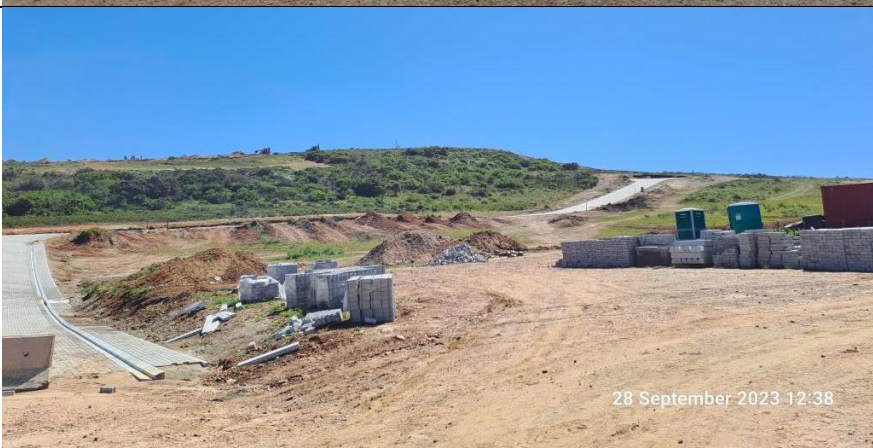
| 12 | | <p>Phase 12 site camp and construction stockpile area.</p> |

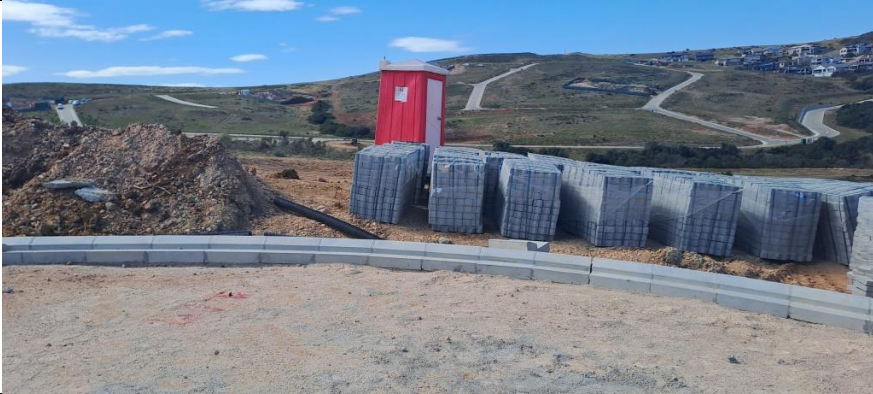
| 14 | | There are sufficient ablution facilities throughout the site. |

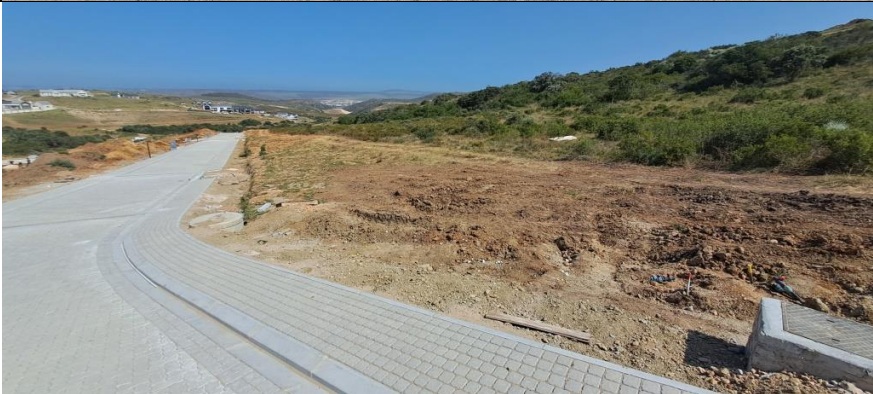
| 12 | | Phase 12 – road verge and sewer midblock connection (right). |

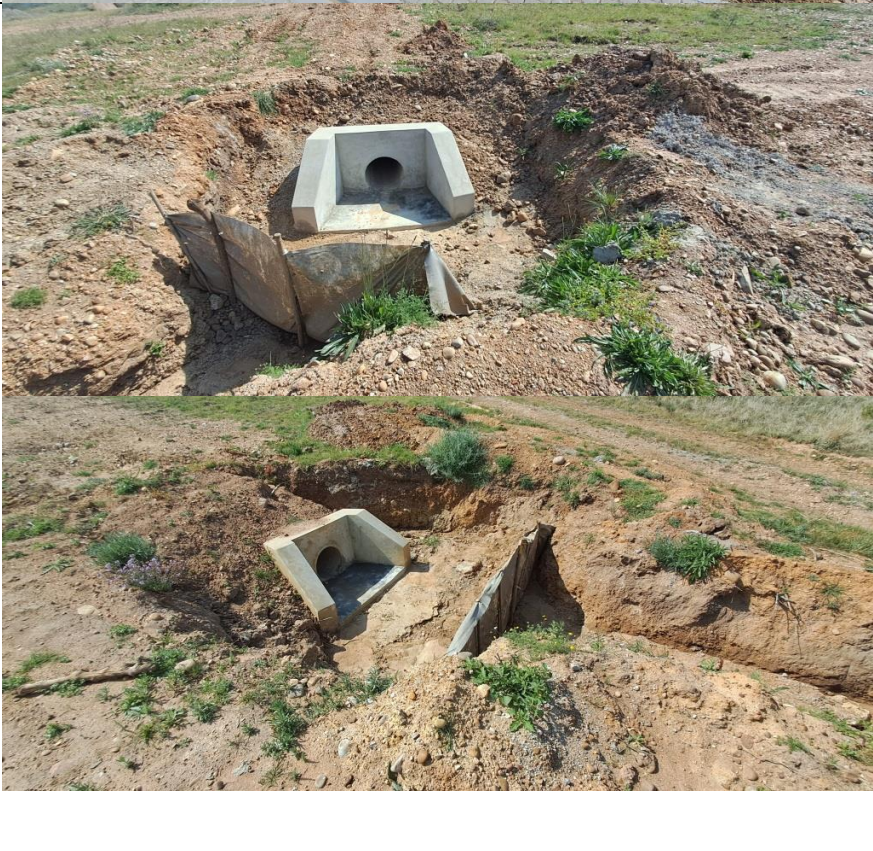
| 12 & 14 | | <p>The contractor has placed appropriate silt fences at the stormwater outlets.</p> <p><u>Request:</u></p> <p>Maintain silt fences (clear silt regularly) to ensure that the function of silt fences is efficient.</p> |

| In the event of erosion damage or silt movement, the contractor is responsible for the clean-up required to reinstate the conditions to normal. | | | | | | All stormwater outlets must be monitored and silt buildup to be removed as well as silt washed beyond the silt fence into green spaces (and rehabilitated). | <b>Ongoing maintenance</b> of the silt fences – keeping it clean, remove silt and make sure they are upright. Remove silt in the conservation area (by hand) |

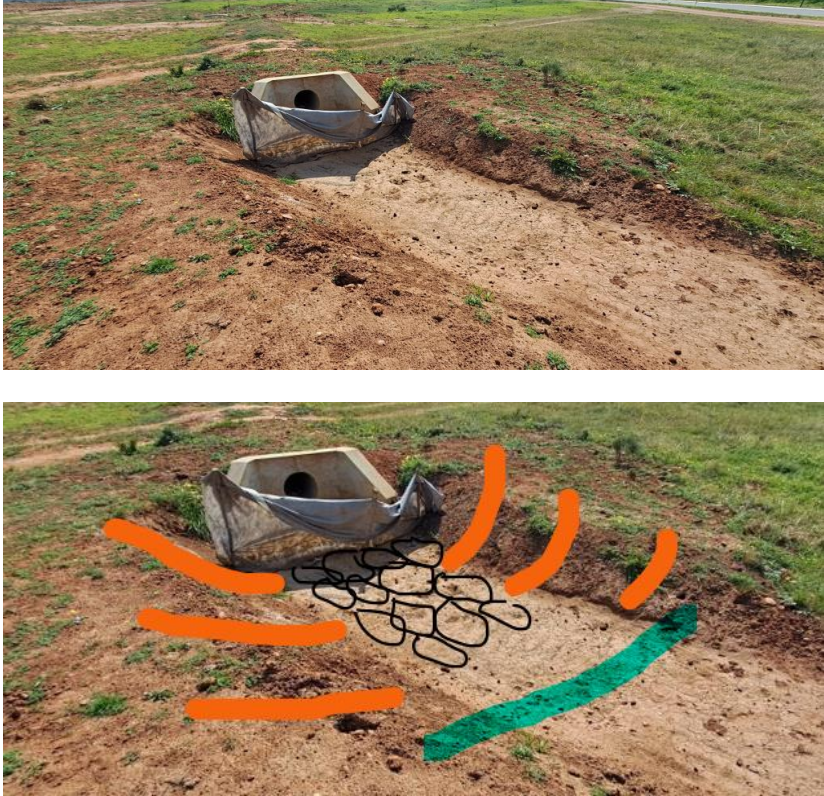
| 4 | <p>ECO suggestion of stormwater outlet completion</p> | <p>The contractor is requested to complete the shaping and rehabilitation of stormwater outlets (phase 4).</p> <p><b>Orange</b> – vygies to stabilise side slopes</p> <p>Black circles – Stones that will slow down the water outlet volume</p> <p><b>Blue line</b> – Move the silt fence back while rehabilitation stabilises.</p> |

The contractors are aware of the environmental regulations mentioned in the EMPr (Environmental Management Plan). Currently there are no record of no-compliance regarding civil installations in **phase 12** and **phase 14**. Rehabilitation of **Phase 4** to be completed. It is recommended that contractors conduct regular toolbox talks with their staff and remind them of the environmental requirements.

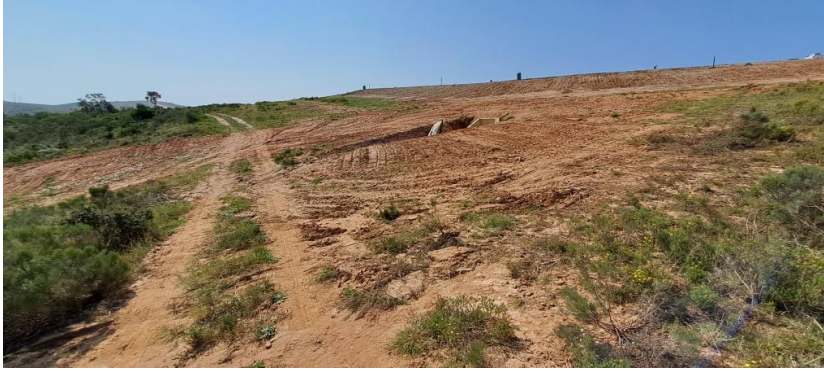
| 4 | | <p>All disturbed areas must be rehabilitated – topsoil must be placed back on top and vegetated.</p> |

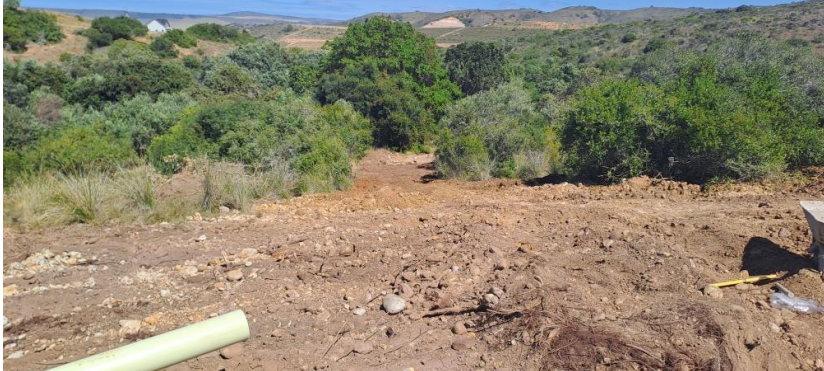
| 12 | | <p>Rehabilitation was done during this monitoring period to close the phase 12 sewer connection.</p> |
