### ENVIRONMENTAL MONITORING REPORT NO.29

OUTENIKUASBOSCH, FARMS OUTENIKUASBOSCH 149 AND HARTENBOSCH  
217, HARTENBOS

**November and December 2023**

**ENVIRONMENTAL MONITORING REPORT NO 29  
November and December 2023**

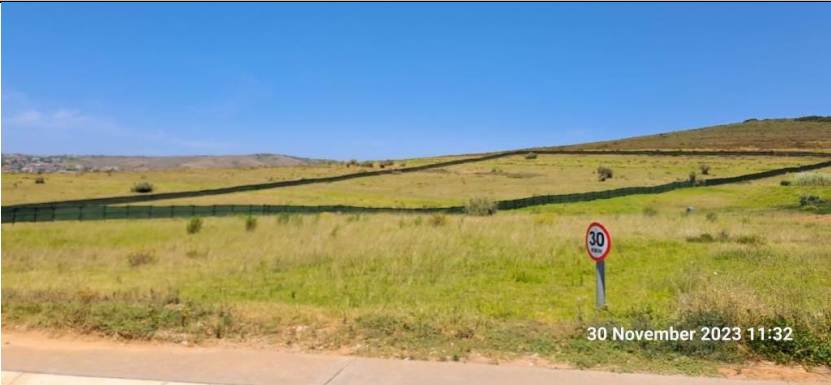
| Phase | Photographic record | Comment and requests |
|---|---|---|
| 19 | | Demarcation of the entire phase 19 development footprint is in place. |

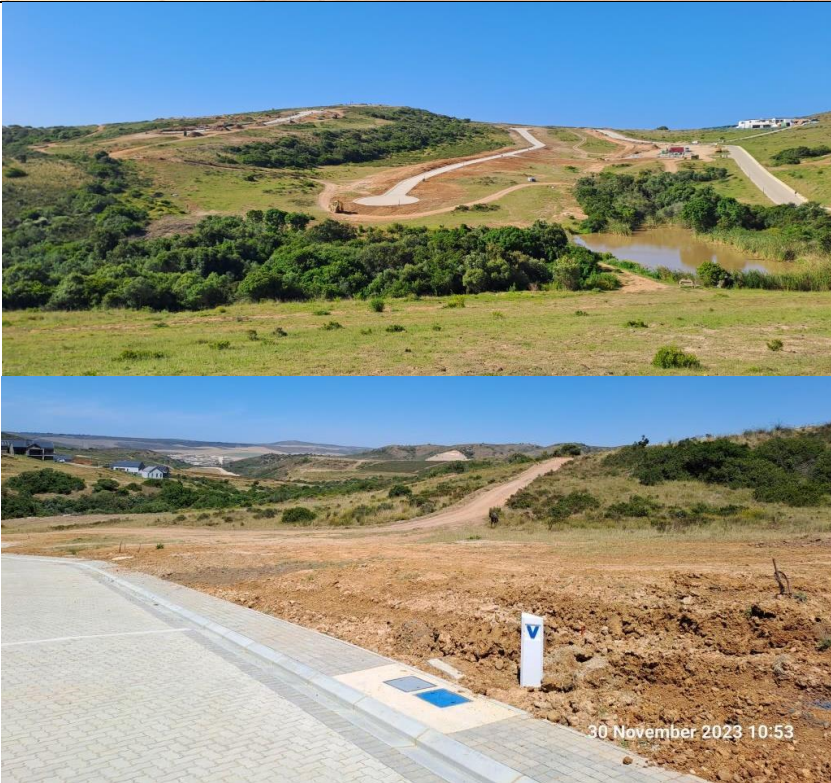
| Phase | Photographic record | Comment and requests |
|---|---|---|
| 12 & 14 | | Phases 12 and 14 - Construction completed.<br><br><u>Request:</u><br><br>Construction haul routes to be demarcated to prevent driving off the tracks. |

| Heritage Resources Authority of the Western Cape, Heritage Western Cape (in accordance with the applicable legislation). | | | | | | | |
|---|--|--|--|--|--|---|---|
| Any temporary haul roads or access roads for construction need to be always maintained by the contractor including demarcation, dust monitoring and management etc. | | | | | | The main temporary haul route used to access Outeniquasbosch is maintained well.<br><br>Construction haul routes to be demarcated to prevent operators and delivery drivers from going off the dedicated haul route. | Construction haul routes to be demarcated to prevent operators and delivery drivers from going off the dedicated haul route. |

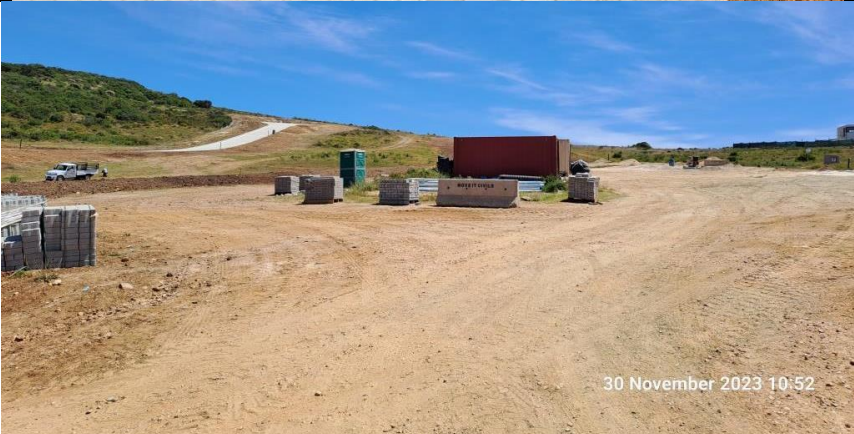
| Phase | Photographic record | Comment and requests |
|---|---|---|
| 12 & 14 | | Site camp disturbed area must be rehabilitated to the satisfaction of the ECO. |

| Heritage Resources Authority of the Western Cape, Heritage Western Cape (in accordance with the applicable legislation). | | | | | | | |
|---|--|--|--|--|--|---|---|
| The contractors' campsite is to be set up in the area indicated and approved by the ECO for this purpose and must be fenced off from the game. | | | | | | Site camps are within ECO and management approved locations at phases 4 and 12 – phase 4 site is less active.<br><br>The site camps areas must be rehabilitated once construction is complete. | Site camp in phase 12 must be disassembled and disturbed area rehabilitated to the satisfaction of the ECO |

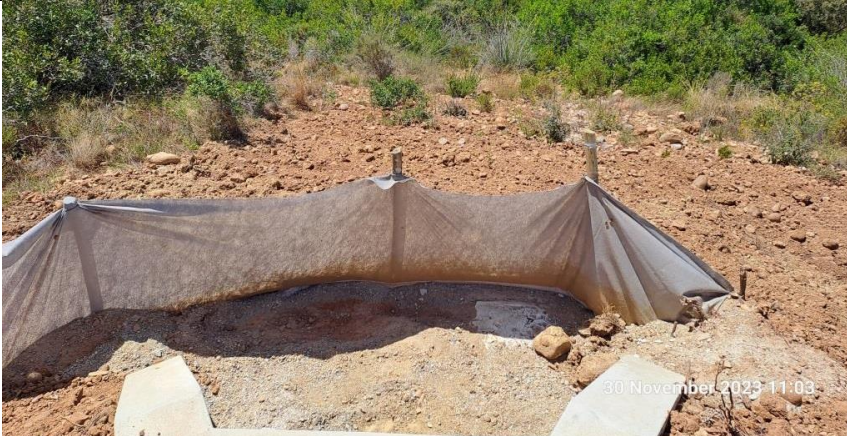
| 12 & 14 | | Silt fences are in place at the stormwater outlets – ongoing maintenance are important. |

| Stormwater and erosion management | | | | | | | |
|---|--|--|--|--|--|---|---|
| The use of erosion control mechanisms such as erosion berms, silt fences, rows of onion bags, mulch, brushwood and deflection bars (the choice depending on the situation), is essential in all exposed areas and where slopes are steep, as runoff can cause erosion. | | | | | | <p>Silt fences are in place.</p> <p><b>Ongoing maintenance</b> of the silt fences – keeping it clean, remove silt and make sure they are upright.</p> | <b>Ongoing maintenance</b> of the silt fences – keeping it clean, remove silt and make sure they are upright. |

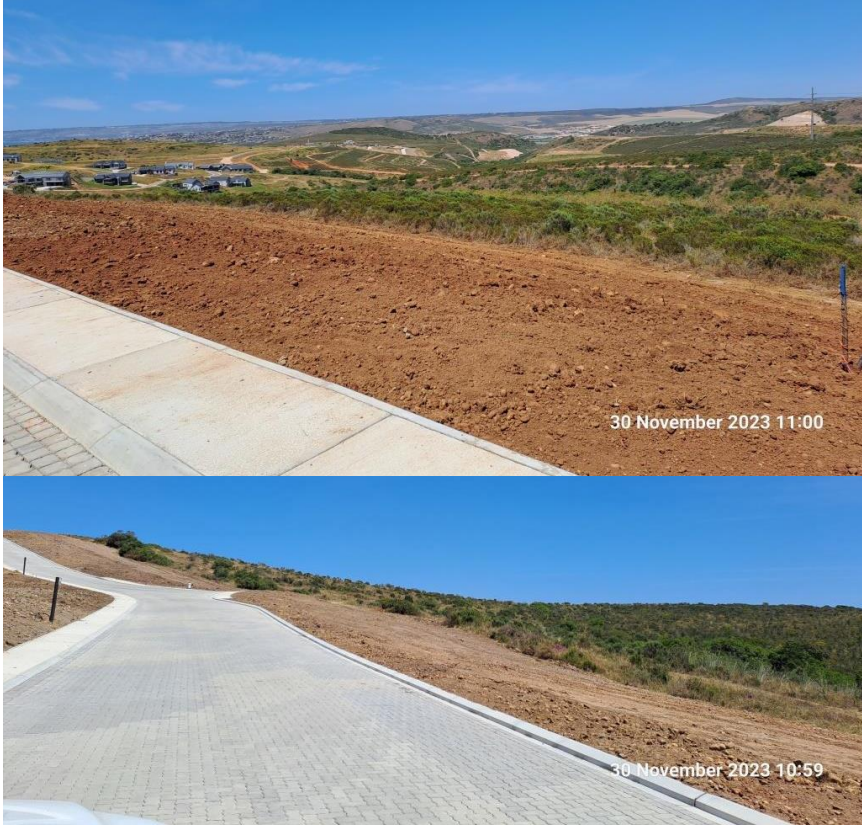
| Phase | Photographic record | Comment and requests |
|---|---|---|
| 12 & 14 | | Road verges have been reshaped, seeded with indigenous grass seed mix and lightly compacted. |
