## ENVIRONMENTAL MONITORING REPORT NO. 30

OUTENIKUASBOSCH, FARMS OUTENIKUASBOSCH 149 AND HARTENBOSCH  
217, HARTENBOS

**January and February 2024**

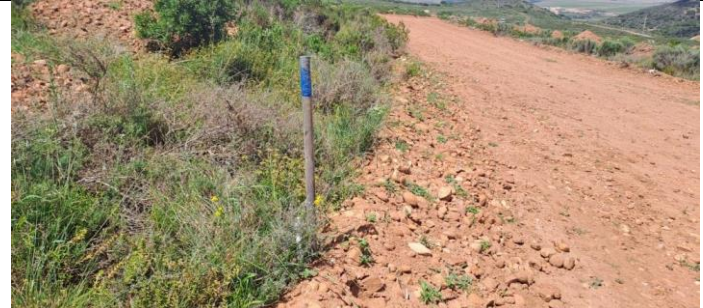
| EMPr requirements | Level of compliance | Comments / Findings | Photo's (if applicable) |
|---|---|---|---|
| All areas outside that of the defined works (roads and pipeline routes) are deemed as no-go areas. These areas have to be properly demarcated to prevent any construction encroachment. | Compliant and ongoing | NO-GO areas are discussed with the contractor, pegged by the surveyor and works are confined to the demarcated area. Construction haul routes must be demarcated (painted stones is recommended) to avoid machinery/delivery vehicles from driving in the veld. | |

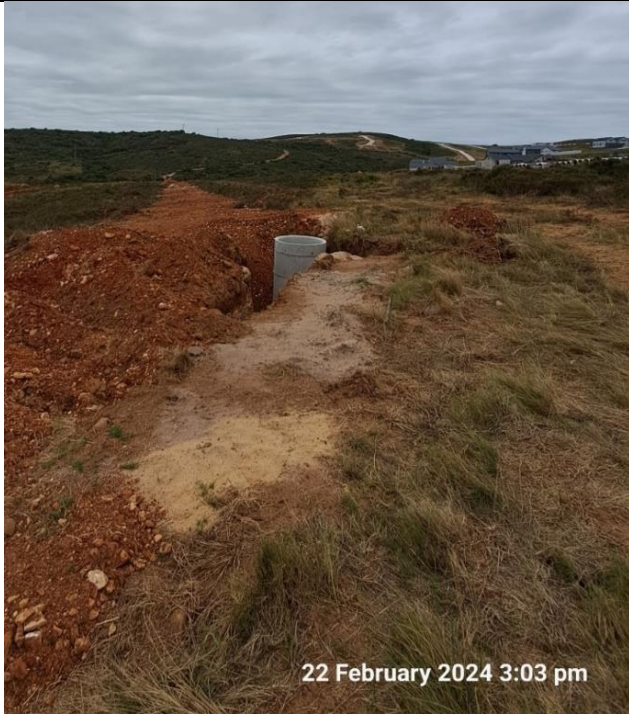
| <p>Should access be required through a no-go area, permission must be obtained from the ECO in writing prior to the use of such an area.</p> | <p>N/A</p> | <p>Nothing reported to the ECO or noted by the ECO during site inspections.</p> | <p>22 February 2024 3:03 pm</p> <p>Mid-block sewer installation. Pegged route were followed.</p> |

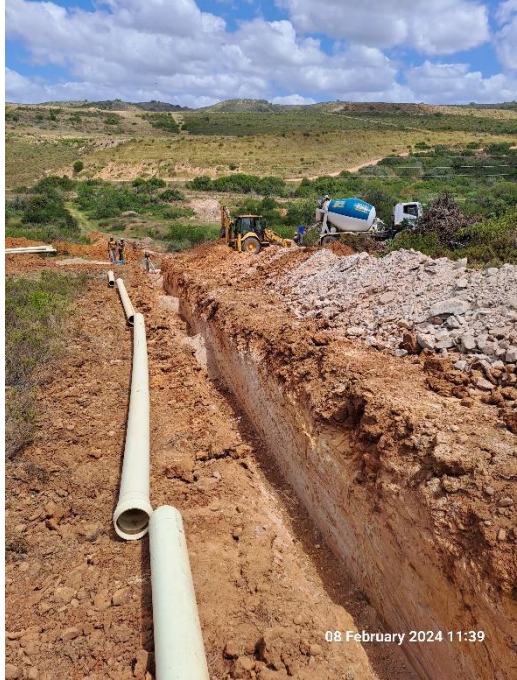
| Fauna and Flora | | | |
|---|---|---|---|
| <p>Animal rescue strategies should be implemented prior to bush clearing when the site is surveyed. The ECO must sign off areas prior to earthworks commencing.</p> <p>Plant rescue and rescue before physical construction starts. - no indigenous vegetation may be cleared from site without the prior approval of the ECO</p> | Ongoing | <p>Plant search and rescue must be done (entire development phase is recommended) prior to clearing of vegetation for installation of services (sewer, water, roads etc.). Topsoil stripping of the roads in phase 9 started before the ECO could sign off the plant search and rescue, however, topsoil (windrows) must be protected for the duration of the construction phase.</p> <p>No harm to any animals were reported to the ECO or noted during ECO site inspections.</p> | <p>08 February 2024 11:39</p> |

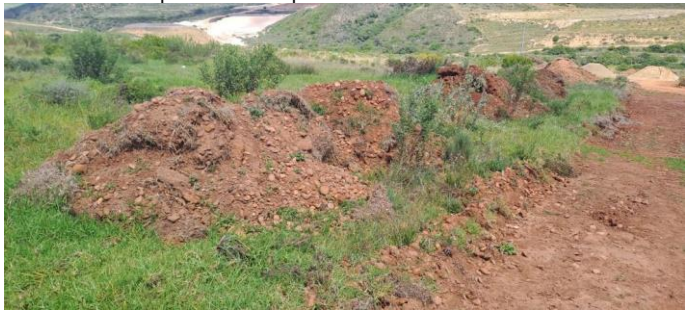
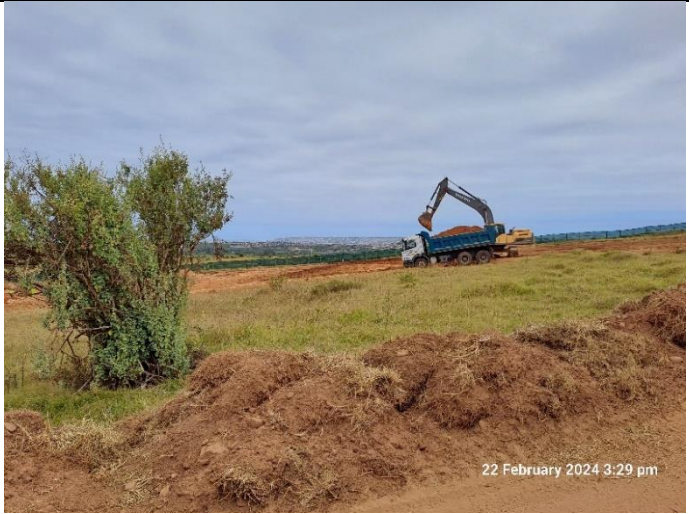
| Fauna and Flora | | | |
|---|---|---|---|
| <p>Topsoil must be stripped from all construction areas before work commences. This topsoil should be stockpiled for use in rehabilitation and landscaping and must not be contaminated with other building/construction materials.</p> <p>The vegetation roots are to be removed together with the top 20cm of topsoil and are to be stockpiled for use during the rehabilitation phase.</p> | Ongoing | <p>Topsoil of the road surface has been stripped and stockpiled to use in rehabilitation.</p> <p>Topsoil of the sewer/water etc infrastructure must be stockpiled on one side of the trench and replaced back on top once installation is complete.</p> | <p>Phase 9 – topsoil stockpiles</p> <p>Phase 19 – bulk excavations</p> |

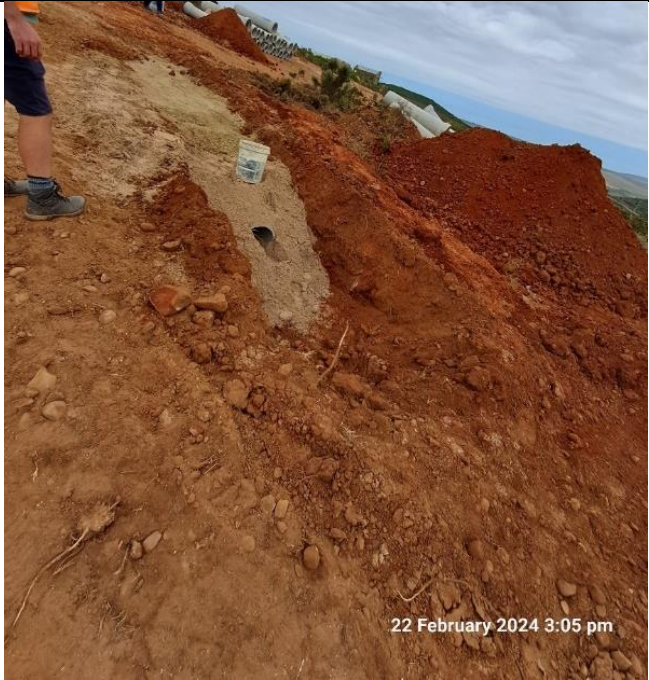
| Trenches for sewage and water pipes running through forested areas, must be dug manually wherever possible. | N/A | Not applicable for phases 9 & 19. | <p>22 February 2024 3:05 pm</p> <p>Within development node – no forested areas</p> |

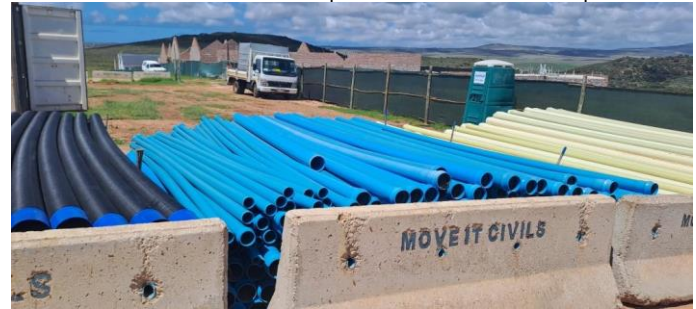
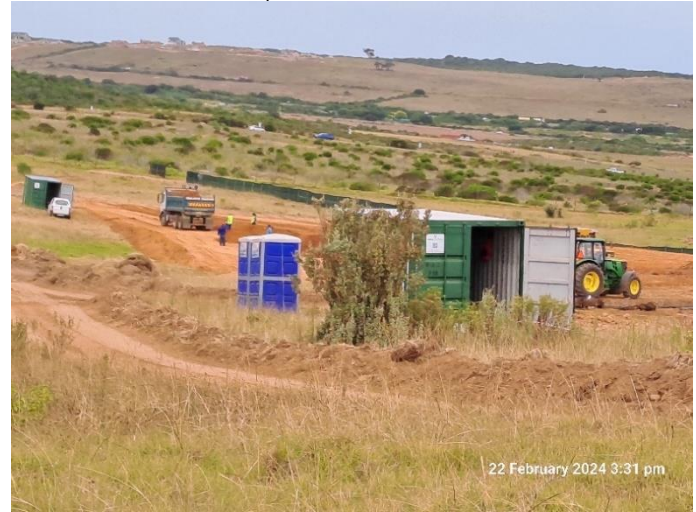
| The contractors' camp site must be in an area indicated and approved by the ECO for this purpose and must demarcated. | Compliant | Phase 9 site camp – same site camp location that was used for phase 4. Site camp is demarcated with concrete barriers and green shade netting. | <p>Phase 9 – same site camp that was used for phase 4.</p> <p>Phase 19 – site camp within the demarcated zone.</p> |

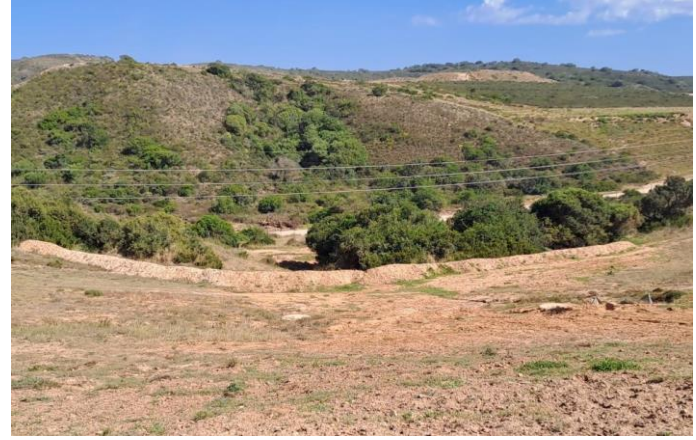
| Erosion control mechanisms must be in place during each stage of the construction phase. | Ongoing | <p>Currently no stormwater related issues on site.</p> <p>Silt fences and stormwater deflection/energy dissipation will be required when the stormwater outlets are connected to the stormwater system.</p> <p>Permanent stormwater management are included in the EMPr (swales/berms).</p> | <p>Phase 4 – stormwater berms</p> |

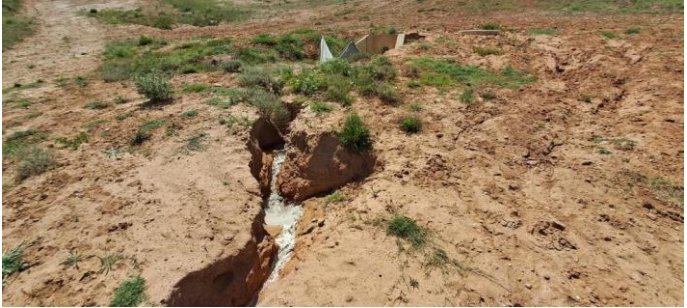
| <p>In the event of erosion damage or silt movement, the contractor is responsible for the clean-up required to reinstate the conditions to normal.</p> | <p>Outstanding<br/>Phase 4</p> | <p>Phase 4 erosion damage still needs to be fixed and rehabilitated – soil berms/swales will be constructed as per the EMPr.</p> | <p>Phase 4 – erosion damage that must still be fixed.</p> |

The contractor is aware that the road verges and stormwater swales/berms in phase 4 must still be completed.

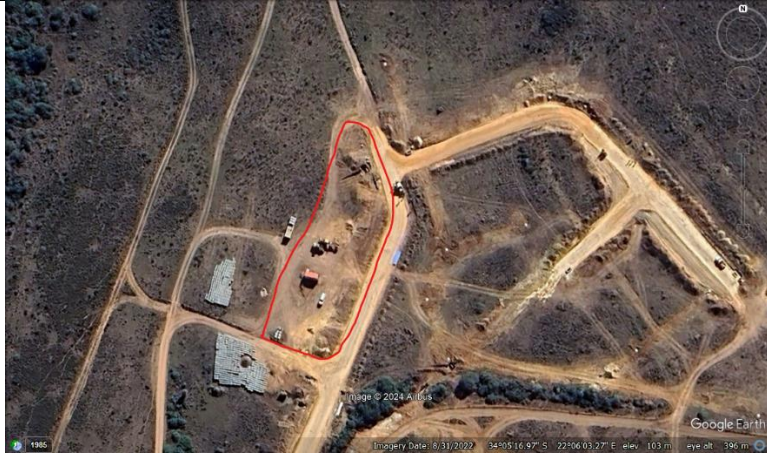
Google Earth - 2022.08.31 - Site camp location for phase 12, 13 and 14.

Rehabilitation of phases 12 and 14 was successful.

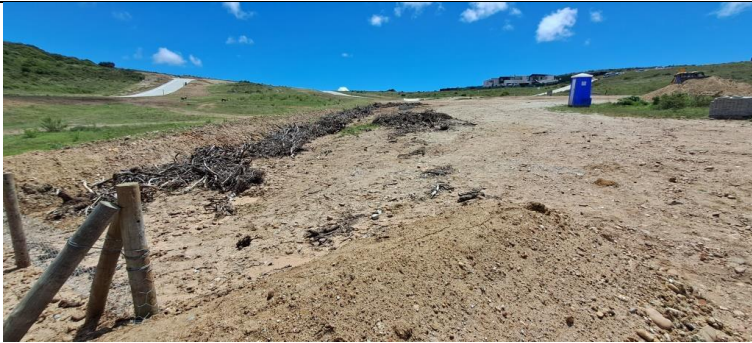
2024.01.17 – Phase 12

The site camp area rehabilitation started. Brushwood placed on top of the rehabilitated area and stormwater berms.

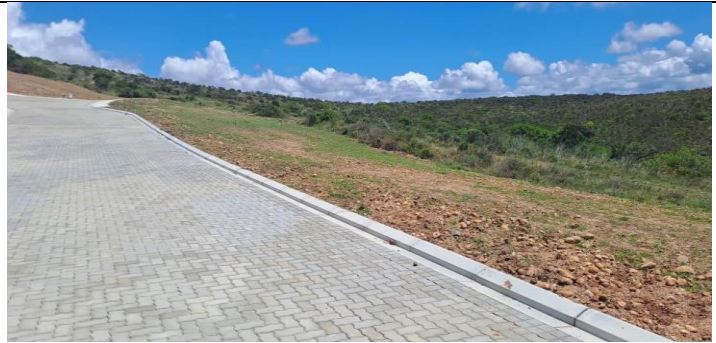
2024.01.17 – Phase 14

Road verges have been shaped and seeded with indigenous grass seed mix.

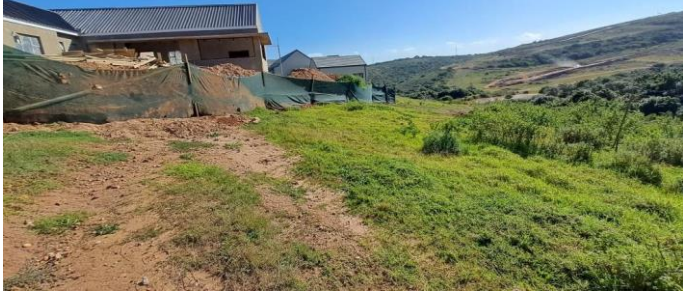
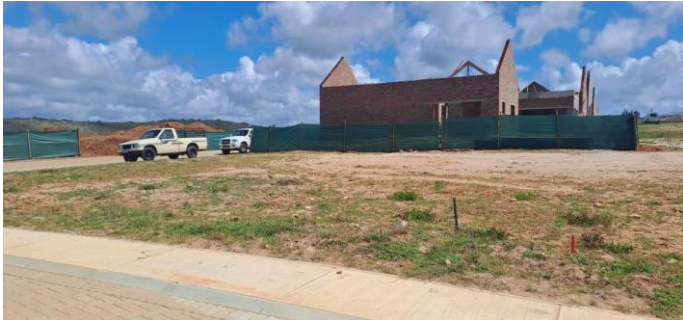
| EMPr requirements | Level of compliance | Comments / Findings | Photo's (if applicable) |
|---|---|---|---|
| All areas outside that of the defined works (development footprint) are deemed as no-go areas. These areas have to be properly demarcated to prevent any construction encroachment. | Ongoing | <p>Houses are clearly demarcated, and compliance is also monitored by the HOA.</p> <p>The private rehabilitation areas used for stockpiling during construction phase must be rehabilitated as required in terms of the EMPr.</p> | <p>2023.07.27 – Phase 10 showing demarcation in place.</p> <p>2024.01.17 – Phase 4</p> |

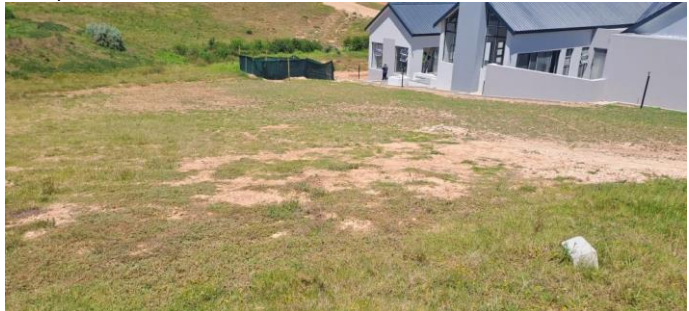
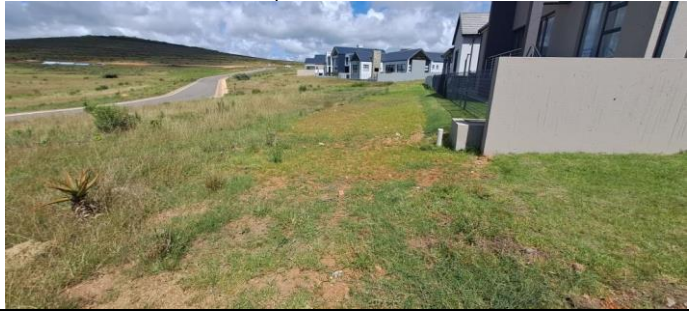
| Fauna and Flora | | | |
|---|---|---|---|
| <p>Animal rescue strategies should be implemented prior to bush clearing when the site is surveyed. The ECO must sign off areas prior to earthworks commencing.</p> <p>Plant rescue and rescue before physical construction starts. - no indigenous vegetation may be cleared from site without the prior approval of the ECO</p> | Ongoing | <p>Concept plan site inspection include identification of any plants that must be rescued before commencement with earthworks. In most cases the erven do not contain any rescue material as the house construction follows shortly after the civil services installation is completed. Leaving little time for indigenous vegetation to establish/regrow.</p> | <p>2024.01.17 – Phase 10 – rehabilitation in progress of the private rehabilitation zone.</p> <p>Rehabilitation of the private rehabilitation zones.</p> |

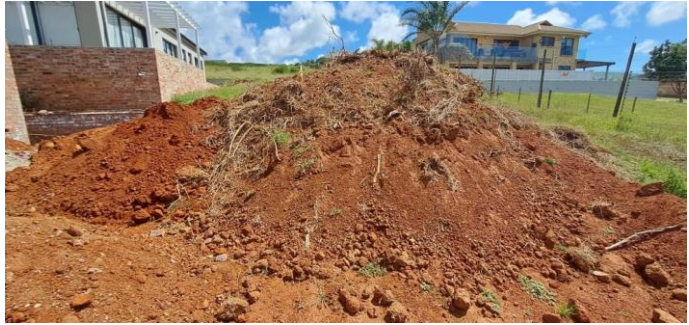
| Fauna and Flora | | | |
|---|---|---|---|
| <p>Topsoil must be stripped from all construction areas before work commences. This topsoil should be stockpiled for use in rehabilitation and landscaping and must not be contaminated with other building/construction materials.</p> <p>The vegetation roots are to be removed together with the top 20cm of topsoil and are to be stockpiled for use during the rehabilitation phase.</p> | Ongoing | <p>Topsoil must be kept separate from subsoil or any home building material.</p> <p>Topsoil is then used during rehabilitation of the private rehabilitation area and any other internal disturbances around the development footprint.</p> | <p>2024.01.17 – Phase 2 - topsoil rescued for rehabilitation</p> |

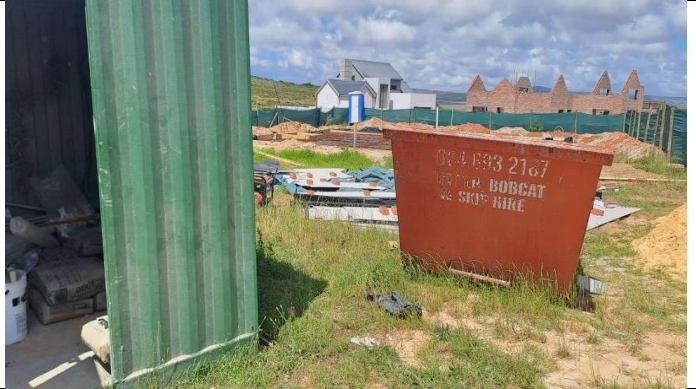
| <b>Specific Requirements from Forestry</b> | | | |
|---|---|---|---|
| The contractors' camp site must be in an area indicated and approved by the ECO for this purpose and must be totally fenced off from the game. | Compliant | Each contractor has set up a site camp/storage area inside fenced of construction boundary as approve by the ECO or HOA. | 2024.01.17 – Phase 4 – site camp within the demarcated construction zone. |

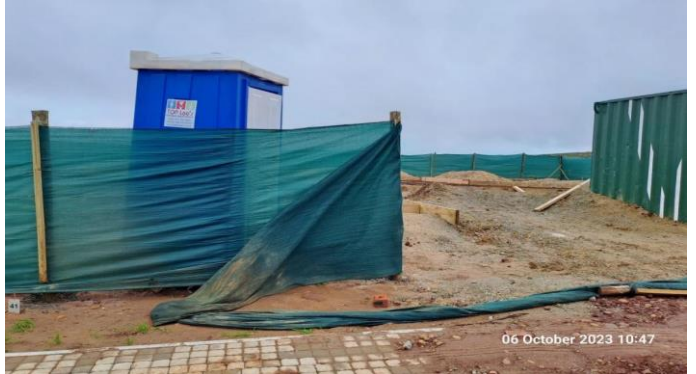
| Portable ablution facilities (chemical toilets) are to be provided at the camp site for the use of the staff. Additional facilities are to be always provided closer to areas of work. | Ongoing | There are sufficient ablution facilities on each site. | 2023.10.06 – Phase 4 - demarcation and suitable toilet facility on site.<br> |

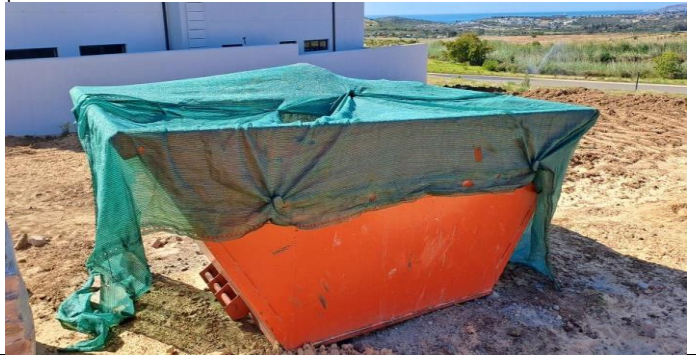
| A fenced off area must be created within the site camp for refuse and waste management as indicated above. ECO to inspect for compliance. | Ongoing | Refuse and waste are treated inside the demarcated construction site, however, construction material and litter often spread outside the demarcated boundary, which is then reported to the contractor and rectified. Skips are covered with shade netting (or similar) to prevent litter blowing away.<br><br>Regular toolbox talks are required to remind contract workers to pick up litter and keep construction material inside the construction boundary/skips. | 2023.08.24 – Phase 1 - Necessary measures are in place to ensure that litter is limited.<br> |
