### ENVIRONMENTAL MONITORING REPORT NO.31

OUTENIKUASBOSCH, FARMS OUTENIKUASBOSCH 149 AND HARTENBOSCH  
217, HARTENBOS

**ENVIRONMENTAL MONITORING REPORT NO 31**

**March 2024**

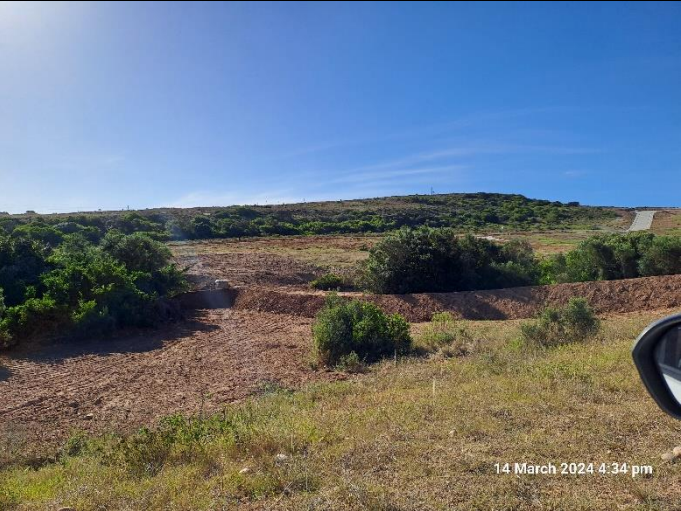
| <p>Topsoil must be stripped from all construction areas before work commences. This topsoil should be stockpiled for use in rehabilitation and landscaping and must not be contaminated with other building/construction materials.</p> <p>The vegetation roots are to be removed together with the top 20cm of topsoil and are to be stockpiled for use during the rehabilitation phase.</p> | Ongoing | <p>Topsoil of the road surface has been stripped and stockpiled to use in rehabilitation.</p> <p>Topsoil of the sewer/water etc infrastructure must be stockpiled on one side of the trench and replaced back on top once installation is complete.</p> | <p>Stormwater berm between phase 11 &amp; 12 completed</p> |

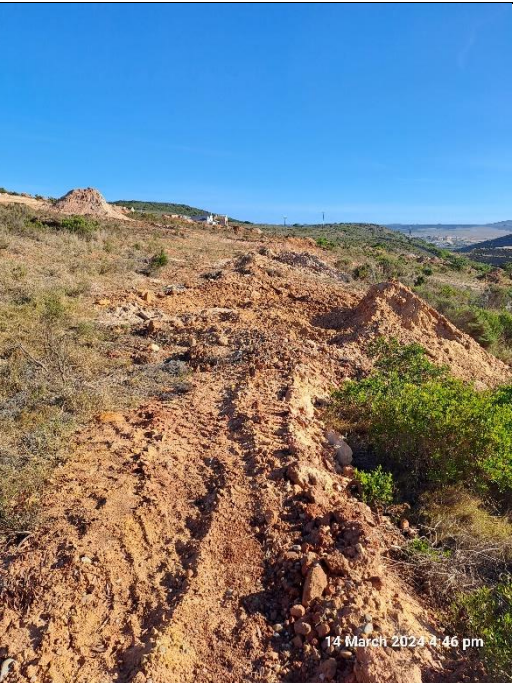
| Specific Requirements from Forestry | | | |
|---|---|---|---|
| Trenches for sewage and water pipes running through forested areas, must be dug manually wherever possible. | N/A | Not applicable for phases 9 & 19. | <p>Trenches are closed and not affecting any forested areas (phase 9)</p> |

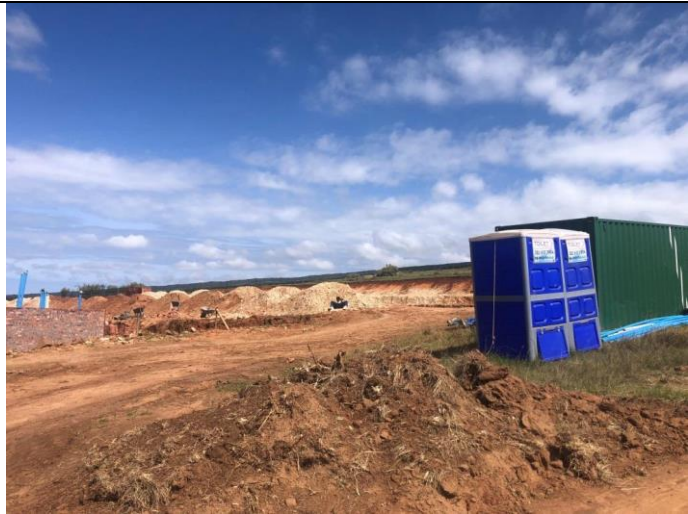
| Portable ablution facilities (chemical toilets) are to be provided at the camp site for the use of the staff. Additional facilities are to be always provided closer to areas of work. | Compliant | There are sufficient ablution facilities located at the site camp and construction site (phase 9 & 19). | |

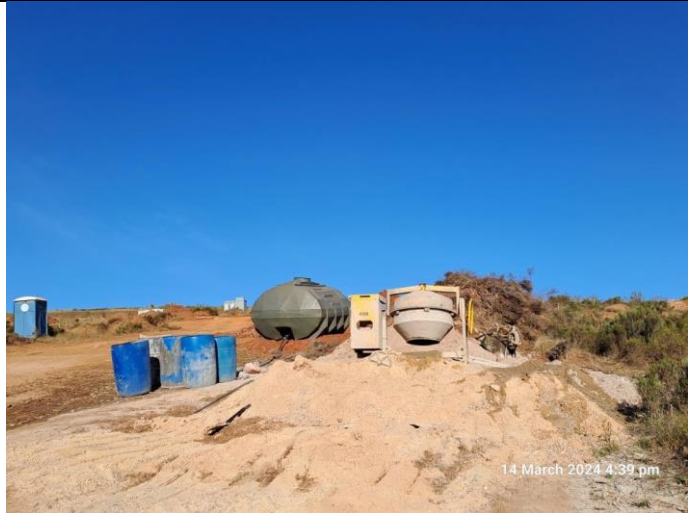
| Any concrete batching areas are to be approved by the ECO prior to utilization and must be equipped with suitable settling ponds and trapping mechanisms to ensure that contaminated water does not leave the restricted area. | Action Required | The cement batching area (stand mixer) in Phase 9 must be bunded to avoid contaminated water wash into the natural vegetation or stormwater network. This was reported to the contractor on the WhatsApp group and immediately actioned – soil berm was created. | |

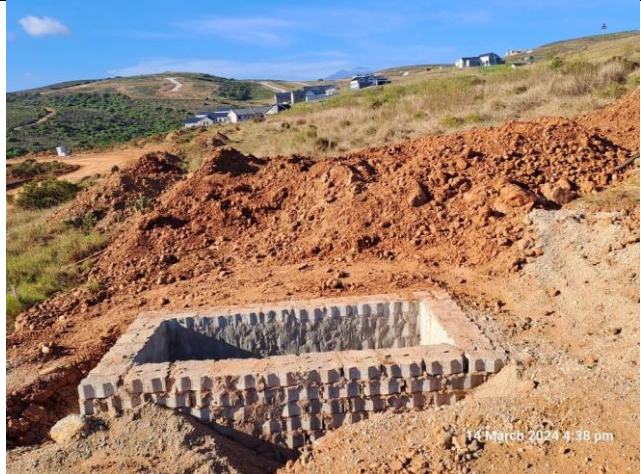
| Erosion control mechanisms must be in place during each stage of the construction phase. | Ongoing | <p>Currently no stormwater related issues on site.</p> <p>Silt fences and stormwater deflection/energy dissipation will be required when the stormwater outlets are connected to the stormwater system - not yet applicable.</p> <p>Permanent stormwater management are included in the EMPr (swales/berms).</p> | <p>Construction of the stormwater inlet structure</p> |
