### ENVIRONMENTAL MONITORING REPORT NO. 32

OUTENIKUASBOSCH, FARMS OUTENIKUASBOSCH 149 AND HARTENBOSCH  
217, HARTENBOS

**April 2024**

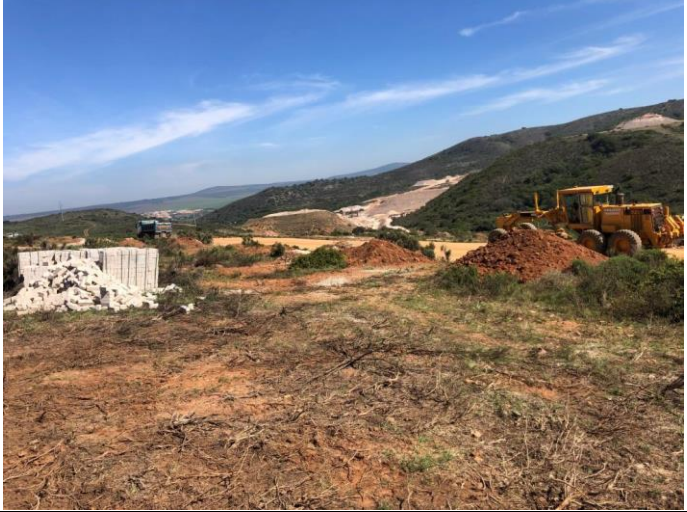
| <b>Topsoil Stripping</b> | | | |
|---|---|---|---|
| <p>Topsoil must be stripped from all construction areas before work commences. This topsoil should be stockpiled for use in rehabilitation and landscaping and must not be contaminated with other building/construction materials.</p> <p>The vegetation roots are to be removed together with the top 20cm of topsoil and are to be stockpiled for use during the rehabilitation phase.</p> | Ongoing | <p>Topsoil of the road surface has been stripped and stockpiled to use in rehabilitation.</p> <p>Topsoil of the sewer/water etc infrastructure must be stockpiled on one side of the trench and replaced back on top once installation is complete.</p> | |

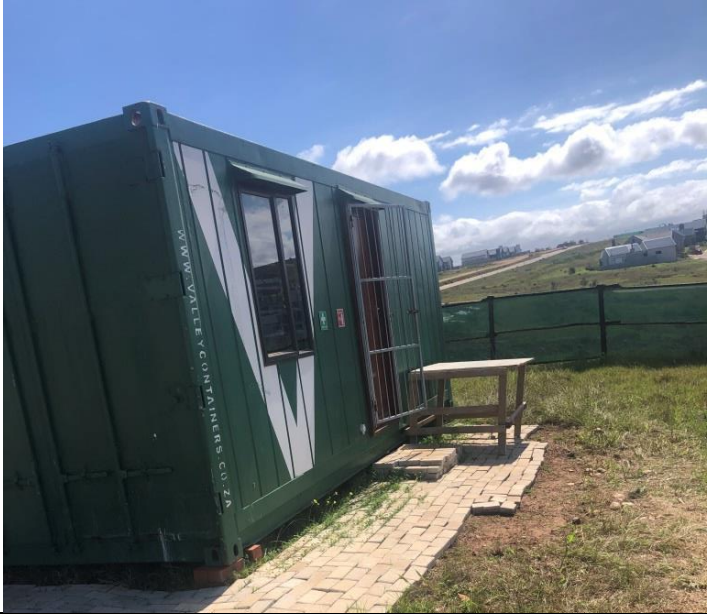
| <p>The contractors' camp site must be in an area indicated and approved by the ECO for this purpose and must be totally fenced off from the game.</p> | <p>Compliant</p> | <p>Phase 9 site camp – same site camp location that was used for phase 4. Site camp is demarcated with concrete barriers and green shade netting.</p> | |

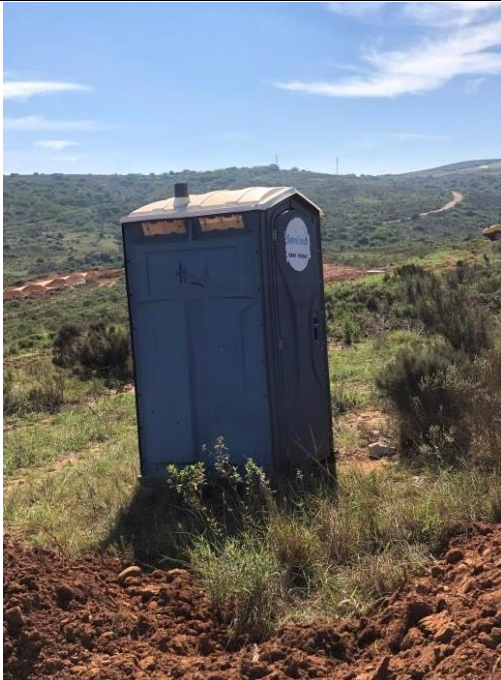
| <p>Portable ablution facilities (chemical toilets) are to be provided at the camp site for the use of the staff. Additional facilities are to be always provided closer to areas of work.</p> | <p>Compliant</p> | <p>There are sufficient ablution facilities located at the site camp and construction site (phase 9 &amp; 19).</p> | |

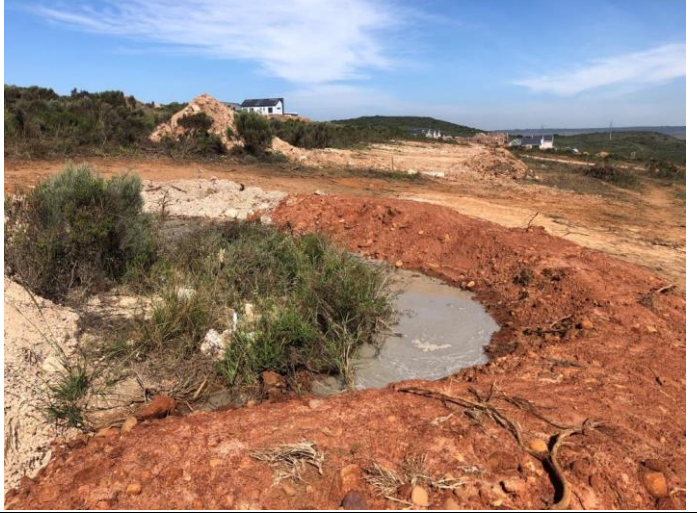
| Any concrete batching areas are to be approved by the ECO prior to utilization and must be equipped with suitable settling ponds and trapping mechanisms to ensure that contaminated water does not leave the restricted area. | Compliant | The cement batching area (stand mixer) in Phase 9 was bunded. | |

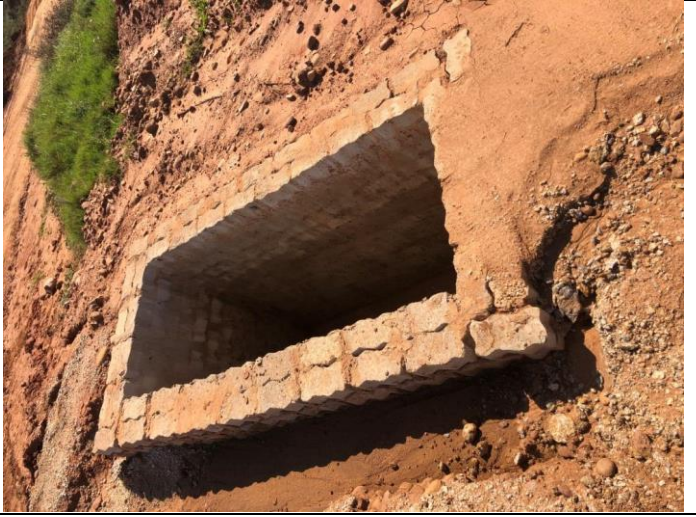
| Storm Water Management | | | |
|---|---|---|---|
| Erosion control mechanisms must be in place during each stage of the construction phase. | Ongoing | <p>Currently no stormwater related issues on site.</p> <p>Silt fences and stormwater deflection/energy dissipation will be required when the stormwater outlets are <b>connected</b> to the stormwater system - not yet applicable.</p> <p>Permanent stormwater management are included in the EMPr (swales/berms).</p> | |

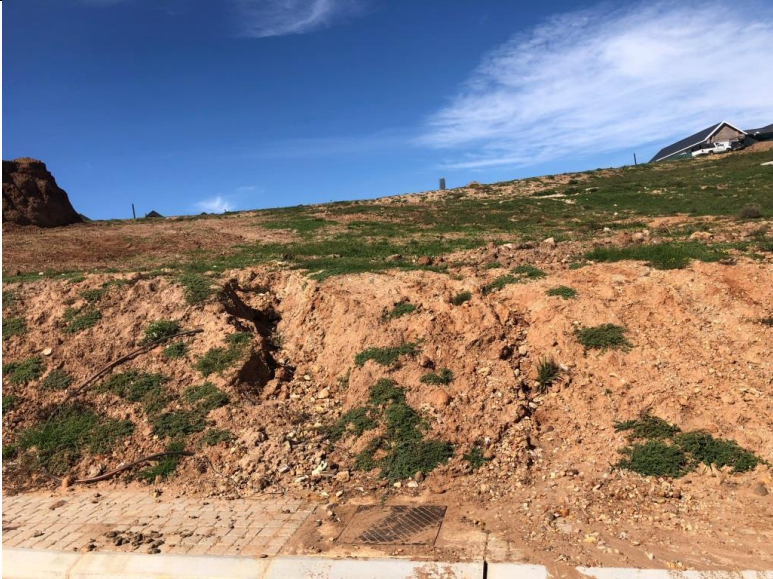
| Phase | Photographic record | Comment and requests |
|---|---|---|
| 4 | | Steep road verges are require additional rehabilitation and revegetation (to keep the slopes stable). |

The contractor is aware that the road verges and stormwater swales/berms in phase 4 must still be completed – construction of the stormwater swales/berms have started.

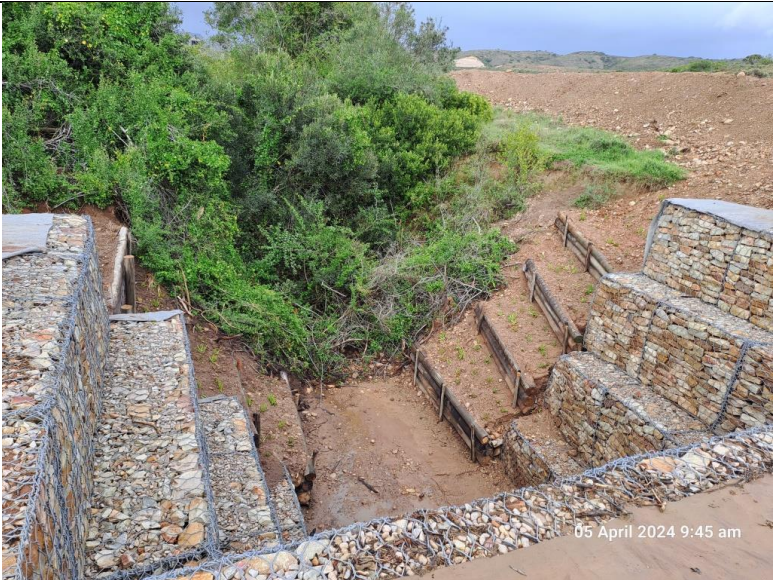
| Phase | Photographic record | Comment and requests |
|---|---|---|
| 11/12 | | Rehabilitation of the stormwater outlet is complete, note slope and soil stabilisation were used (logs and vygies). |
