**ENVIRONMENTAL COMPLIANCE MONITORING REPORT NO.07**

**OUTENIKUASBOSCH, FARMS OUTENIKUASBOSCH 149 AND HARTENBOSCH  
217, HARTENBOS**

**CIVIL SERVICES INSTALLATION (PHASE 10)**

**ENVIRONMENTAL MONITORING REPORT NO 7  
JULY 2021**

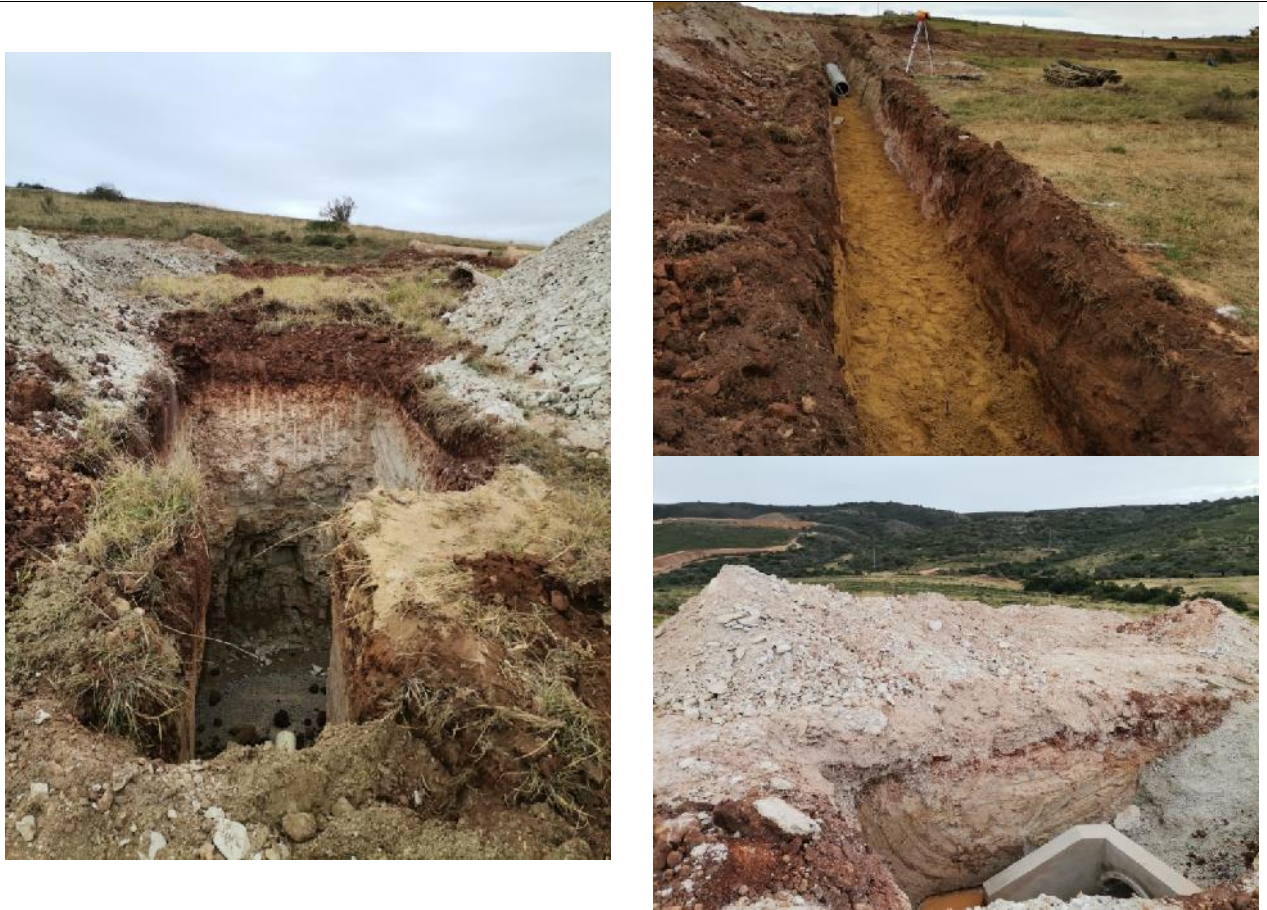
2021.07.28 – The contractor should make sure that the proper demarcation surrounding deep excavations is in place – Health and Safety consultant to monitor person safety requirement.

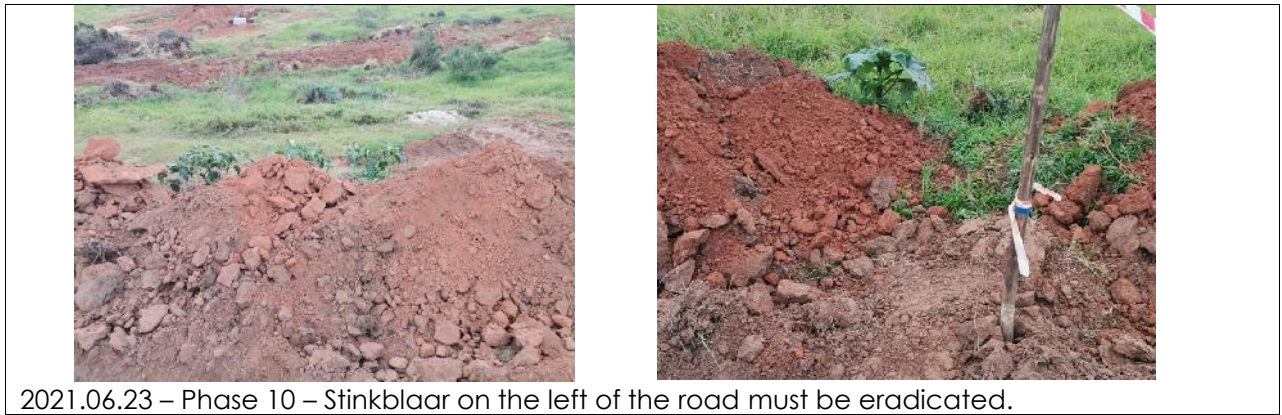
- Alien invasive plant species as a result of construction activity, must be removed - the ECO will inform if and when alien plants are noted. The developer/management team must ensure ongoing alien plant eradication.
- The following list of invasive alien plants and / or weeds **were** noted on Outeniquasbosch and should therefore be managed when spotted:
  - o Stinkblaar (*Datura spp.*) next to the road excavation in **phase 10** must be eradicated.

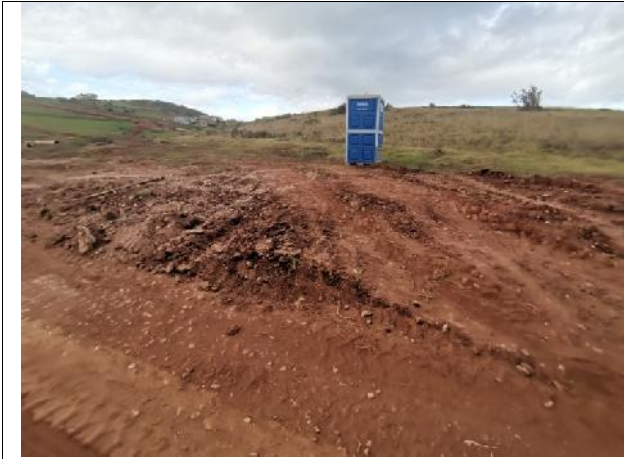
2021.06.23 – Phase 10 contractor providing a portable chemical toilet for the staff.

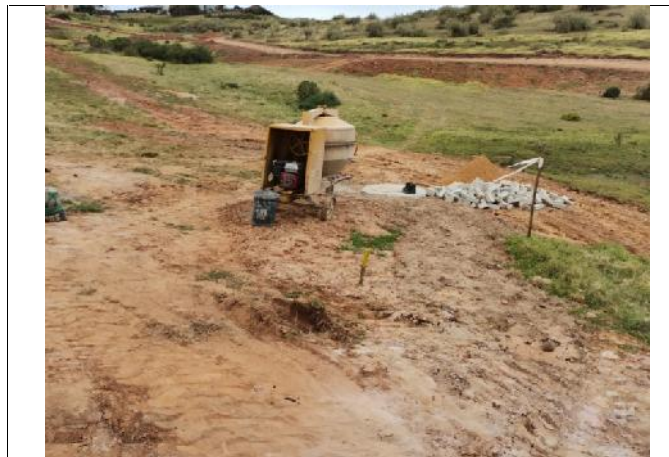
2021.07.28 – Stand mixers are used - a non-permeable layer must be used underneath the concrete mixer, or suitable settling ponds and trapping mechanisms to be implemented – all disturbed areas must be rehabilitated.
