**ENVIRONMENTAL COMPLIANCE MONITORING REPORT NO.21**

**OUTENIQUASBOSCH, FARMS OUTENIQUASBOSCH 149 AND HARTENBOSCH  
217, HARTENBOS**

**CIVIL SERVICES INSTALLATION (PHASES 4 & 11 & 13) & HOUSE  
CONSTRUCTION**

**ENVIRONMENTAL MONITORING REPORT NO 21  
NOVEMBER & DECEMBER 2022**

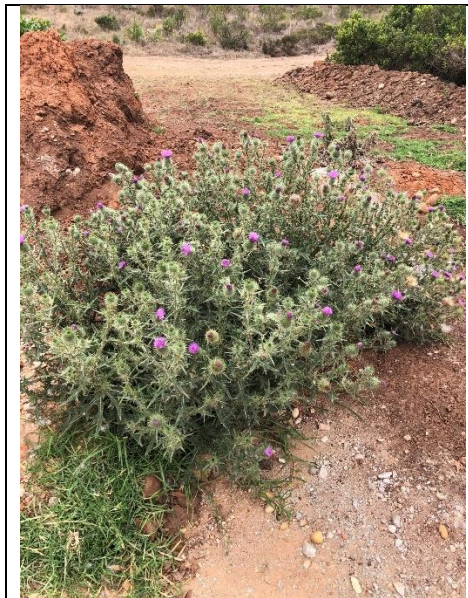
- Alien invasive plant species as a result of construction (all phases) activity must be removed. The developer/management team must ensure ongoing alien plant eradication – Spear thistle (*Cirsium vulgare*) was noted between phases 10 and 11 – this was reported on during the site meeting and subsequently removed.

Spear thistle was removed

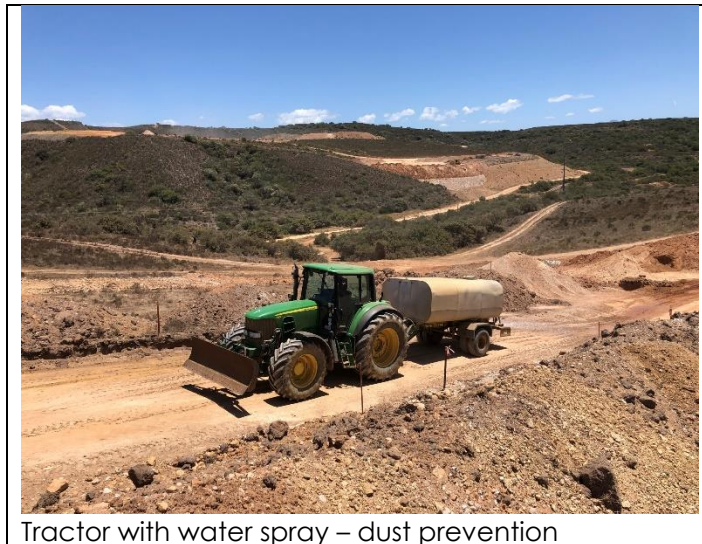
- Dust mitigation measures (keeping the roads wet) are implemented when dust becomes an issue – the civil contractor is using a water truck on dry and hot days to water the construction haul routes.

Tractor with water spray – dust prevention

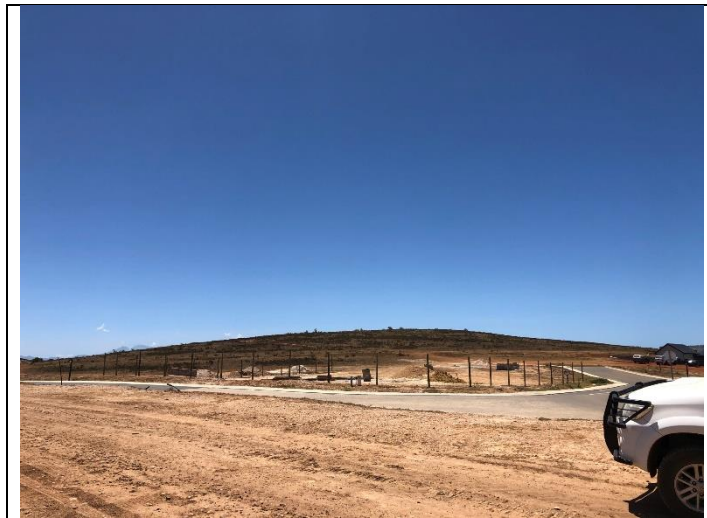
- Civil construction – the cement mixing area for phases 4, 11 & 13 was discussed and agreed, no further encroachment of the mixing area is to occur.
- Home construction – cement mixing is to be contained within the disturbance footprint and on a non-permeable layer (wooden sheet/plastic etc) to prevent soil contamination.
- **Ready-mix trucks are not allowed to be washed on site.**
- The cement slab processing area must be demarcated to prevent further encroachment into natural areas – contractor was busy to install the required demarcation/fence

Main civil contractor – busy installing demarcation/fence around the cement mixing area.

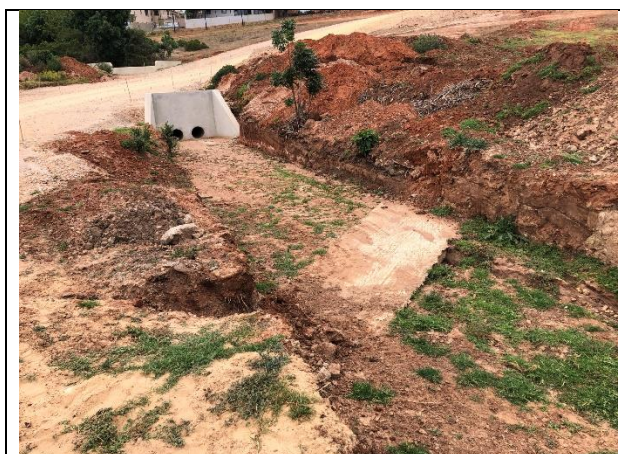
- The contractor is maintaining the current construction haul road. **Please be reminded that driving off the designated haul roads or access roads is not permitted.**
- Construction vehicles must **abide to the speed limit** as this is a wildlife estate with animals roaming freely.
- The temporary haul road next to phase 4 and 10 is demarcated with painted stones – any new haul roads must be approved by the ECO in advance.
- *Singular temporary construction roads in **phases 4 & 11 & 13** must be used. Regular toolbox talks must be done with all drivers and machine operators to remain on the existing temporary construction roads.*
- *Silt fences must be installed in the stormwater outlets to prevent soil erosion and double as litter trap for the duration of the construction phase.*

Silt fence will be installed as soon as the final shaping is done

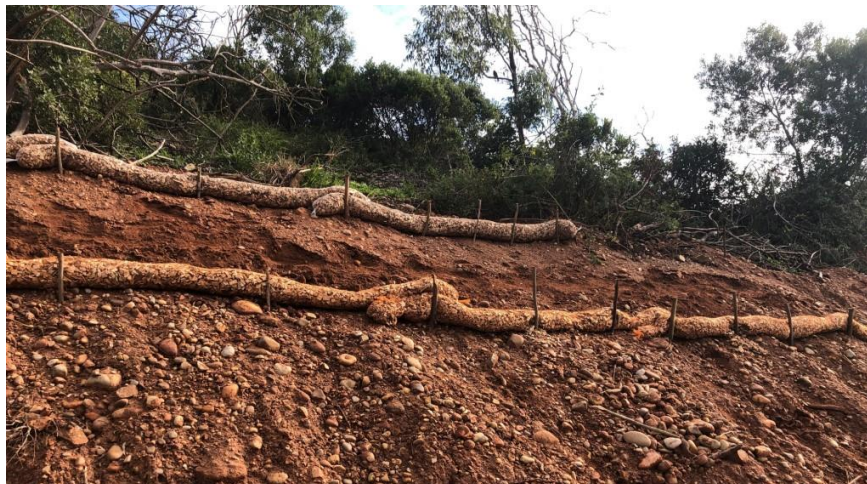
*Example of mulch filled sausages*

Additionally, the contractor can use mulch filled sausages staked horizontally to the steeper slopes along the roads to further curtail soil erosion.
