### ENVIRONMENTAL COMPLIANCE MONITORING REPORT NO.24

OUTENIKUASBOSCH, FARMS OUTENIKUASBOSCH 149 AND HARTENBOSCH  
217, HARTENBOS

**ENVIRONMENTAL MONITORING REPORT NO 24**

**May & June 2023**

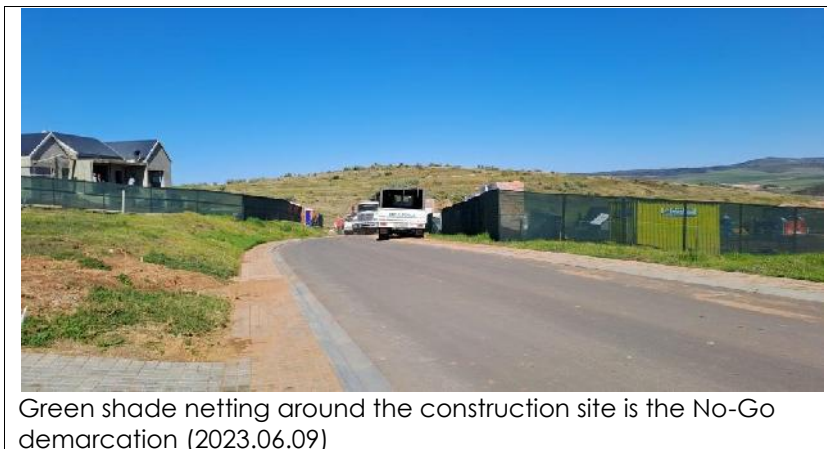
Individual house construction is underway in Phases **1, 2, 3, 10, 11, and 13**. Each building site must be demarcated (including stockpile area), the Architectural Control Officer (ACO) monitors daily compliance. Demarcation around construction sites ensure that no construction activity is contained to the development zone and doubles as silt trap in times of heavy rain.

All construction activities (building and storage) must be within the demarcated development area (of each erf) and not within the rehabilitation zone of the erf – **Construction material is not allowed to be stored outside of the house construction demarcation – ACO to monitor daily.**

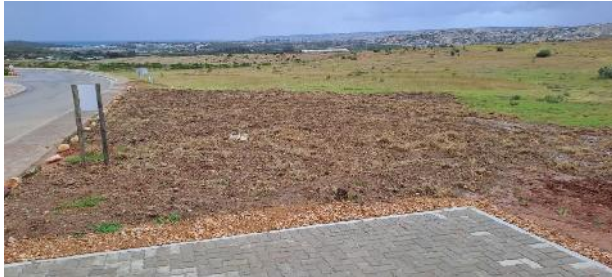
(2023.05.12) – The old temporary parking area at the entrance alongside Oupoot Street have been rehabilitated.

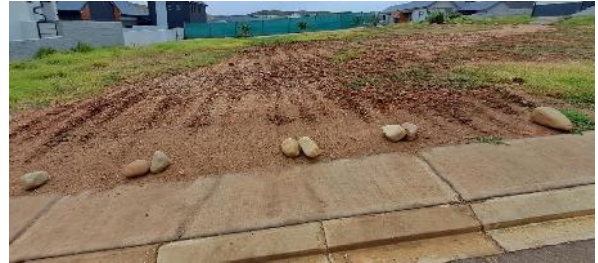
(2023.05.12) – Erven that were disturbed during house construction (**phase 2**) have been rehabilitated.

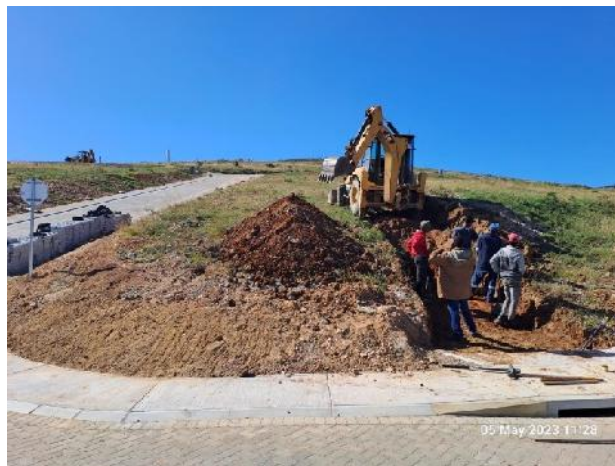
5 May 2023 – contractor busy installing grass blocks in the stormwater channel (phase 11).

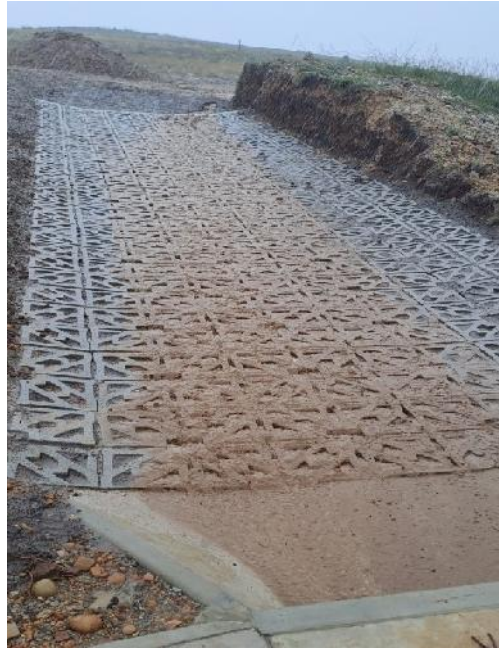
(2023.05.12) – Stormwater management (grass blocks) in **phase 11**.

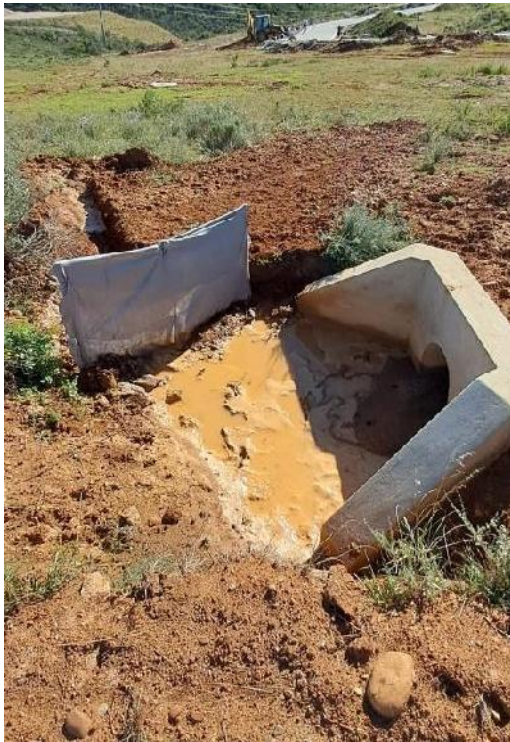
(2023.05.23) – Silt fences at stormwater outlets in phases 4, 12 and 14 proved to be effective **(provided that they are cleaned after rain spell)**

The silt fences that were installed at the stormwater outlets in phases 4, 12 and 14 have proven to work effectively if maintained, the contractor is required to keep the silt fences clean after every rainfall event to ensure that it functions effectively.

Silt fences at the stormwater outlet structures (phases 4, 12 & 14) must be maintained – remove silt and ensure bidim is upright.

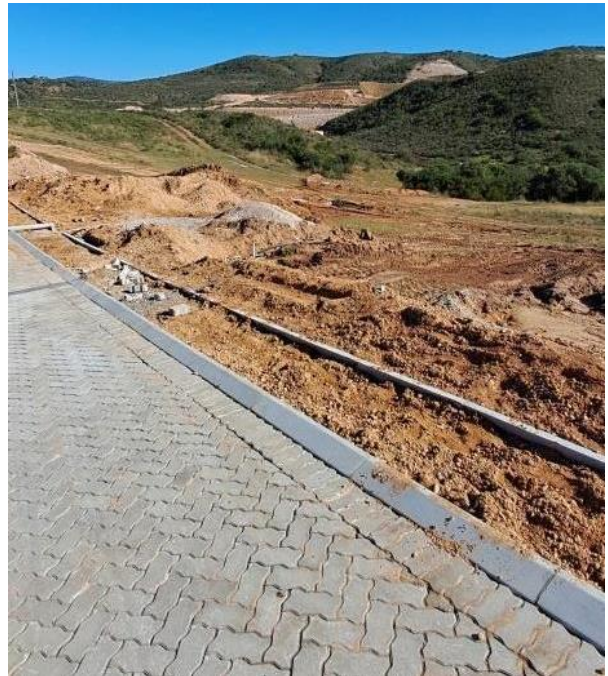
(2023.05.23) – Once the main road and sides/walkways are completed, then the road verges will be rehabilitated **(phase 4)**.

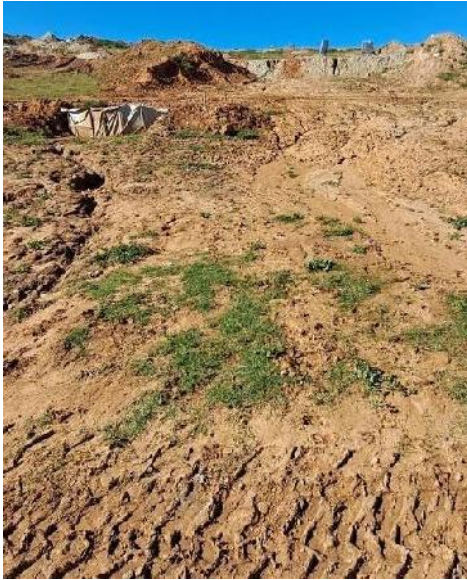
(2023.05.23) - Large areas have been left bare that require immediate rehabilitation **(phase 4)**.

The area received plenty of rain during May and June 2023 and it is therefore important to monitor the site(s) carefully as areas susceptible to erosion that was **not** previously identified as high erosion risk areas have subsequently eroded during the heavy rainfall. Areas that did suffer soil erosion will have to be rehabilitated by replacing topsoil (which can be rescued from any building site in the

development) and seeded with the indigenous grass seed mixture and erosion protection as discussed in section 7.

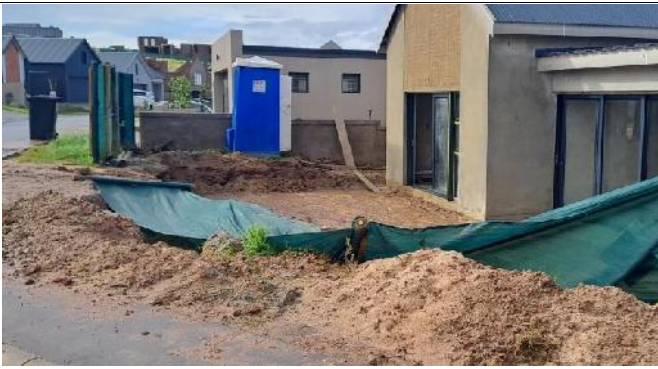
(2023.06.09) – Evidence of ablution facility at individual housing construction (note the green net was temporary removed to work on HOA infrastructure).

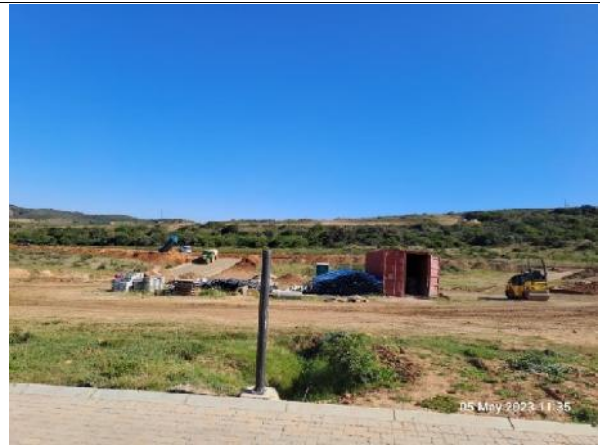
(2023.05.05) – General view of site camp at **phase 12** with included ablution facility.

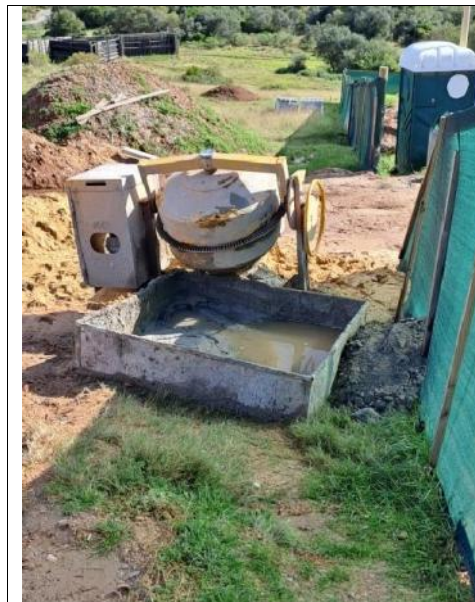
(2023.06.09) – Bunding for cement mixing in place (note that it is required that all construction activities be confined to the demarcated housing construction zone).

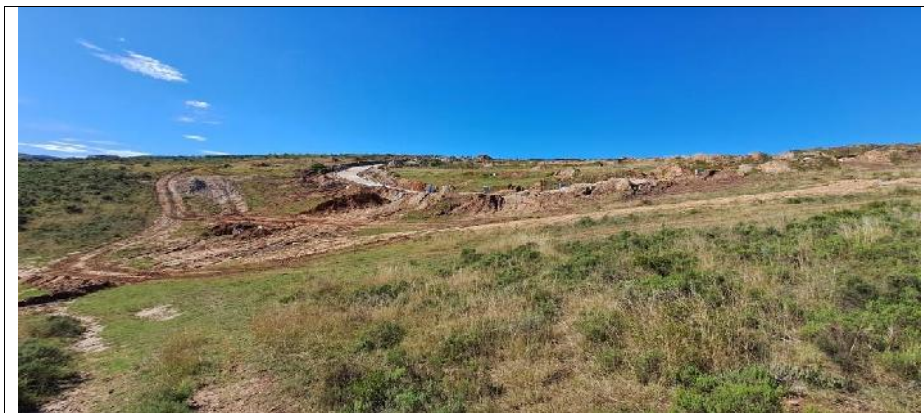
General view of the construction site – Phase 12

**The contractor will be responsible for the rehabilitation** of all disturbed areas (including temporary construction haul routes) at the end of construction and before handing the services back to the developer/HOA.

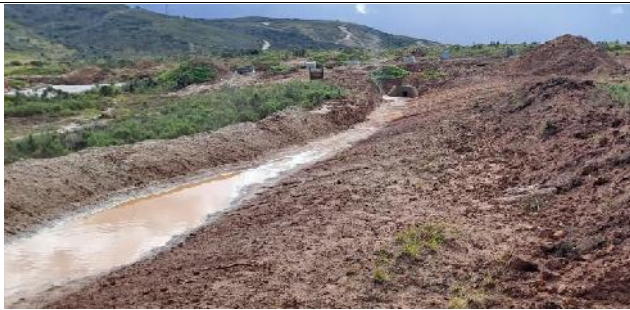
| <p>(2023.06.09) – stormwater swale to be completed and vegetated with indigenous grasses and plants once topsoil is replaced.</p> | <p>(2023.05.23) – Finalise stormwater outlet structures and rehabilitate and erosion protection.</p> |

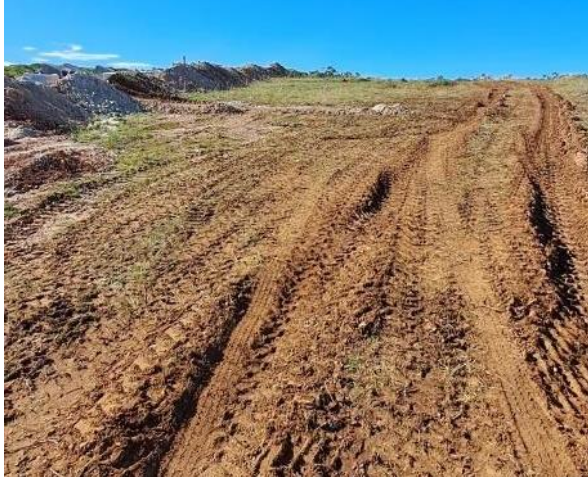
| <p>(2023.05.23) – All temporary construction roads must be rehabilitated – rip compacted soil, replace topsoil and seed with indigenous grass seeds.</p> | |

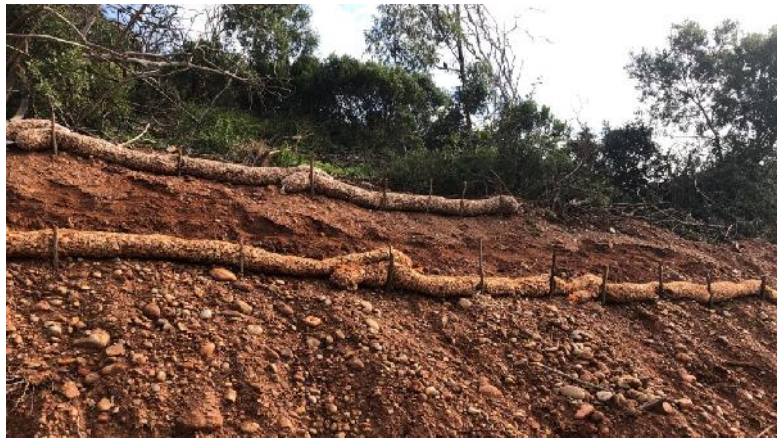
*Example of mulch filled sausages.*

Additionally, the contractor can use mulch filled sausages staked horizontally to the steeper slopes along the roads to further curtail soil erosion.
