### ENVIRONMENTAL MONITORING REPORT NO. 33

OUTENIKUASBOSCH, FARMS OUTENIKUASBOSCH 149 AND HARTENBOSCH  
217, HARTENBOS

**May 2024**

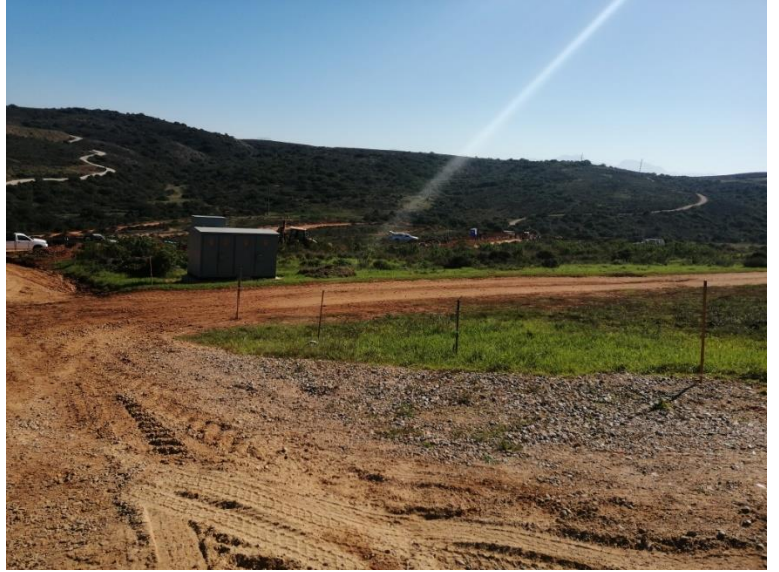
| EMPr Requirements | Level of Compliance | Comments/ Findings | Photos (if applicable) |
|---|---|---|---|
| All areas outside that of the defined works (roads and pipeline routes) are deemed as no-go areas. These areas have to be properly demarcated to prevent any construction encroachment. | Compliant and ongoing | <p>NO-GO areas are discussed with the contractor, pegged by the surveyor and works are confined to the demarcated area.</p> <p><b>Construction haul routes must be demarcated (painted stones is recommended) to avoid machinery/delivery vehicles from driving in the veld.</b></p> | <p>(09.05.24) – phase 9 entrance pegged</p> |

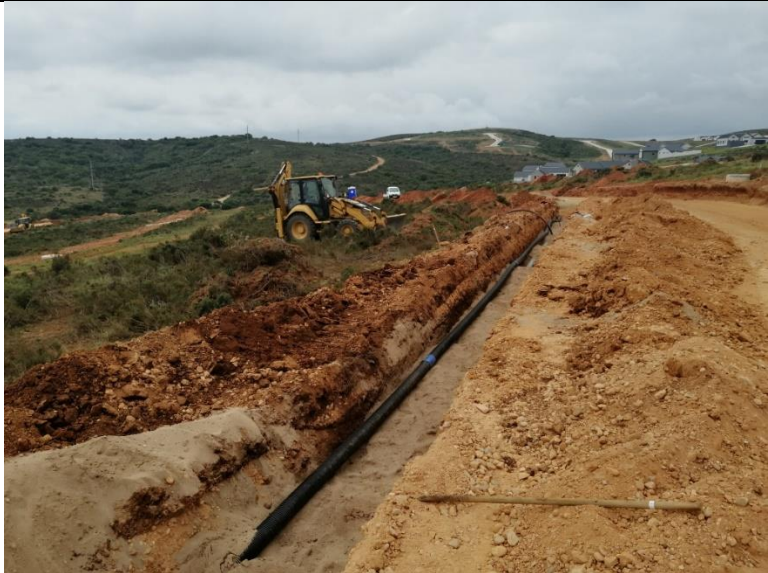
| Topsoil must be stripped from all construction areas before work commences. This topsoil should be stockpiled for use in rehabilitation and landscaping and must not be contaminated with other building/construction materials.<br><br>The vegetation roots are to be removed together with the top 20cm of topsoil and are to be stockpiled for use during the rehabilitation phase. | Ongoing | Topsoil of the road surface has been stripped and stockpiled to use in rehabilitation.<br><br>Topsoil of the sewer/water etc infrastructure must be stockpiled on one side of the trench and replaced back on top once installation is complete. | |

(23.05.24) – trench excavation

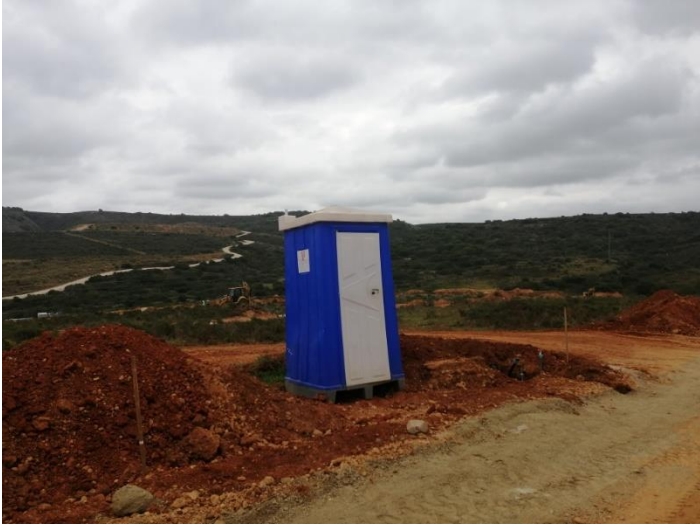
| Portable ablution facilities (chemical toilets) are to be provided at the camp site for the use of the staff. Additional facilities are to be always provided closer to areas of work. | Compliant | There are sufficient ablution facilities located at the site camp and construction site (phase 9 & 19). | <p>(23.05.24)</p> |

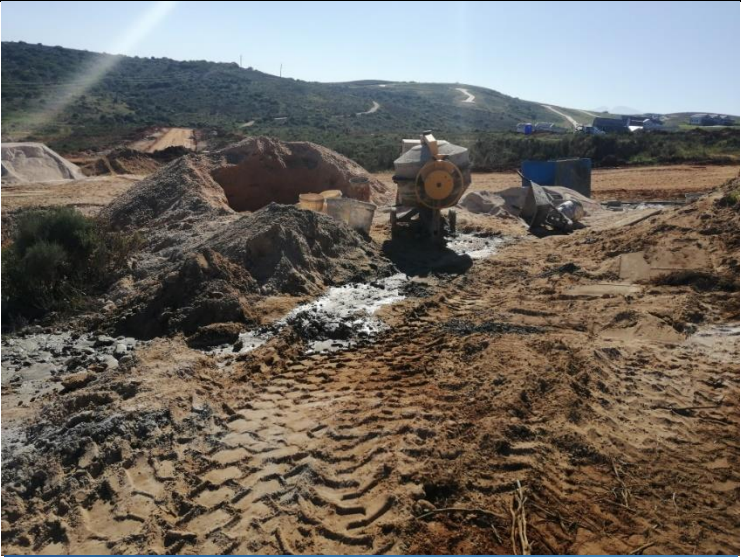
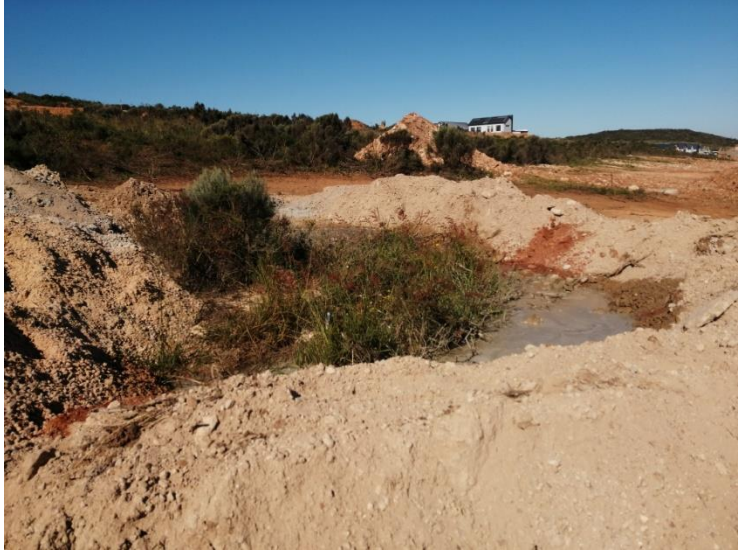
| Any concrete batching areas are to be approved by the ECO prior to utilization and must be equipped with suitable settling ponds and trapping mechanisms to ensure that contaminated water does not leave the restricted area. | Compliant | The cement batching area (stand mixer) in Phase 9 is bunded. | <p>(09.05.24) – soil berm bunding (although the vegetation was not rescued in this particular area)</p> |

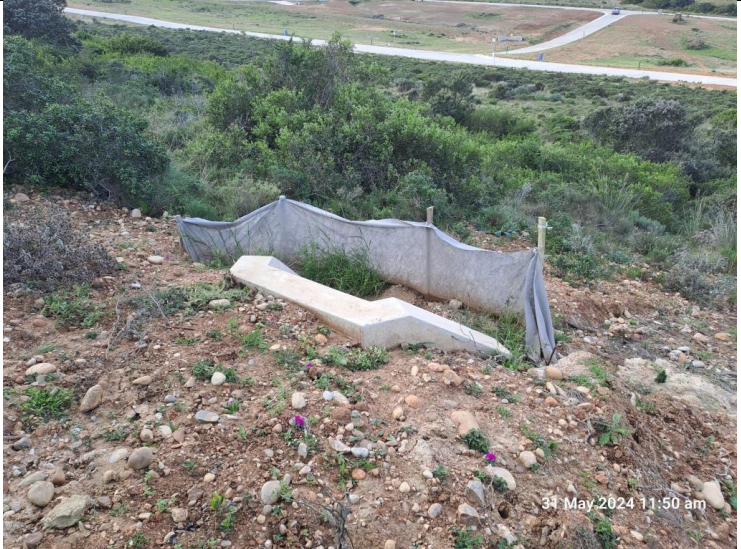
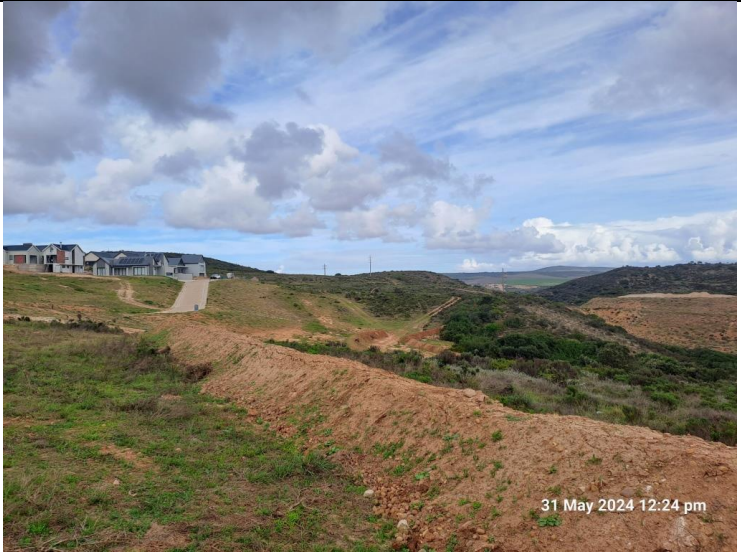
| Erosion control mechanisms must be in place during each stage of the construction phase. | Ongoing | <p>Currently no stormwater related issues on site (during May 2024).</p> <p>Silt fences and stormwater deflection/energy dissipation will be required when the stormwater outlets are connected to the stormwater system (phase 9) - not yet applicable.</p> <p>Permanent stormwater management are included in the EMPr (swales/berms) and implemented as required.</p> | <p>Phase 14 silt fences</p> |

Phases 9 and 19 civil installations are ongoing, and the developer and contractor are compliant with the EMPr. House construction in phase 14 has commenced during this reporting period and strict silt/erosion protection at the base of the green shade netting must be implemented, especially the sites bordering the internal green spaces.

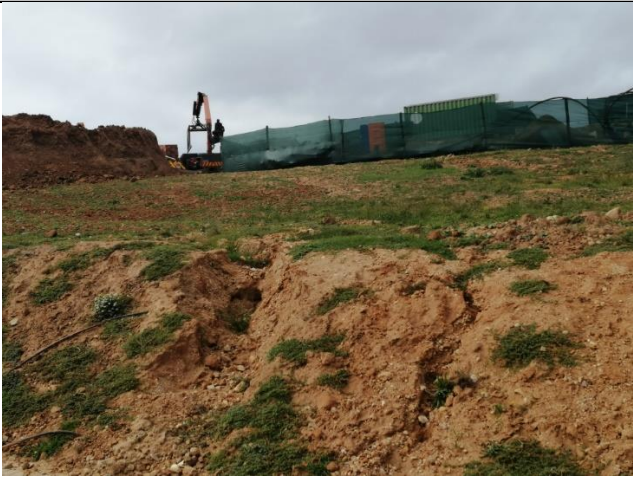
| Phase | Photographic record | | Comment and requests |
|---|---|--|---|
| 4 | <p>(17.05.24)</p> | | Steep road verges will have to be vegetated or suitable erosion protection installed. |

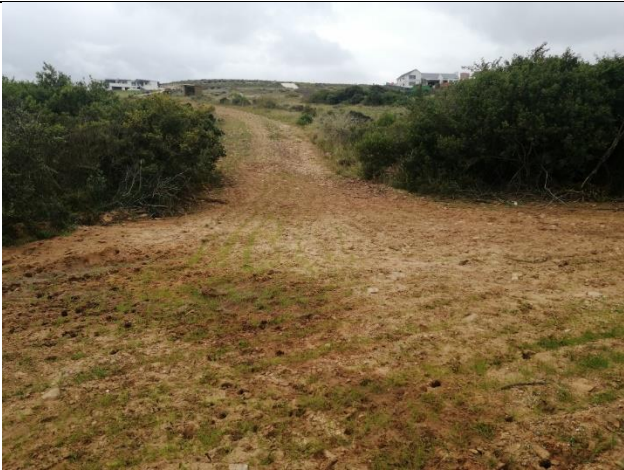
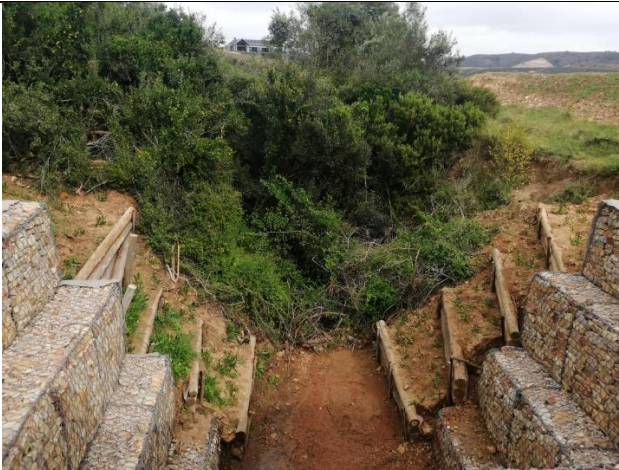
| Phase | Photographic record | | Comment and requests |
|---|---|--|---|
| 11/12 | | | Rehabilitation of the stormwater outlet is complete, note slope and soil stabilisation were used (logs and vygies). |
