# THE ESTABLISHMENT OF A HOUSING DEVELOPMENT AND ASSOCIATED INFRASTRUCTURE ON ERF 10509 AND THE REMAINDER OF FARM CA 597, PHILIPPI

DEA&DP Ref: 16/3/3/6/3/A7/4/3049/21

## FORMAL ECO AUDIT REPORT

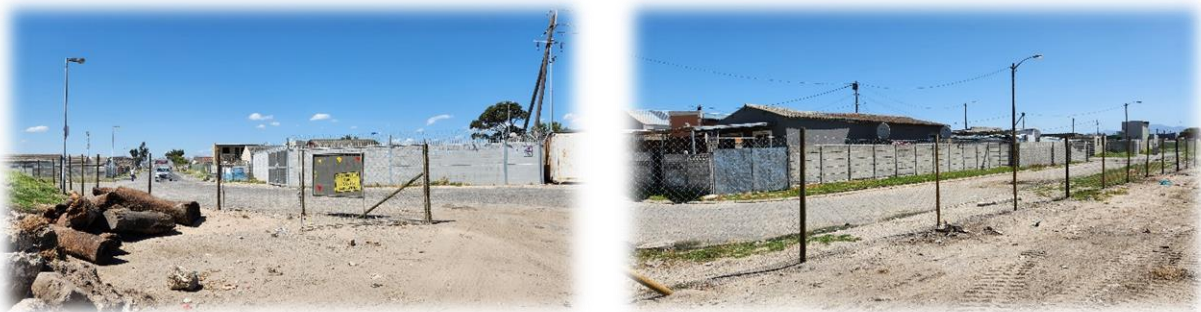
The entire site has been fenced and all construction works takes place within the fenced area.

All areas outside the approved development area are strict No-Go areas. No construction machinery or work force is allowed in the No-Go areas. Please ensure that no machinery or workforce go beyond the approved construction footprint.

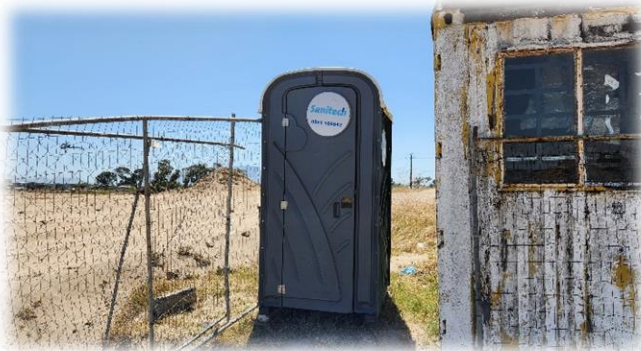
One toilet was found during the audit. Only construction plant operators were on site during the audit and the one toilet was sufficient for the number of operators on site.

Please ensure that the construction site is equipped with a sufficient number of chemical toilets for the number of workers on site. At least 1 chemical toilet per 15 workers is required no more than 150m away from the construction activities. All chemical toilets have to be properly secured to prevent the toilet from falling over in windy conditions.

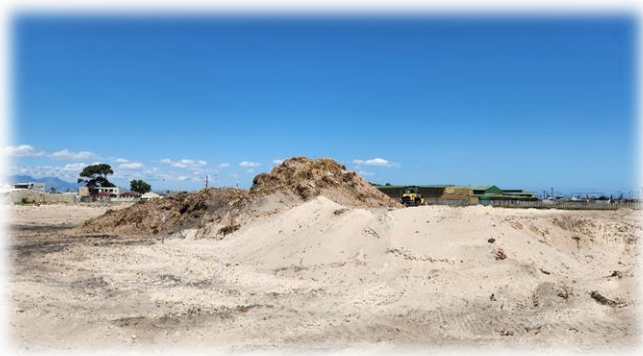
Topsoil has been stripped, stockpiled and a large amount of topsoil has been removed from site. The contractor was requested to please provide details on where the topsoil was taken to.

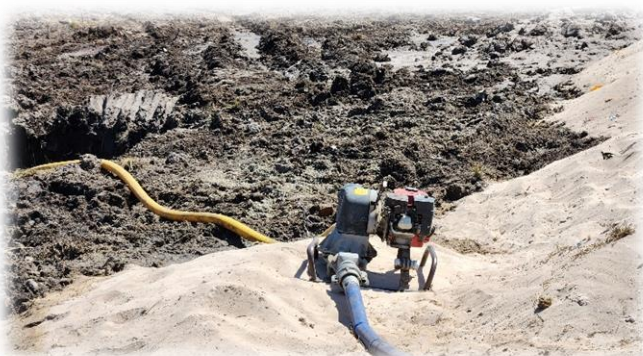
The dewatering pump had no drip tray during the audit. The contractor was requested to please provide a drip tray for the dewatering pump.

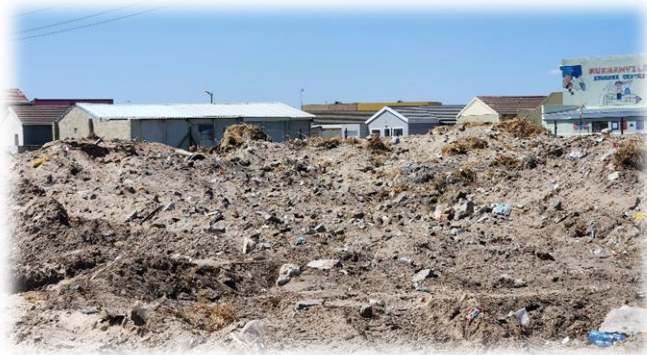
The site was previously used as a illegal dump site for litter and rubble.

A stockpile containing litter and rubble was still present on site with the previous stockpile having been removed from site. The contractor was requested to please provide details on where the current stockpile is proposed to go as well as where the previous stockpile went to.

Please forward disposal slips to the ECO for recordkeeping.

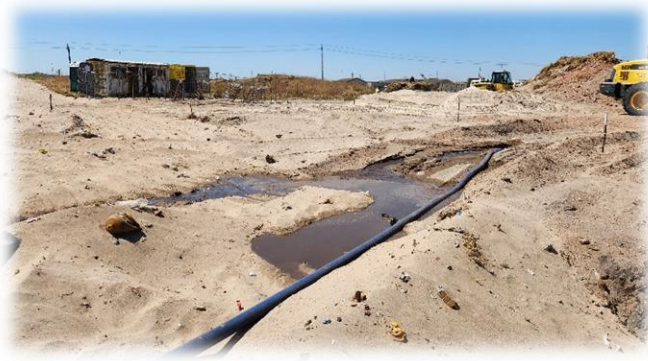
Dewatering took place during the audit and the dewatered water settled in a manageable location.

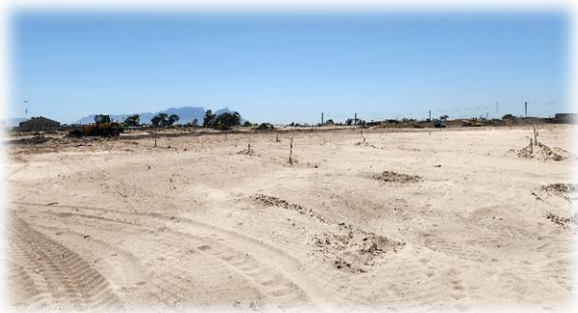
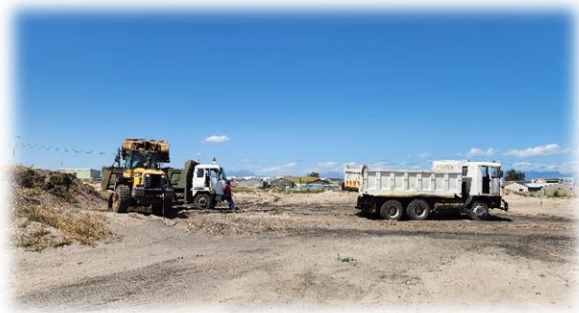
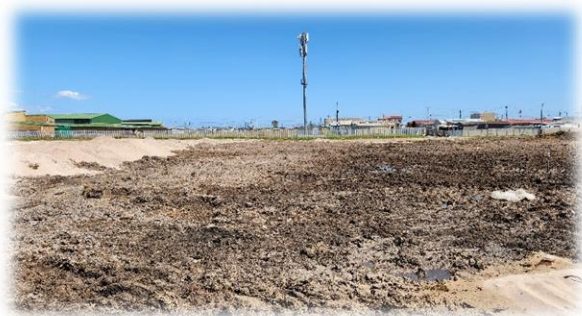
Minimal works took place during the audit. The topsoil has been stripped to date and most of it removed from site. Most of the litter and rubble has been removed from site. Only the cut to fill on site took place during the audit and will continue for the rest of the year prior to the builder's break. After the builder's break the other activities will commence.
