# THE ESTABLISHMENT OF A HOUSING DEVELOPMENT AND ASSOCIATED INFRASTRUCTURE ON ERF 10509 AND THE REMAINDER OF FARM CA 597, PHILIPPI

DEA&DP Ref: 16/3/1/1/A2/30/3067/14

## FORMAL ECO AUDIT REPORT

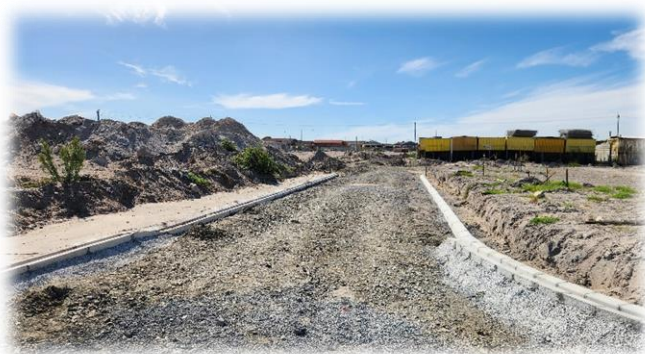
No batching was done during the audit, previous kerb batching was done on road surface and is sufficient.

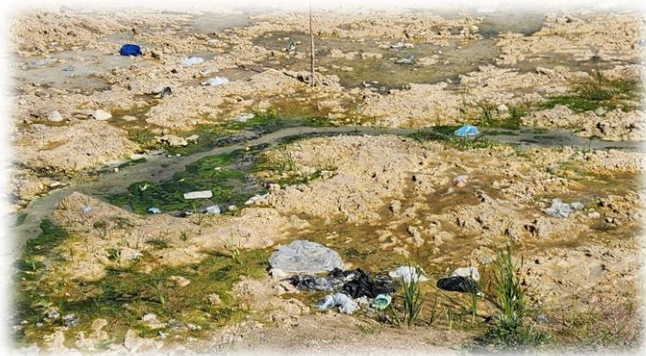
The litter in the pond which originates from the outside of the site causes a maintenance problem as it blows into the pond. The contractor was requested to please conduct a chicken parade in the pond to remove litter.

| | Finding | Close Out Recommendation |
|---|---|---|
| 1. | <p><b>Litter</b></p> <p>The litter in the pond which originates from the outside of the site causes a maintenance problem as it blows into the pond.</p> | <p>Please conduct chicken parade in pond to remove litter.</p> |

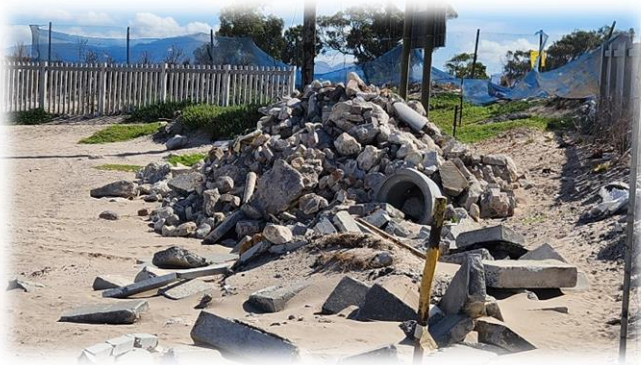
Minimal rubble was temporary stockpiled on site, which is sufficient, prior to it being removed and taken to the crushing facility at the offices of the contractor.

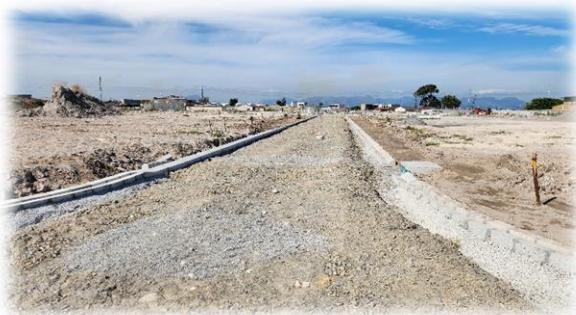
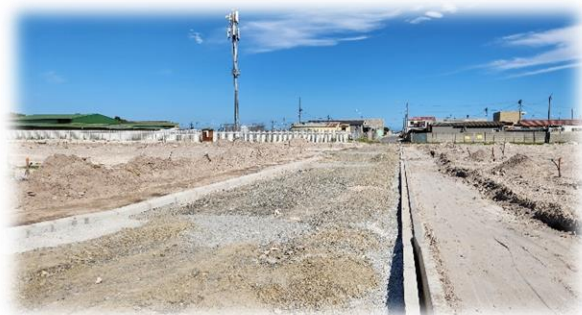
The installation of services has been installed in phase 1 and phase 2. The only works currently taking place are kerbs and layer works on the road.
