**FRESHWATER ECOLOGICAL ASSESSMENT FOR THE  
PROPOSED MOUNT VIEW RESIDENTIAL  
DEVELOPMENT ON THE REMAINDER OF FARM 869,  
FARM 1262, REMAINDER OF FARM 866, REMAINDER  
OF FARM 1054, PORTIONS 2 AND 3 OF FARM 1054  
AND PORTION 2 OF FARM 870, SIR LOWRY'S PASS,  
WESTERN CAPE**

**October 2021**

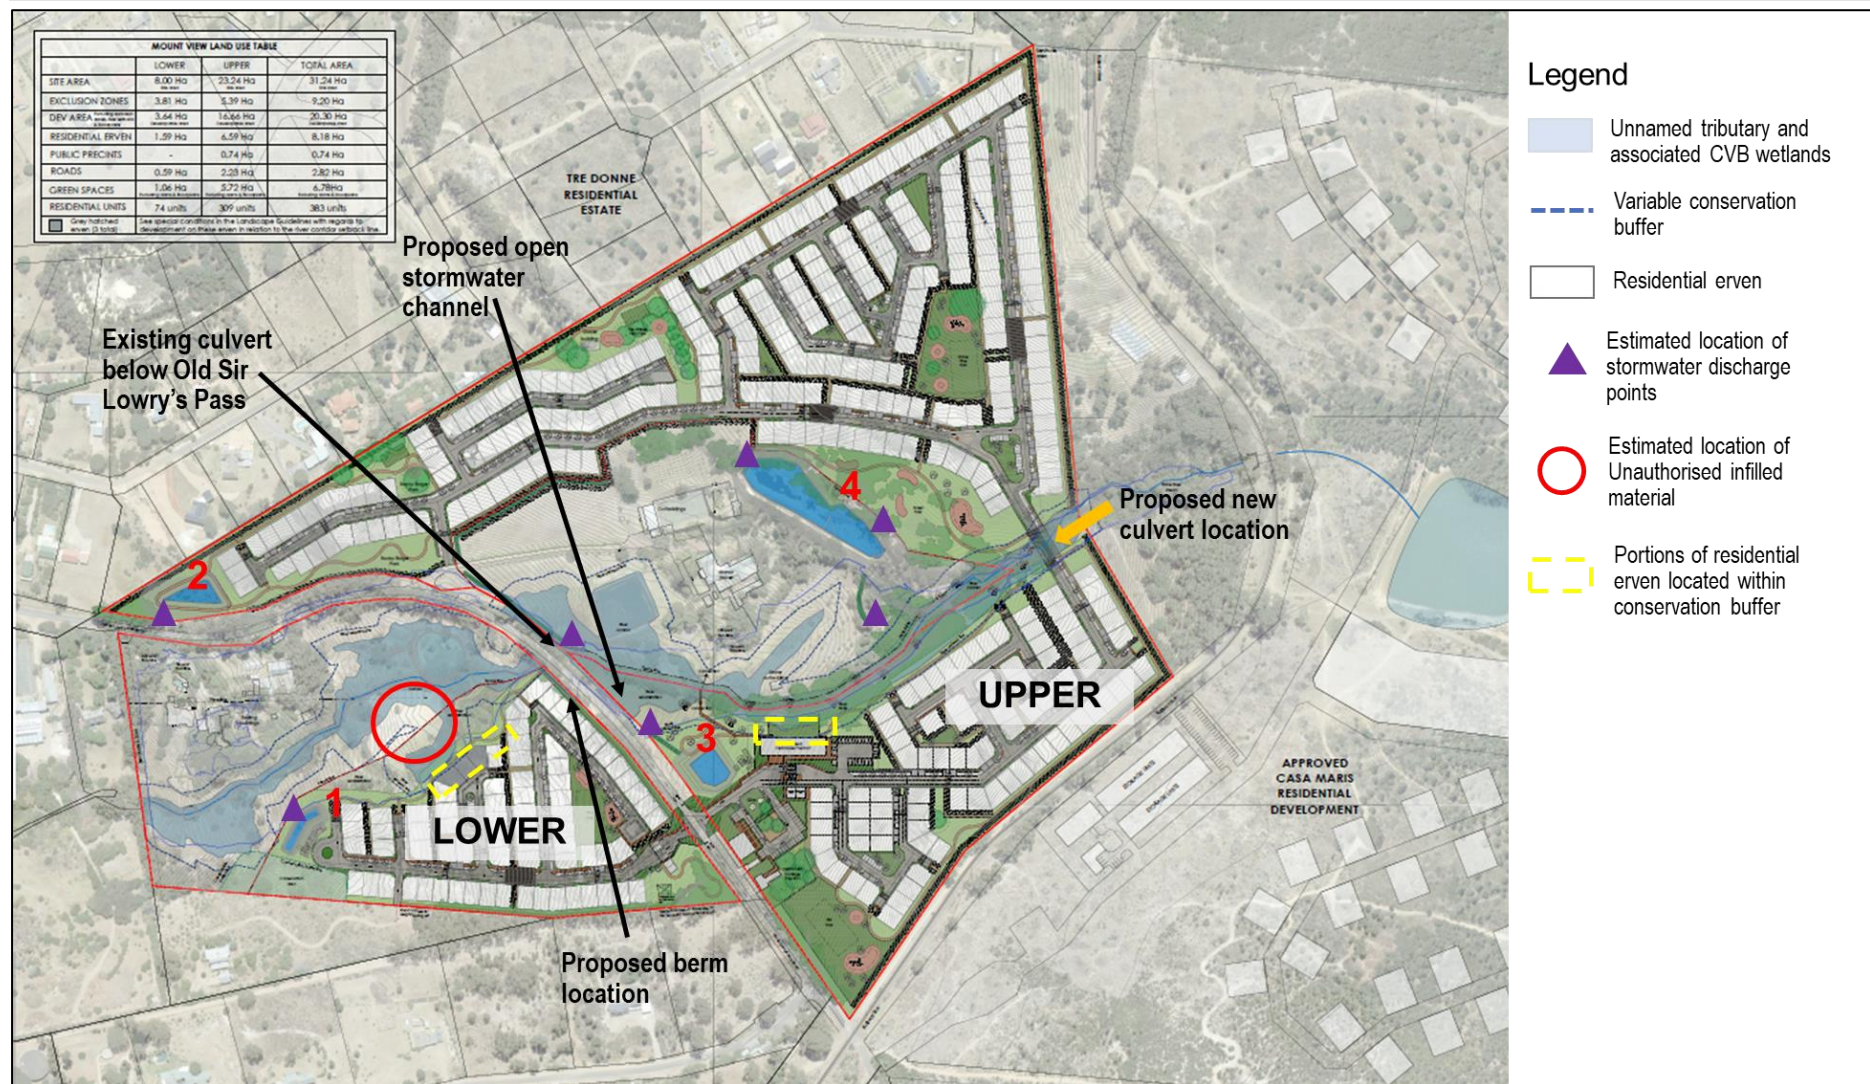
Figure 2: Location of the study and investigation areas depicted on a 1:50 000 topographical map in relation to surrounding environment.

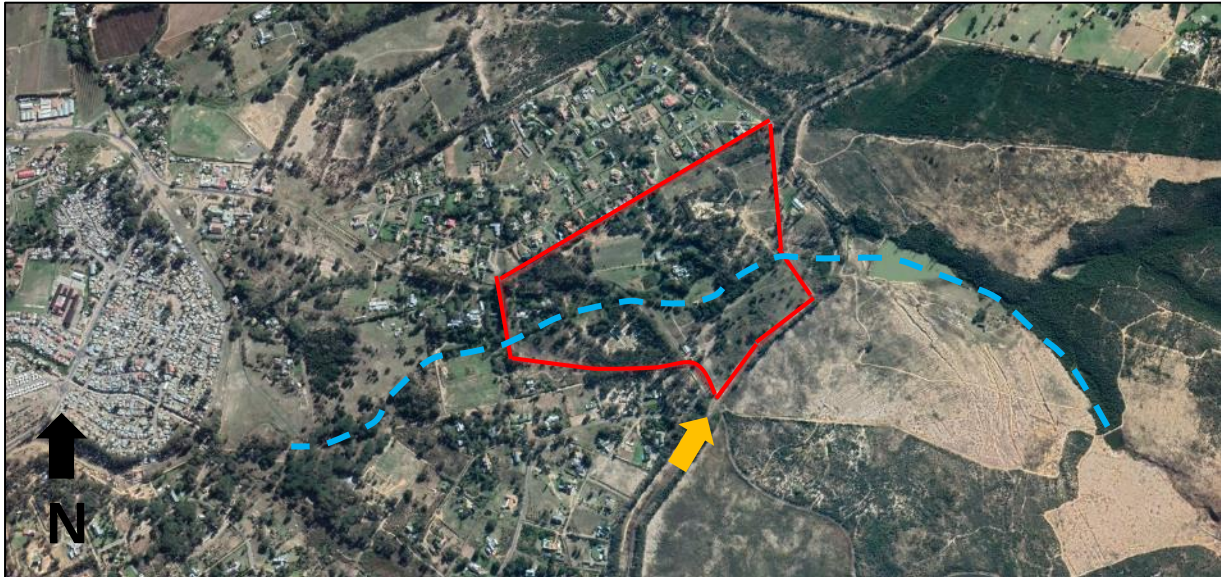
**Figure 11: Digital satellite imagery of the study area (red outline), circa 2020, relative to the watercourse (blue dashed line) and the Old Sir Lowry's Road bisecting the southern extent of the study area (orange arrow).**

On review of the digital satellite imagery, circa 2020 (Figure 11), the surrounding environment has transformed from a largely agricultural land use to a predominantly peri-urban setting. Homesteads and artificial impoundments have been established in the study area and the vegetation associated with the watercourse has decreased in density and cover, specifically associated with the watercourse reach in the northern portion of the study area.

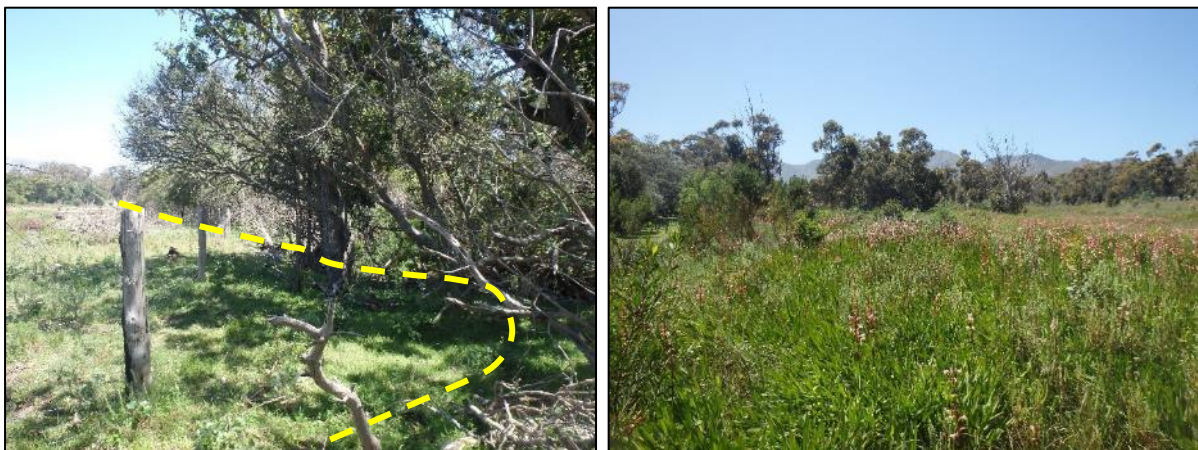
**Figure 12: (Left): The outside edge of the riparian vegetation of the unnamed tributary relative to the terrestrial area in the southern portion of the study area. The riparian edge of the tributary is indicated by the yellow dashed line (Right): Vegetation within the channelled valley bottom wetland associated with the southern extent of the study area (CVB wetland 1).**

- The edge of the riparian area of the unnamed tributary is dominated by tree species, and primarily invasive species including *Casuarina cunninghamiana*, *Eucalyptus camaldulensis*, *Ricinus communis*, *Paraserianthes lophantha*, *Acacia melanoxylon*, *Ligustrum lucidum*, *Pennisetum clandestinum*, *Salix babylonica*, *Solanum mauritianum* and *Quercus robur*. Vegetation within the CVB wetlands varied from a *Watsonia borbonica* and sedge species dominated habitat in the CVB wetland within the southern extent of the study area to a reduced vegetation cover to the rest of the CVB wetland in the study area (see Figure 12 below);

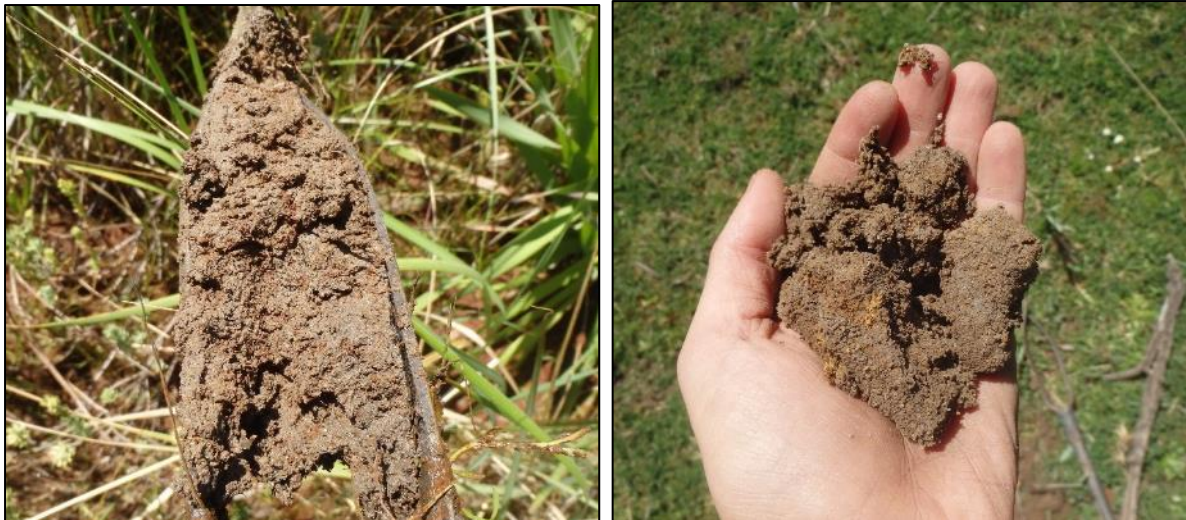
**Figure 13: Photograph indicating mottling and saturated soil identified within CVB wetland 1 (left), and CVB wetlands 2 to 5.**

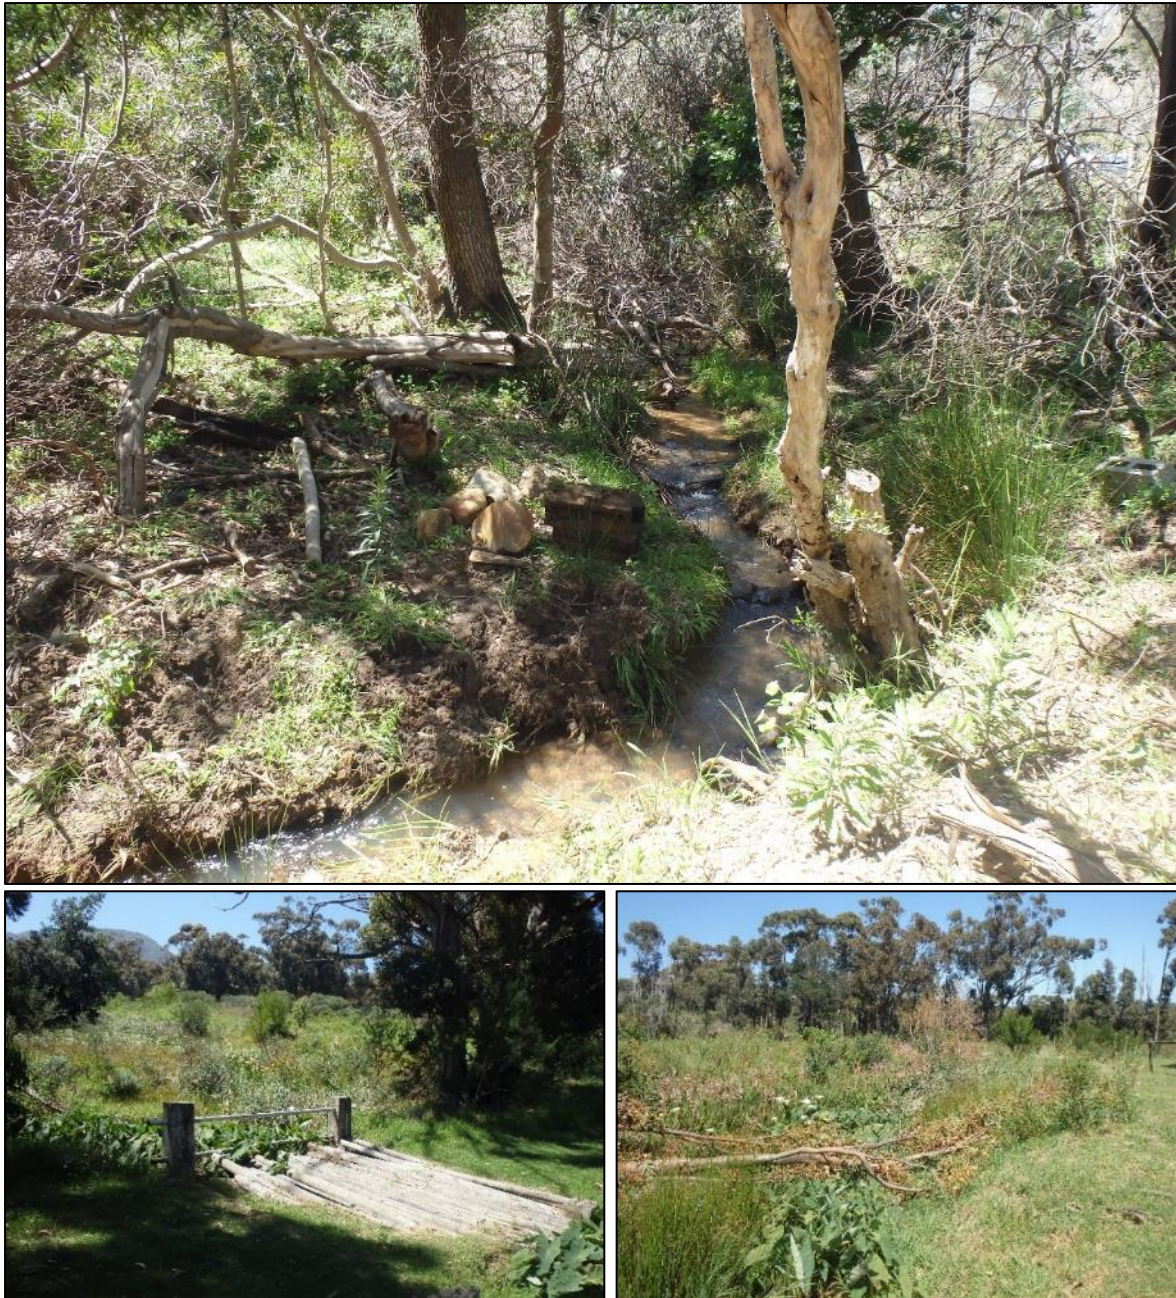
**Figure 15: Photographs of the active channel and riparian habitat of the unnamed tributary of Sir Lowry's Pass River.**

During the site assessment, an unnamed tributary of the Sir Lowry's Pass River was identified bisecting the central portion of the study area, flowing in a general north to south westerly direction. The riparian marginal vegetation of the unnamed tributary is dominated by large tree species such as *Eucalyptus camaldulensis*. Pedestrian walkways were noted along the length of the channel of the tributary indicating use of this system for recreational purposes by the local residents (Figure 15).

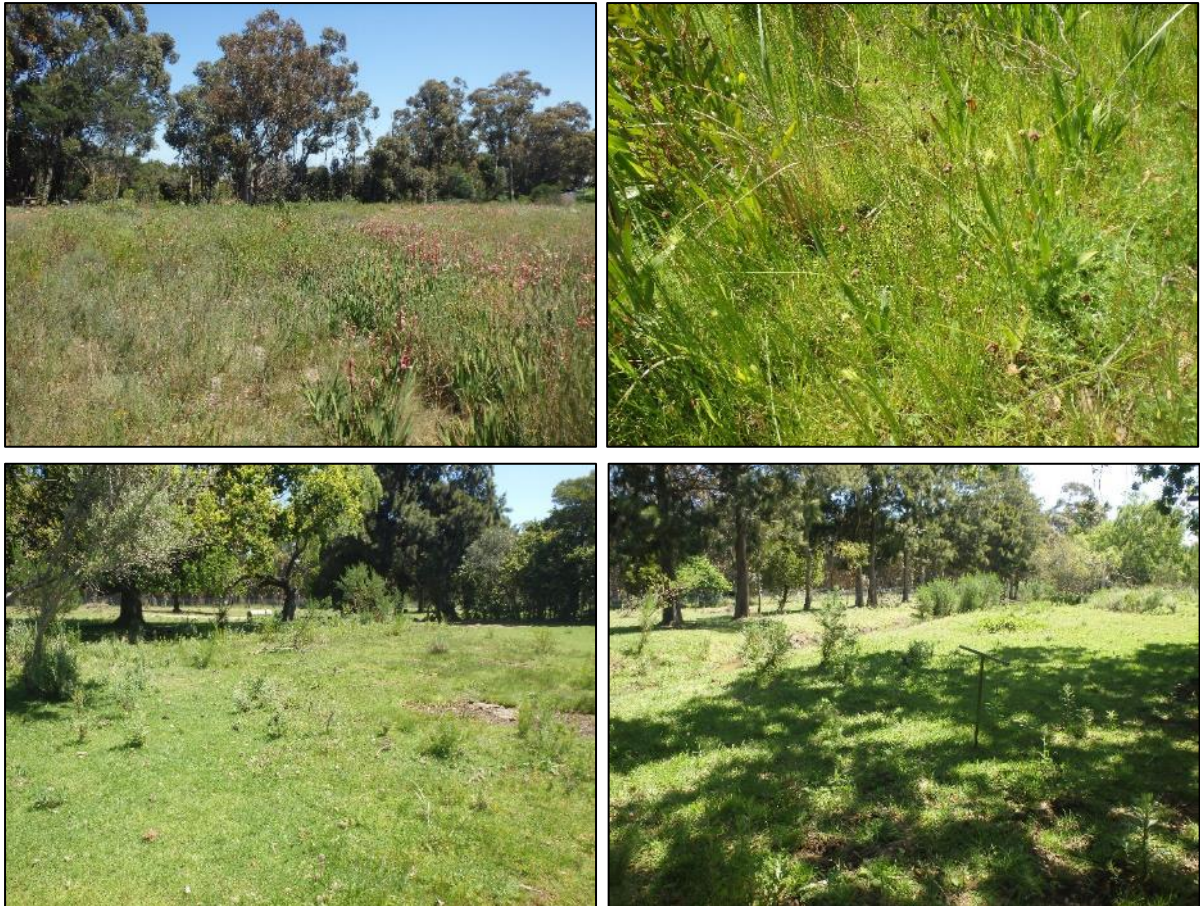
**Figure 16: Photographs of the channelled valley bottom wetlands identified on site. (Top left and right): Vegetation within the CVB wetland associated with the southern extent of the study area (CVB wetland 1), (Bottom left and right): Vegetation within the CVB wetlands (CVB 2 to 5) has been impacted by mowing and grazing associated with the residential area.**

As per the delineation map presented in Figure 14 above, five CVB wetlands were identified to be associated with the unnamed tributary of Sir Lowry's Pass River. CVB wetland 1 was noted to be well vegetated with *Watsonia borbonica* while the rest of the CVB wetlands (CVB wetlands 2 to 5) showed reduced vegetation cover due to mowing and grazing (Figure 16 below).

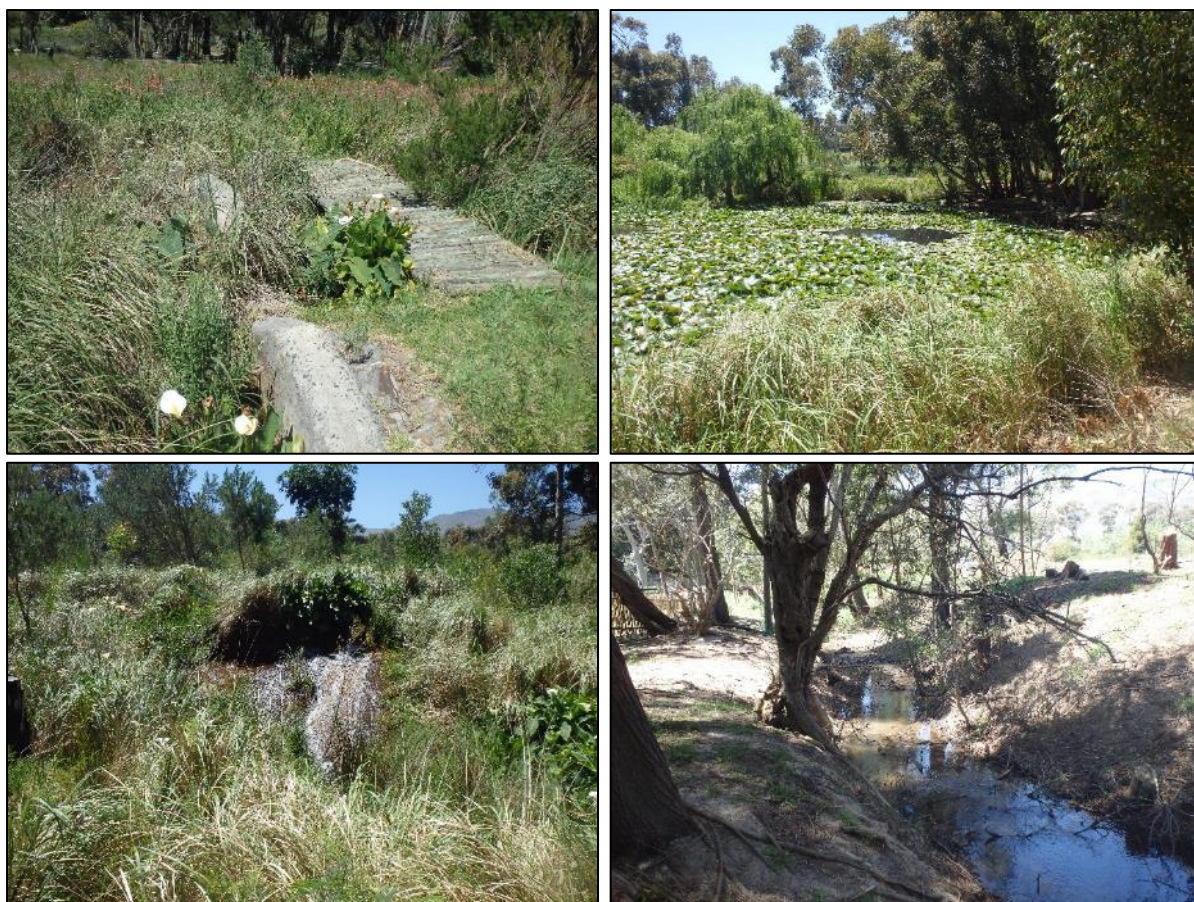
**Figure 17: Modifications noted within the unnamed tributary of Sir Lowry's Pass River and associated CVB wetlands. (Top left): a broken weir and a pedestrian walkway noted within the channel of the unnamed tributary; (Top right): artificial impoundment A and B traversing both the unnamed tributary and CVB wetlands; (Bottom left): Overspill from impoundment A; and (Bottom right): poorly vegetated areas with eroded embankments noted on the northern reach of the tributary.**

Several artificial impoundments were noted within and off stream of the unnamed tributary, including a weir within the channel of the unnamed tributary. Some alien trees noted along the artificial impoundments include *Eucalyptus camaldulensis* and *Salix babylonica*. Some areas of the northern reach of the tributary were noted to be poorly vegetated with eroded embankments (Figure 17).

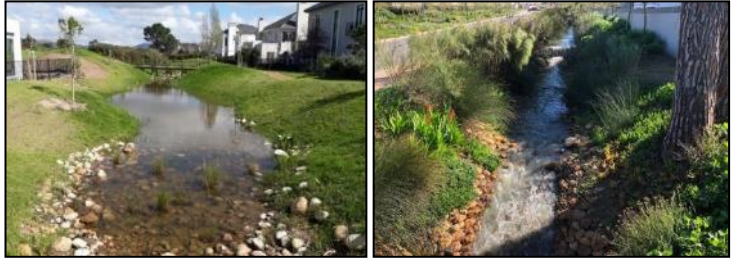
| No. | Phase | Activity | Aspect | Impact | Severity | Consequence | Likelihood | Significance | Risk Rating | Confidence Level | Control Measures | Reversibility of Impact |
|---|---|---|---|---|---|---|---|---|---|---|---|---|
| | Construction Phase | | | | | | | | | | <p><b>Figure B: Examples of open swales, considered to be SuDs utilised as part of residential developments for conveyance of stormwater</b></p> <p>Since some of the stormwater discharge points proposed may fall within the delineated extent of the CVB wetland, the design of the stormwater discharge points must incorporate energy dissipating structures to prevent erosion and incision. Figure C below provides an example of a stormwater outlet into a watercourse habitat.</p> <p><b>Figure C: Schematic of an outlet structure directly adjacent to a wetland.</b></p> <ul style="list-style-type: none"> <li>• Cobbles should be placed in front of the stormwater discharge points and below the reno mattress to further assist with energy dissipation. At no point should erosion or gully formation be allowed as this will have impact on the water dispersal into and across the watercourses, which could potentially reduce the extent and functionality of the wetland in the long-term;</li> <li>• All soils compacted within the watercourses as a result of construction equipment must be loosened prior to revegetation with suitable indigenous species;</li> <li>• No indiscriminate movement of vehicles or personnel is allowed within the watercourses or the 32 m NEMA ZoR where no activities are proposed. Careful planning of all construction equipment must be undertaken beforehand to ensure that the minimum impact on the watercourses occurs; and</li> </ul> | |

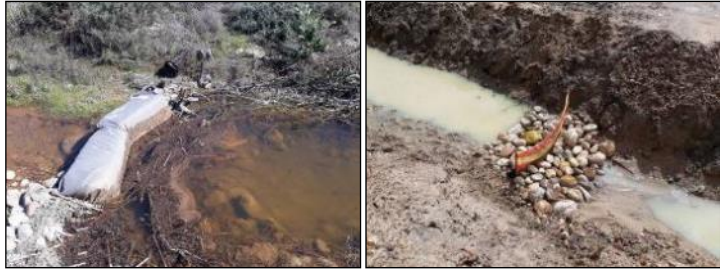
| No. | Phase | Activity | Aspect | Impact | Severity | Consequence | Likelihood | Significance | Risk Rating | Confidence Level | Control Measures | Reversibility of Impact |
|---|---|---|---|---|---|---|---|---|---|---|---|---|
| | | | | | | | | | | | <p><b>Figure E: Examples of silt traps to be used during the construction phase, to limit additional sediment from entering the downstream reach of the the unnamed tributary.</b></p> <ul style="list-style-type: none"> <li>• The area must be suitably compacted and reshaped to levels close to the surrounding wetland habitat to allow opportunities for the reinstatement of wetland habitat and to prevent any erosion or preferential flow paths from occurring;</li> <li>• All shaping must be done as natural as possible, and the area should be designed to have varying depths to facilitate microhabitat formation</li> <li>• The excavated fill material can be spoiled on site. However, not within the watercourses or open spaces;</li> <li>• Excavated materials may not be contaminated, and it must be ensured that the minimum surface area is taken up, and the stockpiles may not exceed 2m in height. Stockpiling of removed materials may only be temporary (may only be stockpiled during the period of construction at a particular site) and should be disposed of at a registered waste disposal facility;</li> <li>• All exposed soil must be protected for the duration of the construction phase with a suitable geotextile (e.g. Geojute or hessian sheeting) to prevent erosion and sedimentation of the tributary;</li> <li>• Since portions of the unauthorised infilled material are located within the CVB wetland 3, the removal thereof will result in loss of wetland habitat. The wetland loss should ideally be reinstated within the fill area following removal of the infilled material to ensure no net loss to the CVB wetland;</li> </ul> | |

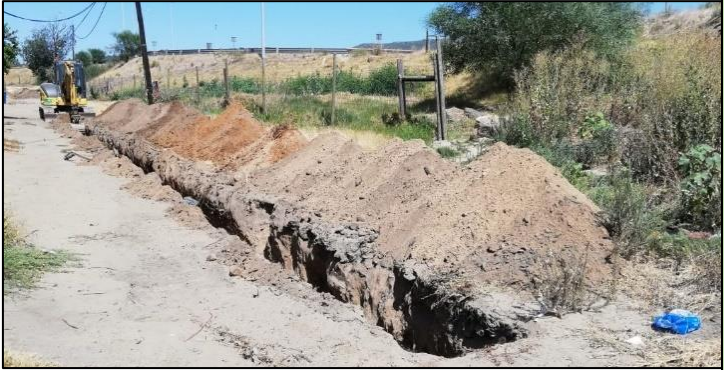
| No. | Phase | Activity | Aspect | Impact | Severity | Consequence | Likelihood | Significance | Risk Rating | Confidence Level | Control Measures | Reversibility of Impact |
|---|---|---|---|---|---|---|---|---|---|---|---|---|
| | | | | | | | | | | | <p><b>Figure F: Excavation for pipe trenching with stockpiles alongside.</b></p> <p><u>Rehabilitation on completion of construction</u></p> <ul style="list-style-type: none"> <li>• Care must be taken when constructing the culverts to ensure that the design accommodates a 1 in 100 year flood event and that the base levels are maintained so that no erosion or ponding of water occurs surrounding the crossing.</li> <li>• Soil surrounding the wingwalls must be suitably backfilled and sloped (minimum of a 1:3 ratio) and concrete aprons as well as gabion mattresses should be installed both up and downstream for energy dissipation and sediment trapping.</li> <li>• All soils within the tributary surrounding the culvert must be loosened on completion of works to allow for re-vegetation.</li> <li>• All footprint areas must remain as small as possible and vegetation clearing to be limited to what is absolutely essential;</li> <li>• All vehicles are to remain within existing roads and no new roads should be developed to access this construction site;</li> <li>• All stockpiles must be located at least 10 m from the delineated extent of the tributary should not exceed 2 m in height and should be covered with a suitable geotextile such as hessian sheeting to prevent excessive dust generation;</li> </ul> | |
