**WATERCOURSE REHABILITATION AND MANAGEMENT  
PLAN FOR THE PROPOSED MOUNT VIEW RESIDENTIAL  
DEVELOPMENT ON THE REMAINDER OF FARM 869,  
FARM 1262, REMAINDER OF FARM 866, REMAINDER OF  
FARM 1054, PORTIONS 2 AND 3 OF FARM 1054 AND  
PORTION 2 OF FARM 870, SIR LOWRY'S PASS,  
WESTERN CAPE**

**March 2021**

| <b>Report Reference:</b> | <b>FEN 20-2103</b> |

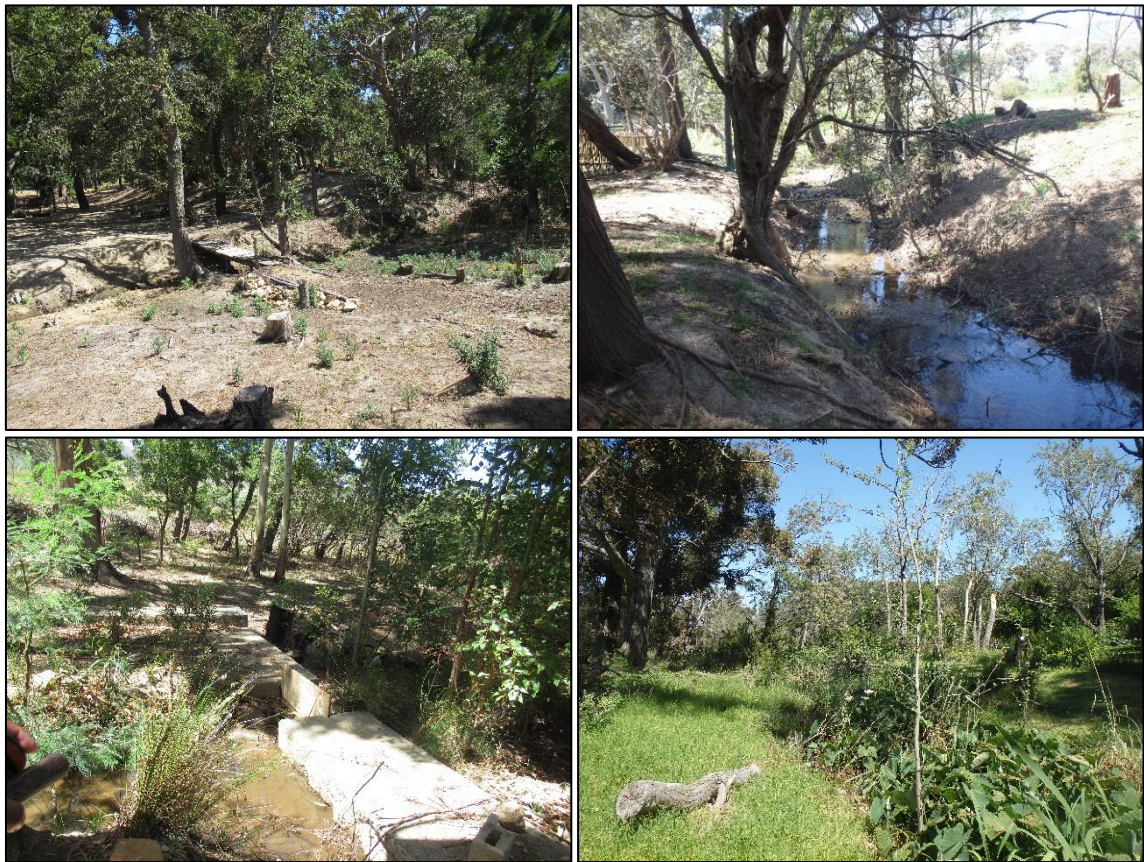
| Unnamed Tributary of the Sir Lowry's Pass River. | |
|---|---|
| <p>Figure 5: (Top left) Vegetation clearing of the riparian habitat along the upstream reach of the unnamed tributary; (Top right): Poorly vegetated areas with eroded embankments noted along the northern reach of the tributary; (Bottom left): Weir in northern extent of tributary, from where the irrigation furrow is diverting water to an artificial impoundment; (Bottom right): Downstream reach of tributary, with <i>Colocasia esculenta</i> in the foreground and riparian trees in the background in the marginal area of the tributary.</p> | |

| Unnamed Tributary of the Sir Lowry's Pass River. | |
|---|---|
| <b>IHI discussion</b> | <p><b>IHI Category D (Largely Modified)</b></p> <p>As per the watercourse assessment (FEN, 2021), The riparian habitat of the unnamed tributary is considered to be largely modified, primarily as a result of the loss of the natural vegetation and the subsequent alien vegetation encroachment including species such as <i>Acacia saligna</i>, <i>Phytolacca octandra</i>, <i>Eucalyptus camaldulensis</i>, <i>Populus x canescens</i> and <i>Salix babylonica</i>. Some areas of the northern reach of the tributary were noted to be poorly vegetated with eroded embankments, however, the majority of the riparian zone was considered well vegetated, albeit with invasive tree species. The instream habitat of the unnamed tributary has been modified through alterations of the natural flow and channel characteristics, specifically as a result of the instream impoundments, weirs and furrows diverting water from the tributary into off stream artificial impoundments.</p> |

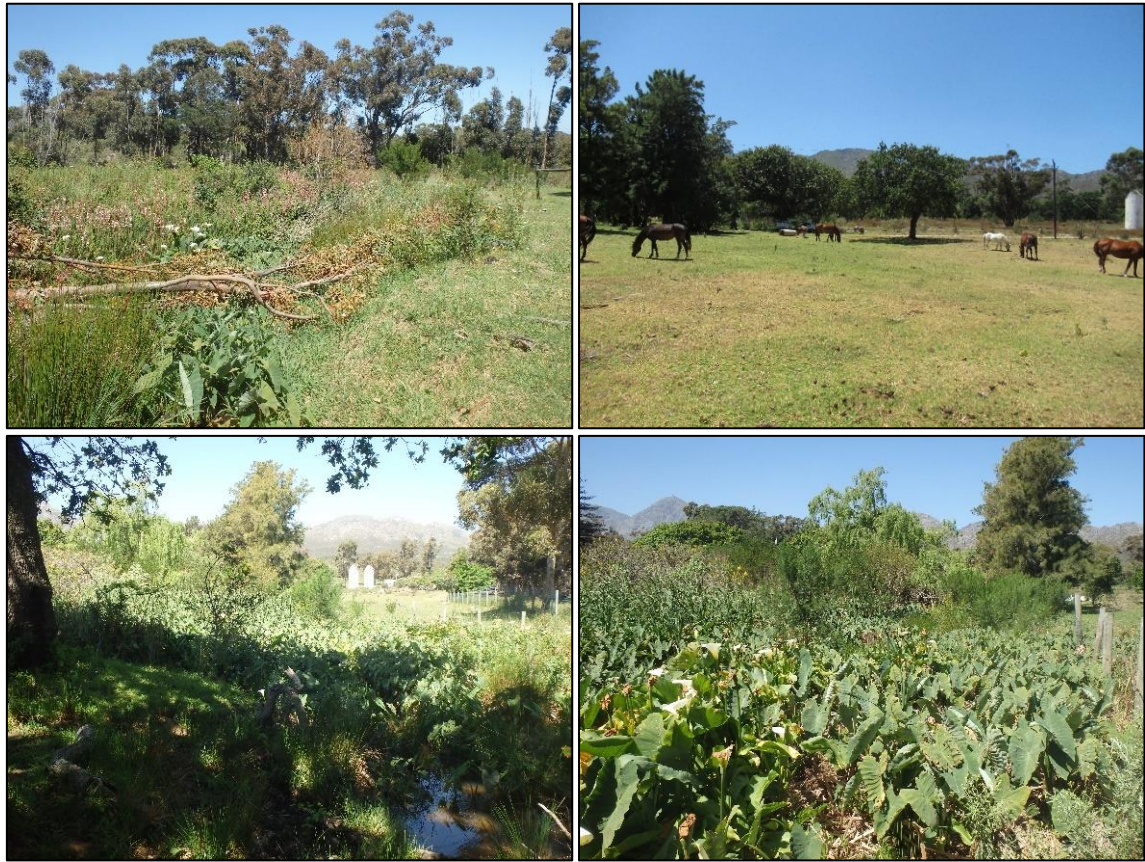
| CHANNELLED VALLEY BOTTOM WETLANDS | | | |
|---|---|---|---|
| PES discussion | <p>Figure 6: Photograph representative of the channelled valley bottom wetlands associated with the unnamed tributary of Sir Lowry's Pass River. (Top left): the CVB wetland (1) associated with the southern extent of the unnamed tributary dominated by <i>Watsonia borbonica</i>; (Top right): CVB wetland (5) within the northern portion of the unnamed tributary receiving surface flow from tributary – no distinct vegetation present due to grazing activities; (Bottom left and right): CVB wetlands at the existing Old Sir Lowry's Pass road crossing.</p> | | |

| CHANNELLED VALLEY BOTTOM WETLANDS | | | |
|---|---|---|---|
| | <p><b>CVB wetland 1: Category C (Moderately Modified)</b><br/> <b>CVB wetlands 2 to 5: Category D Largely Modified</b></p> <p>As per the watercourse assessment (FEN, 2021), The CVB wetland on the southern extent of the study area (CVB wetland 1) is considered moderately modified while the rest of the CVB wetlands (CVB 2 to 5) are considered largely modified. Under natural conditions the CVB wetlands would have been associated with the entire tributary reach and contained a much greater diversity of habitat and plant species. The wetlands have been largely transformed by woody alien invasive vegetation along the tributary and wetland system. Surrounding land-uses, including mowing and grazing have contributed to the reduced surface roughness of the CVB wetlands and impoundments affecting water distribution and retention patterns within the wetland by concentrating and impeding flow, particularly the CVB wetlands 2 to 5, has also resulted in modification to the wetlands.</p> | | |

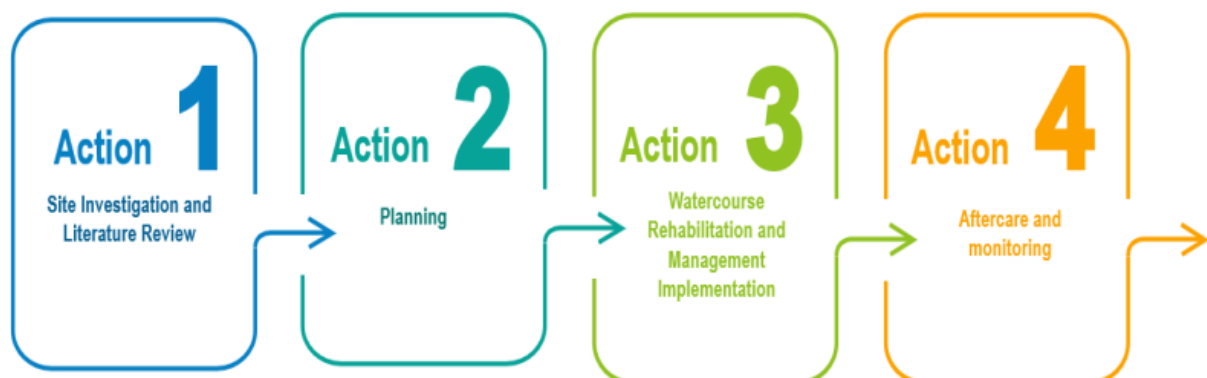
Figure 7: The four (4) key actions of the WRMP implementation.

This implementation of this WRMP is based on four (4) key actions illustrated in Figure 7 and discussed in detail in Section 5.1.1 – Section 5.1.11.

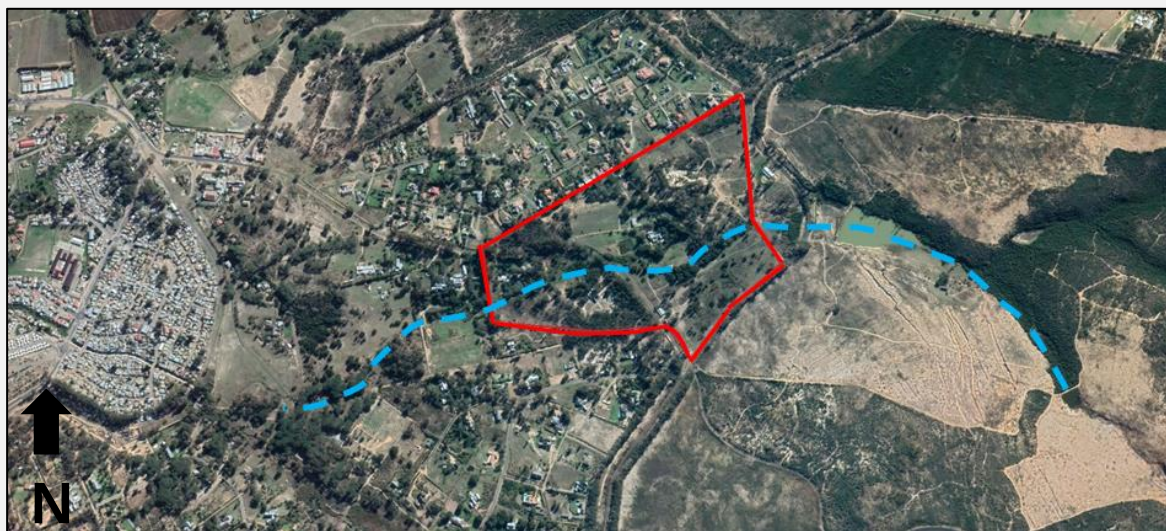
**Figure 9: Digital satellite imagery of the study area (red outline), circa 2020, relative to the watercourse (blue dashed line).**

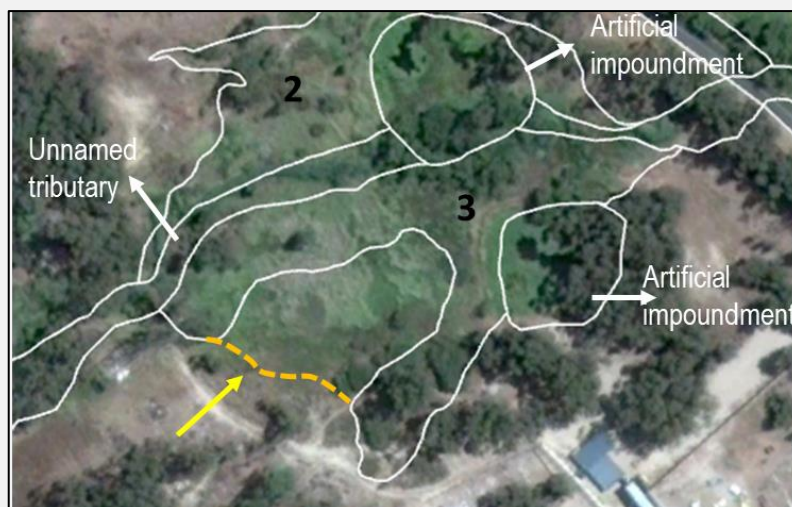
**Figure 11: Digital satellite imagery (February 2014) of the area of unauthorised infilled material south east of Old Sir Lowry's Pass Road. No infilling is present in the wetland (yellow arrow) and the CVB wetland is continuous in this area. Orange dotted lines depict where the wetland edge was previously based on digital signatures. Numbers depict the different CVB wetlands.**

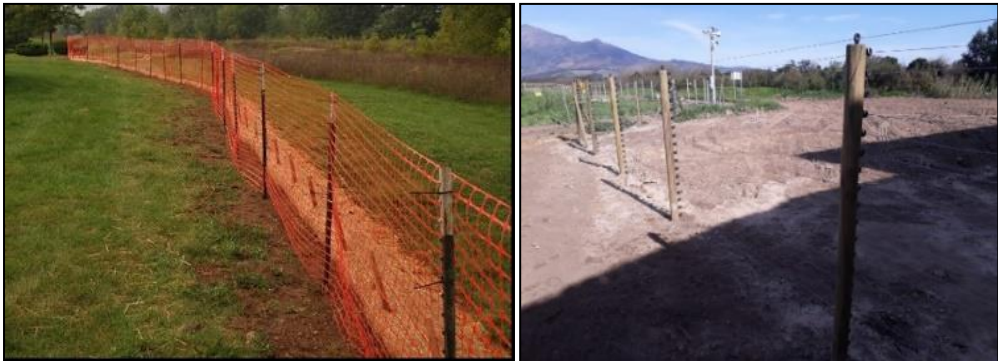
| Responsible persons | Proponent | ECO |
|---|---|---|
| | <p><b>Figure 13: Example of temporary safety fencing used to demarcate a watercourse.</b></p> | |

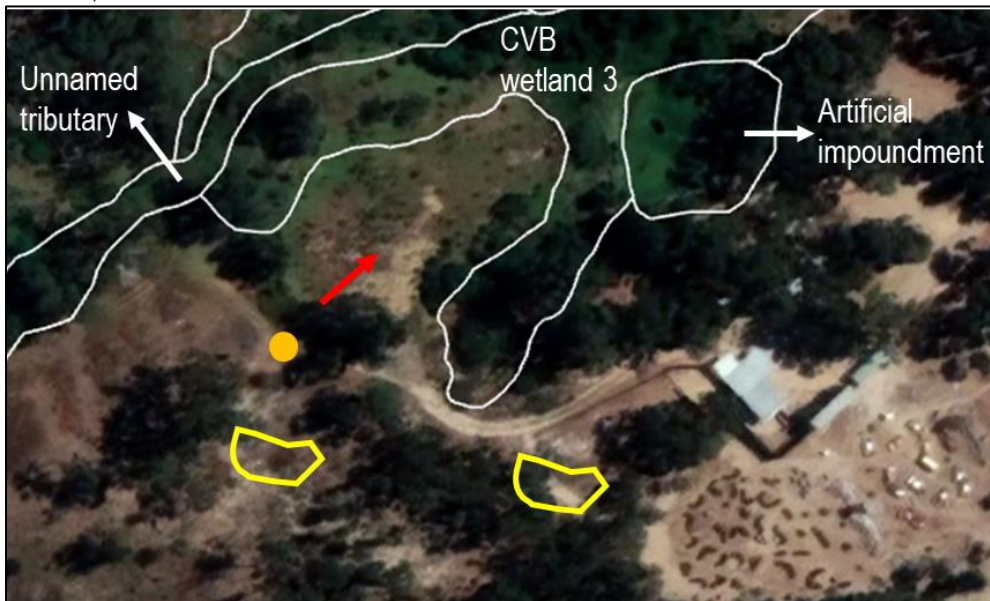
| Responsible persons | Proponent | ECO |
|---|---|---|
| | <p>Figure 15: Orange point indicate the position where construction machinery must be located relative to the unauthorised fill area (red arrow) and CVB wetland. Yellow areas indicate representative areas for temporary stockpiling of material removed from the unauthorised fill area.</p> | |

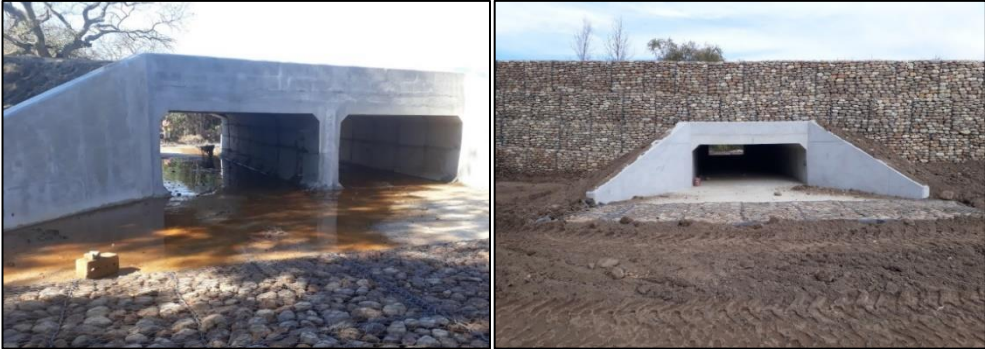
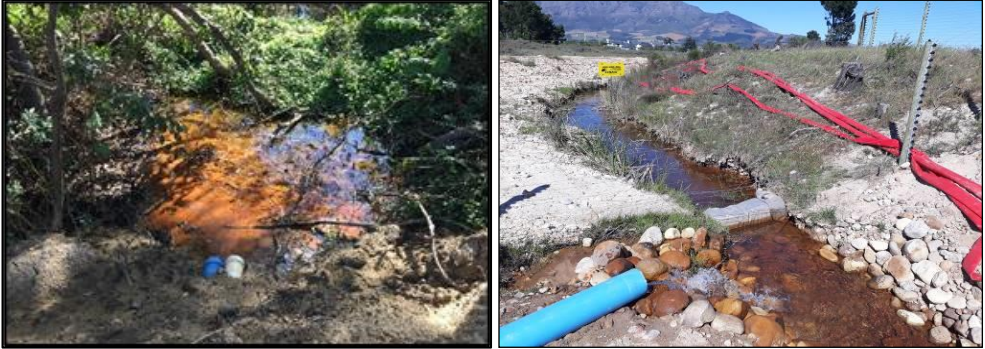
| Responsible Persons | Proponent | Environmental Control Officer |
|---|---|---|
| | <p><b>Figure 19: Example of suitable culvert crossings within a watercourse.</b></p> <ul style="list-style-type: none"> <li>It is recommended that the construction associated with the culverts be undertaken during the dry summer months, when limited throughflow of water is experienced. However, should construction occur within the raining season, a diversion must be excavated around the proposed culvert crossing location for the period of construction to ensure hydrological connectivity is maintained, however this should be considered at the time of construction on consultation with the ECO.</li> <li><u>With regards to the diversion of flow in preparation for the installation of the culvert crossing:</u> <ul style="list-style-type: none"> <li>Should construction works not be finalised during the dry season, a sump area should be created directly upstream of the proposed new culvert crossings in order to prevent any summer runoff from ponding in the construction area, especially during casting of concrete. Water must be diverted downstream, around the construction area by means of a PVC pipe.</li> <li>The pipe within the downstream reach should be at ground level and within a well vegetated area and/or lined with cobbles to prevent incision as a result of the high velocity of water being released (for example see Figure 20 below).</li> </ul> </li> </ul> <p><b>Figure 20: Examples of a sump area upstream of instream construction area and the outlet pipe with sediment traps downstream of a construction area.</b></p> <ul style="list-style-type: none"> <li>Should gravity not be sufficient to convey water to the downstream reach of the tributary, the contractor may pump water from the sump area to the downstream reach. The pump must be suitably bunded and a drip tray provided at all times.</li> <li>Suitable sediment traps such as geotextile wrapped hay bales or geotextile nets must be installed every 20 m from the pipe outlet (Figure 21). Should nets be utilised, stones must be installed both upstream and downstream of the nets.</li> </ul> | |

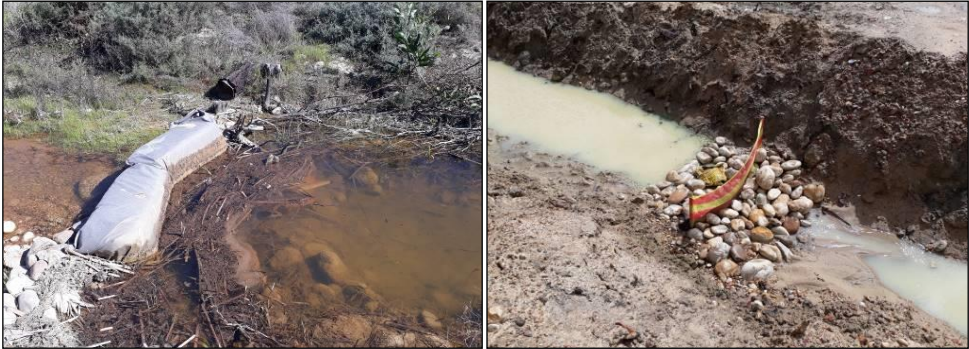
| Responsible Persons | Proponent | Environmental Control Officer |
|---|---|---|
| | <p><b>Figure 21: Examples of silt traps to be used during the construction phase, to limit additional sediment from entering the downstream reach of the tributary.</b></p> <ul style="list-style-type: none"> <li>- The duration of impacts within the tributary should be minimised as far as possible by ensuring that the duration of time in which flow alteration and sedimentation will take place is minimised; and</li> <li>- It is recommended that a freshwater specialist or ECO should monitor the diversion site once a week during the diversion period to monitor the tributary conditions during construction and after the removal of the diversion. Any improvements/ maintenance of these sediment traps must be addressed immediately on request of the freshwater specialist and/or ECO.</li> </ul> <p>• <u>With regards to excavation and soil compaction activities within the tributary associated with the culvert:</u></p> <ul style="list-style-type: none"> <li>- During excavation activities, soil removed from the dewatered section should be stockpiled outside the delineated edge of the unnamed tributary;</li> <li>- Excavated materials should not be contaminated, and it should be ensured that the minimum surface area is taken up, and the stockpiles may not exceed 2 m in height. Mixture of the lower and upper layers of the excavated soil should be kept to a minimum, so as for later usage as backfill material or as part of rehabilitation activities; and</li> <li>- All exposed soil must be protected for the duration of the construction phase with a suitable geotextile (e.g. Geojute or hessian sheeting) to prevent erosion and sedimentation of the tributary.</li> </ul> <p>Should the installation of the proposed culverts require concrete works, the following measures are recommended:</p> <p><b>Cement usage</b></p> <ul style="list-style-type: none"> <li>• Concrete and cement-related mortars can be toxic to aquatic life. Proper handling and disposal should minimize or eliminate discharges into watercourses. High alkalinity associated with cement, which can dramatically affect and contaminate both soil and ground water. The following recommendations must be adhered to: <ul style="list-style-type: none"> <li>- Fresh concrete and cement mortar should not be mixed within 10 m of the unnamed tributary of Sir Lowry's Pass River and the wetlands. Mixing of cement may be done within the construction camp, may not be mixed on bare soil, and must be within a lined, bound or bunded portable mixer. Consideration must be taken to use ready mix concrete;</li> <li>- No mixed concrete shall be deposited directly onto the ground whilst it awaits placing. A batter board or other suitable platform/mixing tray is to be provided onto which any mixed concrete can be deposited whilst it awaits placing;</li> <li>- Cement bags must be disposed of in the demarcated hazardous waste receptacles and the used bags must be suitably disposed of; and</li> <li>- Spilled or excess concrete must be disposed of at a suitable landfill site.</li> <li>- Only indigenous vegetation species may be used as part of the landscaping of the development, and invasive plant species should be eradicated.</li> </ul> </li> <li>• Rehabilitation on completion of construction:</li> </ul> | |

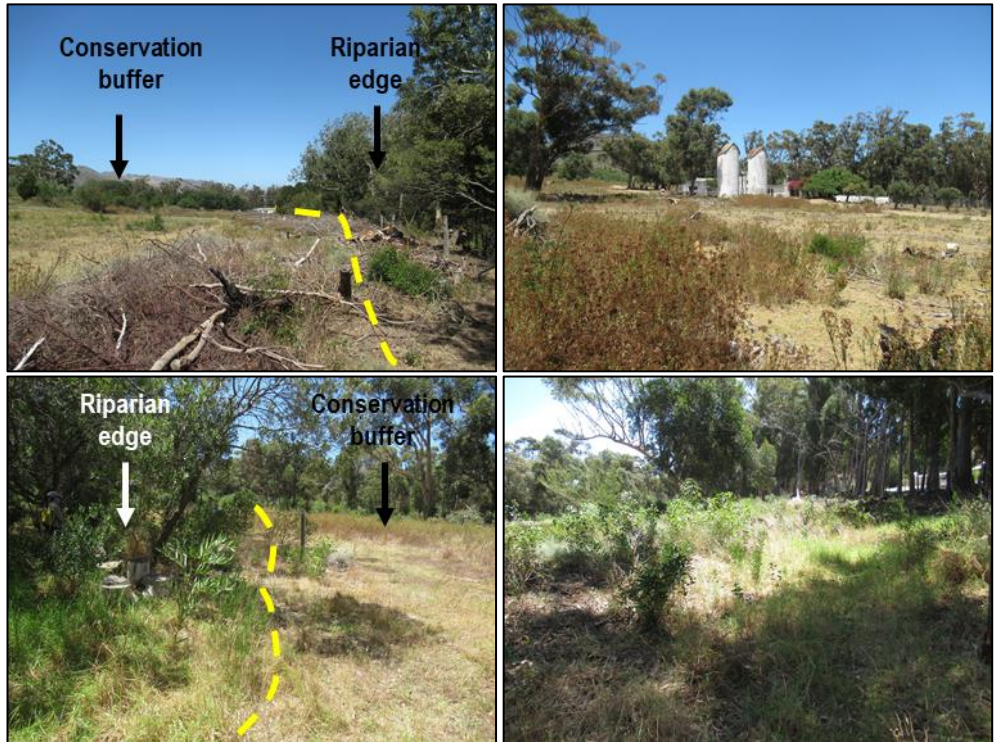
| Responsible Persons | Proponent | Environmental Control Officer |
|---|---|---|
| Rehabilitation and maintenance of the conservation buffer | <p>The conservation buffer applied to the watercourses in the study area in accordance with the (CoCT) Floodplain and River corridor Management Policy (2009), is the terrestrial habitat surrounding the watercourses. As with the watercourses, the conservation buffer is also invaded with AIPs, has been overgrazed and various off stream artificial impoundments are located herein (Figure 23). Three portions of private erven associated with the proposed lower and upper Mount View mixed-use development, as well as the flood management berm as part of the floodline alteration activities, will encroach into the designated conservation buffer, and portions of <i>in situ</i> compacted walkways are proposed within the conservation buffer, (Figure 24).</p> <div data-bbox="384 887 1382 1626"> </div> <p>Figure 23: Typical conditions of the conservation buffer associated with the watercourses in the study area. (Top) Conservation buffer along the upstream reach, and (Bottom) downstream reach of the unnamed tributary. Yellow dashed lines estimated the boundary of the riparian habitat.</p> | |

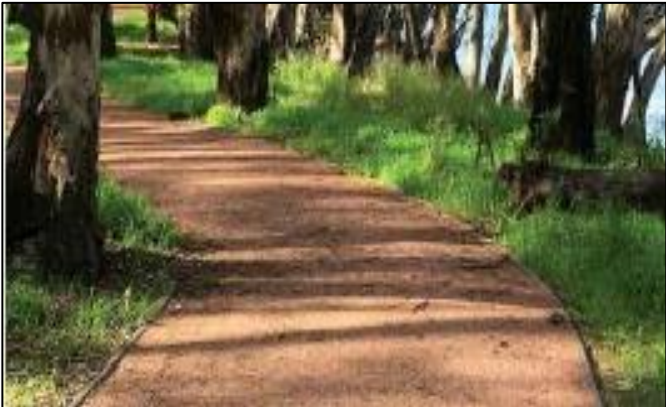
| Responsible Persons | Proponent | Environmental Control Officer |
|---|---|---|
| | <p><b>Figure 26: Example of compacted soil walkway within a riparian zone.</b></p> <p><u>Cement works for the construction of a stub wall</u></p> <p>See Task 4 with regards to concrete mixing on site.</p> <p><u>Rehabilitation on completion of construction</u></p> <ul style="list-style-type: none"> <li>• Revegetation of the areas surrounding the walkways with suitable indigenous species is recommended. These can be low growing species such as grasses, shrubs, or fynbos vegetation to allow for access especially during fire emergencies;</li> <li>• Once construction activities are done, the surrounding area to the construction footprint and the conservation buffer in general must be suitably rehabilitated. Only indigenous vegetation species may be used as part of the landscaping of the development with inputs from a suitably qualified botanist, and invasive plant species should be eradicated as per Task 2 above.</li> <li>• It is recommended that the conservation buffer be managed and maintained by the Homeowner Association (HOA) and not by private residents.</li> </ul> | |

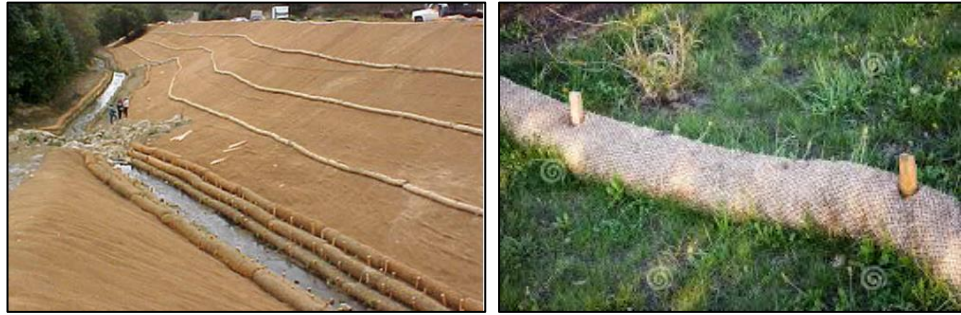
**Figure 32: Examples of Coir logs for hydroseeding along embankments.**
