**ESTABLISHMENT OF A RESIDENTIAL DEVELOPMENT AND ASSOCIATED INFRASTRUCTURE  
ON PORTION 2 OF FARM GOEDE VERWACHTING NO. 870, REMAINDER OF FARM NO. 869,  
FARM NO. 1262, REMAINDER OF FARM NO. 866, REMAINDER OF FARM NO. 1054, AND  
PORTIONS 2 AND 3 OF FARM NO. 1054, SIR LOWRY'S PASS VILLAGE.**

DEA&DP Reference: 16/3/3/1/A3/53/2005/22

**FORMAL ECO AUDIT REPORT**

27 August 2024

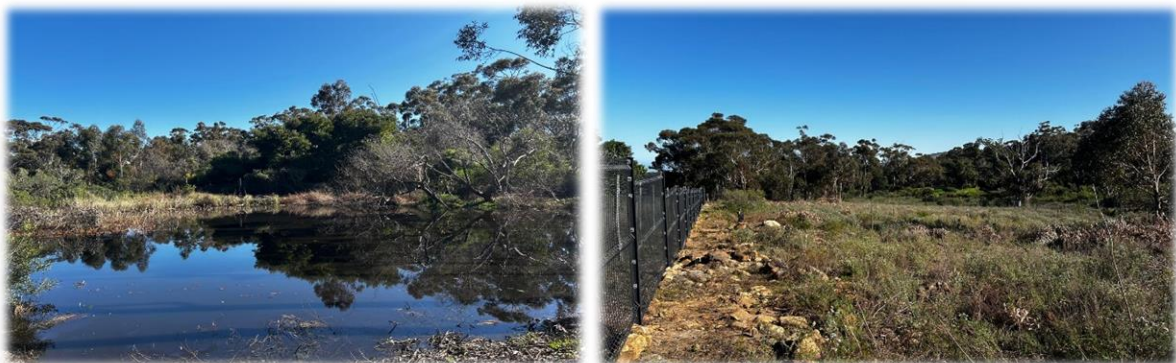
The watercourse area has been fenced with Clearview fencing, the dam should please be demarcated or temporarily fenced

| | Finding | Close Out Recommendation |
|---|---|---|
| 4 | <p><b>Demarcation</b></p> <p>The Dam should please be demarcated until rehabilitation can commence within that area</p> | <p>The Dam should please be demarcated until rehabilitation can commence within that area</p> |

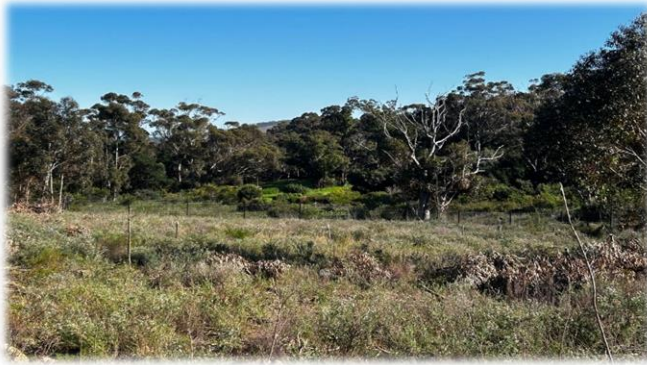
The southwestern corner of the site has been demarcated, thank you for that.

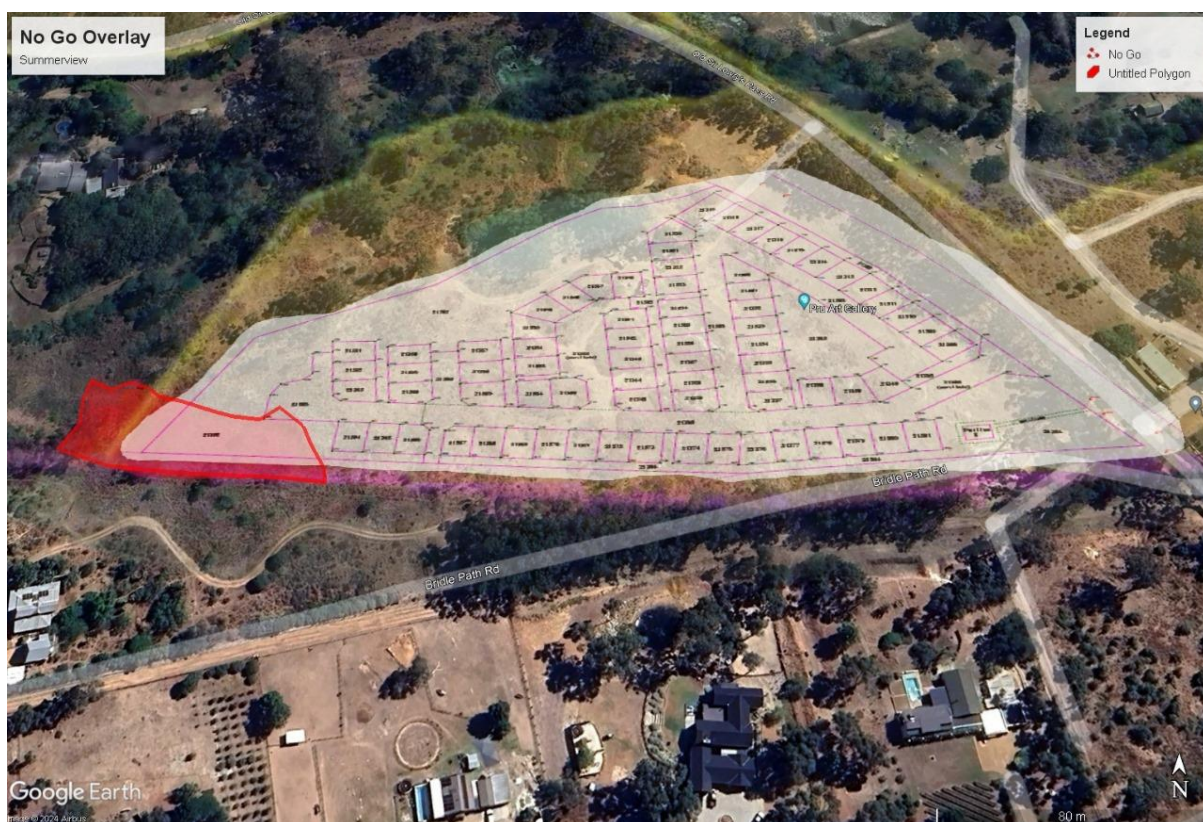
The contractor was advised that the following red area on the overlay map should please be demarcated.

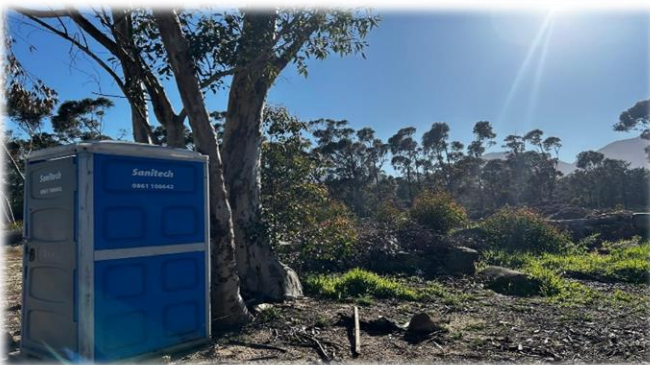
Toilets were noted on site, within close proximity to where the works took place. The contractor is advised to please secure the toilets to the ground.

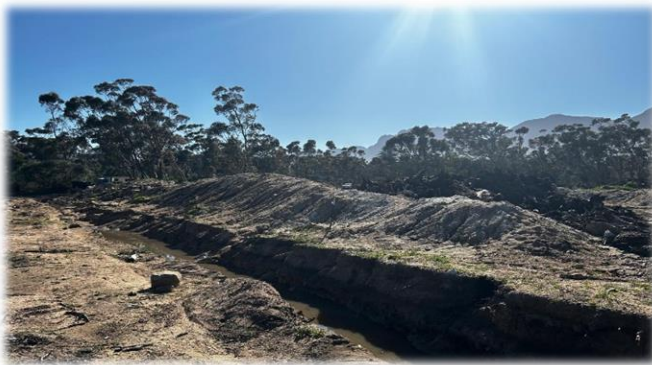
The topsoil on site should please be seen as a no go area, and no stockpiling may be done within the delineated watercourses or the applicable buffer area.

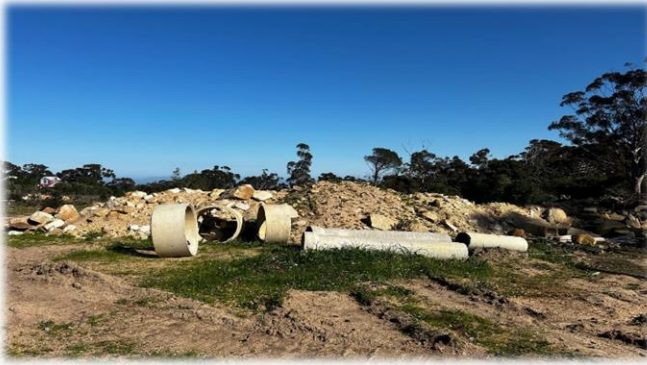
Rubble was securely stockpiled on site, the contractor should please dispose of the rubble if not reused.

Please forward all rubble disposal receipts to the ECO for record keeping.

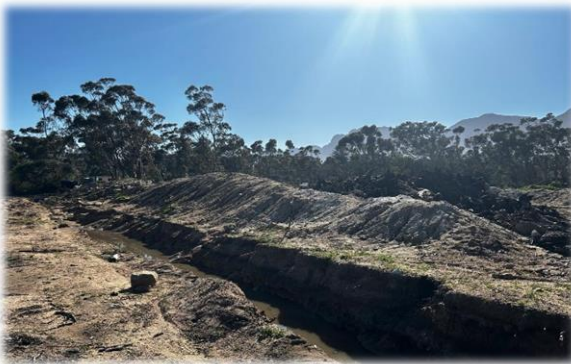
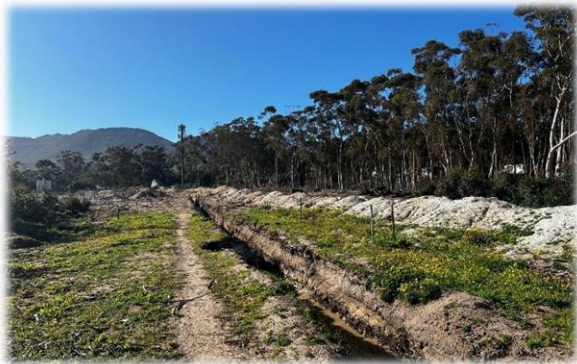
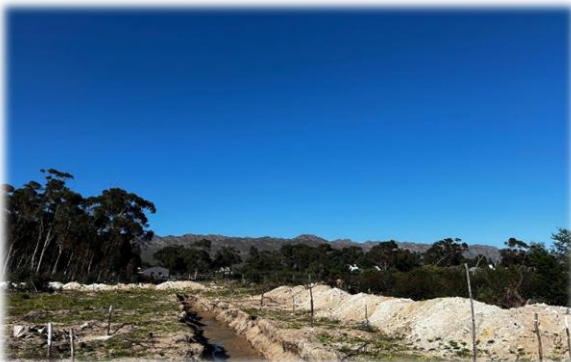
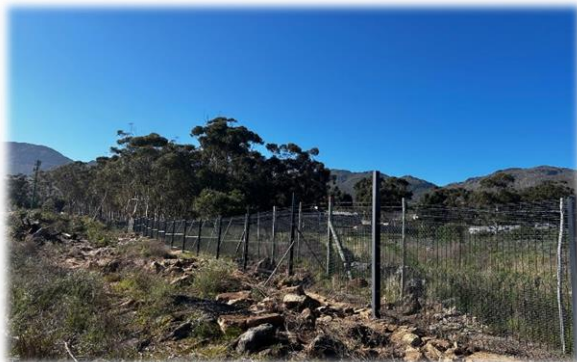
The contractor was busy with finishing the fencing on site, and some of the stormwater and sewer pipes have been installed, but the rains are delaying the civil services a bit.
