**THE UPGRADE OF PROTEA AND MAINTENANCE TO WAARBURGH ROAD NEAR  
JOOSTENBERG VLAKTE, WESTERN CAPE**

Contract No: C1049.03

**FORMAL ECO AUDIT REPORT**

5 April 2024

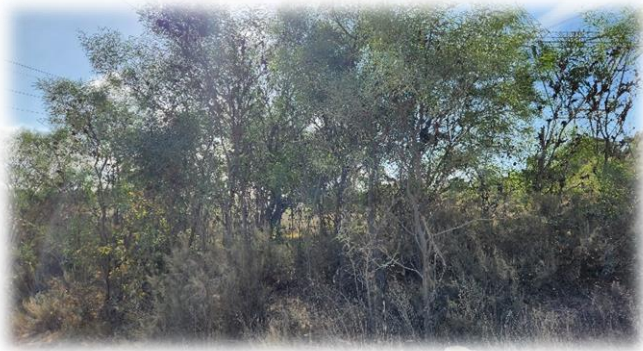
No alien clearing was done to date.

The contractor was advised to please first conduct alien clearing prior to the stripping of the topsoil to prevent alien vegetation within the stockpiled topsoil.

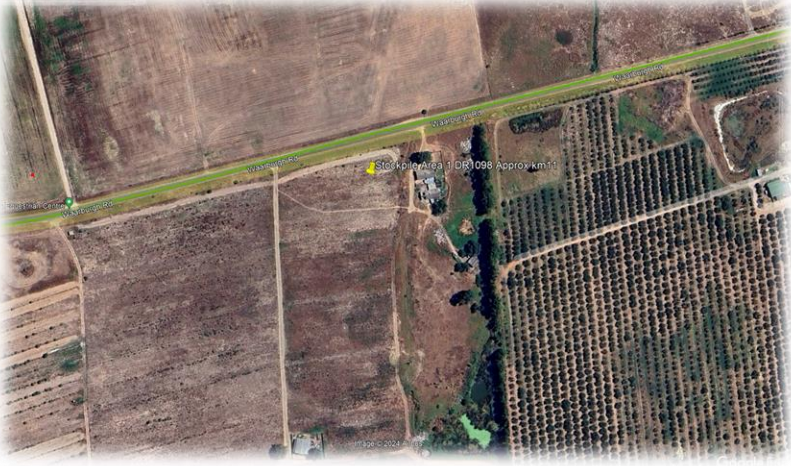
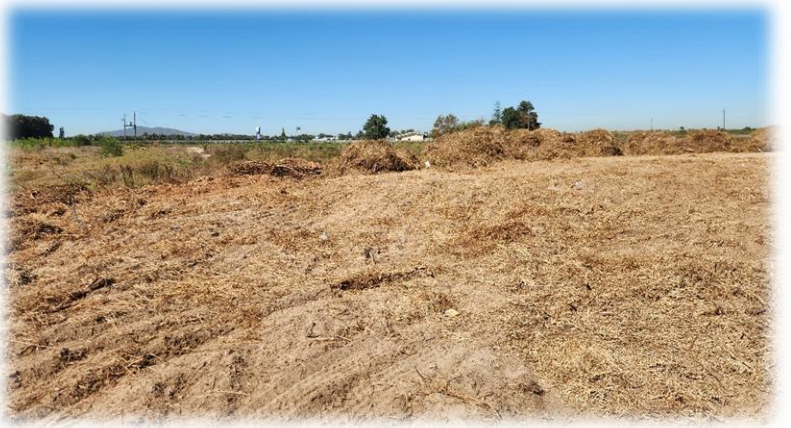
| Stockpile Area No. | Comment | ECO Recommendation |
|---|---|---|
| 1. | <p><b>Stockpile Area 1 on DR1098 at approx. km11 (LHS)</b></p> <p>Existing farmed area.</p> <p>According to google earth, the area has recently been used for farming (plough land)</p> <p>The contractor already used the area during the 1<sup>st</sup> ECO visit and area was not scanned prior to the start of using the area.</p> | <p>Permission letter, prior to stockpiling, and happy letter, after stockpiling, is required from property owner.</p> |

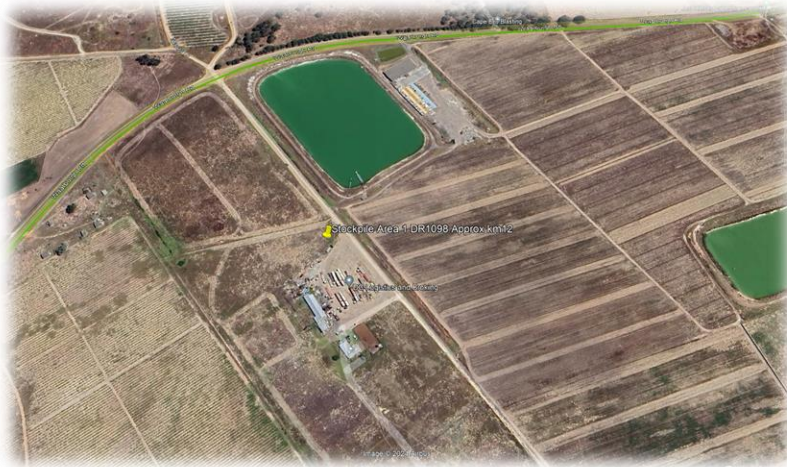
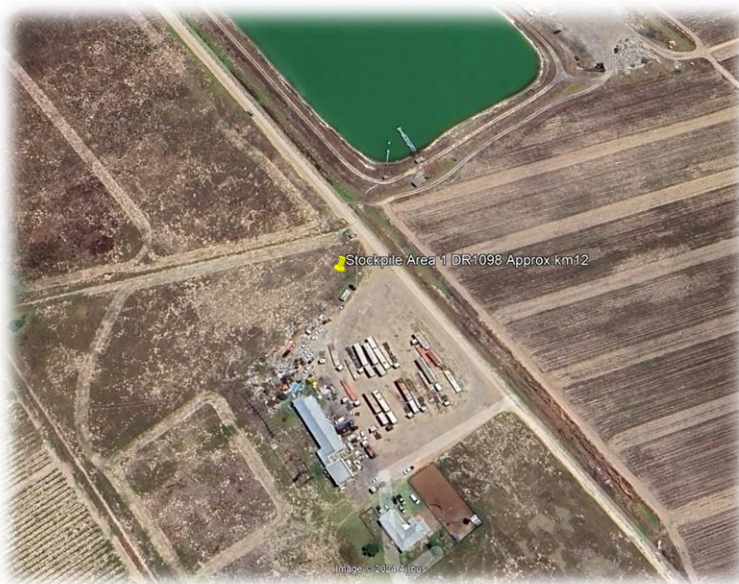
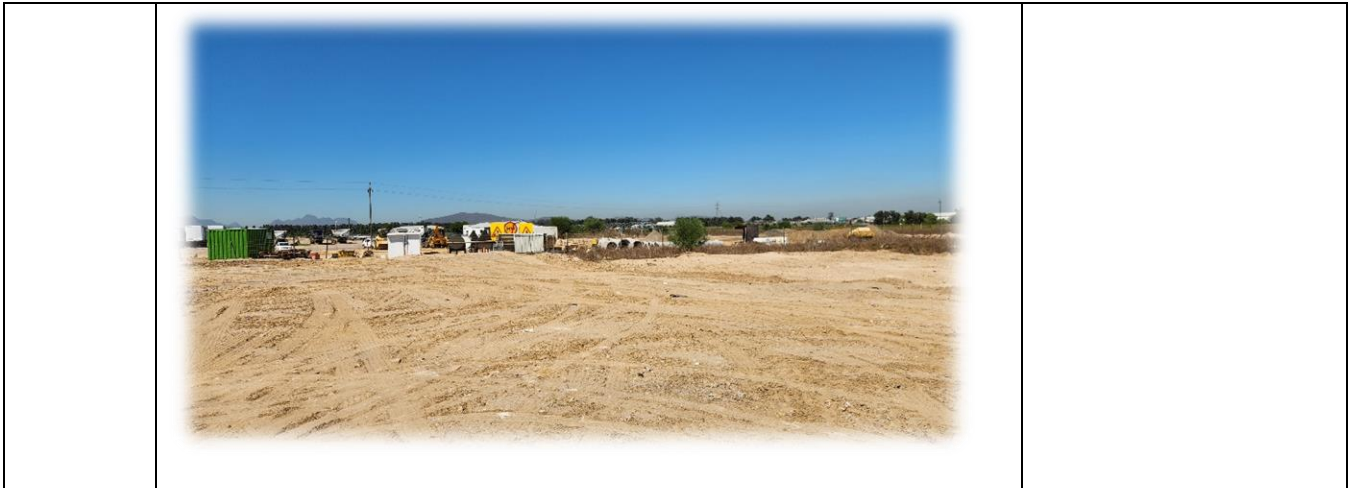
Existing disturbed area, highly invested with alien vegetation. According to google earth the area was recently cleared.

The contractor already used the area during the 1<sup>st</sup> ECO visit and area was not scanned prior to the start of using the area.

is required from property owner.

The contractor is advised to please inform the ER and ECO of potential stockpile areas prior to the start of using the area.

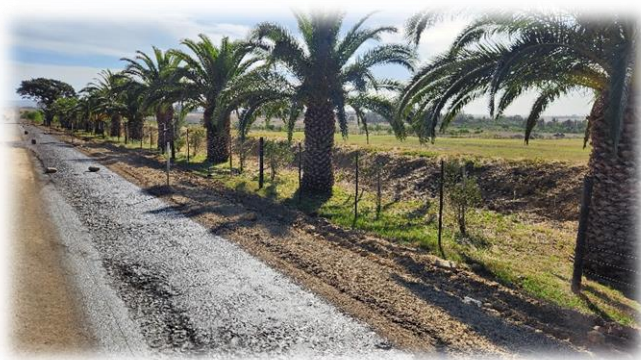
Topsoil has been stripped at a few locations along the site and currently stockpiled at Stockpile Area 1 above.

It is important to keep record of where topsoil from different sections is stockpiled to ensure the correct topsoil is returned to the same area.

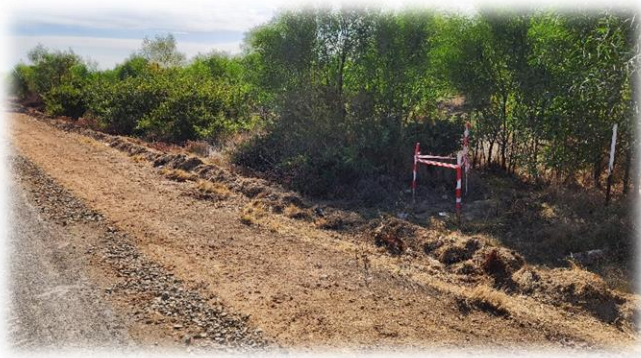
If topsoil is windrowed and kept next to the where the works take place, no damage is allowed to the topsoil. This is to prevent high hydroseeding cost at the end of construction.

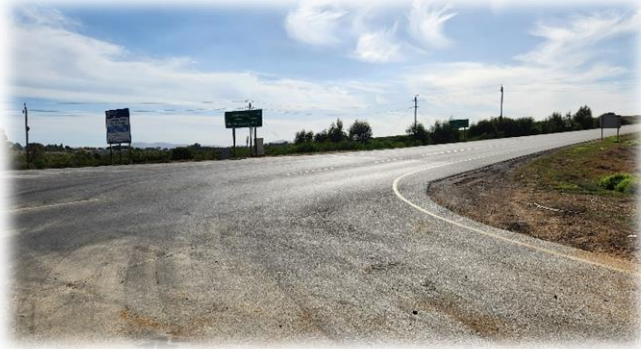
The road surface was clean during the audit, please ensure that areas to the stockpile and spoil sites are kept clean from mud/sand to prevent the material being a danger to traffic.

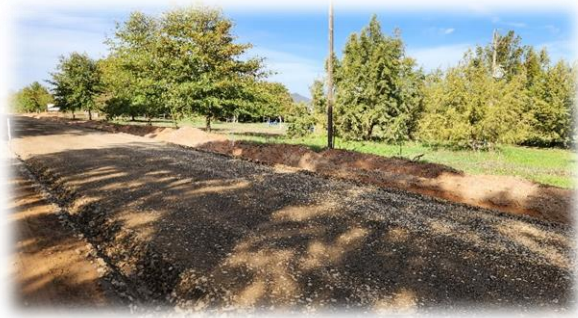
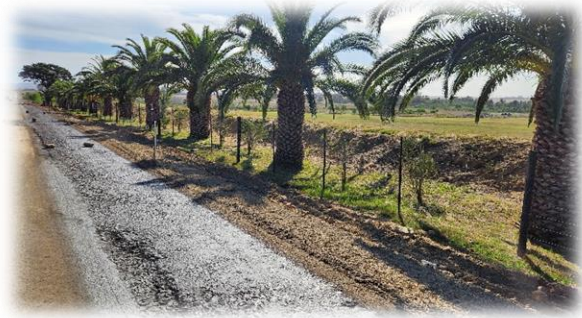
Layer works have commenced on the 1<sup>st</sup> sections of the road as well as the temporary widening for the bypass to allow half width construction of the road.
