**THE UPGRADE OF PROTEA AND MAINTENANCE TO WAARBURGH ROAD NEAR  
JOOSTENBERG VLAKTE, WESTERN CAPE**

Contract No: C1049.03

**FORMAL ECO AUDIT REPORT**

9 May 2024

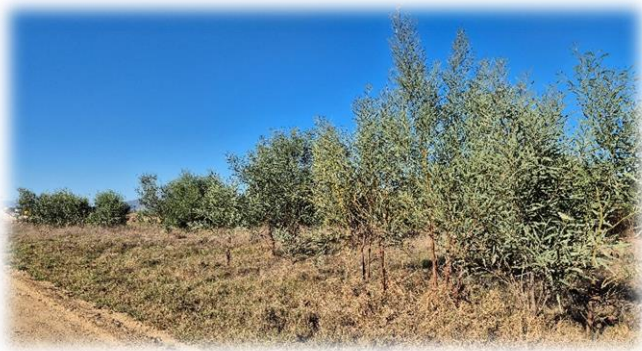
No alien clearing was done to date.

The contractor was advised to please first conduct alien clearing prior to the stripping of the topsoil to prevent alien vegetation within the stockpiled topsoil.

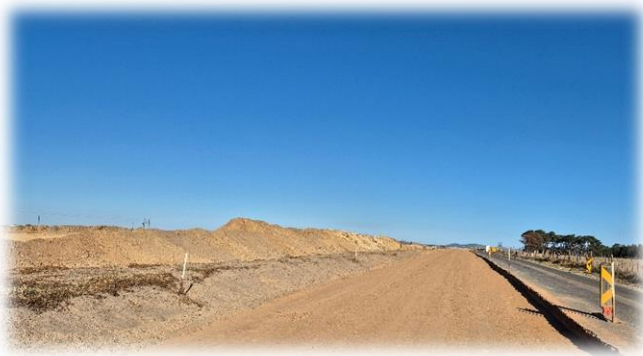
The contractor identified a spoil area (of clean material) on a farm next to the road, the farmer proposes to create a berm on agricultural land next to Waarburgh Road.

Spoiling of material on the berm has commenced.

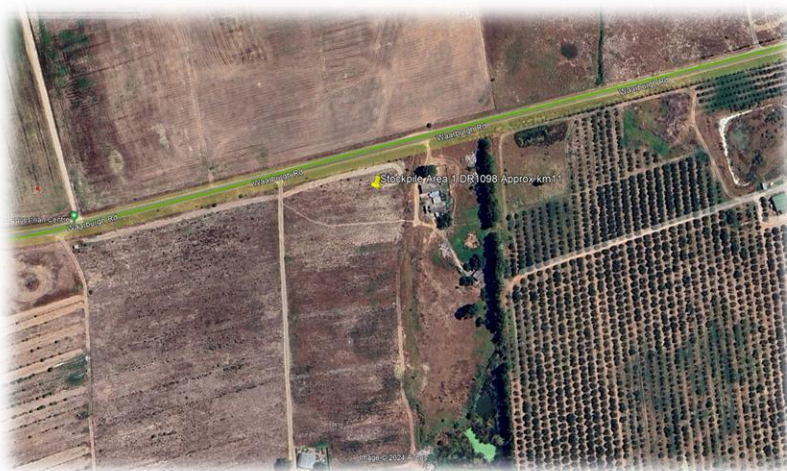
| Stockpile Area No. | Comment | ECO Recommendation |
|---|---|---|
| 1. | Stockpile Area 1 on DR1098 at approx. km11 (LHS) | Permission letter, prior to stockpiling, and happy |

Existing farmed area.

According to google earth, the area has recently been used for farming (plough land)

The contractor already used the area during the 1<sup>st</sup> ECO visit and area was not scanned prior to the start of using the area.

letter, after stockpiling, is required from property owner.

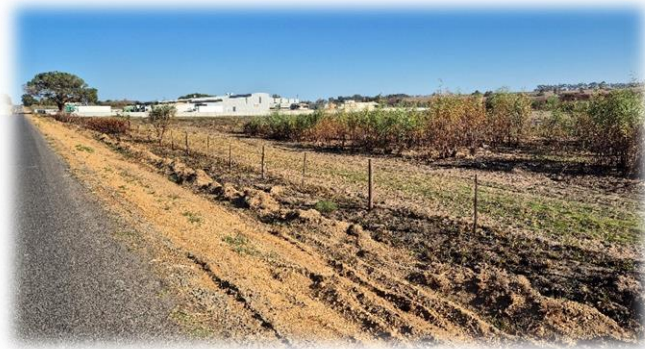
Topsoil has been stripped at a few locations along the site and currently stockpiled at Stockpile Area 1 above.

It is important to keep record of where topsoil from different sections is stockpiled to ensure the correct topsoil is returned to the same area.

If topsoil is windrowed and kept next to the where the works take place, no damage is allowed to the topsoil. This is to prevent high hydroseeding cost at the end of construction.

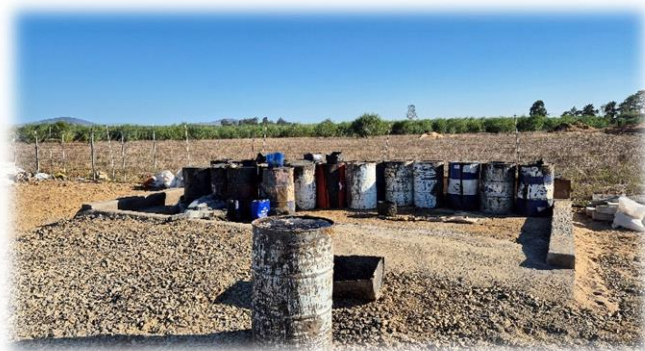
Stockpile Area 2 has been identified to be used as bitumen handling area. The contractor is advised to please ensure impermeable area is created underneath the bitumen tanks to prevent bitumen spills.

Bitumen drums were placed on an impermeable area at Stockpile Area 2 which is sufficient.

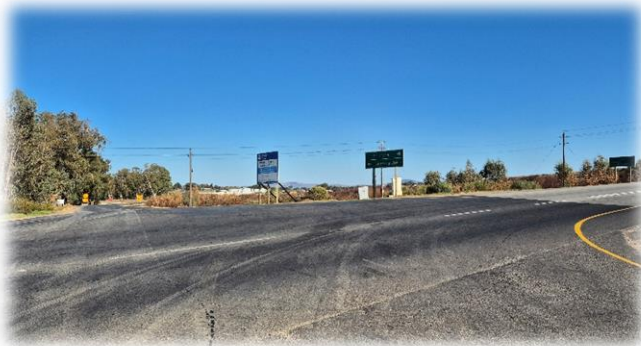
The road surface was clean during the audit, please ensure that areas to the stockpile and spoil sites are kept clean from mud/sand to prevent the material being a danger to traffic.

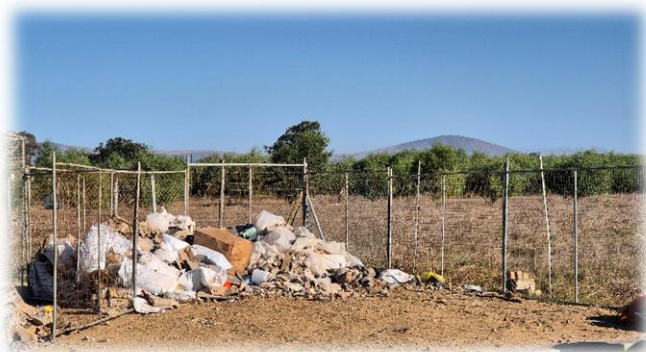
No construction related litter was noted laying around during the audit.

A litter structure was noted at Stockpile Area 2. The contractor is advised to please place empty cement bags into the large white bags or black bags, this is to prevent cement leaching from the bags during rain.

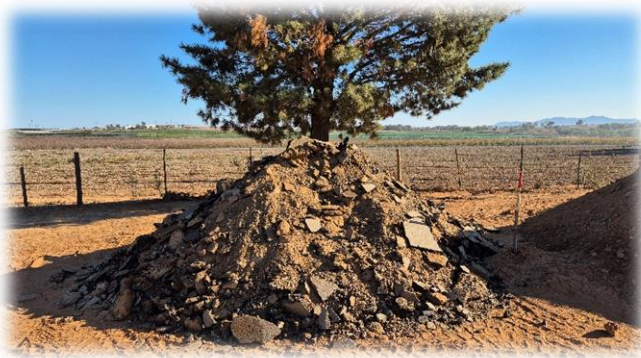
Millings were noted to be stockpiled. The millings will be reused in the layer works.

The contractor was advised to please ensure that the rubble is disposed appropriately if not reused. Please forward rubble disposal receipts to the ECO for record keeping.

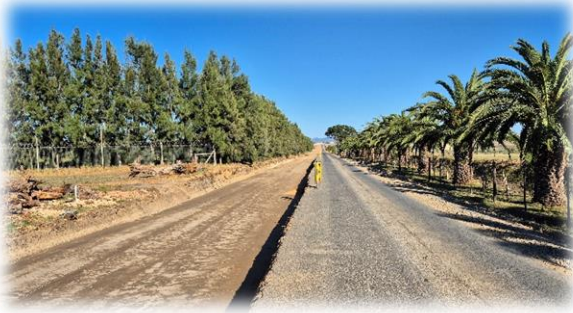
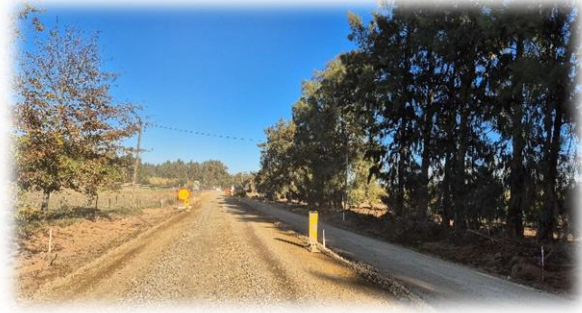
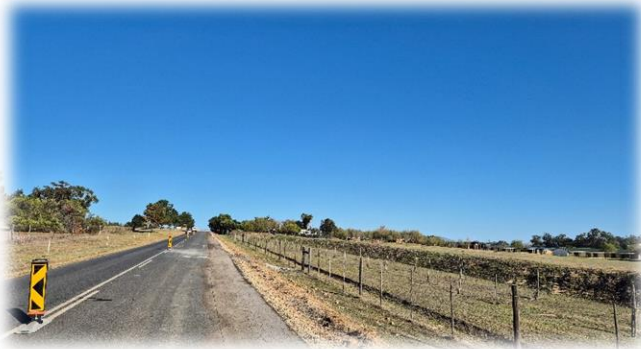
Layer works have commenced on the 1<sup>st</sup> sections of the road as well as the temporary widening for the bypass to allow half width construction of the road.
