**THE UPGRADE OF PROTEA AND MAINTENANCE TO WAARBURGH ROAD NEAR  
JOOSTENBERG VLAKTE, WESTERN CAPE**

Contract No: C1049.03

**FORMAL ECO AUDIT REPORT**

8 November 2024

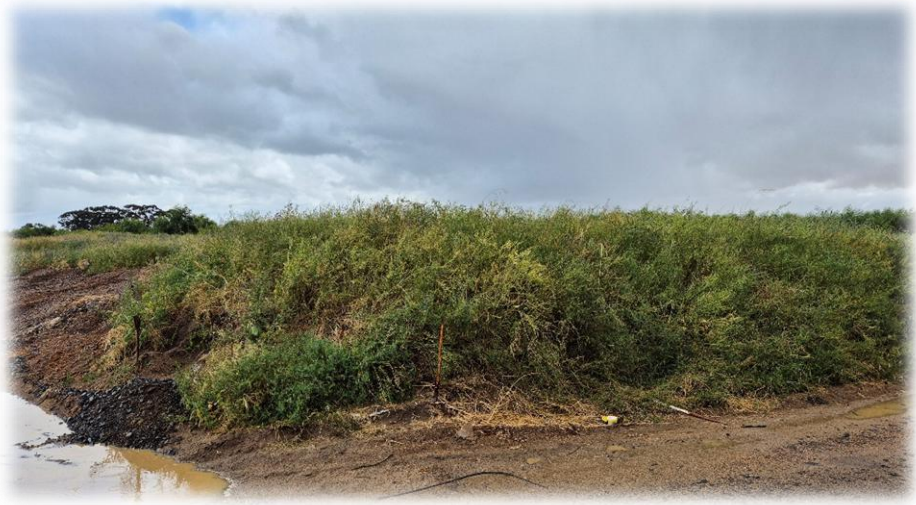
| <b>Topsoil management</b> | Topsoil has been stripped at a few locations along the site and currently stockpiled at Stockpile Area 1 and 2. | Compliant |

| | <p>Where possible topsoil has been windrowed, but due to limited space on site stockpiling is preferred.</p> <p><u>It is important to keep record of where topsoil from different sections is stockpiled to ensure the correct topsoil is returned to the same area.</u></p> | |

| <b>Soil</b> | <p>Topsoil has been stripped at a few locations along the site and currently stockpiled at Stockpile Area 1 and 2. The topsoil must be spread after the completion of the works as part of the rehabilitation works.</p> <p><u>It is important to keep record of where topsoil from different sections is stockpiled to ensure the correct topsoil is returned to the same area.</u></p> | Compliant |

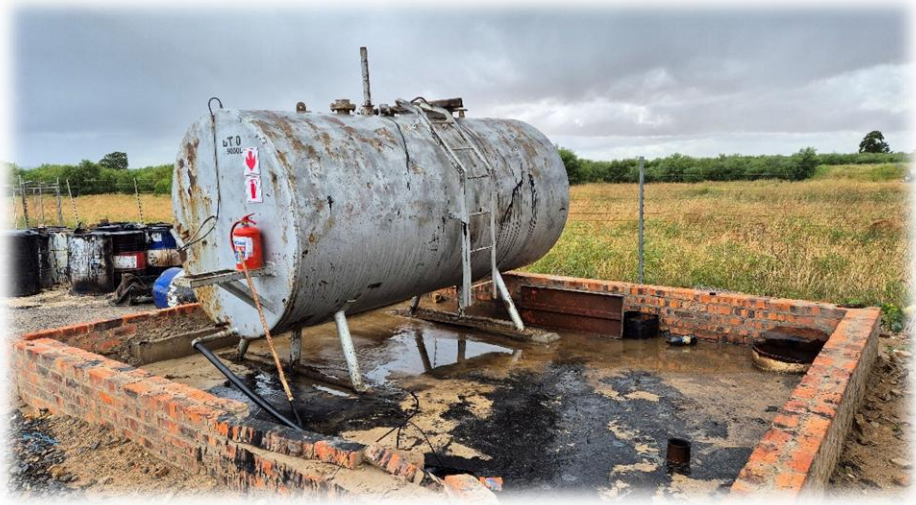
| <b>Dangerous and Toxic Materials</b> | <p>Oils and chemicals are stored at the site camp area in appropriate containers. No large fuel storage takes place on site.</p> <p>A bunded area with 110% storage capacity has been constructed for the bitumen tanker.</p> | <p>Compliant</p> |

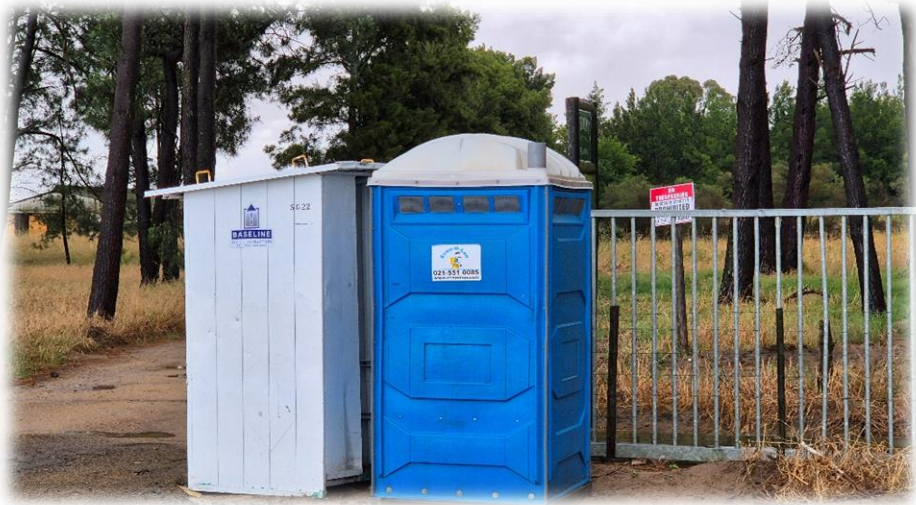
| <b>Toilets and ablution facilities</b> | <p>A few mobile toilets were noted on site.</p> <p>The contractor will be responsible for providing all sanitary arrangements for his and the sub-contractors team. A minimum of one chemical toilet shall be provided per 15 persons.</p> <p>Toilets provided by the contractor must be easily accessible and a maximum of 150m from the works area to ensure they are utilised.</p> | Compliant |

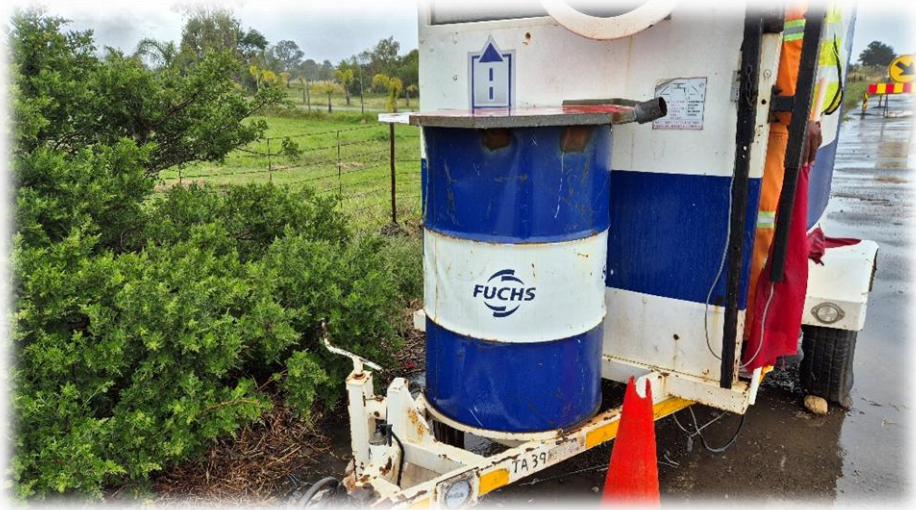
| <b>Waste management</b><br><br>Please refer to the waste minimization plan as part of the EMP. | <p>Litter and rubble disposal receipts are required to be forwarded to the ER and ECO for record keeping.</p> <p>No receipts were received to date.</p> | Partial compliant |

| | <p><u>Should rubble not be proposed to be disposed at a registered landfill site (for example a farmer wants the rubble), authorisation is required from Western Cape Government: Environmental Affairs and Development Planning: Waste Department</u></p> <p>Bins were placed at the closures.</p> | |

| | Finding | Close Out Recommendation |
|---|---|---|
| 1. | <b>Waste management</b><br><br>Litter and rubble disposal receipts are required to be forwarded to the ER and ECO for record keeping. | No receipts were received to date. Please forward disposal receipts for record purposes. |

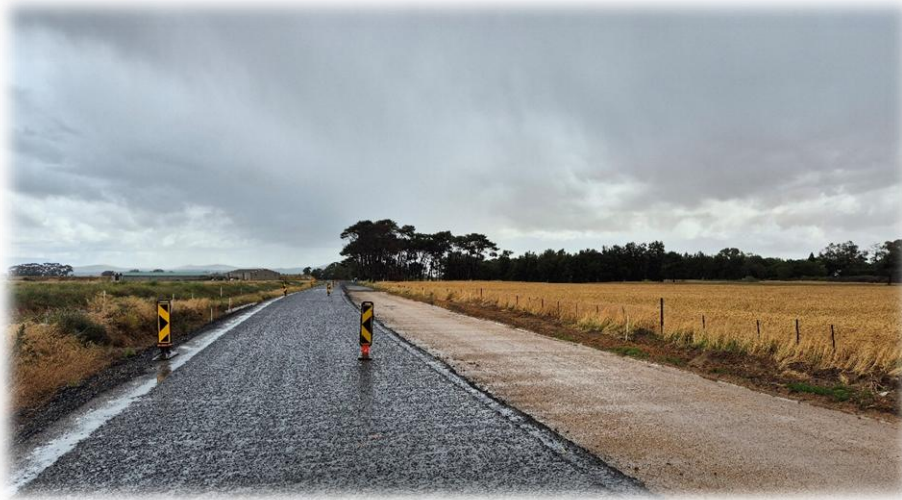
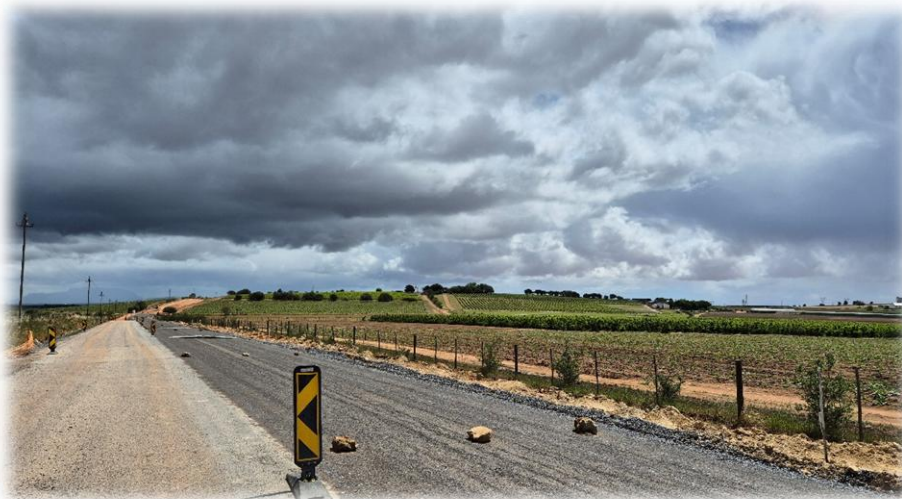
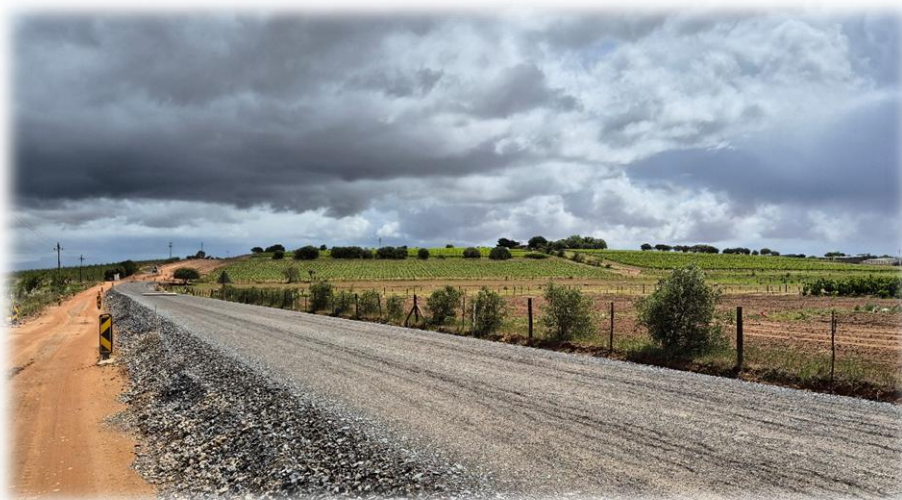
Traffic has been placed on the sections which were recently surfaced. The next sections to be surfaced soon were progressing well.

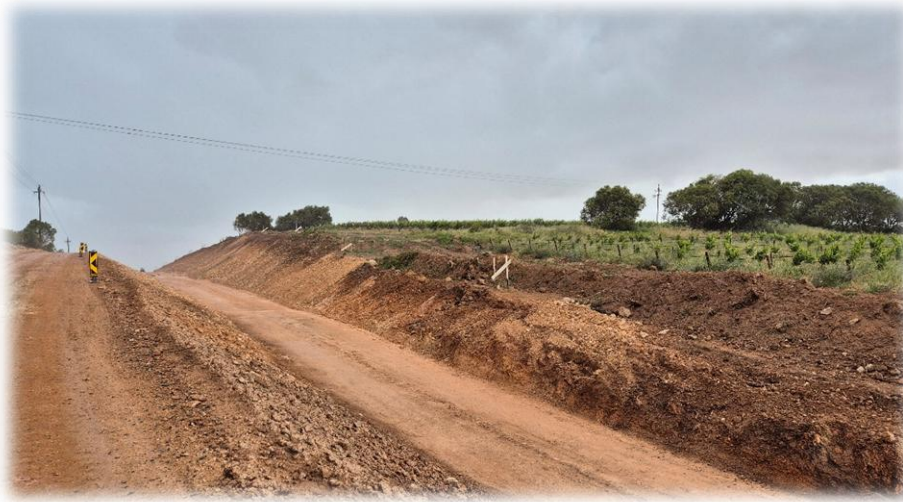
The cutting on Protea Road commenced and progressed well.

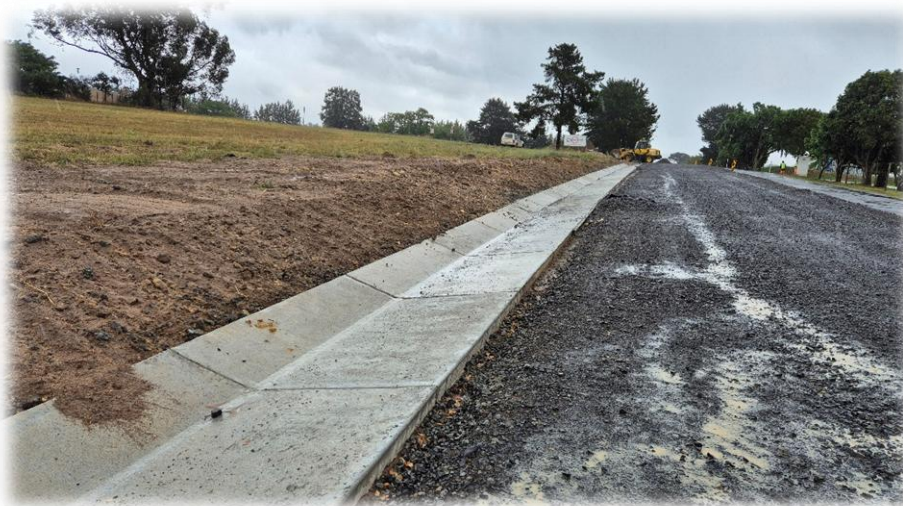
The concrete lined side drains were also underway.
