## ENVIRONMENTAL MONITORING REPORT 04 FOR THE RIVERBANK MAINTENANCE AT SAN MARINO, KEURBOOMSTRAND, PLETTENBERG BAY

| <b>HillLand Reference</b> | PLE23/1011/32 |
| <b>Date</b> | 16 October 2023 |

Environmental Monitoring Report No. 04

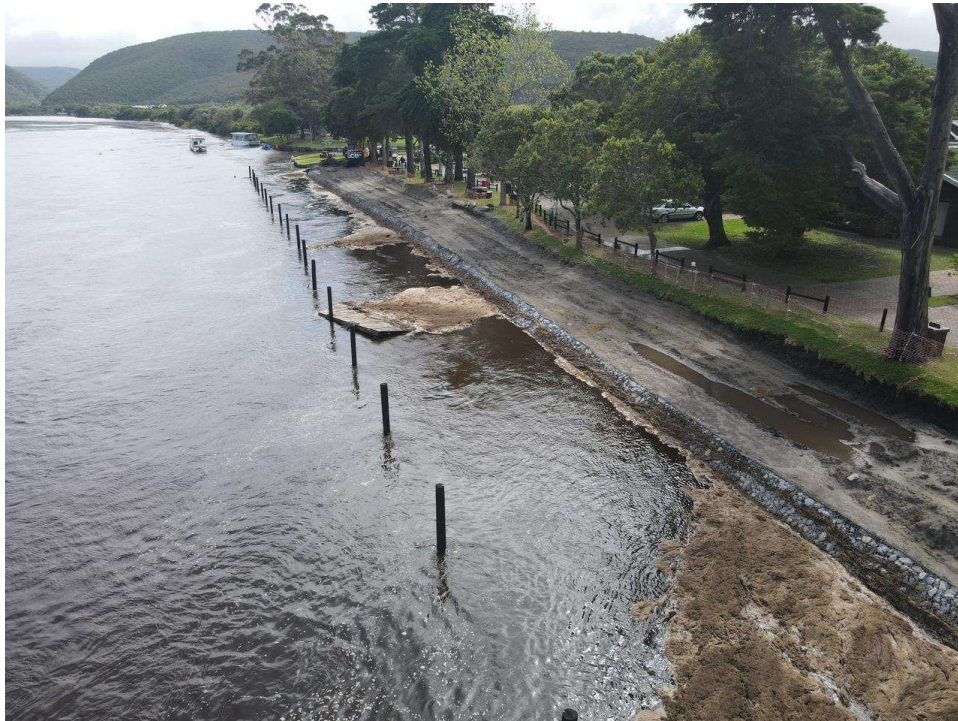
*Drone footage following storm surge*

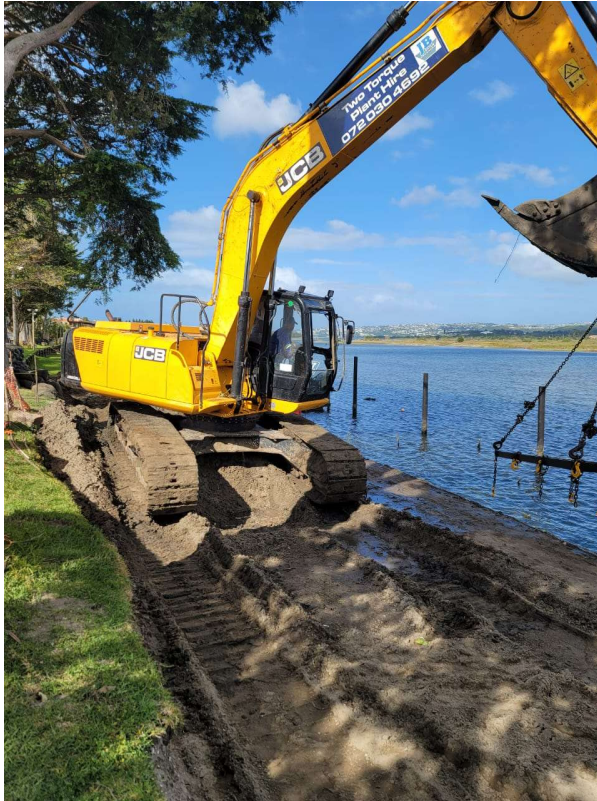
3. **Excavation for a level working platform for the reno mattress base / toe was done at low tide.** – all excavate material placed within the working zone and used to hand fill sandbags. Any organisms within the sand had opportunity to move back into the river during high tide. Toe reno mattresses installed other than at the termination sections on either site – ongoing, termination and tie-in with Blue Waters in progress.

*Tie-in with Blue Waters in progress - Photograph taken 20 September 2023*

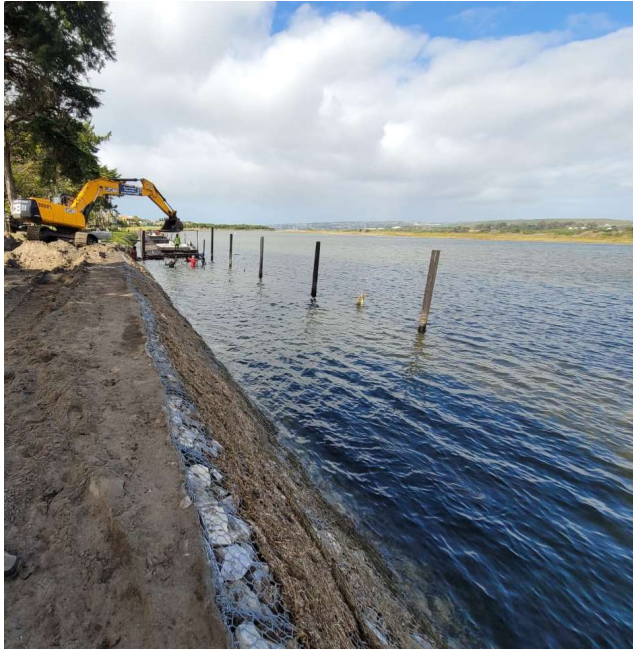
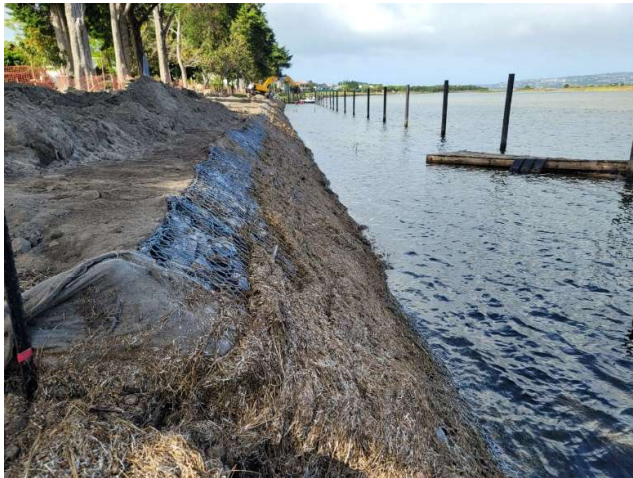
Completed installation along the bank - Photograph taken 20 September and 13 October 2023

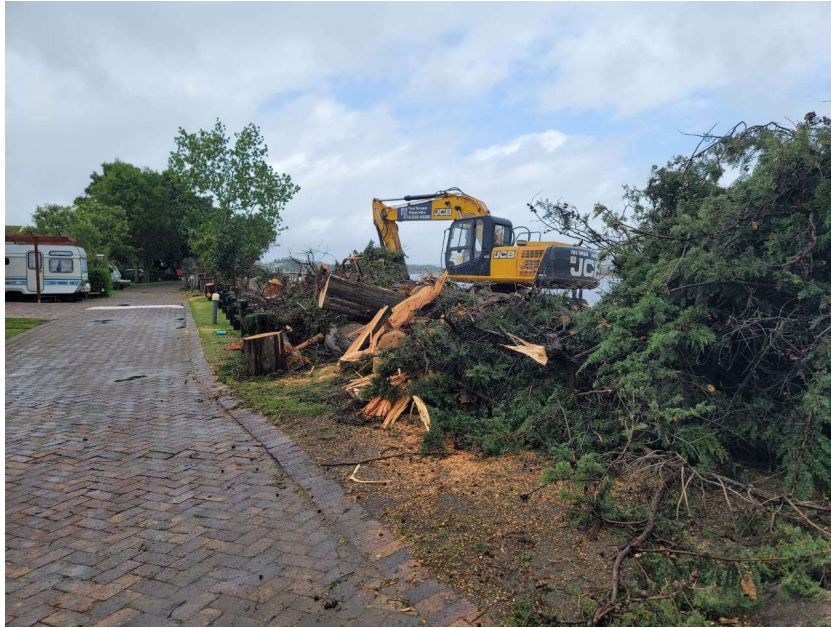
*Cut of exotic trees – to be replaced with indigenous trees – photograph taken 13 October 2023*

| All cut vegetation shall be disposed of off-site at an approved disposal site. Stockpiling of cut vegetation shall only be permitted in areas indicated by the ECO. <b>No</b> cut vegetation shall be burnt on site. | | | Cut exotic trees will be disposed off and the trees will be replaced with indigenous trees. |

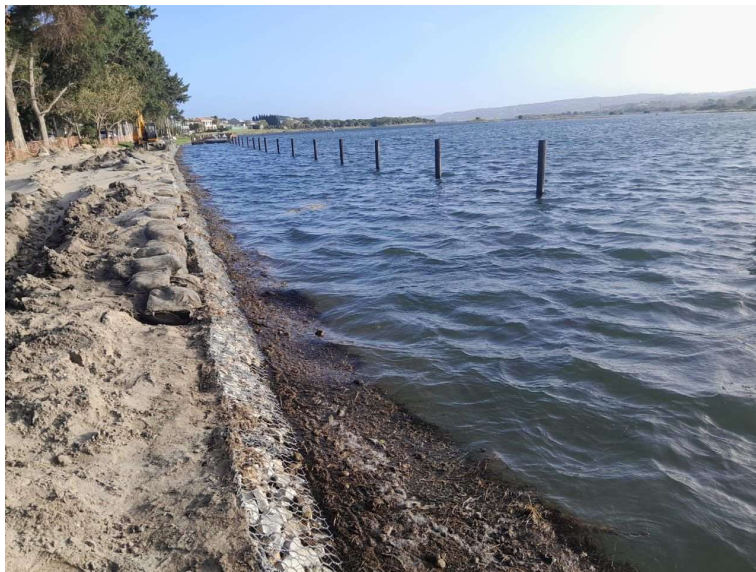
**Bank during flood event – photographs taken 17 September 2023. The site handled the flood event well with no issues.**

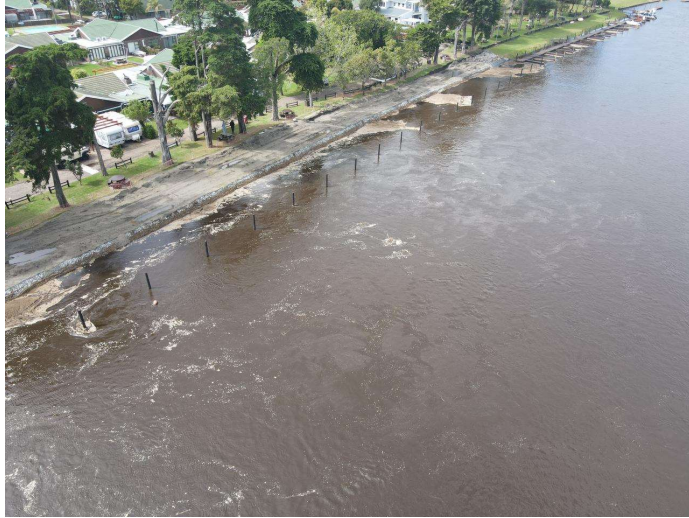
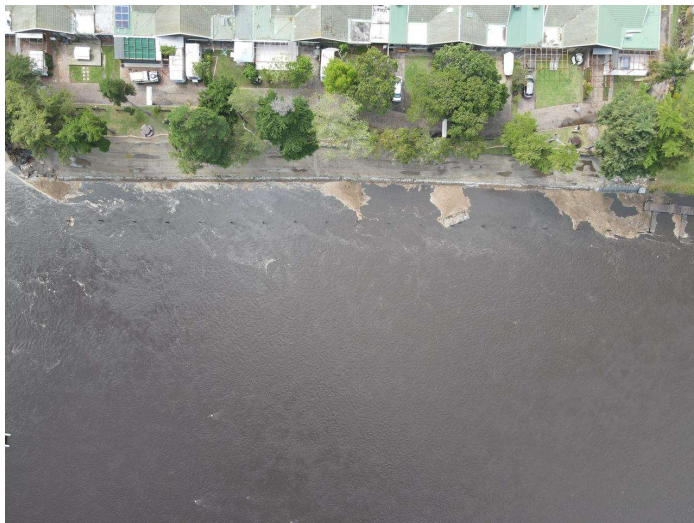
**Bank during storm surge – photographs taken the 26<sup>th</sup> September 2023. The site handled the flood event well with no issues.**
