### ENVIRONMENTAL MONITORING REPORT # 2 FOR Erf 4716, GROOT BRAKRIVIER

**ERF 4716, GROOTBRAK, WILLIE NEL  
ENVIRONMENTAL MONITORING REPORT NO 2  
JUNE 2023**

## **Environmental Monitoring Report No. 2**

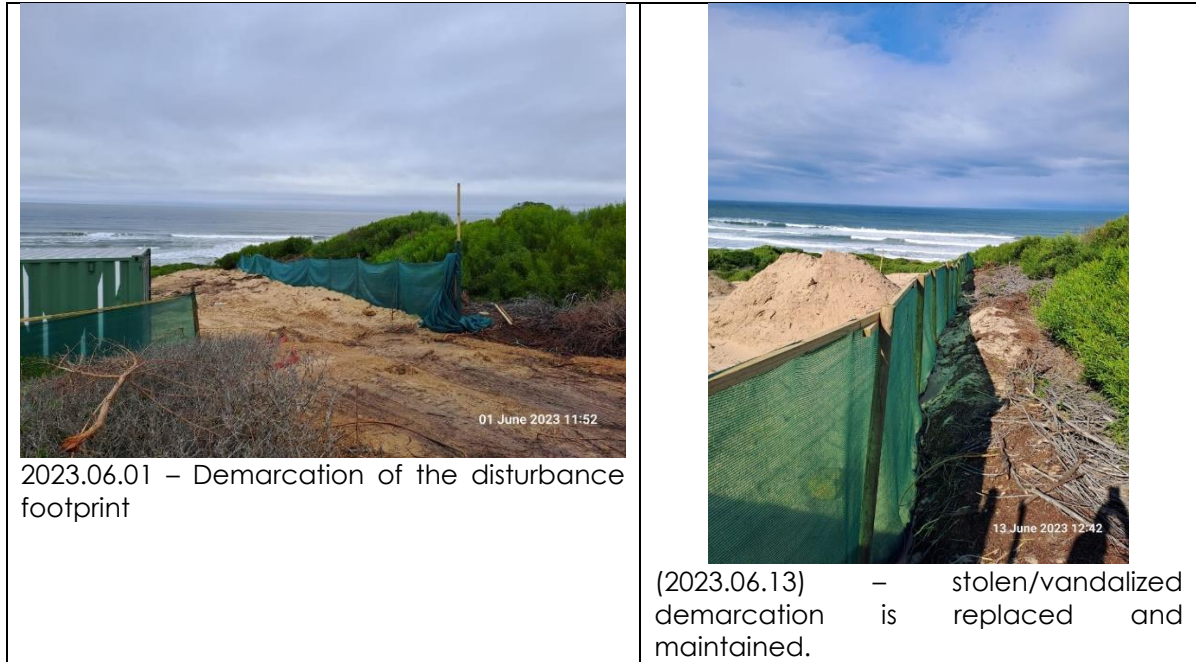
- Installation of the demarcation of the housing footprint (south of MR6817) was done and is maintained.
- It was reported to the ECO that several of the wooden poles (for the demarcation) and sections of the shade netting were stolen.
  - o The owner reported the matter to the SAPS and Mossel Bay Municipality (refer to Annexure A). This remains an issue. Incidents should be reported to the local authorities as and when it occurs, and it is recommended that a night watchman be appointed to safeguard any material and equipment on site during the construction phase.

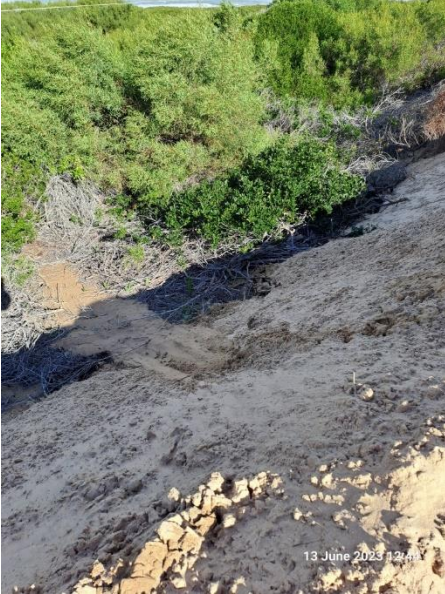
NO-GO demarcation doubles as a silt trap (shade netting buried approximately 200 mm beneath the soil), however, ongoing theft issues make it difficult.

(2023.06.13) – Gabion retainer will be installed to further stop the sand movement

A gabion wall will be constructed on the southern platform edge of the development footprint for stability and erosion protection.

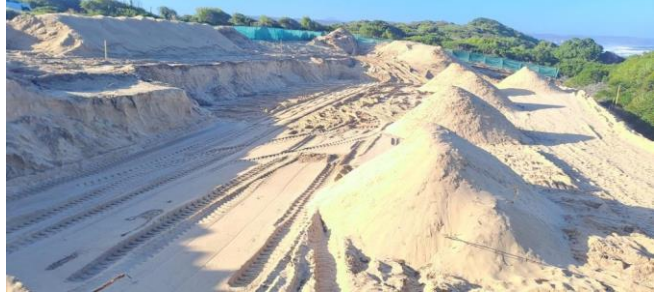
(2023.06.22) – busy with bulk excavation and earthworks.

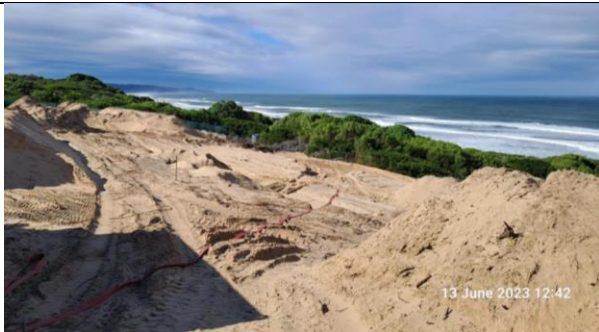
(2023.06.13) – Busy with bulk excavation and earthworks

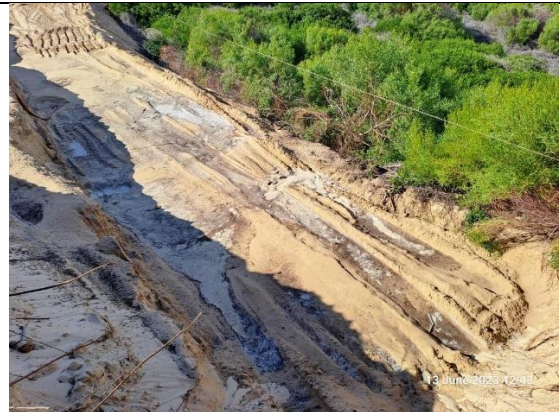
(2023.06.13) – Most southern edge of the property where most earthworks have been completed – gabion retainer will be installed along the southern boundary of the disturbance footprint.

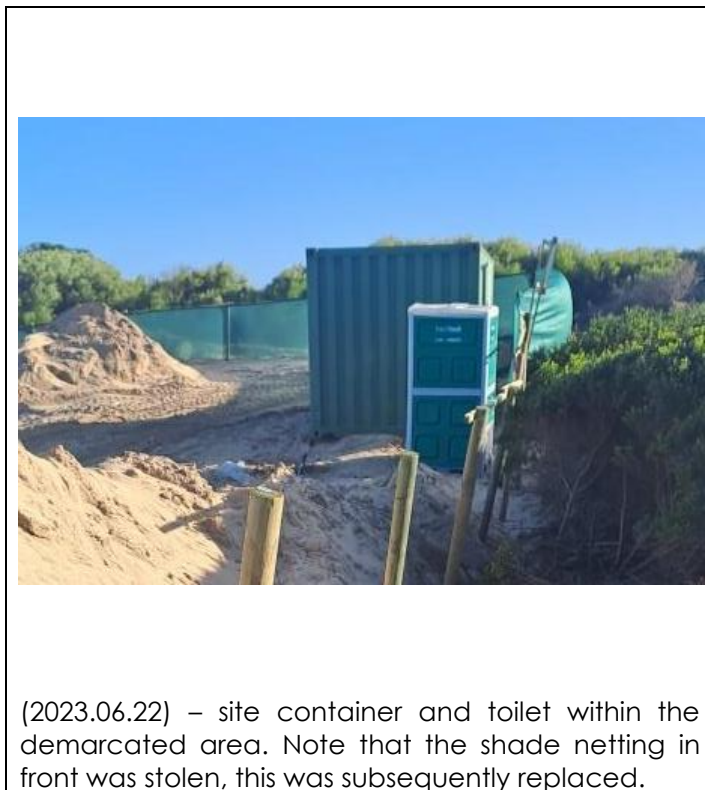
The site camp is kept within the already demarcated disturbance footprint; no new/additional clearing is allowed for this purpose.

The main contractor must ensure that there is a bin/skip for building rubble and litter and sufficient ablution facilities for the staff – ablution facility must be regularly serviced, and the litter bag must be removed daily.

The portable toilet must be tied down and regularly serviced.
