MOS24/1136/33  
15 March 2024

**RE: NON-COMPLIANCE PENALTY IN TERMS OF THE ENVIRONMENTAL MANAGEMENT PROGRAMME FOR FAILURE TO INSTALL NO-GO DEMARCATION – ERF 4716, GROOT BRAK RIVIER**

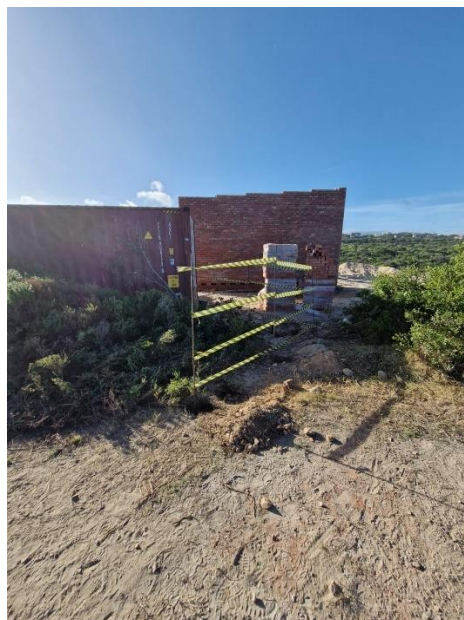
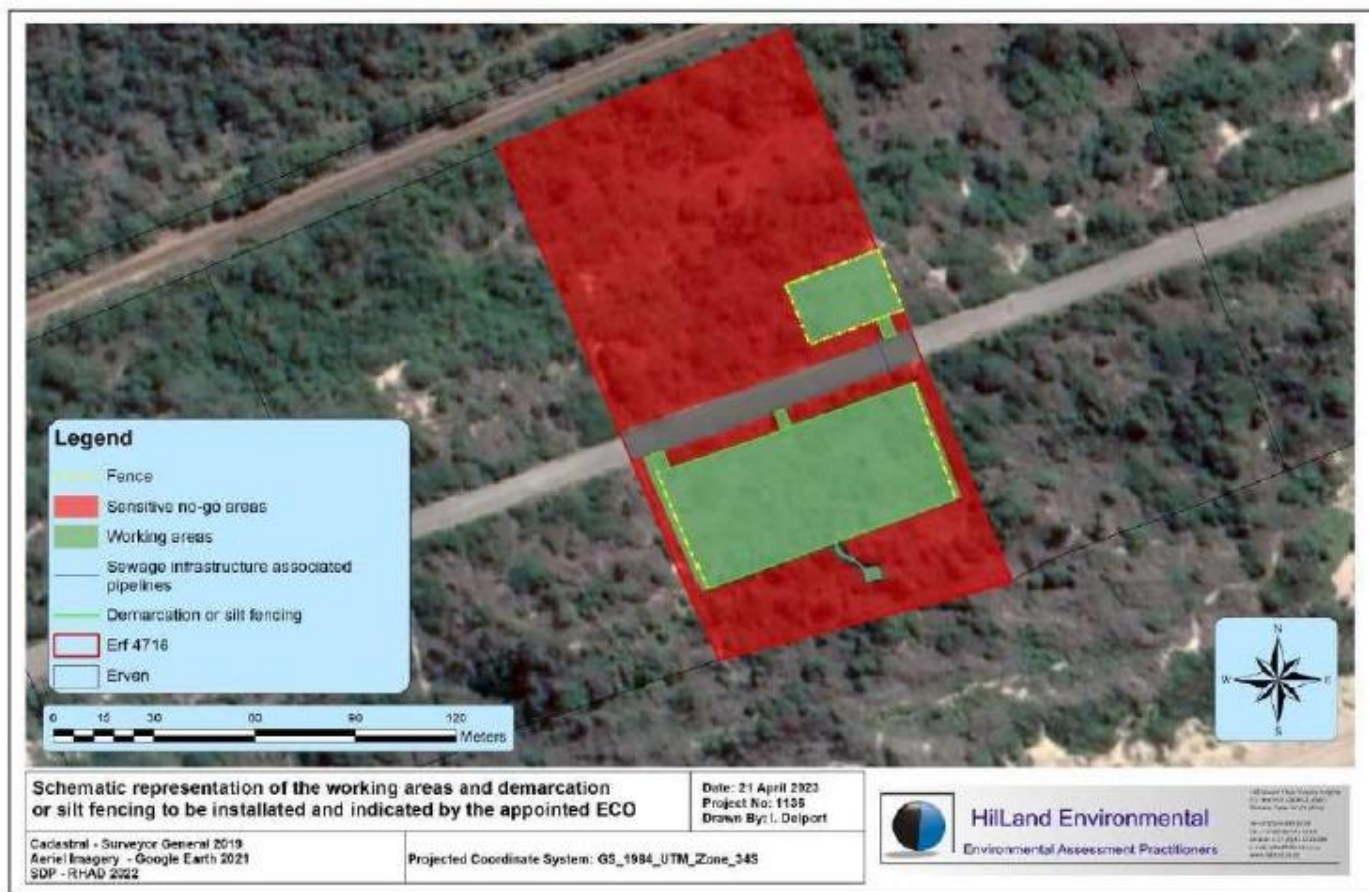
14 March 2024

The contractor was requested to install the No-Go demarcation for the garage site on May 2023, written request on the WhatsApp group on 1<sup>st</sup> March 2024 and second verbal request on 12<sup>th</sup> March 2024. During our follow-up inspection on 14<sup>th</sup> March 2024, the No-Go demarcation had still not been installed for the garage site and as result thereof, workers are walking through the No-Go zone where the Milkwood trees were transplanted to.

Damage to and protection of the transplanted milkwood trees – the trees transplanted have been damaged through construction activities and failure to demarcate and protected the trees. Thank you for now demarcating the trees, however access through the No-Go area is still disturbing these trees, they need to be watered daily. In order to try revive these trees please include compost around the trees and an application of Bounce back or similar product.

**The contractor is hereby instructed to install the No-Go demarcation for the garage site by no later than 16 March 2024 and submit photographic proof thereof to the ECO.**

Shade netting to be installed around the working area as required.

- The contractor must buy either three (3) X 20 Liters or five (5) X 4 Liters additional Milkwood trees (*Sideroxylon inerme*) and plant as indicated by the ECO.
- The rescued and new trees must be looked after (compost, food and water) for the remainder of the construction phase.
