**THE HIGH-PERFORMANCE SPORT CENTRE, SPORTS ACADEMY AND ASSOCIATED  
INFRASTRUCTURE ON PORTION 28 (A PORTION OF PORTION 15) AND PORTION 63 (A  
PORTION OF PORTION 25) OF FARM GUSTROUW NO. 918, STRAND.**

EA DEA&DP Ref: 16/3/3/1/A3/57/2031/23

**INFORMAL ECO AUDIT REPORT**

12 August 2024

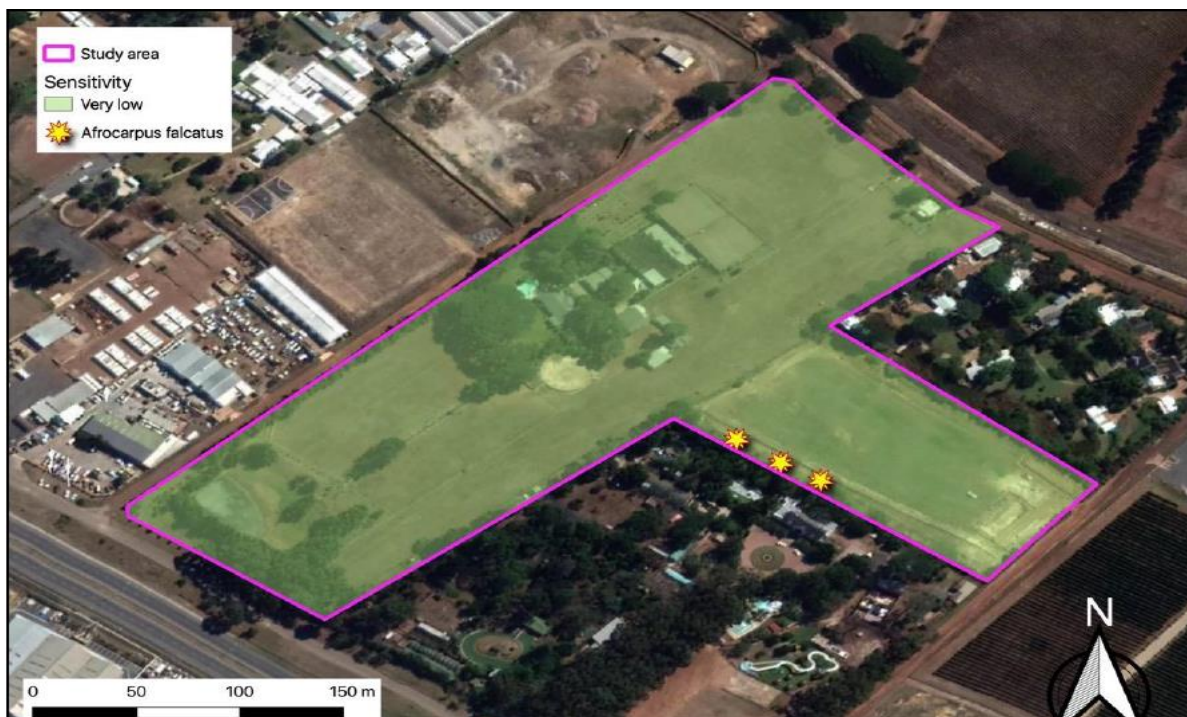
No Yellowwood trees were observed on the HPSC side during the audit, according to the contractor the trees were not present on site and possibly within the Monkey Town border. Three Yellowwood trees were spotted on the MonkeyTown property, but the coordinates on maps looks like two of the trees should have been bigger and older.

The contractor to please indicate on the SDP that the trees were not located within the development footprint. The waypoints for these species are: AF1 (S34.11872° E18.88320°), AF2 (S34.11886° E18.88344°) and AF3 (S34.11896° E18.88364°).

**The contractor was advised to please confirm that the trees coordinates are outside of the boundary of the development.**

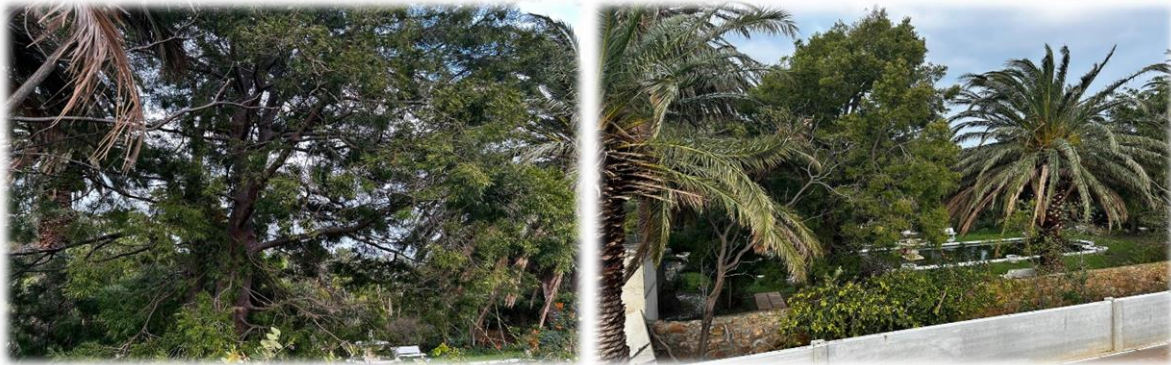
Below is one of the big trees observed during the audit, presumably the one on –  
(34.1190502,18.8835699)

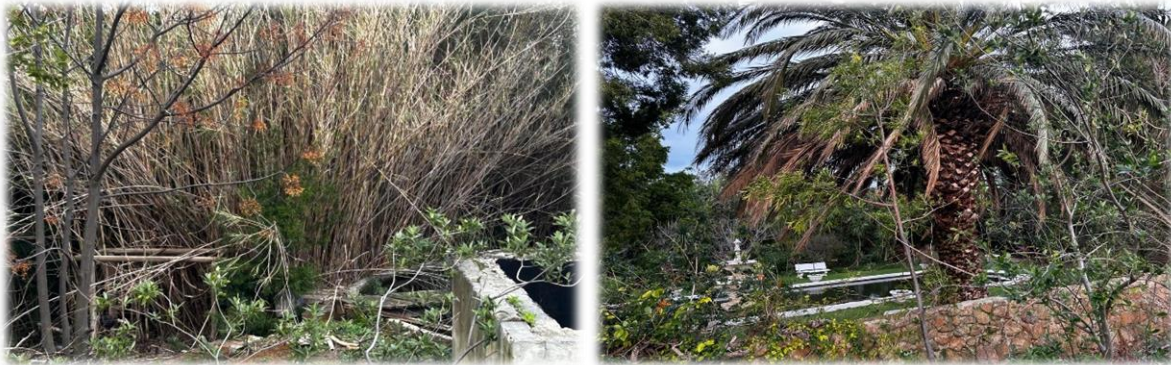
The other two trees observed were very small, and the ECO is not sure if these were the trees referred to in the Botanical study.

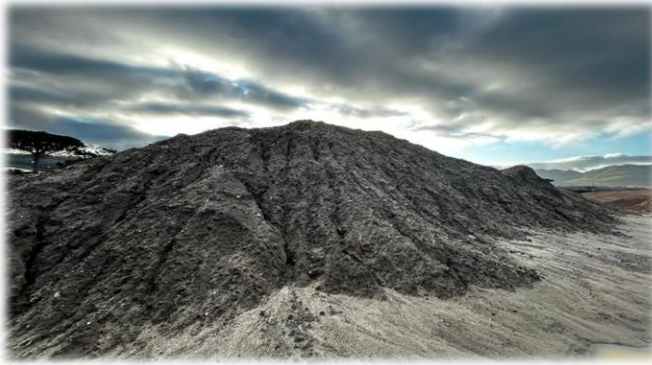
The topsoil stockpiles were not demarcated during the audit, the contractor should please demarcate the topsoil stockpiles on site.

The topsoil has been placed on site, the contractor should please demarcate the topsoil and ensure that the erosion to the topsoil is maintained.

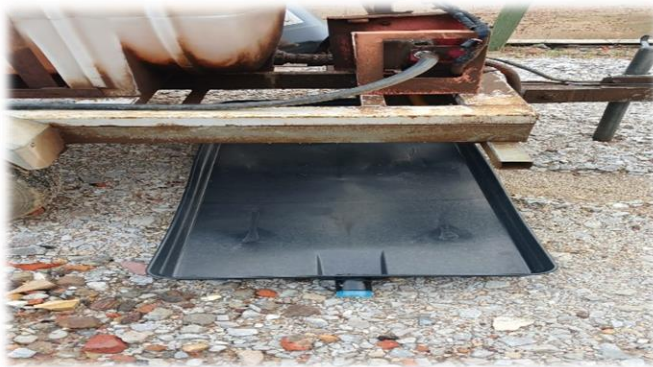
A bowser was seen on site, the contractor placed a drip tray underneath the bowser, thank you for that.

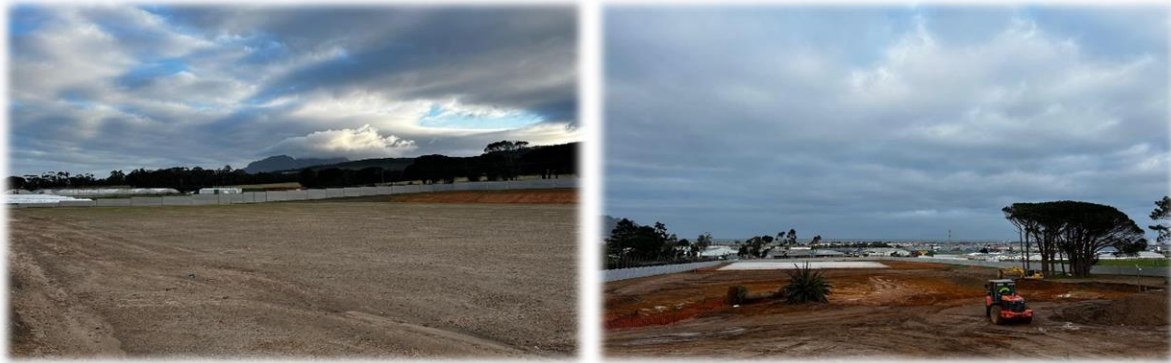
Dust was not an issue during the audit, as it was raining. Most of the platforms for the fields have been done and one of the fields has been sown with grass seeds already.

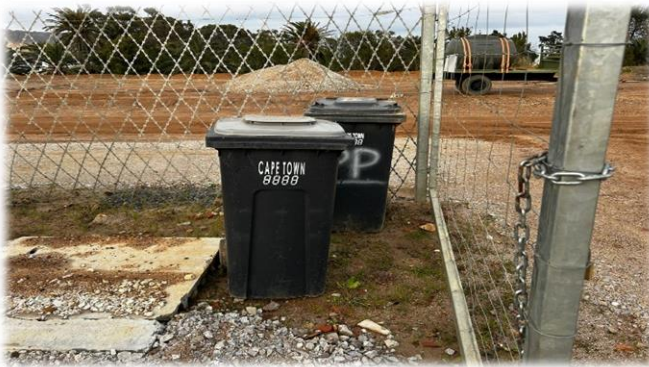
No construction related litter was noted laying around during the audit.

Bins have been placed in the site camp, thank you for that.
