**THE HIGH-PERFORMANCE SPORT CENTRE, SPORTS ACADEMY AND ASSOCIATED  
INFRASTRUCTURE ON PORTION 28 (A PORTION OF PORTION 15) AND PORTION 63 (A  
PORTION OF PORTION 25) OF FARM GUSTROUW NO. 918, STRAND.**

EA DEA&DP Ref: 16/3/3/1/A3/57/2031/23

**FORMAL ECO AUDIT REPORT**

FINDINGS IN TERMS OF THE APPROVED EMPR DURING THE SITE VISIT ON THE 27<sup>TH</sup> OF JANUARY 2025

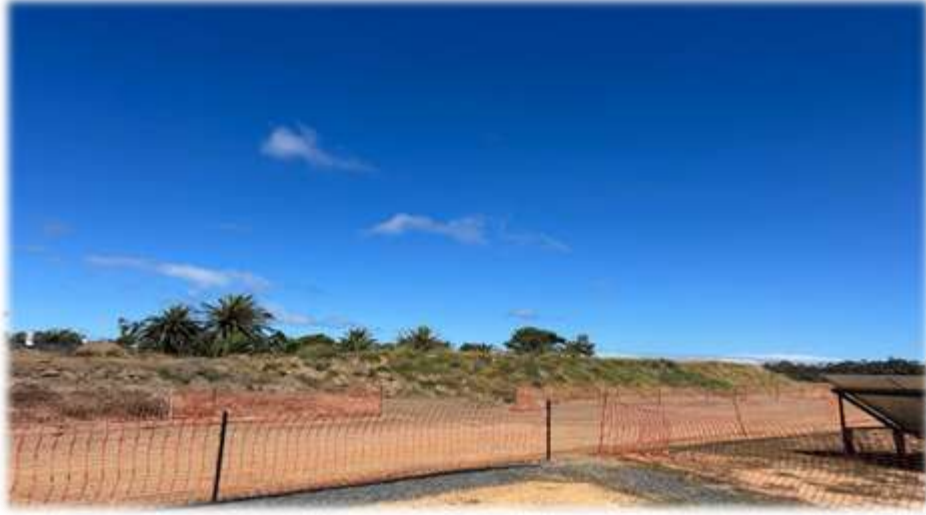
| | <p>The topsoil stockpile exceeds 2m in height but the space on site is very limited, erosion and aliens are monitored constantly.</p> <p>The topsoil is clearly demarcated on site and the contractor is busy placing the topsoil back on site.</p> | |

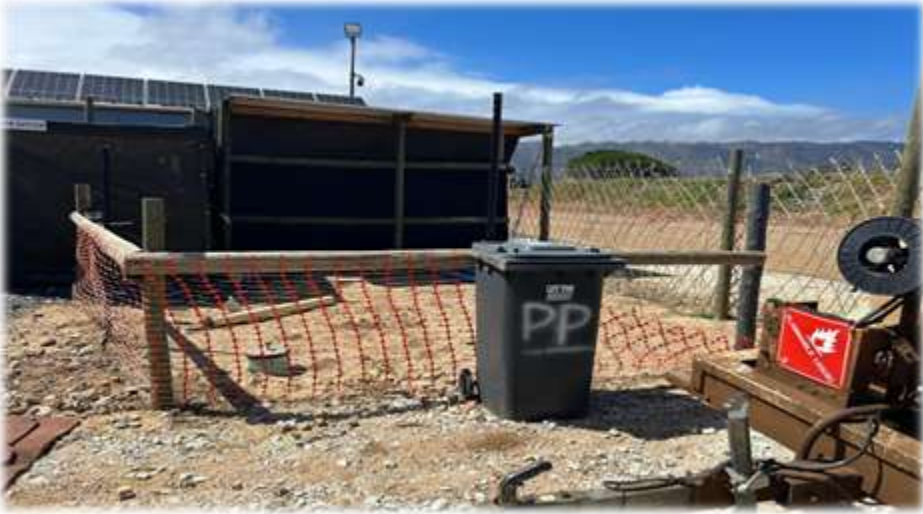
| <b>Eating areas and camp followers</b> | <p>An eating area was seen on site, thank you for that.</p> <p>A designated smoking area has been provided on site.</p> <p>No litter was seen in the site camp. A bin was placed on site.</p> | Compliant |

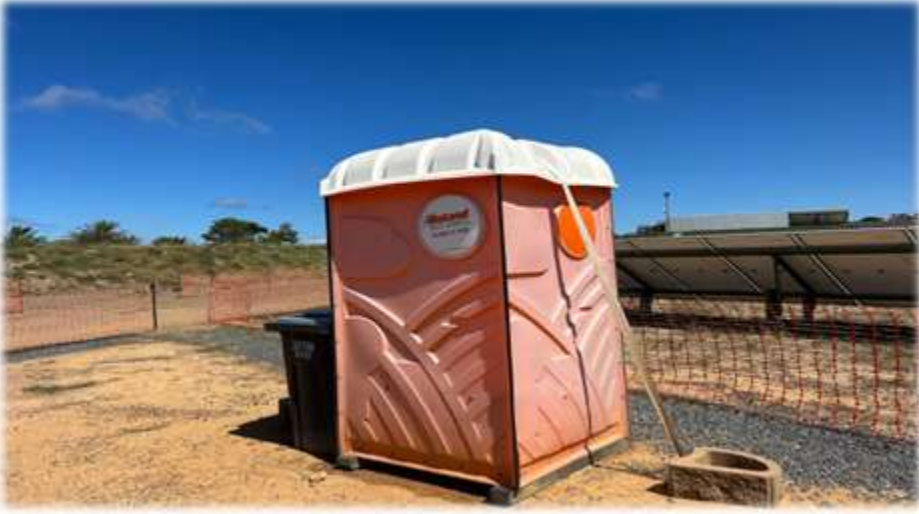
| <p><b>Toilets</b></p> | <p>Sufficient toilets were observed in the site camp.</p> | <p>Compliant</p> |

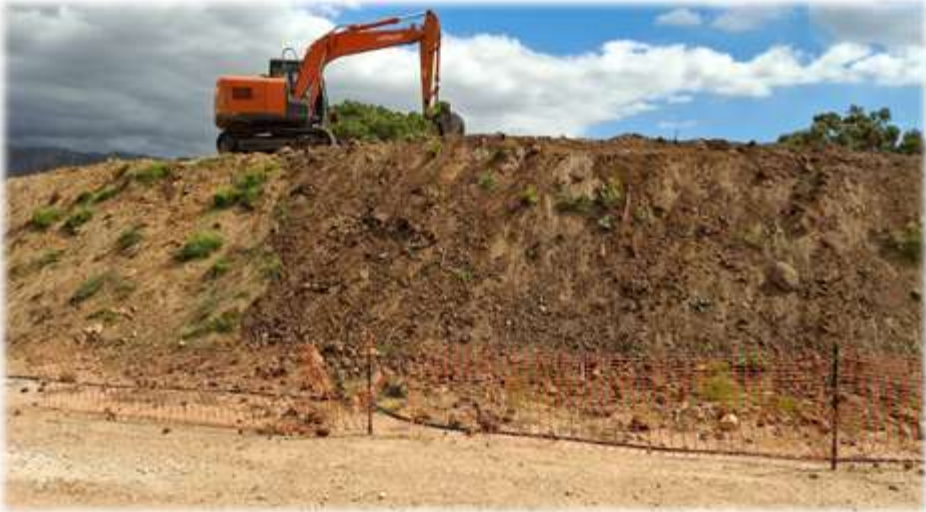
| <b>Soil</b> | <p>The topsoil was stripped, stockpiled and demarcated during the audit. Single handling of the topsoil was done.</p> <p>No alien species were noted on the topsoil.</p> | <p>Compliant</p> |

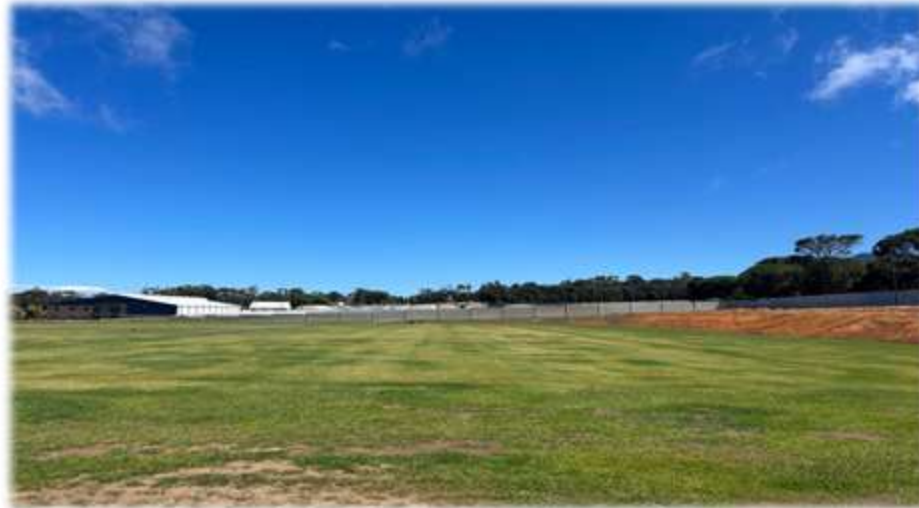
| <b>Groundwater</b> | <p>Implement an appropriate subsurface drainage system for the sports fields to prevent water ponding due to clay in the soil profile.</p> | <p>Need confirmation</p> |

Develop an irrigation plan to avoid over-irrigation and ensure treated effluent does not contaminate groundwater. Effluent must meet the DWS general limit.

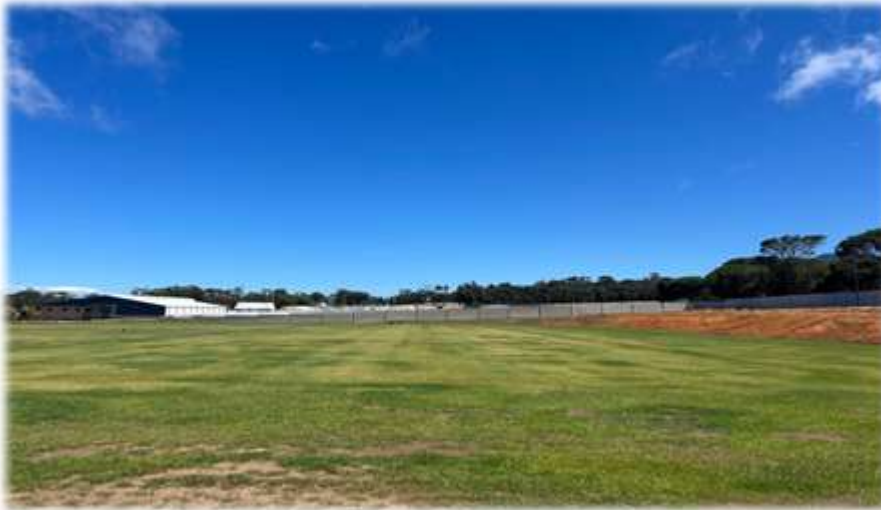
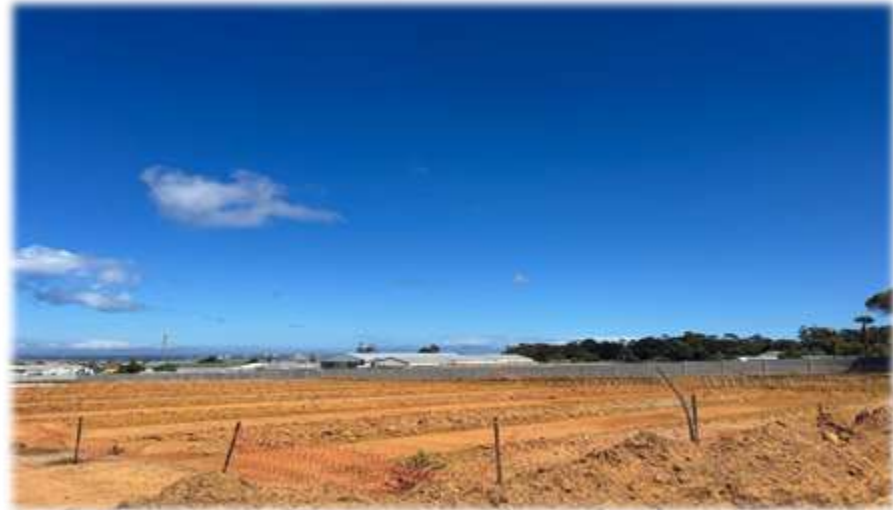
The contractor was completed with the high field, and started with the middle field during the audit with the placing of the topsoil on the field.
