## *Borehole Yield and Quality Testing at Portion 63 of Farm 918, Strand, Western Cape.*

GEOSS Report No: 2023/06-16

*23 June 2023*

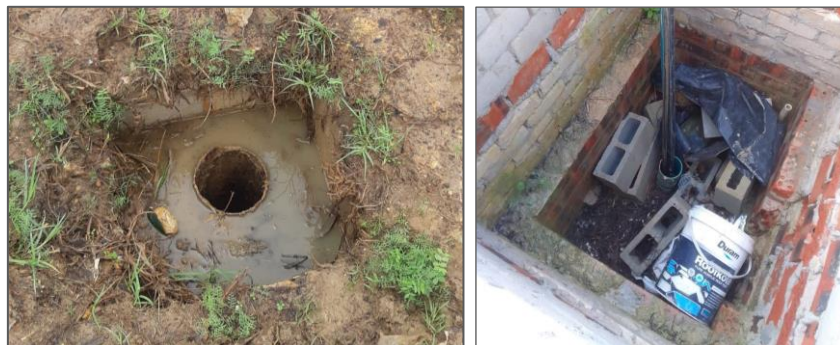
*Figure 1: (Left) HP\_BH3 before testing, (Right) HP\_BH4 during testing.*

GEOSS South Africa (Pty) Ltd was appointed by Heloïse Groenewald from GNEC Environmental Consultants to conduct a camera log, and yield and water quality testing of two boreholes at Portion 63 of Farm 918, Strand, Western Cape. The boreholes that were tested are displayed in **Figure 1**.

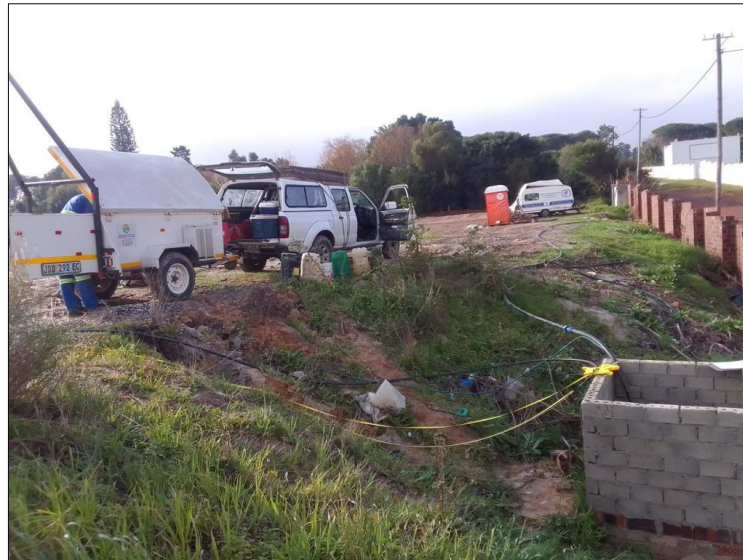
Please note that HP\_BH4 was not tested to its full capacity due to access to the borehole being limited as HP\_BH4 is situated on a slope and in cased in a brick block, refer to **Figure 12**. This prevented the safe installation of larger testing equipment. It is assumed that the borehole could deliver a larger volume, should the area around the borehole be levelled out to allow access to the borehole.

*Figure 12: Borehole testing set up a few meters away from the HP\_BH4.*

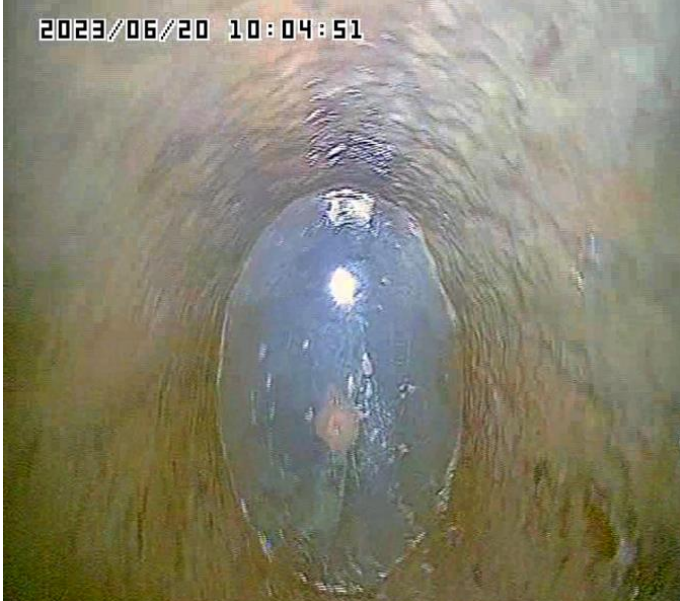
| <p>2023/06/20 10:04:51</p> | <p>The water level at the time of the camera log was 21.46 mbgl</p> |

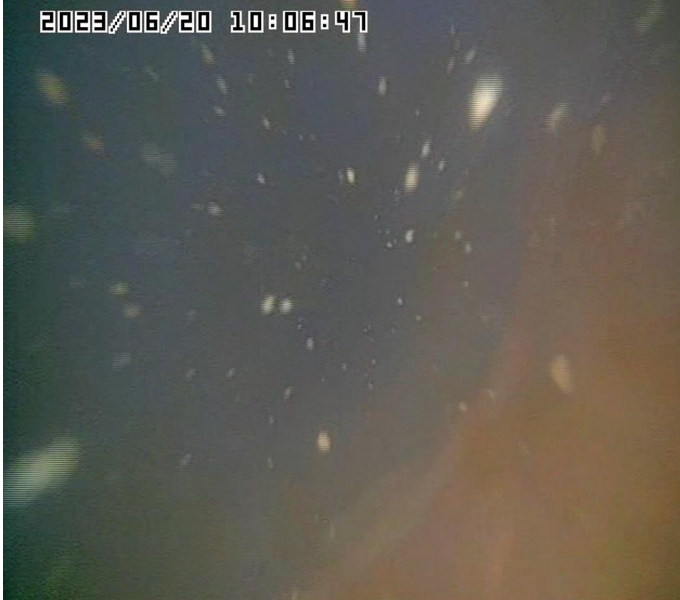
| <p>2023/06/20 10:06:47</p> | <p>The end of the borehole casing was observed at 41.71 mbgl</p> |

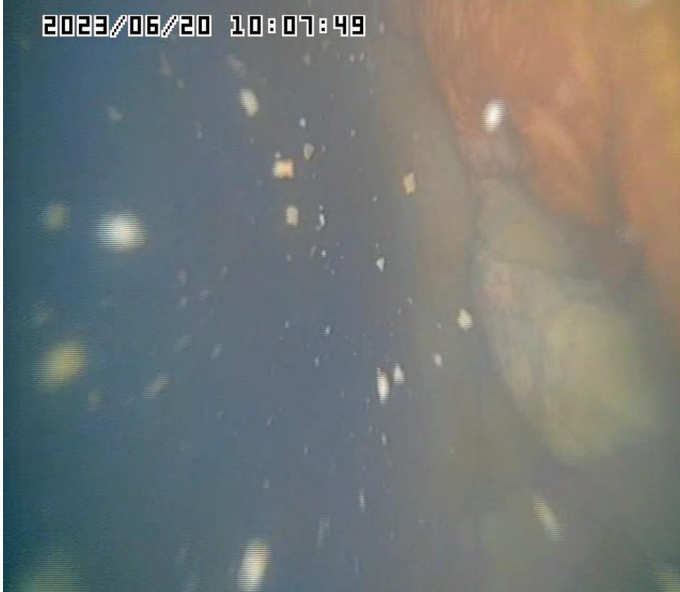
| <p>2023/06/20 10:07:49</p> | <p>A fracture was observed at 42.46 mbgl</p> |

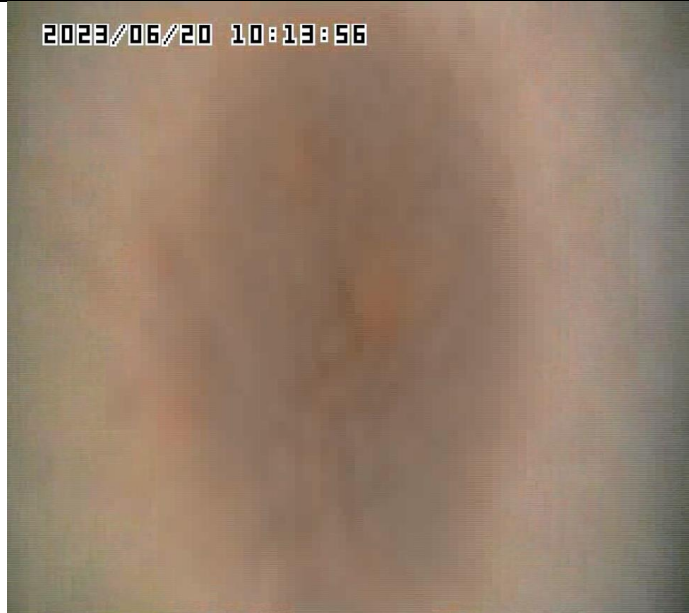
| | <p>No deeper fractures could be observed in the borehole, however; based on the yield testing results, it is evident that deeper fractures exist. The end of the borehole was measures at 112.26 mbgl.</p> |

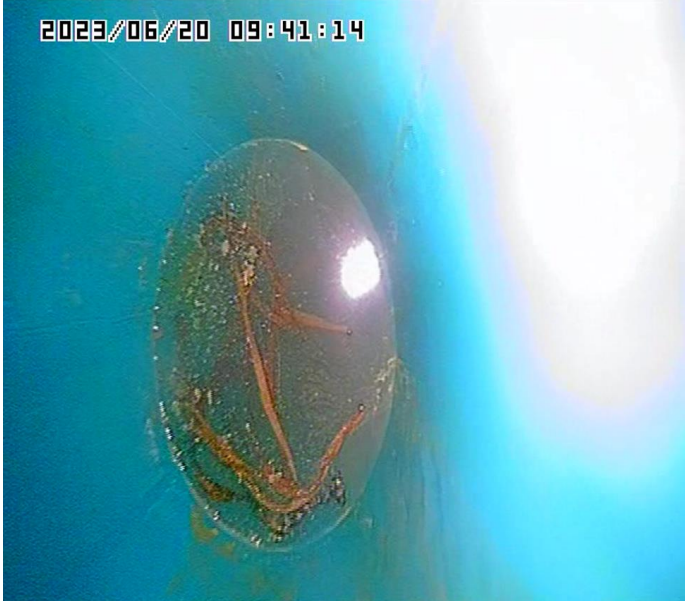
| <p>2023/06/20 09:41:14</p> | <p>The water level at the time of the camera log was 19.04 mbgl</p> |

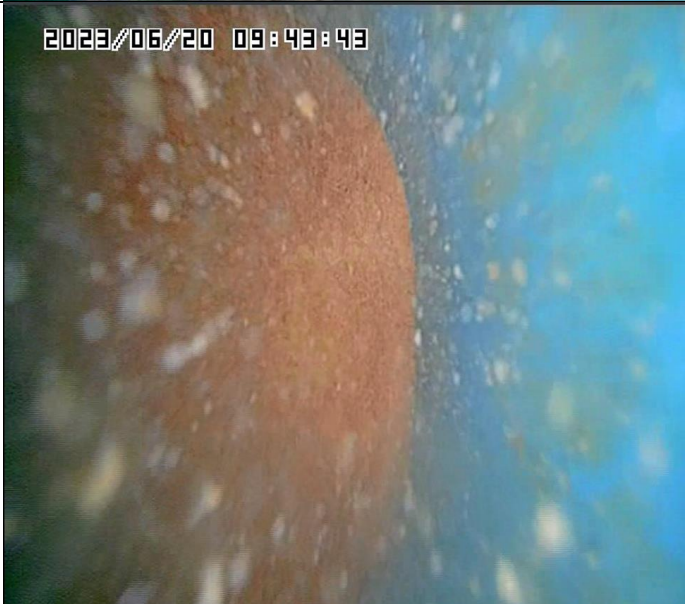
| <p>2023/06/20 09:43:43</p> | <p>The end of the borehole was measures at 33.65 mbgl</p> |
