**THE PERIODIC MAINTENANCE OF TRUNK ROAD 16/8 AND TRUNK ROAD 16/9  
BETWEEN MURRAYSBURG AND THE NORTHERN CAPE BORDER**

Contract No: C1213

**FORMAL ECO AUDIT REPORT**

3 March 2025

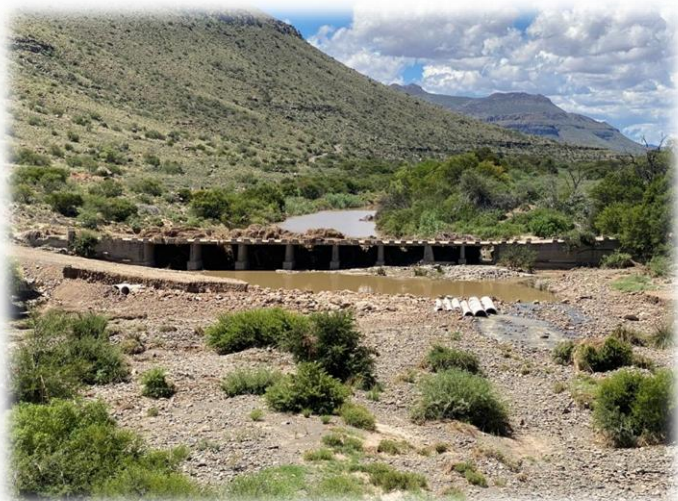
The contractor was advised to please limit the footprint at the two approaches to the proposed bypass, stockpiles were noted within the vegetation along the fence. Only the footprint of the approach road is authorised and not any additional vegetation clearance.

The ECO was notified that the bypass washed away after numerous warnings to the contractor to remove the bypass as soon as possible.

The bypass was not being used during audit as it washed away, the contractor is requested to please remove the remains of the bypass from the watercourse as soon as possible.

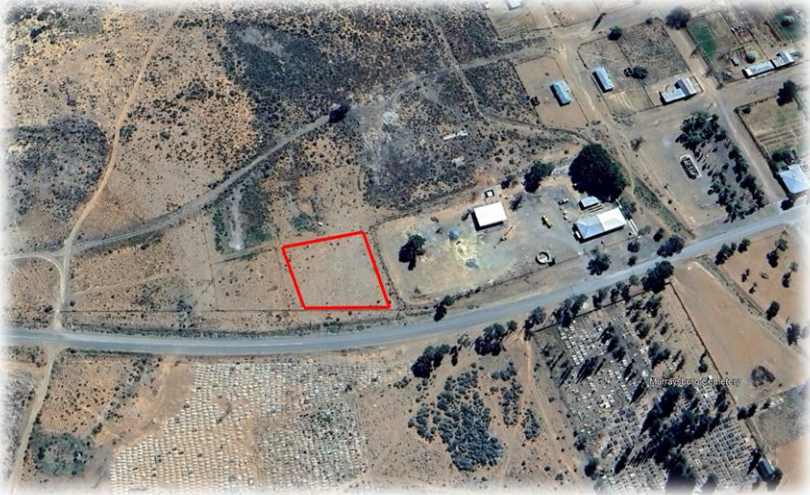
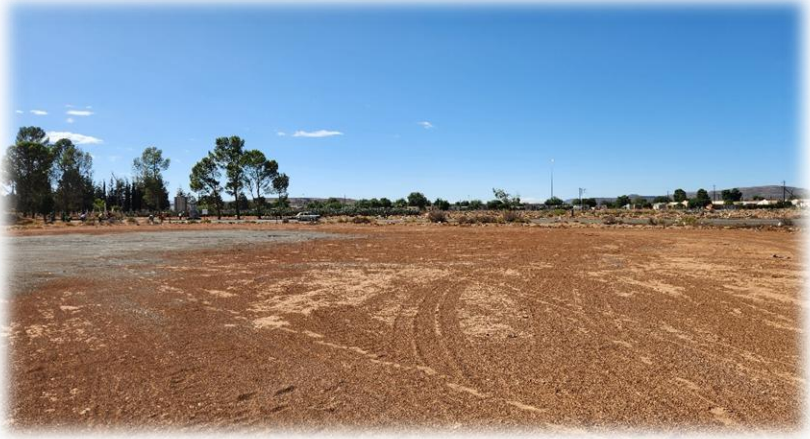
| Stockpile Area No. | Comment | ECO Recommendation |
|---|---|---|
| 1. | <p><b>Stockpile Area 1 (next to Municipal yard)</b></p> <p>An area previously disturbed with limited vegetation available was identified for the 1<sup>st</sup> stockpile area. The area was not in use during the audit, but will be used during the surfacing of the road.</p> | The area is ideal due the proximity as well as due to the area being previously disturbed. |

| | | <p>A permission letter, must please be send to the ECO for record keeping, and happy letter, after completion of the works, is required from property owner.</p> |

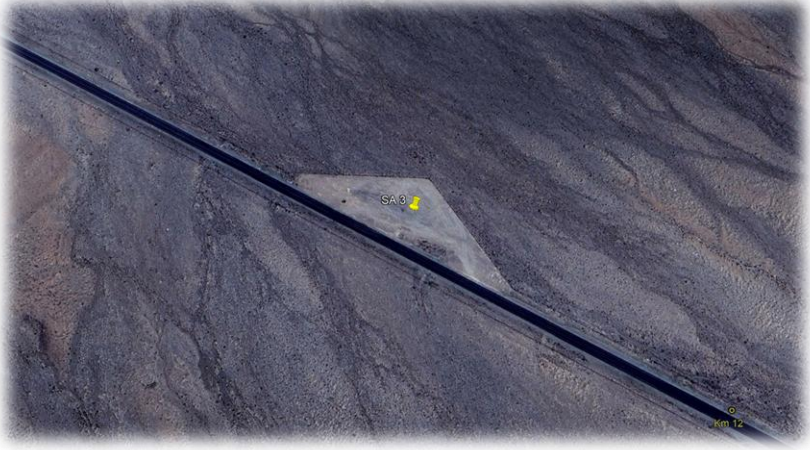
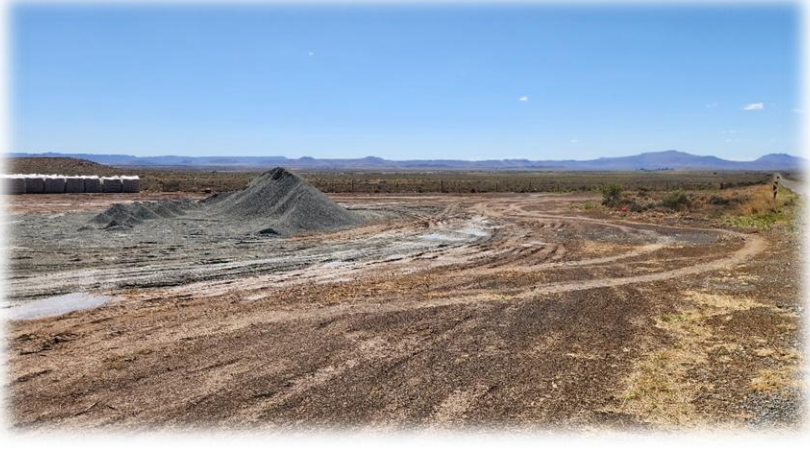
| <p>2.</p> | <p><b>Stockpile Area 2 at approx. km 11.8 on TR16/9 (Stockpile area 3 as part of EIA process)</b></p> <p>An existing cleared area used a rest area within the road reserve. The area is used to stockpile surfacing stone and will be used for the pre-coating of the stone.</p> | <p>The area is ideal due the proximity as well as due to the area being previously disturbed and within the road reserve.</p> |

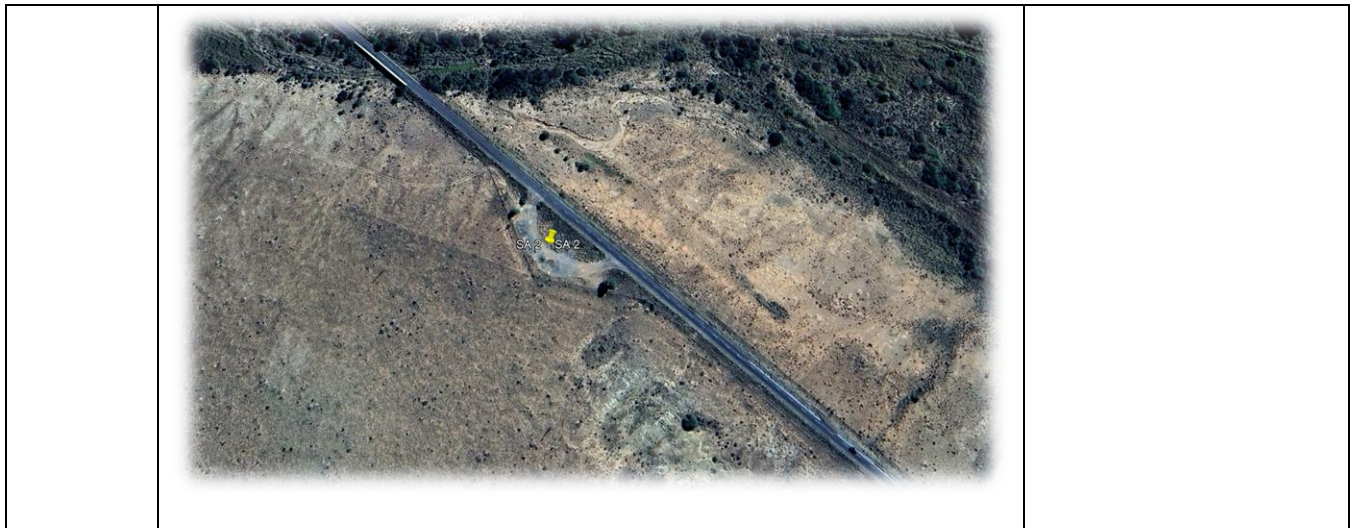
| <p><b>3.</b></p> | <p><b>Stockpile Area 3 at approx. km 46.4 on TR16/8 (Stockpile area 2 as part of EIA process)</b></p> <p>An existing cleared area used a rest area and stockpile area of the maintenance teams, within the road reserve. The area will be used to stockpile surfacing stone and will be used for the pre-coating of the stone.</p> | <p>The area is ideal due the proximity as well as due to the area being previously disturbed and within the road reserve.</p> |

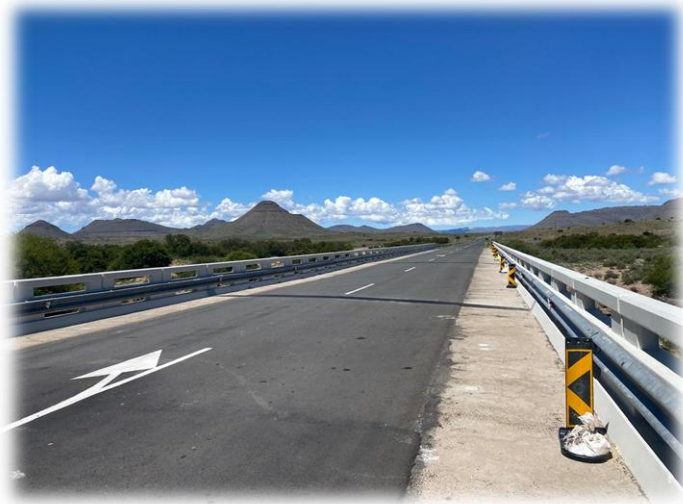
The surfacing of the two roads as part of the contract has been completed.

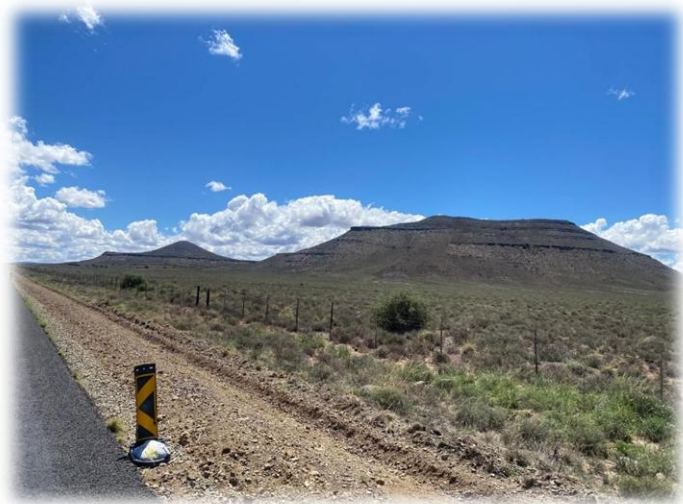
Most of the works along the site has been completed with the last activity being the construction of the shoulder build up.
