## ENVIRONMENTAL MONITORING REPORT No. 3

*The Residential Development on Erf 19001, Heather Park, George:  
Arbour Estate*

**GEO24/1176/39**

**June, July and August 2024**

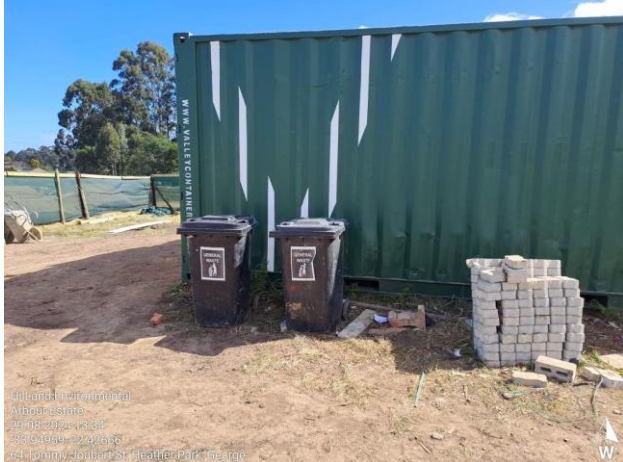
| EMPr Requirement | Level of Compliance | Comment/ Findings | Photo's (if applicable) |
|---|---|---|---|
| This area must be indicated by the ECO. | Compliant | Site camp approved by ECO. | <p> <small> 401 Land Development<br/> 2/1001 Estate<br/> 15/05/2024 14:00<br/> 2304966 - 22 42666<br/> 44 Johny Joubert St Heather Park, Gauteng </small> </p> |

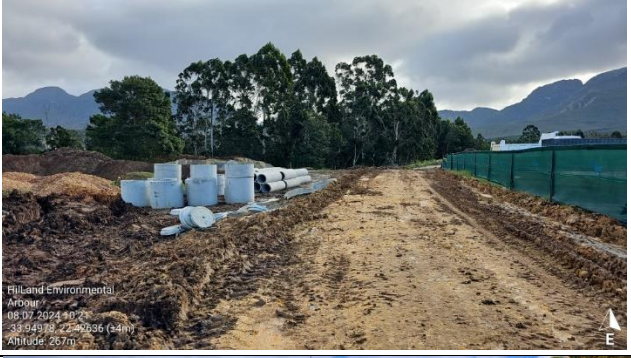
| <p>The site camp must be screened from view using materials that blend into the surrounding vegetation.</p> | <p>Compliant</p> | <p>Green shade net fence around site camp</p> | <p>Hill and Environmental<br/>Arbour<br/>06.07.2024 10:55<br/>23.04498, 22.52846 (44m)<br/>Altitude: 267m</p> |

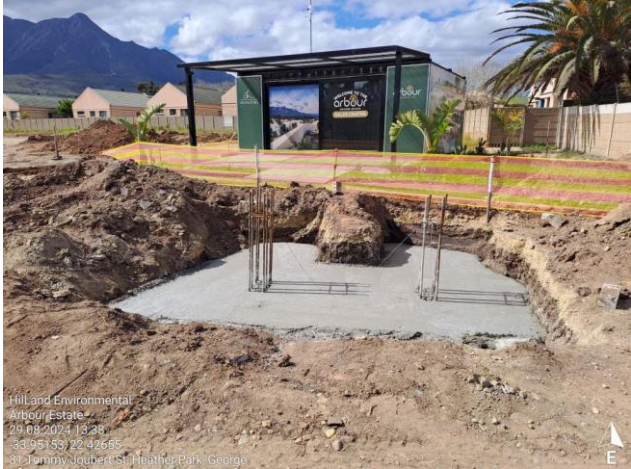
| <p>The site construction boarding must be a dark colour with minimal branding.</p> | <p>Compliant</p> | <p>Minimal branding and dark green colours used.</p> | <p>Hill and Environmental<br/>Arbour Estate<br/>20.08.2024 13:28<br/>33.95153, 22.42665<br/>at Jimmy Jouber St, Heather Park, George</p> |

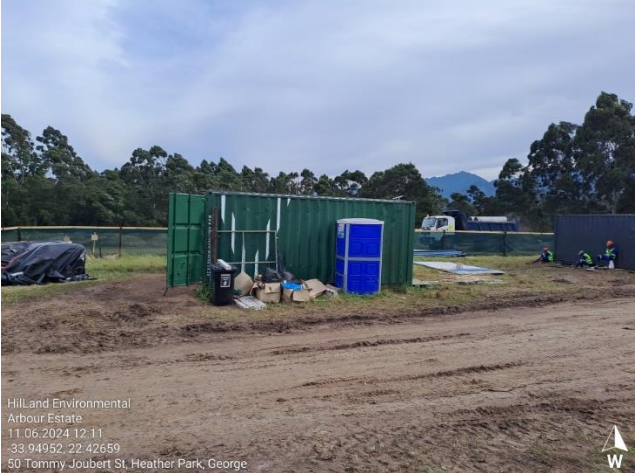
| <p>An area needs to be dedicated for waste and refuse management, which needs to be fenced off.</p> | <p>Compliant</p> | <p>Waste area in site camp.</p> | <p>Hilland Environmental<br/>Arbour Estate<br/>11.06.2024 12:11<br/>-33.94952, 22.42659<br/>50 Tommy Joubert St, Heather Park, George</p> |

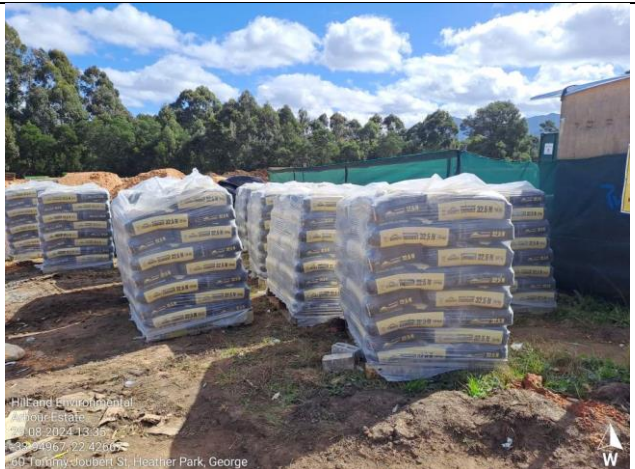
| <p>Storage of all materials must occur in this camp unless otherwise approved by the ECO.</p> | <p>Compliant</p> | <p>Construction materials are stored in the site camp and on future development areas as agreed by the ECO.</p> | <p>Hilland Environmental<br/>Arbour Estate<br/>11.08.2024 13:36<br/>-33.94952, 22.42659<br/>50 Tommy Joubert St, Heather Park, George</p> |

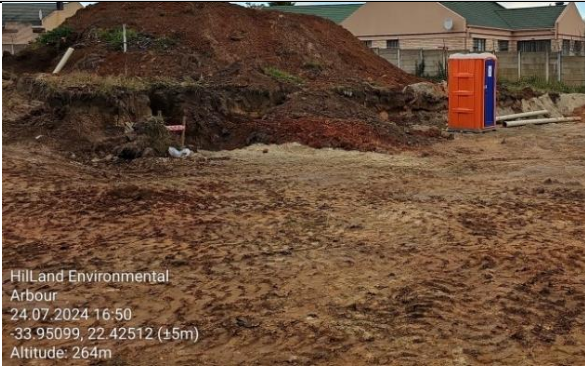
| Ablution Facilities | | | |
|---|---|---|---|
| One chemical toilet needs to be provided for every 15 people on site. | Compliant | Suitable chemical toilets available on site. | <p>Hill and Environmental<br/>Arbour<br/>24.07.2024 16:50<br/>33.95099, 22.42512 (±5m)<br/>Altitude: 264m</p> |

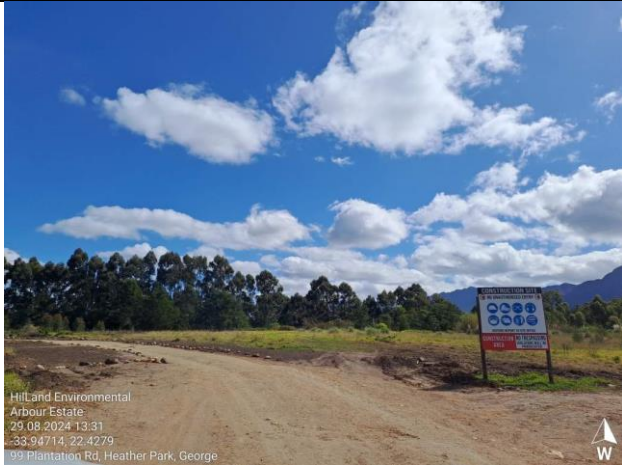
| Construction vehicles must be restricted to designated roads only. | Complaint | <p>Vehicles using the haul roads designated on site.</p> <p>Homewood and Plantation Street entrances to ensure that the haul road remains within the agreed parameters with the landowner and municipality.</p> | <p>Hilland Environmental<br/>Arbour Estate<br/>29.08.2024 13:31<br/>-33.94714, 22.4279<br/>39 Plantation Rd, Heather Park, George</p> |

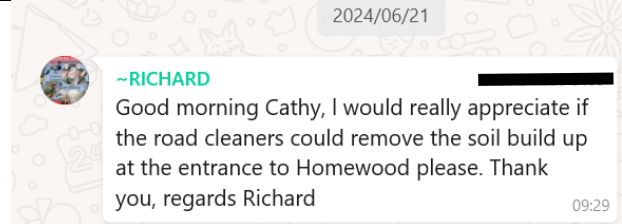
| Where the above-mentioned is unavoidable, the road must be cleaned. | <b>Needs continual attention</b> | <p>Cleaning was immediately actioned.</p> <p>21 June – complaint received to clean the Homewood entrance area.</p> | <p>2024/06/21</p> <p>~RICHARD</p> <p>Good morning Cathy, I would really appreciate if the road cleaners could remove the soil build up at the entrance to Homewood please. Thank you, regards Richard</p> <p>09:29</p> |

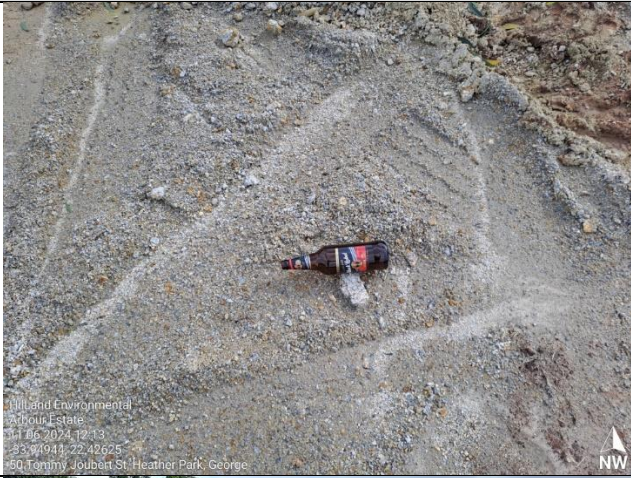
| Working Site | | | | |
|---|---|---|--|---|
| The site must be kept neat and clean. | <b>Needs continual attention</b> | <p>Scattered litter on site to be cleaned up. Chip packets and cigarette packets noted.</p> <p>Rubbish in the riparian area is an ongoing problem from the neighbouring residents who cross the property.</p> | | <p>Hill and Environmental<br/>Arbour Estate<br/>06-07-2024 12:13<br/>-33.94941, 22.42625<br/>150, Tormini, Joubert St, Heather Park, George</p> |

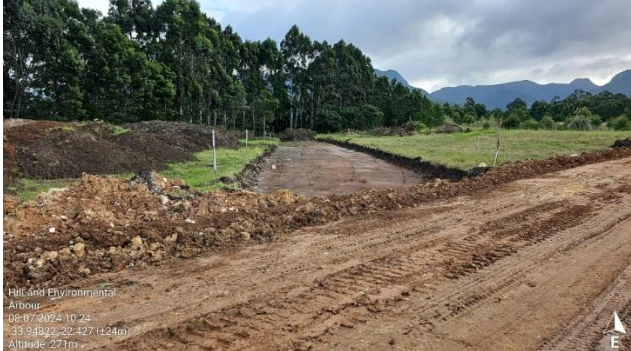
| Working Site | | | | |
|---|---|---|--|---|
| Vegetation clearing must be delayed as long as possible prior to construction and it must be limited to the minimum footprint. | Compliant | Vegetation clearing is done as the works need to progress. Haul roads demarcated to avoid the creation of multiple haul roads. | | <p>Hill and Environmental<br/>Arbour<br/>06-07-2024 10:24<br/>-33.94922, 22.427 (124m)<br/>Altitude 271m</p> |

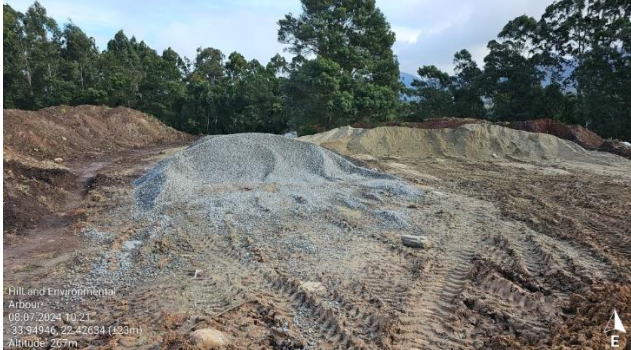
| <p>Stockpiles/ storage sites for construction material must be approved by the ECO.</p> | <p>Compliant</p> | <p>ECO has approved all stockpile and storage sites, all within the development footprint</p> | <p>Hill and Environmental<br/>Arbour<br/>06.07.2024 11:21<br/>33.9494, 22.42634 (s4m)<br/>Altitude: 265m</p> |

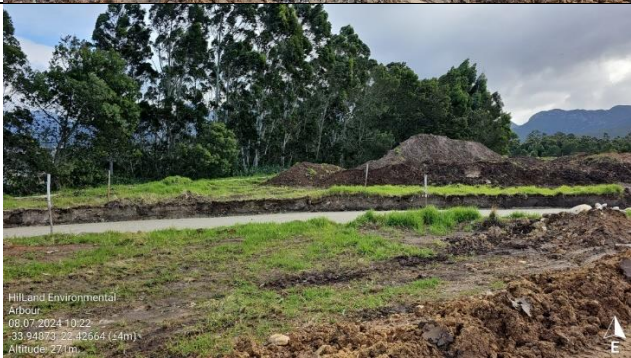
| <p>All stockpile sites in the development area need to be demarcated with silt-fences or danger tape.</p> | <p>Compliant</p> | <p>All stockpile sites are defined – where silt movement is a concern, silt fences or sandbags are in place.</p> | <p>Hill and Environmental<br/>Arbour<br/>06.07.2024 10:22<br/>33.94873, 22.42664 (s4m)<br/>Altitude: 271m</p> |

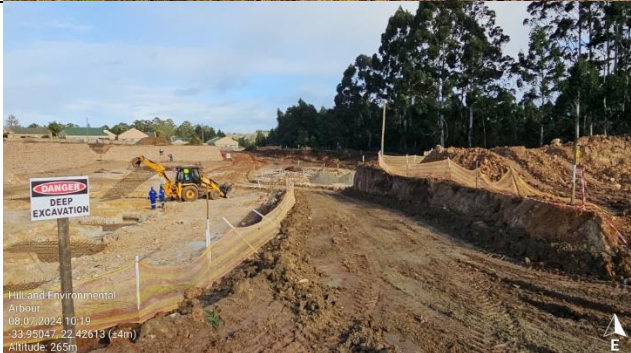
| <p>The working zone must be demarcated, and all activities must be restricted to the demarcated working zone.</p> | <p>Compliant</p> | <p>The working zones are demarcated with orange netting fences and danger signs.<br/><br/>Work restricted to the working areas only.</p> | <p>Hill and Environmental<br/>Arbour<br/>06.07.2024 10:19<br/>33.95047, 22.42613 (s4m)<br/>Altitude: 265m</p> |

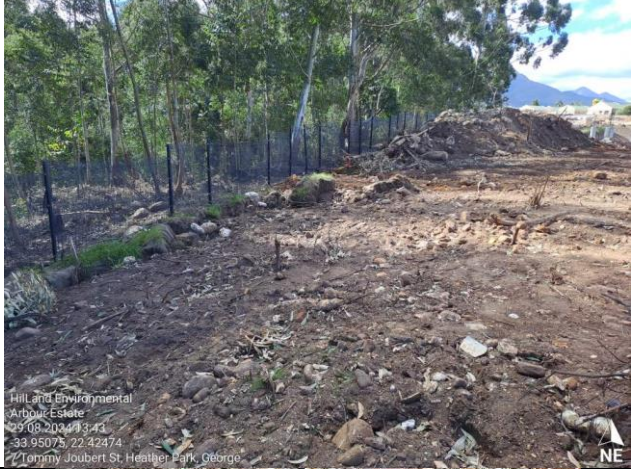
| <p>No-go fencing is required between the working zone and the steep forest slopes. The riparian area is a strict no-go area.</p> | <p>Compliant</p> | <p>No-Go fence installed along the steep forest slope. Temporary access required through the area for sewer line connection and alien clearing team.</p> | <p>Hill and Environmental<br/>Arboretum Estate<br/>29 08 2024 13:43<br/>33 95075, 22 42474<br/>Tommy Joubert St. Heather Park, George</p> <p>NE</p> |

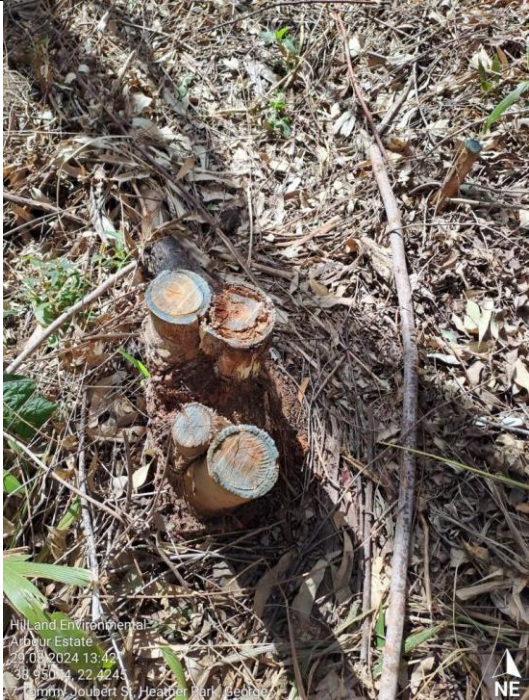
| <p>Should access be required through a no-go area, written permission must be acquired from the ECO.</p> | <p>Compliant</p> | <p>Access through no-go area has been approved by the ECO for the alien clearing team.</p> <p>Temporary access required for sewer line connection to existing bulk municipal sewer</p> | <p>Hill and Environmental<br/>Arboretum Estate<br/>29 08 2024 13:42<br/>33 95075, 22 42474<br/>Tommy Joubert St. Heather Park, George</p> <p>NE</p> |

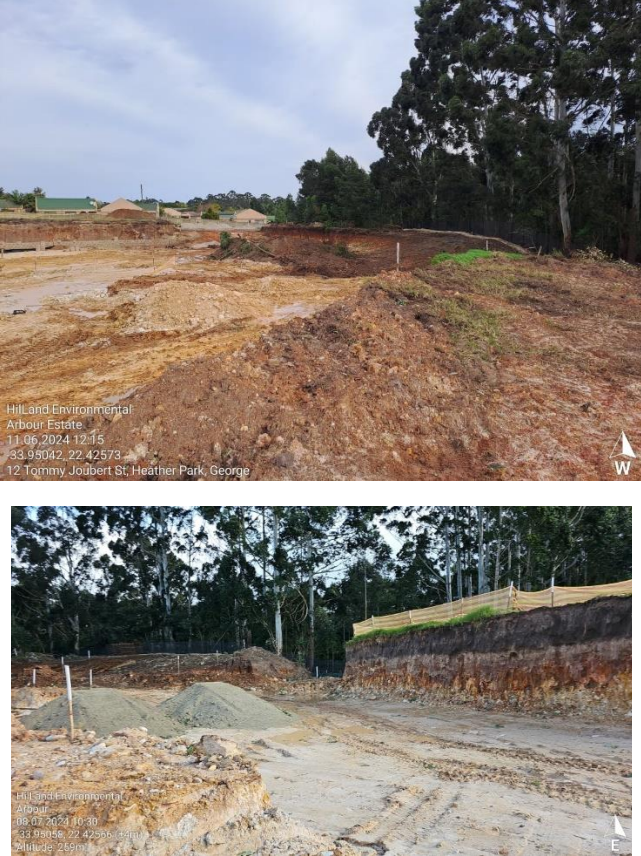
| <p>During civil construction the areas not under construction are considered no-go areas.</p> | <p>Compliant</p> | <p>The development area is the working and stockpile area. While work is taking place in phase 1, later phases are used for stockpile sites.</p> <p>Excavation for the apartment basement close to the edge of bush line. Historically dumped material removed from the area to allow for rehabilitation.</p> | <p>Hill and Environmental<br/>Arbour Estate<br/>11.06.2024 12:15<br/>33.95042, 22.42573<br/>12 Tommy Joubert St, Heather Park, George</p> <p>Hill and Environmental<br/>Arbour Estate<br/>11.06.2024 16:30<br/>33.95042, 22.42573<br/>12 Tommy Joubert St, Heather Park, George</p> |

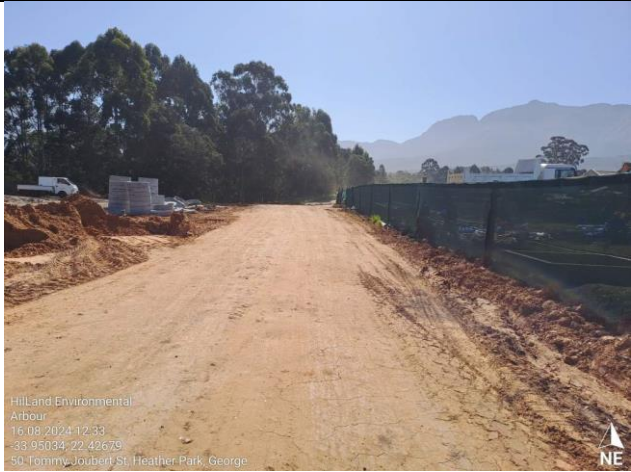
| <p>The total footprint of a building zone should be demarcated with a 1.5 m high shade cloth for the entire period of the construction. All areas outside of this demarcation are no-go areas for all construction staff.</p> | <p>Compliant</p> | <p>The working site is demarcated with 1.8m high shade cloth fences, the security fence and entry control are in place.</p> <p>There have been no complaints of construction staff entering neighbouring properties.</p> | |

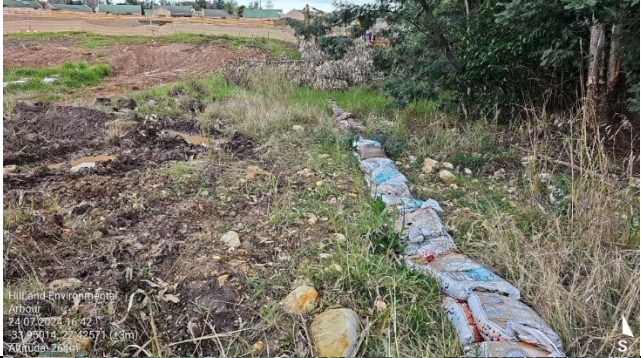
| Silt fences must be installed before construction work commences. | Compliant | Haybale fencing was installed prior to any ground clearing commencing. Rows of sandbags have been installed to guide water flow. These are shifted as required | <p>Hill and Environmental<br/>Arbour<br/>24.07.2024 16:42<br/>33.95014, 22.42574 (±3m)<br/>Altitude: 265m</p> |

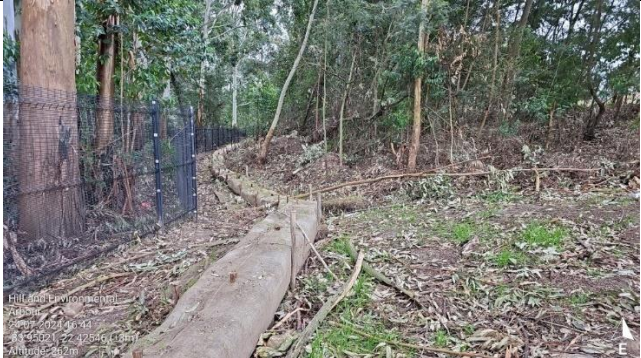
| A haybale screen must be installed 2.5 m offset from the top of the steep slope <b>prior</b> to any earthworks or vegetation clearing. | Compliant | The haybale screen was installed in March 2024 prior to the commencement of any earthwork activities. | <p>Hill and Environmental<br/>Arbour<br/>24.07.2024 16:42<br/>33.95014, 22.42574 (±3m)<br/>Altitude: 265m</p> |

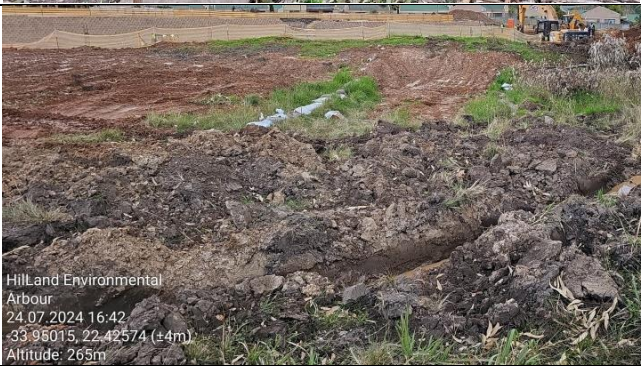
| The use of silt-fences, onion bags, mulch, brushwood, sandbags and deflection berms must be imposed to minimise run-off, potential silt run-off and contaminated water leaving the site. These measures are essential in exposed areas. | Compliant | Rows of sandbags have been installed to minimize run-off and erosion.<br><br>Bidem silt fences are installed where required | <p>Hill and Environmental<br/>Arbour<br/>24.07.2024 16:42<br/>33.95015, 22.42574 (±4m)<br/>Altitude: 265m</p> |

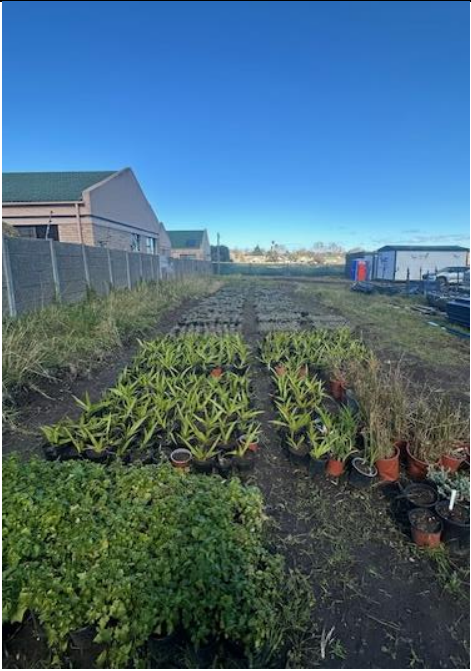
| Plant rescue must be undertaken prior to the commencement of any clearing activities taking place on site. | Compliant | Plant search and rescue was done in March 2024. | <p>(30.07.2024)</p> |

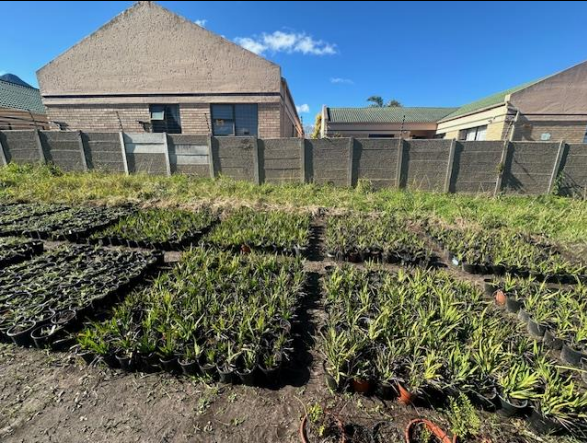
| Rescued plants must be collected – with their roots and sod intact - and stored in the on-site nursery. | Compliant | Rescued plants are kept in the nursery in the site camp. | <p>(30.07.2024)</p> |

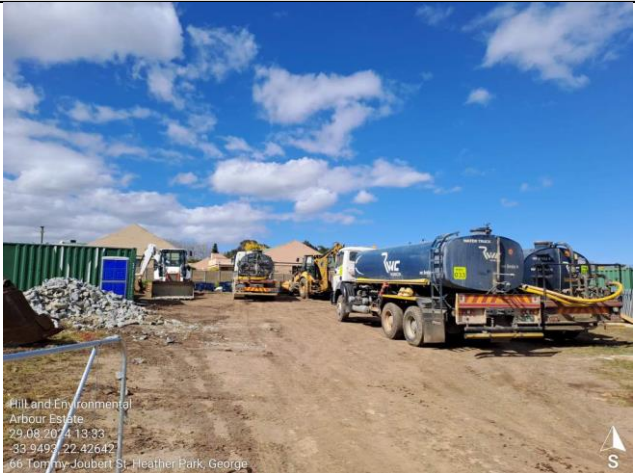
| Visual Requirements | | | |
|---|---|---|---|
| All excavation machinery and trucks must be stored/ kept out of sight of residential areas as far as possible. | Compliant | All machinery and trucks are kept in the construction camp site. | <p> <small> Hilland Environmental<br/> Arbour Estate<br/> 29.08.2024 13:33<br/> 33.949° 22.42642°<br/> 66 Tommy Joubert St, Heather Park, George </small> </p> |

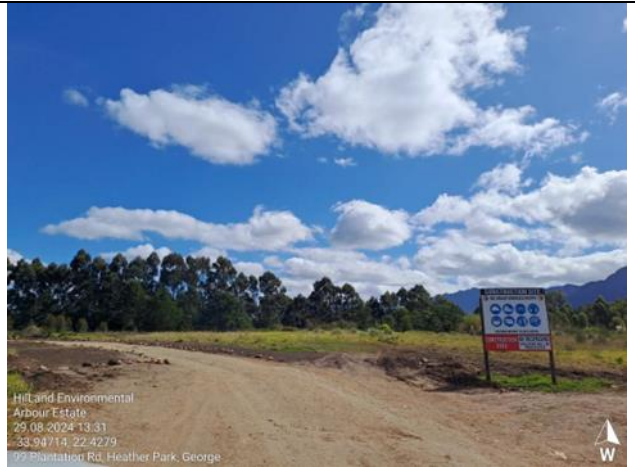
| Visual Requirements | | | |
|---|---|---|---|
| Excessive signage outside the construction camp is prohibited. | Compliant | There is minimal signage outside the construction camp. | <p> <small> Hilland Environmental<br/> Arbour Estate<br/> 29.08.2024 13:31<br/> 33.94714° 22.4279°<br/> 92 Plantation Rd, Heather Park, George </small> </p> |

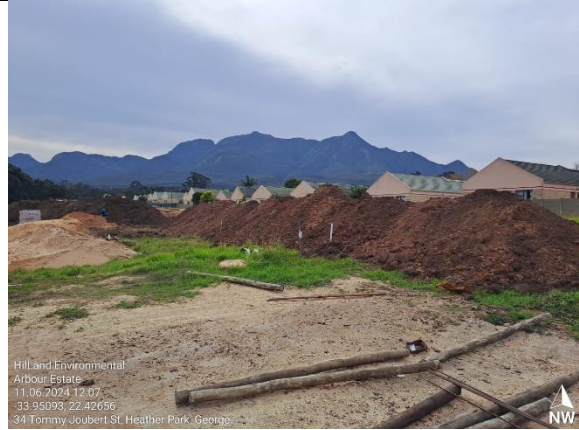
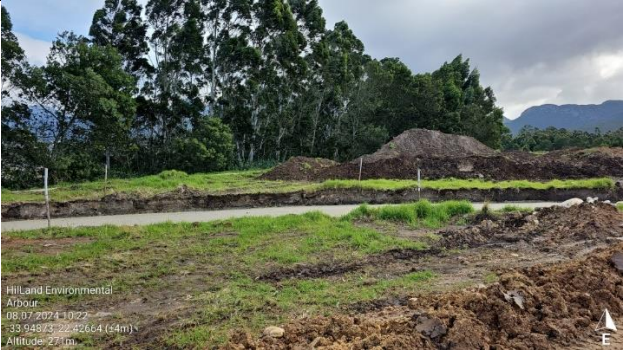
| Hazardous Materials | | | |
|---|---|---|---|
| Topsoil, and accompanying roots and biomass, must be stripped and stockpiled from all construction areas <b>PRIOR</b> to work commencement in that specific area, but <b>after plant rescue</b> . | Compliant | Topsoil has been stripped from all the areas under construction and stockpiled on site. | <p> <small> Hilland Environmental<br/> Arbour Estate<br/> 11.06.2024 12:07<br/> 33.95093, 22.42656<br/> 34 Tommy Joubert St. Heather Park, George </small> </p> |

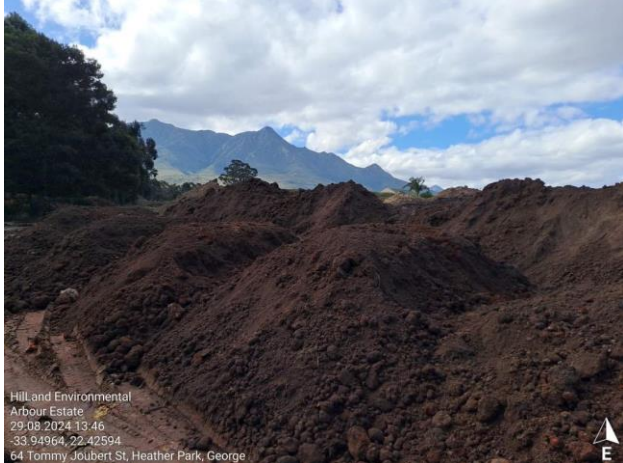
| Topsoil stockpiles may not be contaminated with subsoil, building rubble or alien plant species. | Compliant | No non-compliance noted. | | <p>Hill and Environmental<br/>Arbour Estate<br/>29/08/2024 13:46<br/>33.94964, 22.42594<br/>64 Tommy Joubert St, Heather Park, George</p> | |

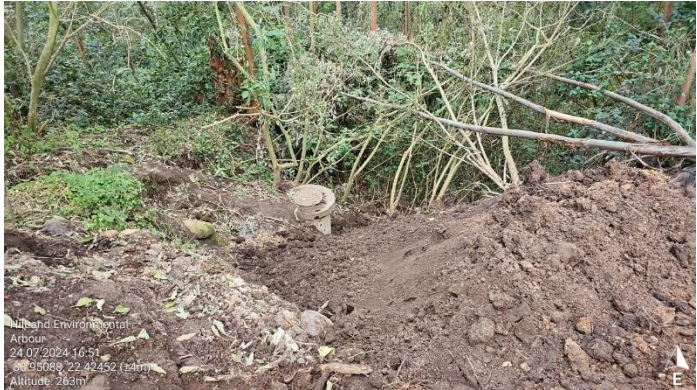
| Soil removed for construction services must be placed on the side of the trench, with the topsoil on one side and the subsoil on the other side. The subsoil must be replaced first, then the topsoil. | Compliant | <p>Internal service installation is all within the road reserve areas.</p> <p>Connection to the main sewer has commenced</p> <p>The erosion which was pre-existing on the municipal sewer line needs to be repaired.</p> | <p>Land and Environmental<br/>Arden<br/>24/07/2024 16:51<br/>36 35088 22 42452 (tmm)<br/>Altitude: 263m</p> |

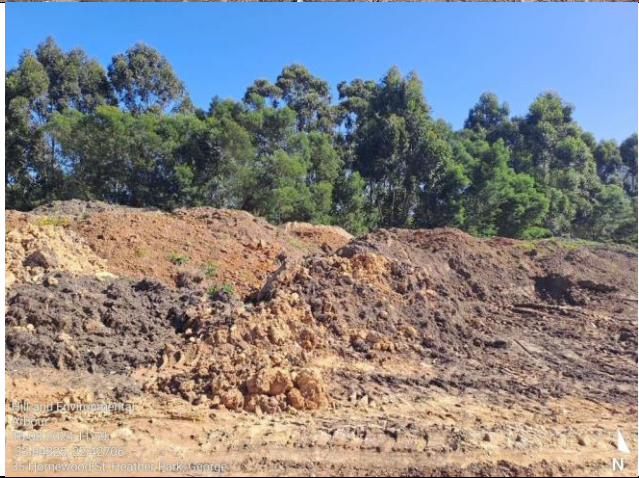
| Excess subsoil to be used for cut and fills must be stored in stockpile areas approved by the ECO. Subsoil that is not going to be used must be removed immediately to an approved disposal facility. | Compliant | <p>Stockpile sites have been approved by the ECO.</p> <p>Excess material removed from site.</p> | <p>Land and Environmental<br/>Arden<br/>24/07/2024 16:51<br/>36 35088 22 42452 (tmm)<br/>Altitude: 263m</p> |

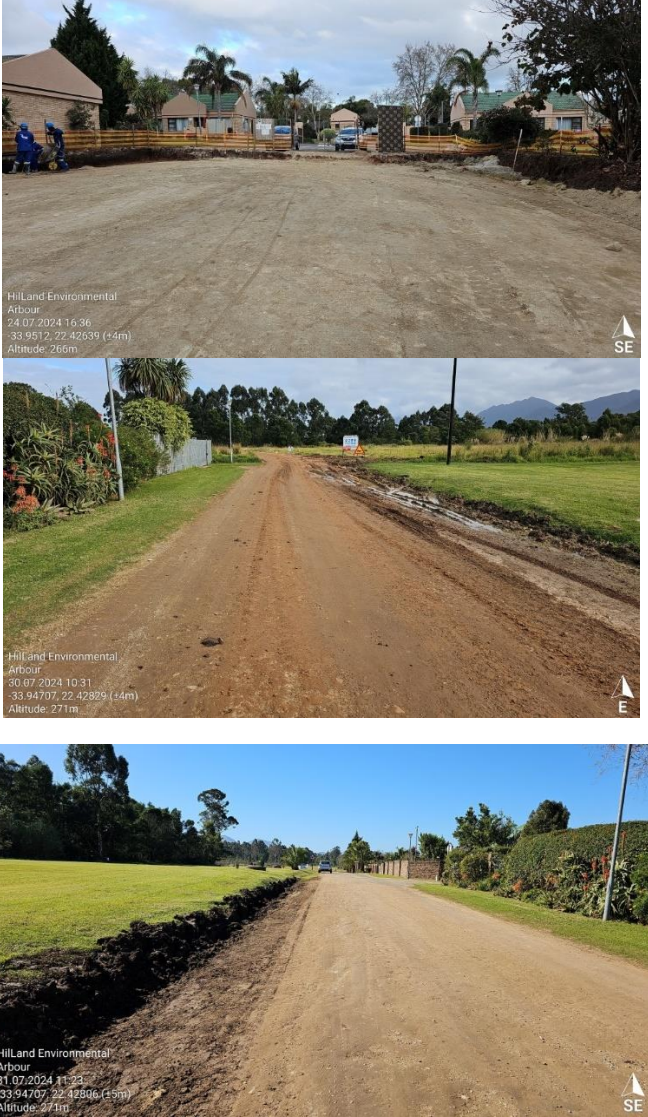
| <p>Site access is through Homewood Estate and it shall be controlled by an access control gate on the property. Alternate construction access to be approved by the ECO.</p> | <p>Compliant</p> | <p>Arbour Estate is accessed through Homewood Estate and the entrance has a controlled gate.</p> <p>From May onwards the alternative access from the back was approved by the municipality and is also in use and being managed and monitored.</p> <p>21<sup>st</sup> June – Homewood request for road cleaning at the entrance through the group chat with the contractor, applicant and ECO – immediately cleaned.</p> <p>15<sup>th</sup> August – Homewood request for entrance road cleaning – immediately cleaned as the ECO had requested same on the 14<sup>th</sup> August</p> <p>Note entrance needs to be kept clean and free of mud and the access track MUST remain less than 4m in width and may not encroach beyond this. Municipality and neighbour will withdraw permission for this alternative access should this be exceeded or the municipal roads not maintained in a clean state.</p> <p>Clearing was immediately implemented and stormwater flow in Plantation ave opened to link to the existing swale.</p> | <p>HillLand Environmental<br/>Arbour<br/>24.07.2024 16:36<br/>33.9512, 22.42639 (+4m)<br/>Altitude: 266m</p> <p>HillLand Environmental<br/>Arbour<br/>30.07.2024 10:31<br/>33.94707, 22.42829 (+4m)<br/>Altitude: 271m</p> <p>HillLand Environmental<br/>Arbour<br/>31.07.2024 11:23<br/>33.94707, 22.42806 (+5m)<br/>Altitude: 271m</p> |

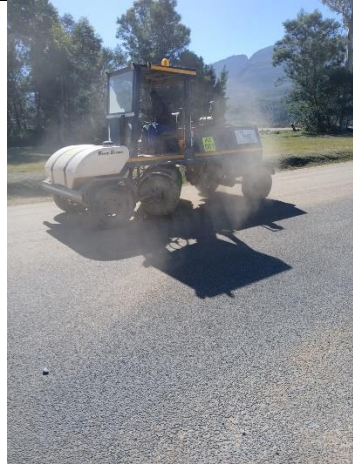
| | | | <p>Road cleaner 31<sup>st</sup> July</p> |

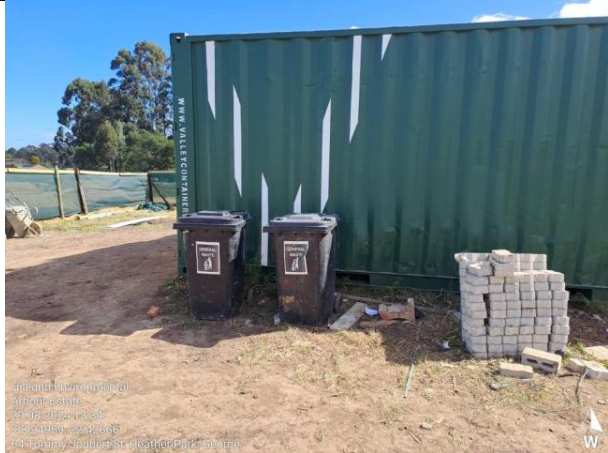
| Waste Management | | | |
|---|---|---|---|
| The contractor must ensure that there are sufficient disposal facilities on site. | Compliant | Sufficient disposal facilities at this stage of construction. | |

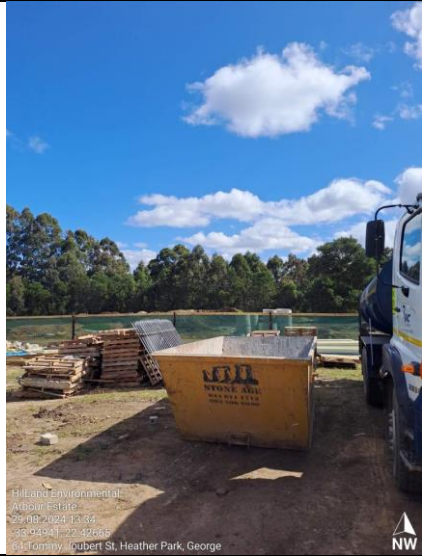
| Solid waste may be temporarily stored on-site in a designated area and it must be removed on a weekly basis. | Compliant | Waste is temporarily stored in the site camp in skips. | |

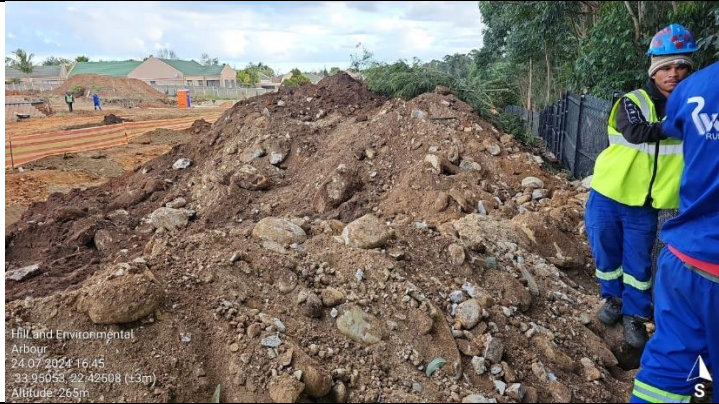
| Contaminated soil or excess concrete must be disposed of appropriately | Compliant | Contaminated material discovered on site during the installation of the bulk sewer connection. (historic dumping not associated with this development). All contaminated material to be removed from the site as part of the rehabilitation of the area. | |

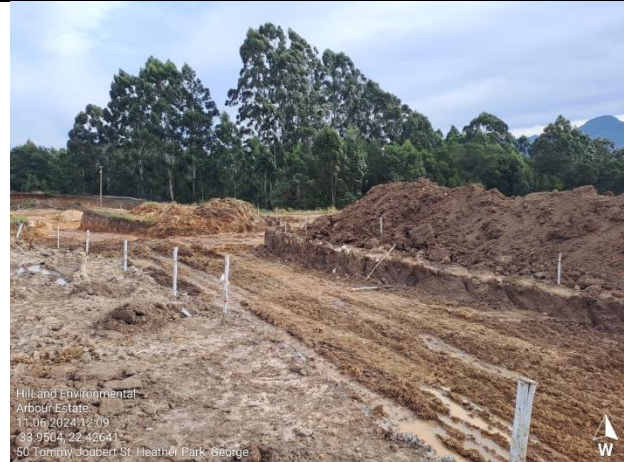
| Temporary stockpiles cannot be placed in areas that will be an eyesore to neighbours and if they generate dust this needs to be managed. | Compliant | No non-compliance noted. | <p>Hill and Environmental<br/>Arbour Estate<br/>11.06.2024 12:09<br/>33.9564, 22.42641<br/>50 Tommy Doobert St. Heather Park, George</p> |

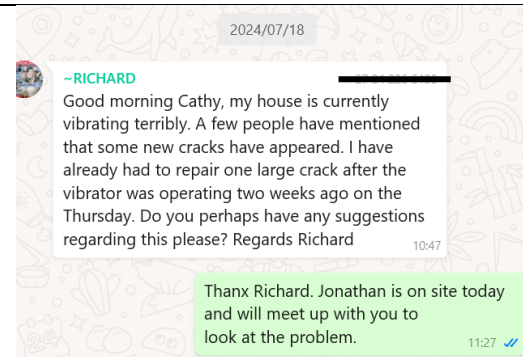
| Any damage to private property or open space area must be reinstated to the state it was before construction commenced. | compliant | 18 July -Damage complaint received and investigated | |

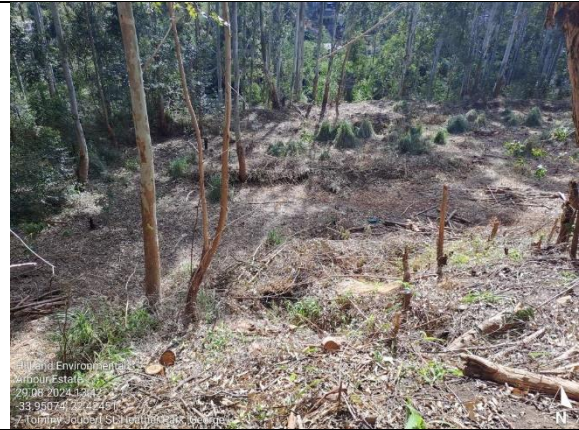
| Gum trees have a NEMBA permit to remain on the slopes outside the riparian zone while the indigenous forest is established as a visual and noise screen. | Compliant | The Gum trees that must remain during rehabilitation of the indigenous forest vegetation have not been removed. | |

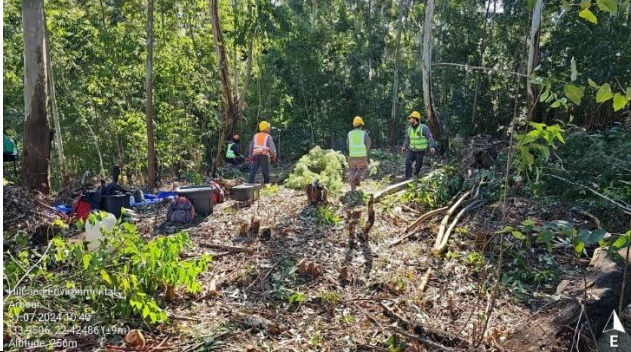
| <p>The developer must clear aliens according to the approved ACP, commencing before handing over to the HOA who will continue according to the ACP.</p> | <p>Compliant</p> | <p>Removal of alien trees has commenced in accordance with the ACP.</p> | |

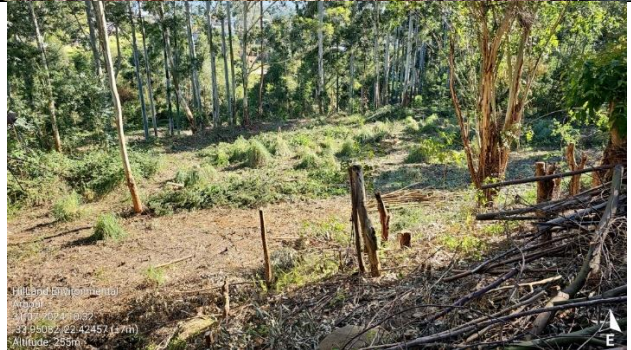
| <p>All alien invasive seedlings must be removed continually for the life of the development – this responsibility will be given to the HOA.</p> | <p>Compliant</p> | <p>No non-compliance noted during this report period.</p> | |
