## ENVIRONMENTAL MONITORING REPORT NO. 16

*Springfield Estates on Portion 53 of Farm 195, George*

| <b>Report Period</b> | June 2025 |

**PORTION 53 OF THE FARM KRAAIBOSCH 195, GEORGE  
ENVIRONMENTAL MONITORING REPORT NO 16**

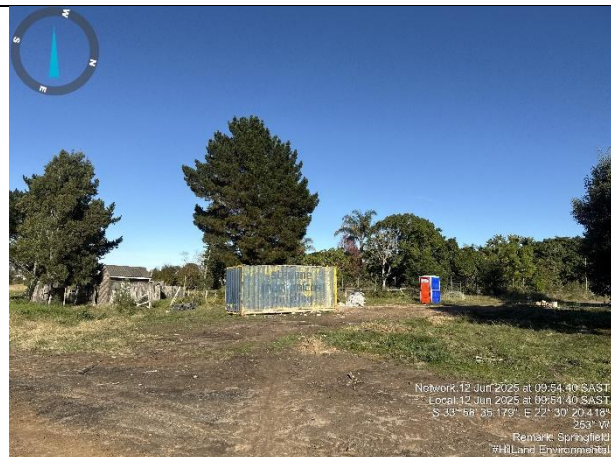
Site camp area

Construction site camp was set up on a future erf as agreed by the developer and the ECO and is currently in the process of being dismantled (one container left) – the full area must be rehabilitated. No-Go demarcation of the southern no-go area remains in place. The installation of the main sewer line is complete, and final rehabilitation (topsoil replaced and seeded) was done – minor repairs on the sewer line in process.

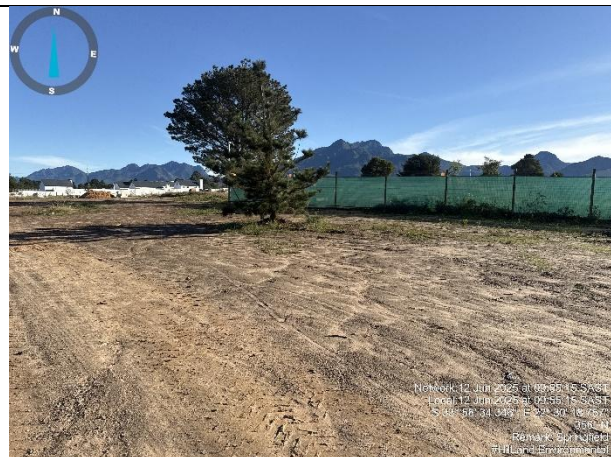
Construction material stockpile area still need to be rehabilitated.

It is important to note that all disturbed areas (as a result of construction activities) must be rehabilitated as required in terms of Section 7 of the EMPr.

- All disturbed areas (during the construction phase, both civils and top structures, including the site camp area) must be rehabilitated.
- Stockpiles (topsoil, subsoil and clay) still need to be demarcated (signs or physical demarcation).
- Invasive alien plant control on the stockpiles (hand pulling).
  - Rehabilitation entails removing construction rubble and contaminated soil, replacing topsoil, topsoil must not be compacted, and spread the grass seed mix (see below).

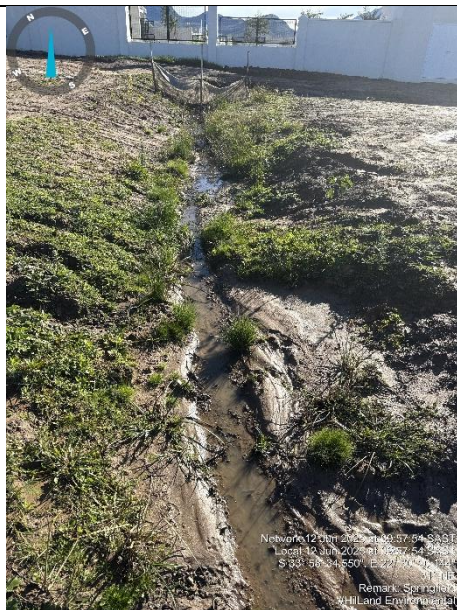
Silt fences are in place and must be maintained.

Silt fence and/or erosion protection have been installed at the temporary stormwater outlets south of the sales phase 1 development and must be maintained.

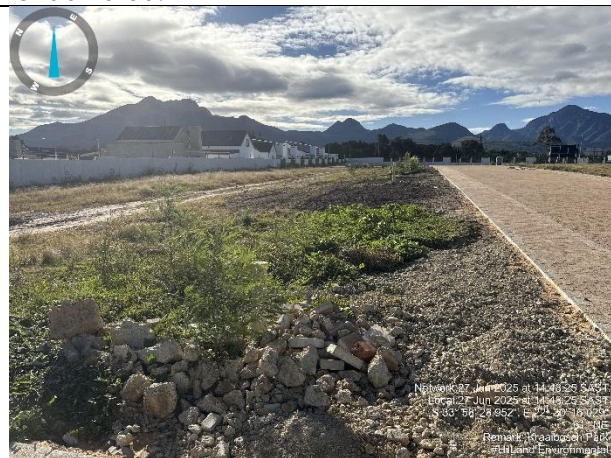
Paving snags in process.  
 Invasive aliens as a result of construction activity to be removed by the contractor.  
 Construction rubble to be disposed at the municipal disposal facility.

Continuous invasive alien clearing needs to be implemented throughout the construction site and stockpiles (civil contractor and developer responsibility).

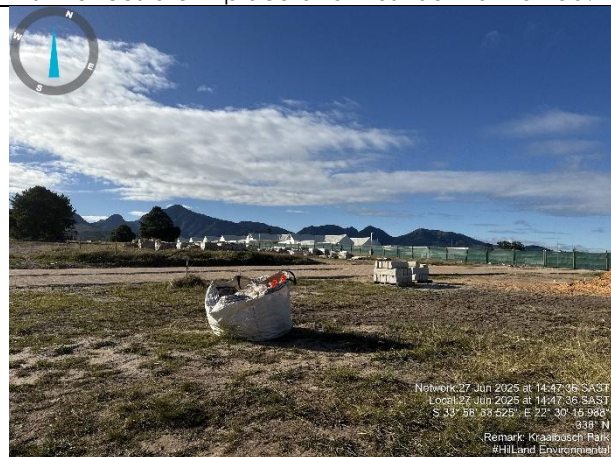
Litter / waste bags on site.

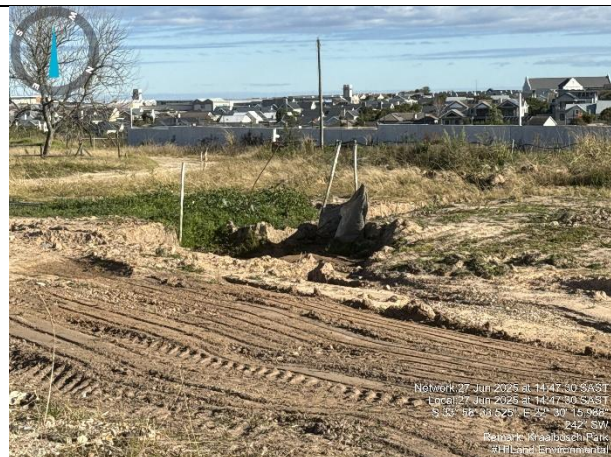
Temporary stormwater outlet shaping to be finalised.  
 Silt fence is in place.
