## ENVIRONMENTAL MONITORING REPORT NO. 8

### Springfield Estates on Portion 53 of Farm 195, George

| Report Period | September 2024 |

**PORTION 53 OF THE FARM KRAAIBOSCH 195, GEORGE  
ENVIRONMENTAL MONITORING REPORT NO 8**

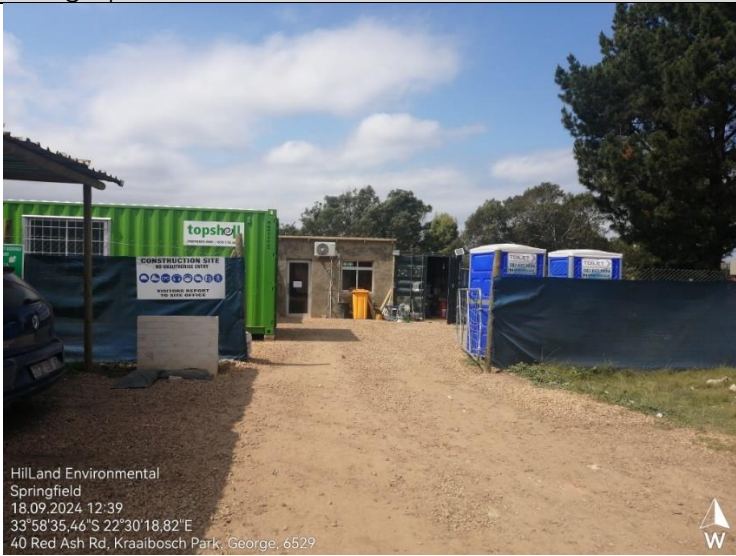
| Photographic record | Comments and requests |
|---|---|
| <p>Hilland Environmental<br/>Springfield<br/>18.09.2024 12:39<br/>33°58'35.46"S 22°30'18.82"E<br/>40 Red Ash Rd, Kraaibosch Park, George, 6529</p> | <p>Site camp in future development area.</p> |

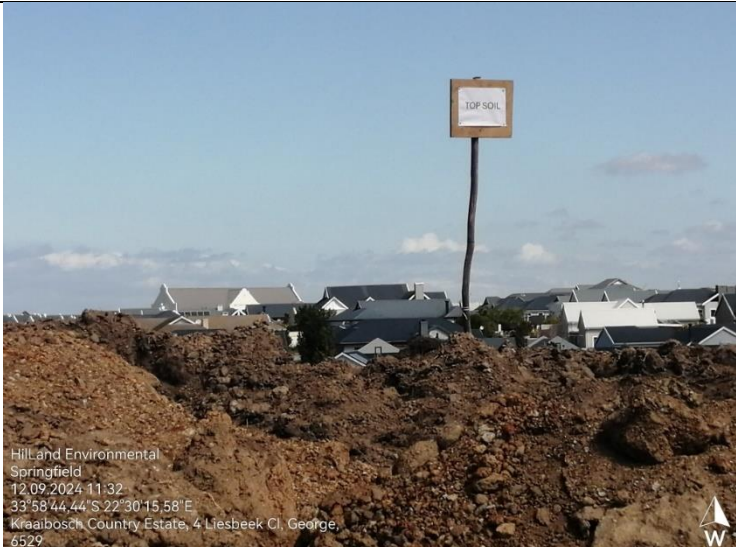
| Photographic record | Comments and requests |
|---|---|
| <p>Hilland Environmental<br/>Springfield<br/>12.09.2024 11:32<br/>33°58'44.44"S 22°30'15.58"E<br/>Kraaibosch Country Estate, 4 Liesbeek Cl, George, 6529</p> | <p>Topsoil stockpile sign was replaced.</p> |

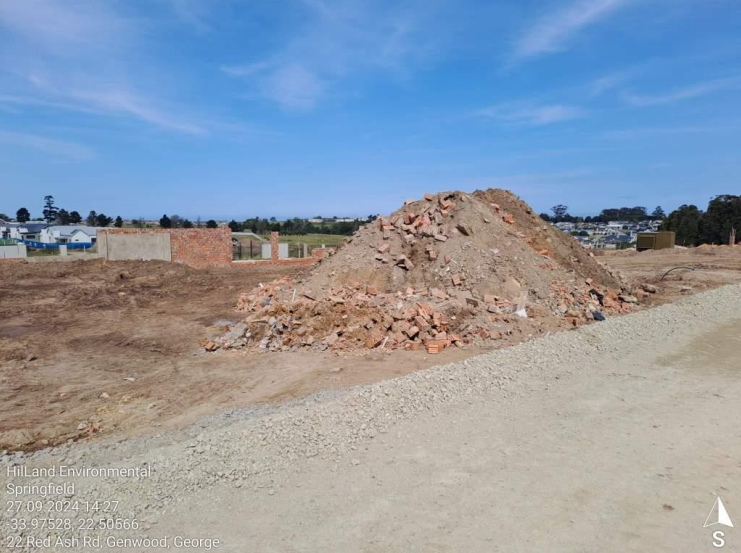
| <p>HillLand Environmental<br/>Springfield<br/>27.09.2024 14:27<br/>33° 9' 52.8" S 22° 50' 56.6" E<br/>22 Red Ash Rd, Genwood, Georgia</p> <p>S</p> | <p>Temporary rubble stockpile on future development area.</p> |

The building rubble stockpile issue that was reported to the contractor during this reporting period, are being addressed. The contractor submitted a detailed method statement regarding the topsoil, subsoil and building rubble stockpiling. They have started removing the building rubble stockpile(s) during this reporting period as per the method statement.

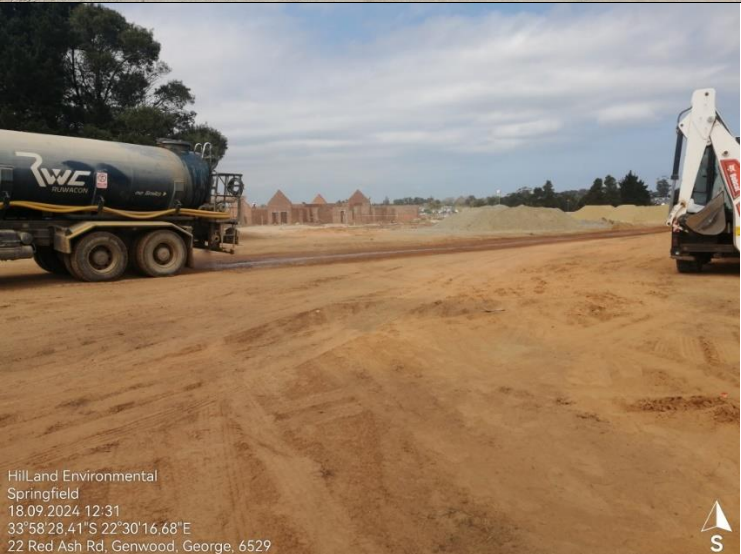
| <p>HillLand Environmental<br/>Springfield<br/>18.09.2024 12:31<br/>33° 58' 28.41" S 22° 30' 16.68" E<br/>22 Red Ash Rd, Genwood, Georgia, 6529</p> <p>S</p> | <p>Dust suppression noted during site inspection.</p> |

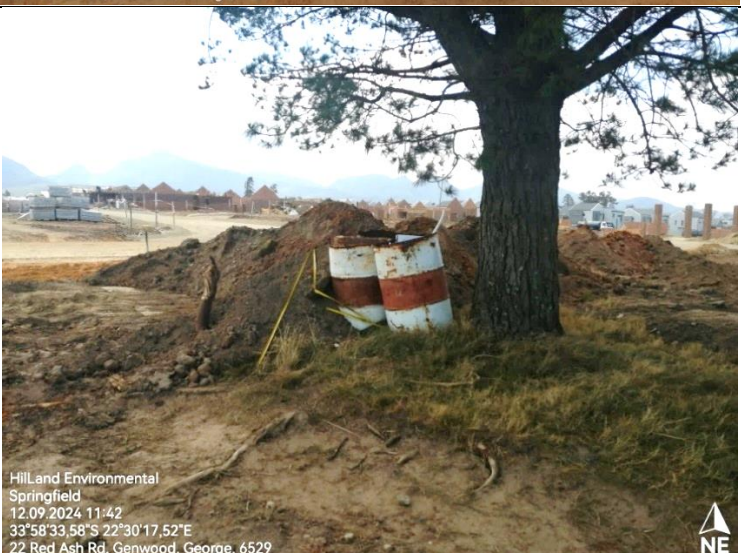
| <p>HillLand Environmental<br/>Springfield<br/>12.09.2024 11:42<br/>33° 58' 33.58" S 22° 30' 17.52" E<br/>22 Red Ash Rd, Genwood, Georgia, 6529</p> <p>NE</p> | <p>Bins are on site and in the site camp.</p> |

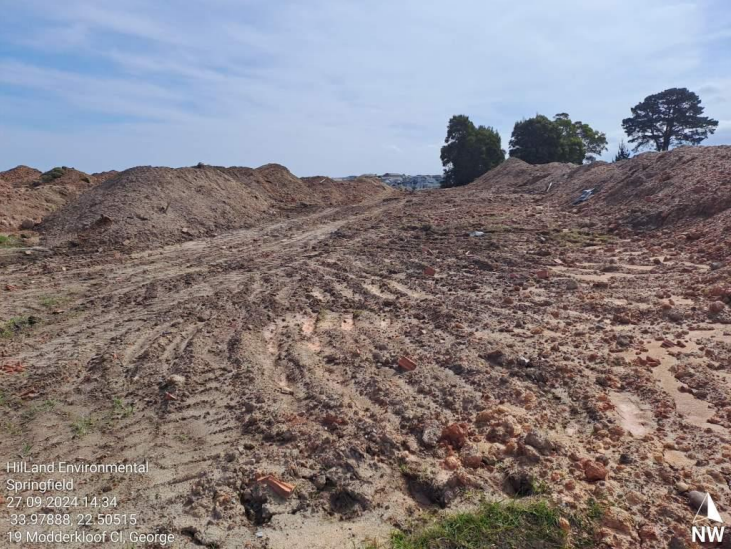
| <p>HillLand Environmental<br/>Springfield<br/>27.09.2024 14:34<br/>33° 9' 888, 22° 50' 515<br/>19 Modderkloof Cl, George</p> | <p>Rubble stockpile next to subsoil stockpile is being removed. The leftover bricks on the ground will still need to be removed.</p> |

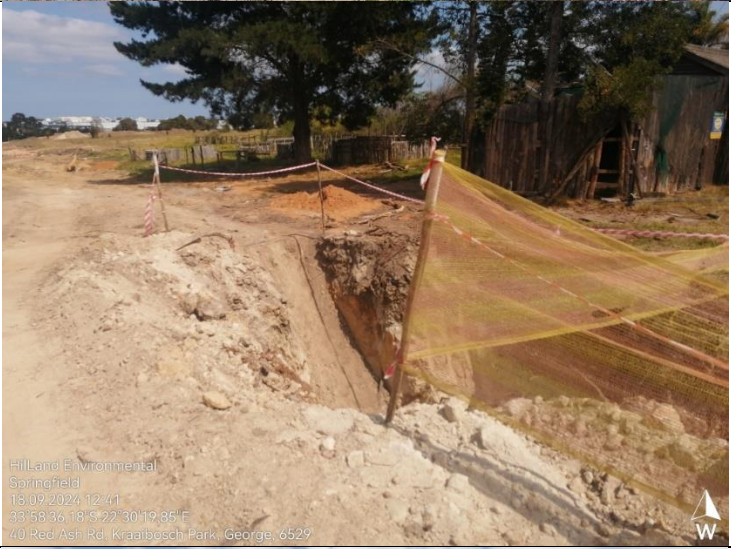
| <p>HillLand Environmental<br/>Springfield<br/>18.09.2024 12:41<br/>33° 58' 34, 18° 5' 22' 30' 19, 85° E<br/>70 Red Ash Rd, Kraaibosch Park, George, 6529</p> | <p>Trenches are demarcated with orange netting fences.</p> |

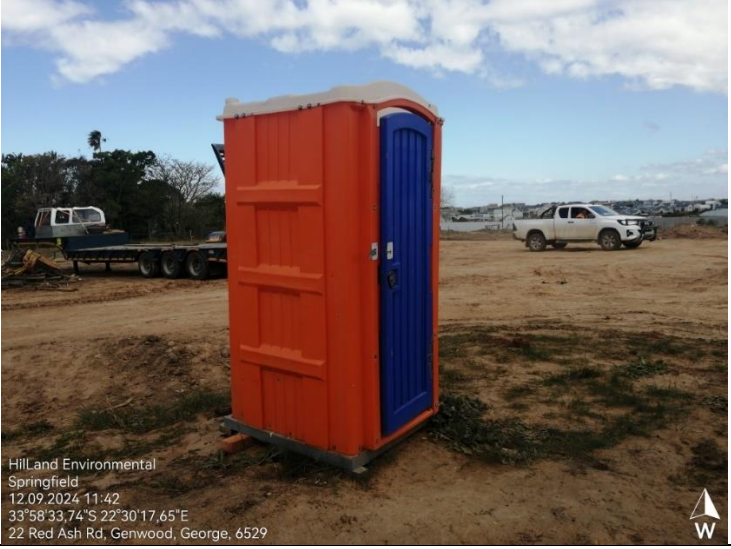
| <p>HillLand Environmental<br/>Springfield<br/>12.09.2024 11:42<br/>33° 58' 33, 74° S 22° 30' 17, 65° E<br/>22 Red Ash Rd, Genwood, George, 6529</p> | <p>Sufficient ablution facilities on site.</p> |

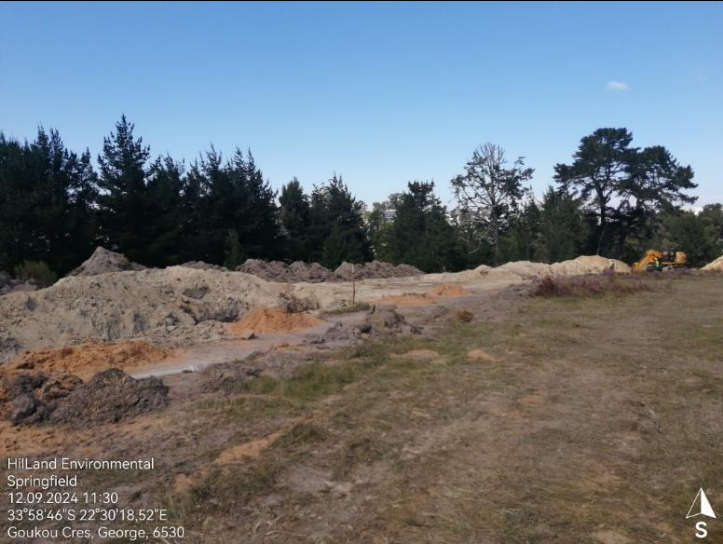
| <p>HillLand Environmental<br/>Springfield<br/>12.09.2024 11:30<br/>33°58'46"S 22°30'18.52"E<br/>Goukou Cres, George, 6530</p> <p style="text-align: right;">S</p> | <p>Sewer line trench has been excavated and is being backfilled as the sections of the pipe are installed. The contractor is reminded that the topsoil must be replaced back (on top) once backfilling is complete.</p> |

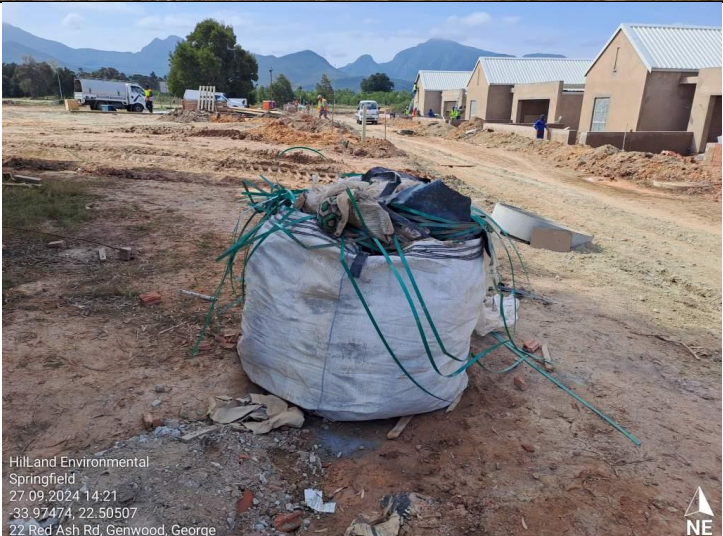
| <p>HillLand Environmental<br/>Springfield<br/>27.09.2024 14:21<br/>33°57'47.4"S 22°50'50.7"E<br/>22 Red Ash Rd, Genwood, George</p> <p style="text-align: right;">NE</p> | <p>Litter is stored in bags and bins.</p> |
