## ENVIRONMENTAL MONITORING REPORT NO. 9

*Springfield Estates on Portion 53 of Farm 195, George*

**PORTION 53 OF THE FARM KRAAIBOSCH 195, GEORGE  
ENVIRONMENTAL MONITORING REPORT NO 9**

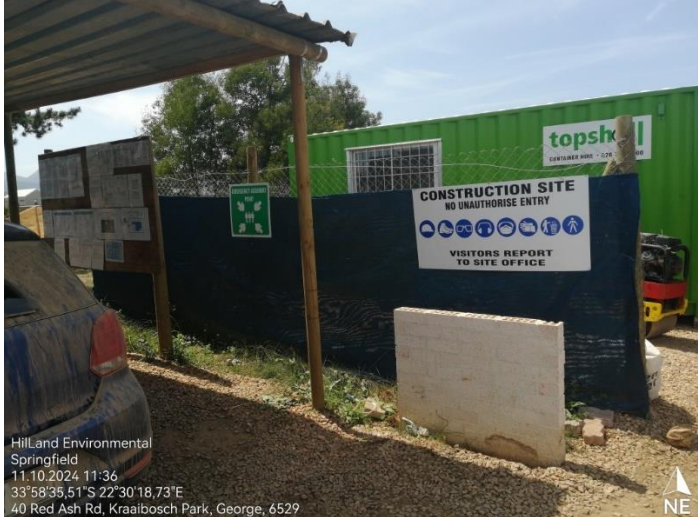
| Photographic record | Comments and requests |
|---|---|
| <p>HillLand Environmental<br/>Springfield<br/>11.10.2024 11:36<br/>33°58'35.51"S 22°30'18.73"E<br/>40 Red Ash Rd, Kraaibosch Park, George, 6529</p> | <p>Site camp in future development area – no environmental issues noted.</p> |

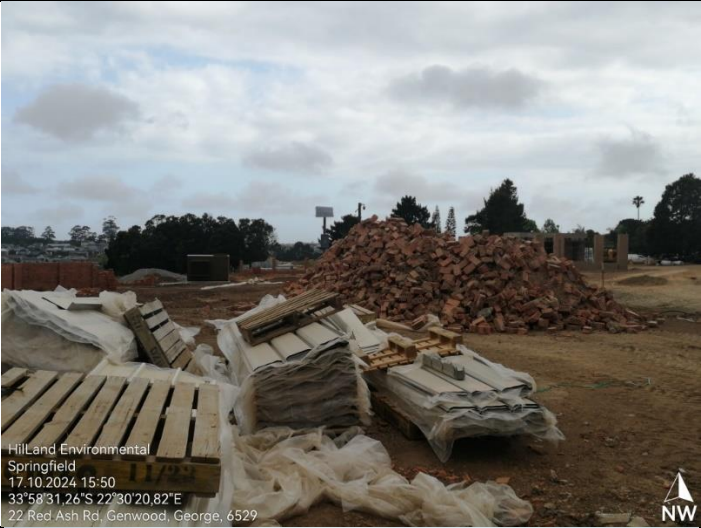
| <p>HillLand Environmental<br/>Springfield<br/>17.10.2024 15:50<br/>33°58'31.26"S 22°30'20.82"E<br/>22 Red Ash Rd, Genwood, George, 6529</p> <p>NW</p> | <p>Temporary rubble stockpile on future development area within the current development zone, this is acceptable in terms of the EMPr.</p> |

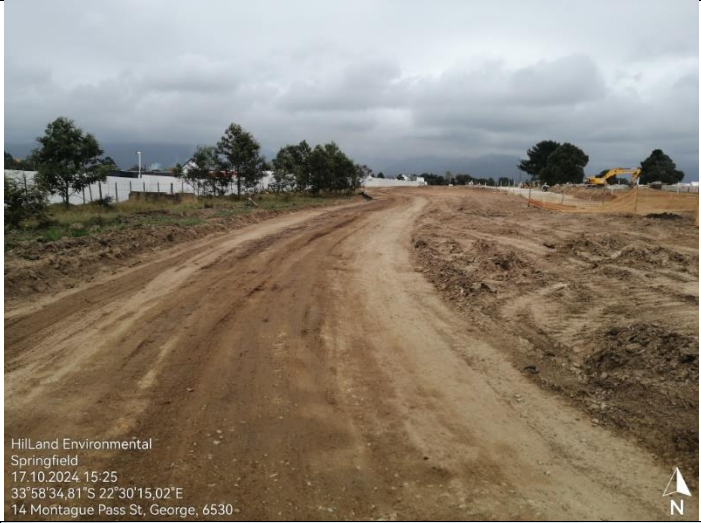
| <p>HillLand Environmental<br/>Springfield<br/>17.10.2024 15:25<br/>33°58'34.81"S 22°30'15.02"E<br/>14 Montague Pass St, George, 6530</p> <p>N</p> | <p>The haul roads are watered for dust suppression.</p> |

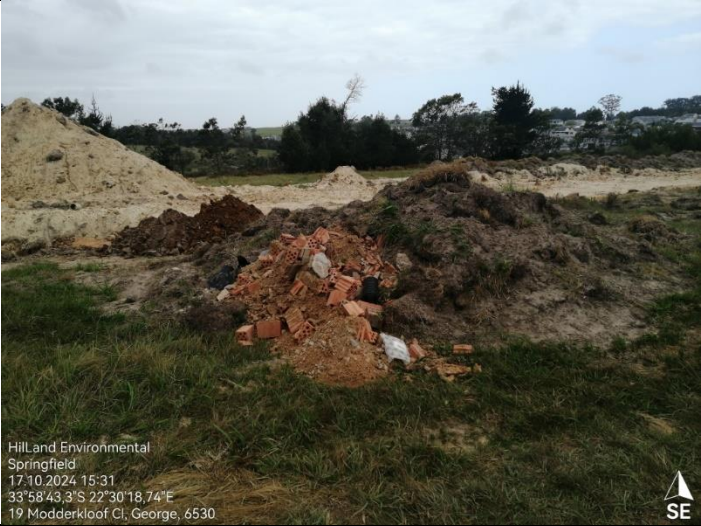
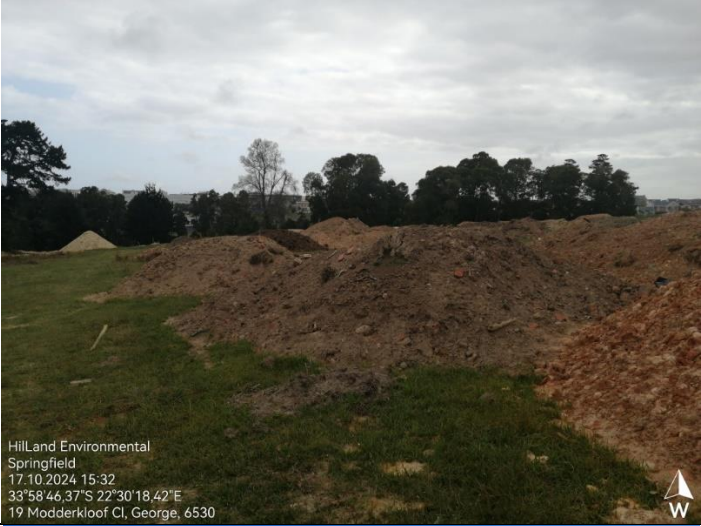
| <p>HillLand Environmental<br/>Springfield<br/>17.10.2024 15:31<br/>33°58'43.3"S 22°30'18.74"E<br/>19 Modderkloof Cl, George, 6530</p> <p>SE</p> | <p>More rubble was dumped next to the stockpile after the original rubble piles were removed. Subsequent to this, a penalty for non-compliance was issued to the main contractor - the contractor started removing the rubble.</p> |

| <p>HillLand Environmental<br/>Springfield<br/>17.10.2024 15:32<br/>33°58'46.37"S 22°30'18.42"E<br/>19 Modderkloof Cl, George, 6530</p> | |

| Solid waste may be temporarily stored on-site in a designated area, and it must be removed on a weekly basis. | Yes | No | | The building rubble near the subsoil and topsoil stockpile must be removed to avoid further contamination of subsoil. |

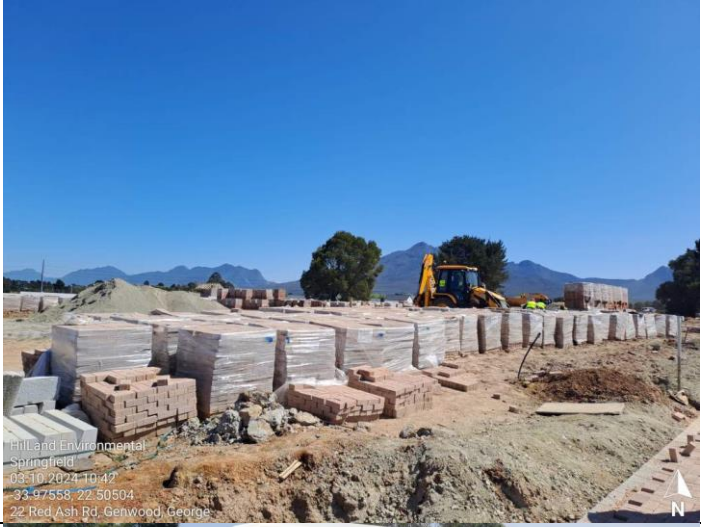
| <p>HillLand Environmental<br/>Springfield<br/>03.10.2024 10:47<br/>33°57'55.8" S 22°50'50.4" E<br/>22 Red Ash Rd, Genwood, George</p> | <p>Housing construction material is stockpiled on future development areas in sales phase 2.</p> |

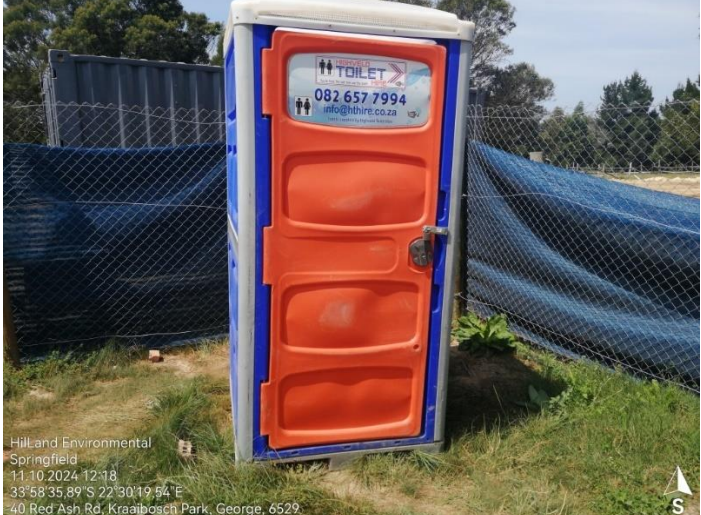
| <p>HillLand Environmental<br/>Springfield<br/>11.10.2024 12:18<br/>33°58'35.89"S 22°30'19.54"E<br/>40 Red Ash Rd, Kraaiposch Park, George, 6529</p> | <p>Sufficient ablution facilities on site.</p> |

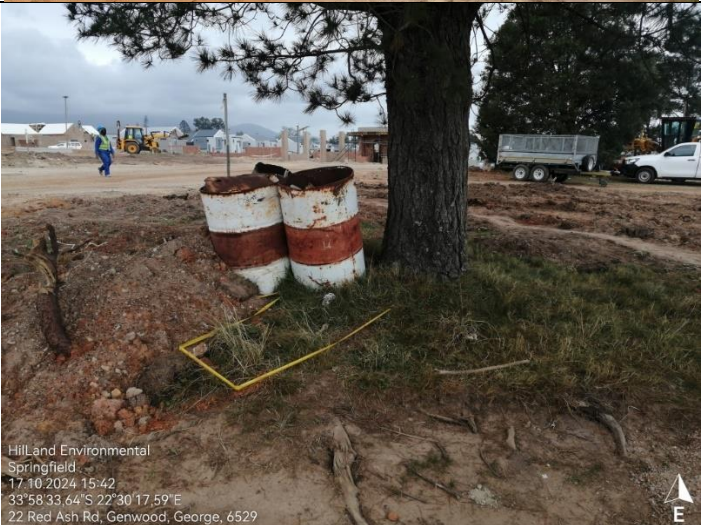
| <p>Hill and Environmental<br/>Springfield<br/>17/10/2024 15:42<br/>33°58'33.64"S 22°30'17.59"E<br/>22 Red Ash Rd, Genwood, George, 6529</p> <p>E</p> | <p>Litter is stored in bags and bins.</p> |

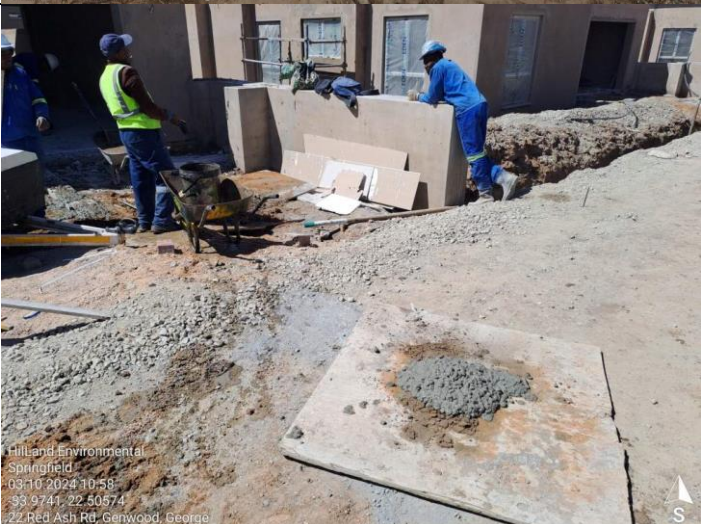
| <p>Hill and Environmental<br/>Springfield<br/>03/10/2024 10:58<br/>33°57'41.22"S 22°50'57.41"E<br/>22 Red Ash Rd, Genwood, George</p> <p>S</p> | <p>House construction cement batching done on impermeable surfaces.</p> |

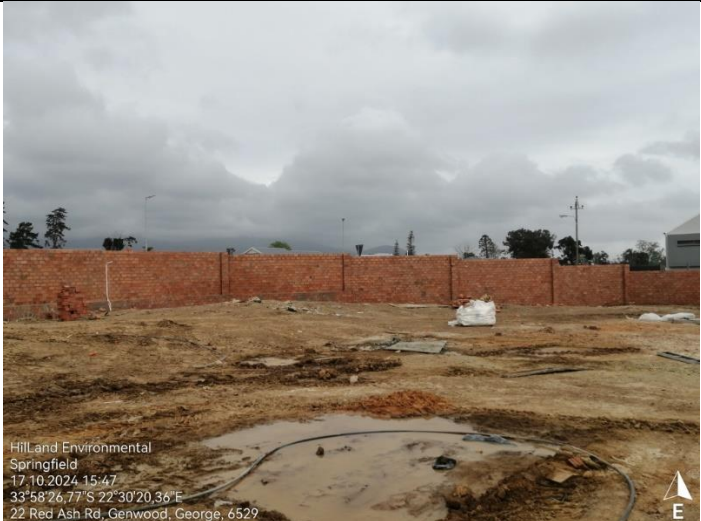
| <p>Hill and Environmental<br/>Springfield<br/>17.10.2024 15:47<br/>33°58'26.77"S 22°30'20.36"E<br/>22 Red Ash Rd, Genwood, George, 6529</p> | <p>The construction of the northern wall is in process.</p> |

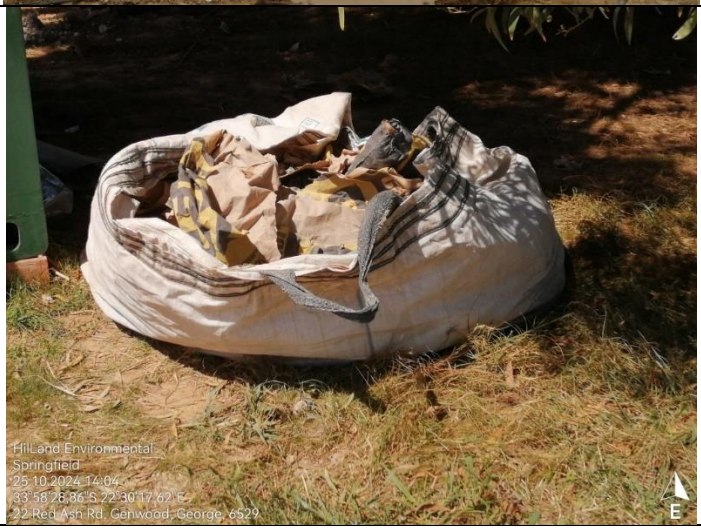
| <p>Hill and Environmental<br/>Springfield<br/>25.10.2024 14:04<br/>33°58'26.86"S 22°30'17.62"E<br/>22 Red Ash Rd, Genwood, George, 6529</p> | <p>Cement bags are stored in large bags and taken to a tile factory where they are reused.</p> |
