## ENVIRONMENTAL MONITORING REPORT NO. 12

## Springfield Estates on Portion 53 of Farm 195, George

| <b>Report Period</b> | February 2025 |

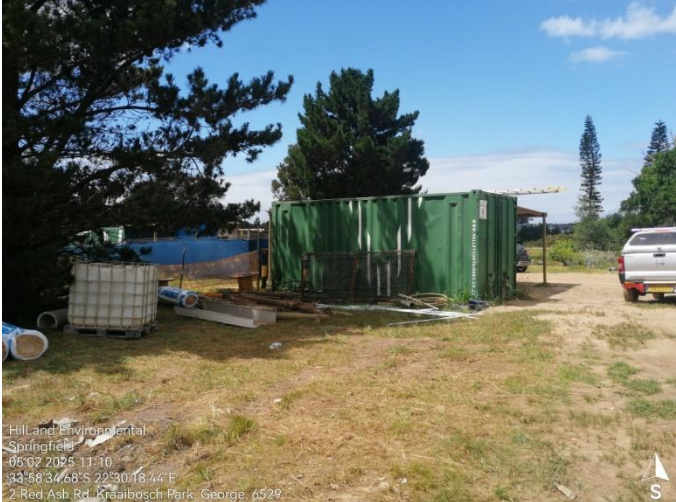
| Photographic record | Comments and requests |
|---|---|
| <p>Hill and Environmental<br/>Springfield<br/>08/02/2025 11:10<br/>33°58'34.68"S 22°30'18.44"E<br/>2 Red Ash Rd, Kwaibosch Park, George, 6520</p> | <p>Site camp in future development area – no environmental issues noted.</p> |

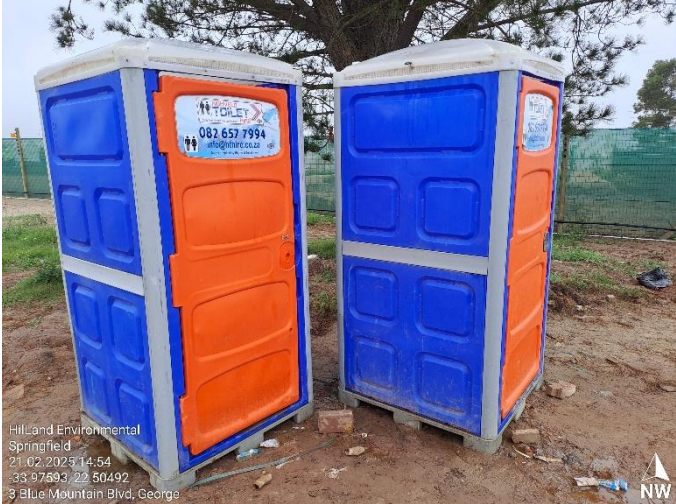
| <p>HillLand Environmental<br/>Springfield<br/>21.02.2025 14:54<br/>33.97593, 22.50492<br/>3 Blue Mountain Blvd, George</p> | <p>Sufficient ablution facilities on site. The contractor must ensure that the toilets are serviced regularly.</p> |

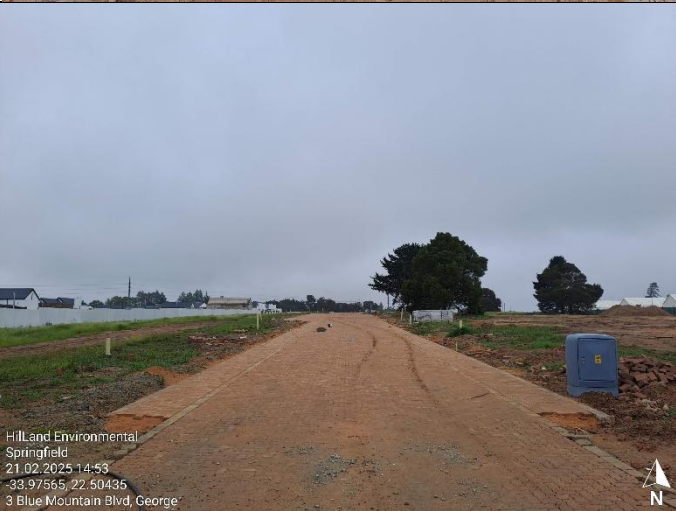
| <p>HillLand Environmental<br/>Springfield<br/>21.02.2025 14:53<br/>33.97555, 22.50435<br/>3 Blue Mountain Blvd, George</p> | <p>Paving in process</p> |

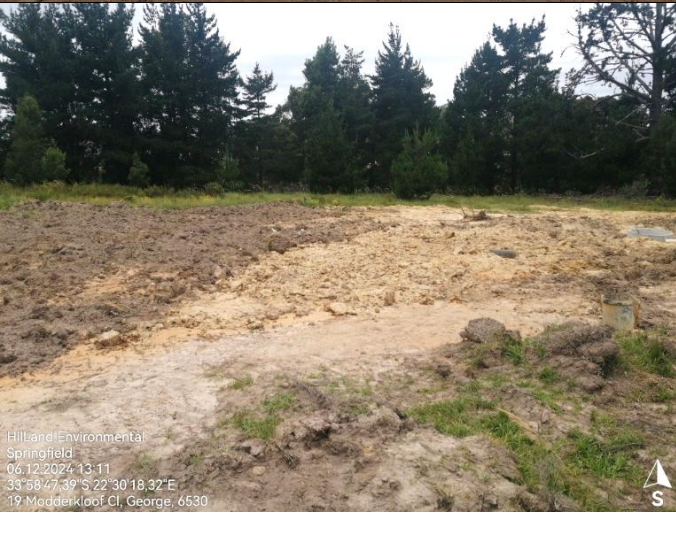
| <p>HillLand Environmental<br/>Springfield<br/>06.12.2024 13:11<br/>33.58477, 39°S 22°30'18.32"E<br/>19 Modderkloof Cl, George, 6530</p> | <p>Sewer line trench has been backfilled, there is still a section that must be rehabilitated with topsoil and grass seed mix.</p> |

| Soil excavated for installation of services must be placed to the side of the trench, with topsoil on one side and subsoil on the other side and replaced in the same sequence once done. | Ongoing | | | Ongoing – there is still a short section of the main sewer line that will need to be rehabilitated with topsoil cover. |

| Concrete and Cement Works | | | | |
|---|---|---|---|---|
| All disturbed areas will require stabilization on completion of the work by the contractor. | Ongoing | | | Landscaping of private gardens has commenced. Sewer line rehabilitation still to be completed. |

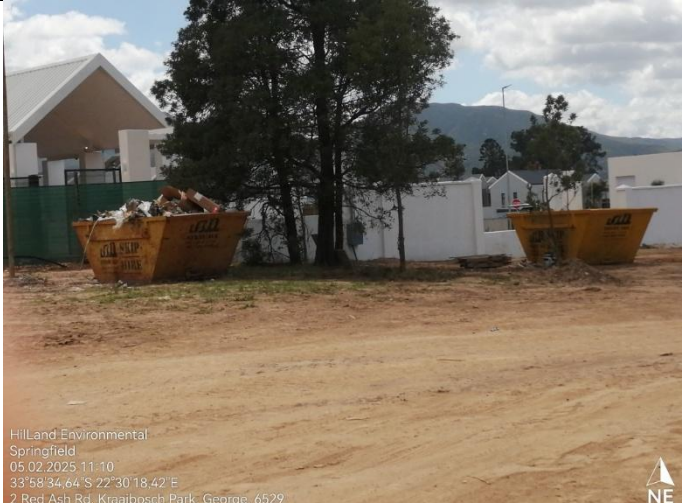
| <p>HillLand Environmental<br/>Springfield<br/>05.02.2025 11:10<br/>33° 58' 34.64" S 22° 30' 18.42" E<br/>2 Red Ash Rd. Kraaibosch Park, George. 6529</p> | <p>Skips are on site – to be emptied regularly to avoid plastic blowing in the wind.</p> |

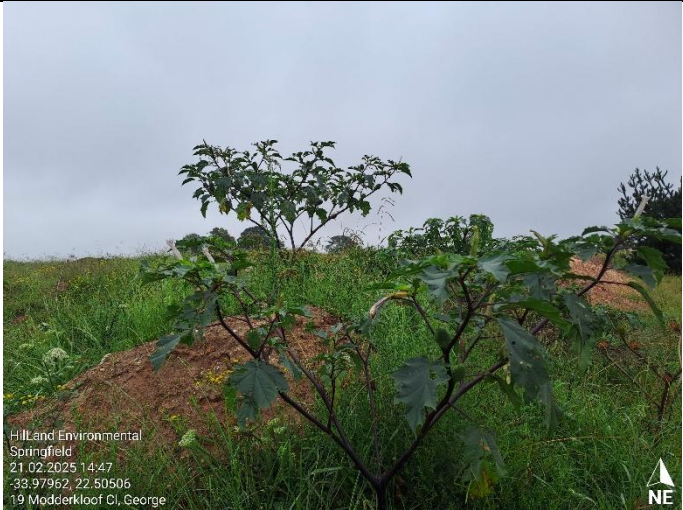
| | <p>Regular follow-up control of alien invasive species to be done – <i>Datura</i> sp. to be hand-pulled.</p> <p>The <i>Datura</i> is mainly growing on the stockpiles.</p> |

Continuous invasive alien clearing needs to be implemented throughout the construction site and stockpiles (civil contractor and developer responsibility).

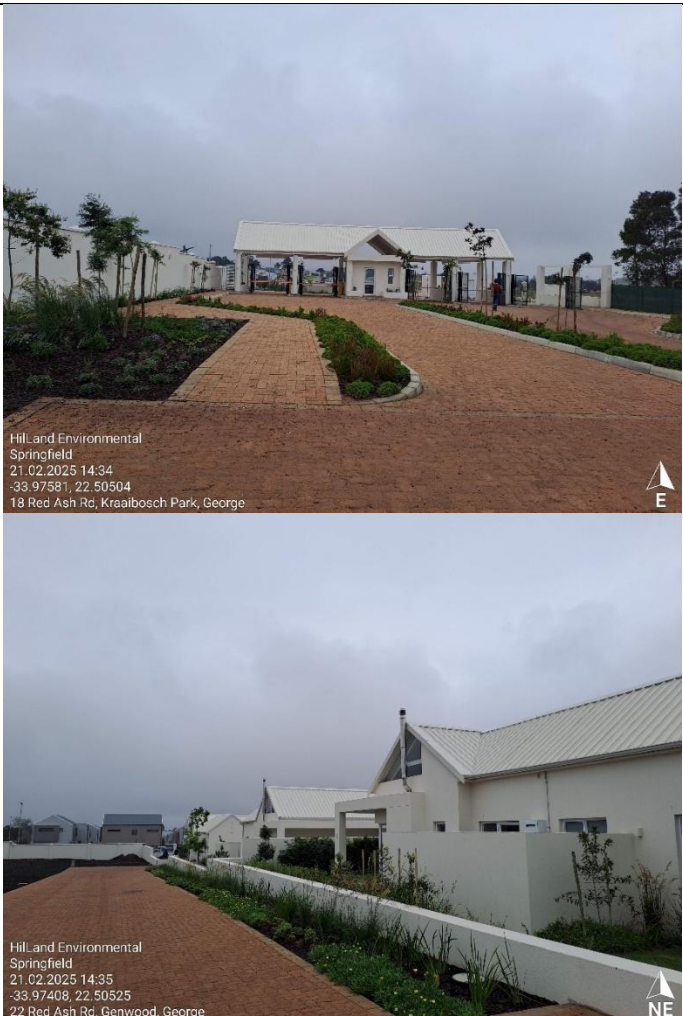
| | <p>The sales phase 1 houses and bulk civil construction and the gate house is complete – contractor is busy with final tie ins and snags.</p> |

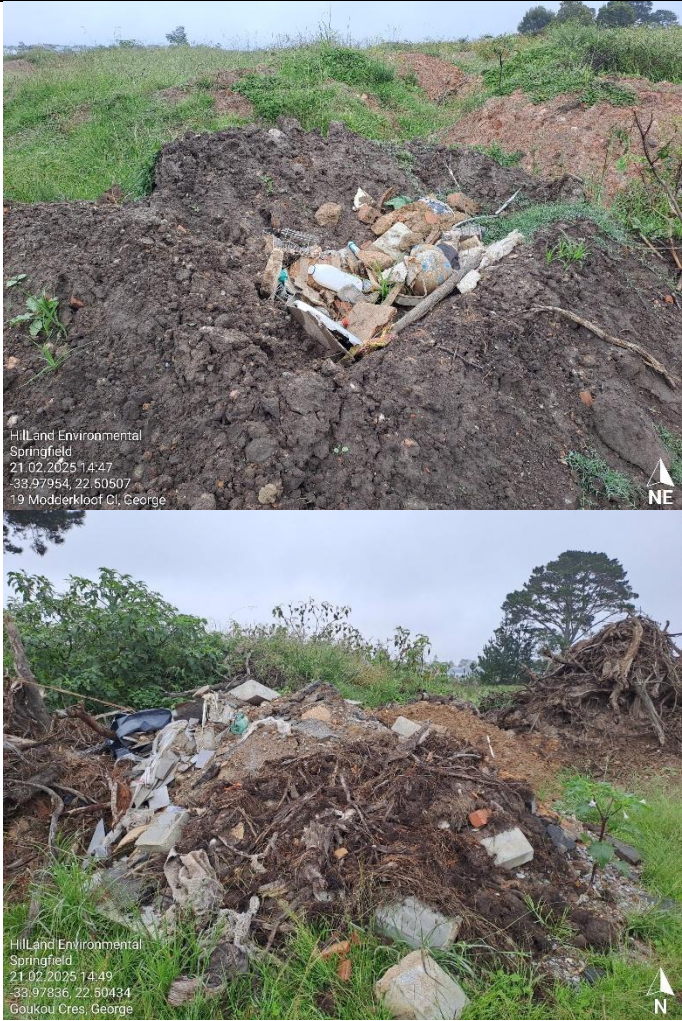
| <p>HillLand Environmental<br/>Springfield<br/>21.02.2025 14:47<br/>33.97954, 22.50507<br/>19 Modderkloof Cl, George</p> <p>HillLand Environmental<br/>Springfield<br/>21.02.2025 14:49<br/>33.97836, 22.50434<br/>Gaukous Cres, George</p> | <p>Rubble and waste in/on the topsoil stockpile must be removed.</p> |

| Stormwater Management | | | | |
|---|---|---|---|---|
| The topsoil stockpile may not be contaminated with any building materials or subsoil, and it must be protected against wind and water erosion. | Yes | No | | <b>Topsoil stockpile has vegetation cover – note that invasive alien plants must not be allowed to grow on the stockpiles.</b><br><br><b>Topsoil is to be kept separate at all times to prevent contamination.</b><br><br><b>The building rubble stockpile near/on the subsoil and topsoil stockpile must be removed.</b> |

| | | | | <b>Topsoil and subsoil demarcation to be implemented and maintained.</b> |

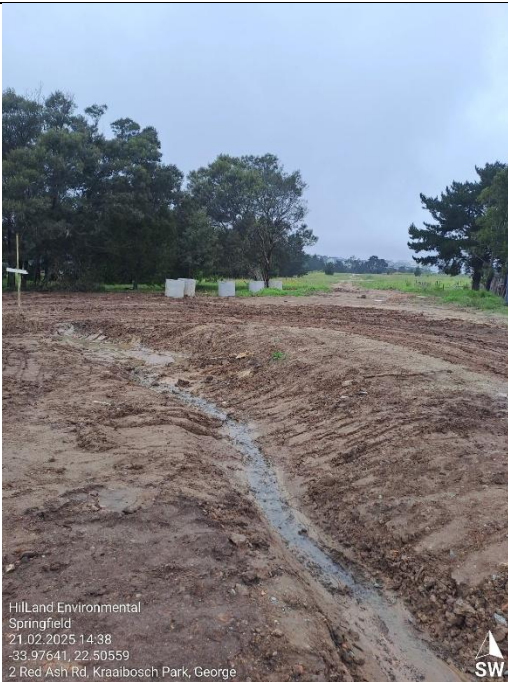
| <p>HillLand Environmental<br/>Springfield<br/>21.02.2025 14:38<br/>33.97641, 22.50559<br/>2 Red Ash Rd, Kraalbosch Park, George</p> | <p>Suitable erosion / silt protection is required at the outlets. The outlet channel south of the gatehouse, Road 3 and the temporary outlets south of Jasmine Avenue.</p> <p>Bidim silt fences / sandbags to be installed in the stormwater outlet</p> |

| Stormwater Management | | | | |
|---|---|---|---|---|
| Silt fences, sandbags or berms must be used to limit runoff during construction. | Yes | No | | Silt fence or sandbags to be installed at the stormwater outlets of phase 1 and road 3 temporary outlet. |

Silt fence and/or erosion protection must be installed at the temporary stormwater outlets south of the sales phase 1 development.
