## ENVIRONMENTAL MONITORING REPORT NO. 14

*Springfield Estates on Portion 53 of Farm 195, George*

| <b>Report Period</b> | April 2025 |

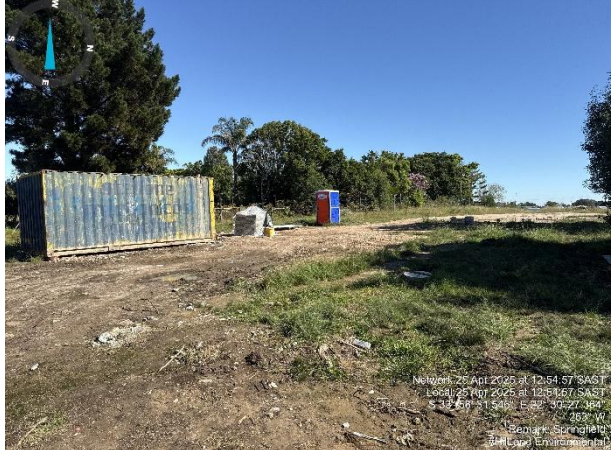
| Construction Site Camp | | | | |
|---|---|---|---|---|
| The area of the site camp must be approved by the ECO. | Yes | | | <p>Position of the site camp (on a future erf) was agreed by the ECO, engineer and developer.</p> <p>The contractor is busy dismantling the site camp. Note that the full area must be rehabilitated.</p> <p>Network: 25 Apr 2025 at 12:54:57 SAST<br/> Location: 25 Apr 2025 at 12:54:57 SAST<br/> S 33° 58' 33.52" E 26° 37' 27.34" W<br/> Remark: Springfield<br/> W.H. L. Environmental</p> |

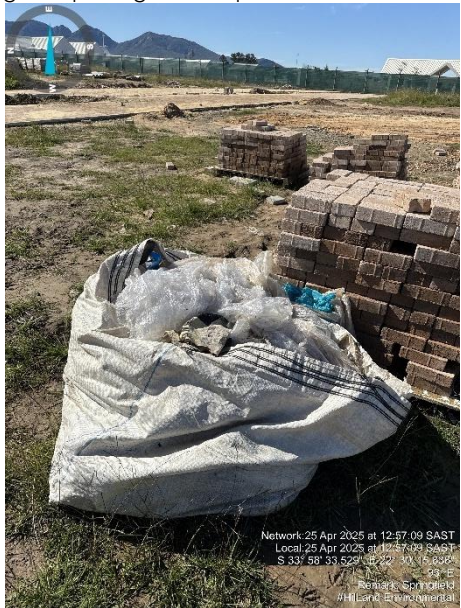
| Construction Site Camp | | | | |
|---|---|---|---|---|
| A dedicated area must be created in the site camp for refuse and waste management. Regular litter picking must be done. | Yes | | | <p>General waste bin is in the site camp and waste skips/bins are available in the construction area. Large bags placed around the construction area are used for storing all cement bags.</p> <p>Ongoing litter picking is still required.</p> <p>Network: 25 Apr 2025 at 12:57:09 SAST<br/> Location: 25 Apr 2025 at 12:57:09 SAST<br/> S 33° 58' 33.52" E 26° 37' 27.34" W<br/> Remark: Springfield<br/> W.H. L. Environmental</p> |

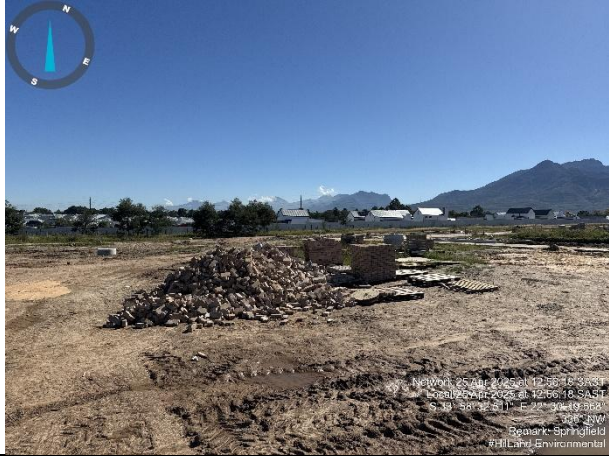
| | | | | <p>Construction material is stored in the development footprint.</p> |

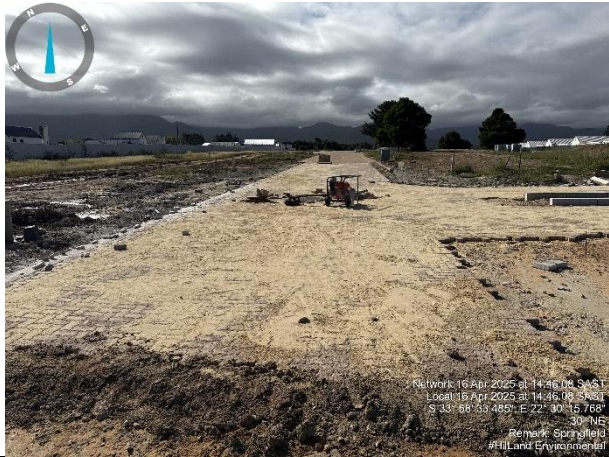
| | | | | <p>Construction material is stored in the development footprint.</p> |
|---|---|---|---|---|
| Construction vehicles must be restricted to the designated roads and haul routes only. | Yes | | | <p>Internal roads are complete, and vehicles are using the roads. Construction haul routes are used.</p> <p>The buffer area (south) must remain a no-go area at all times, and no transgression was noted.</p> |

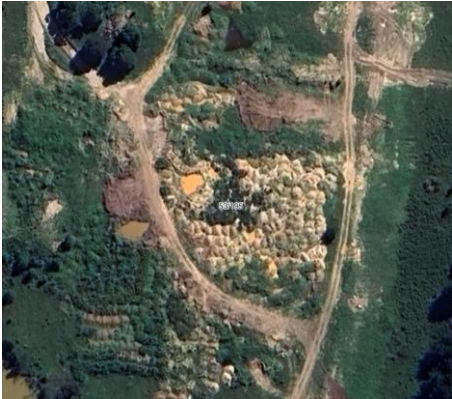
| Silt fences, sandbags or berms must be used to limit runoff during construction. | <b>Yes</b> | <b>No</b> | | Silt fences have been installed at the temporary stormwater outlets. Additional silt protection may be required at the end of Jasmine Ave. as runoff water may cause erosion issues until the rest of the road is constructed. |
|---|---|---|---|---|
| No materials may be stockpiled within the buffer area. | <b>Yes</b> | | | <p>No construction material stockpiled within the buffer.</p> <p>The subsoil and topsoil stockpiles are located on future erven, which will have to be demarcated (signs/netting/pegs).</p> <p>Google Earth image of the stockpile area (future development zone).</p> |

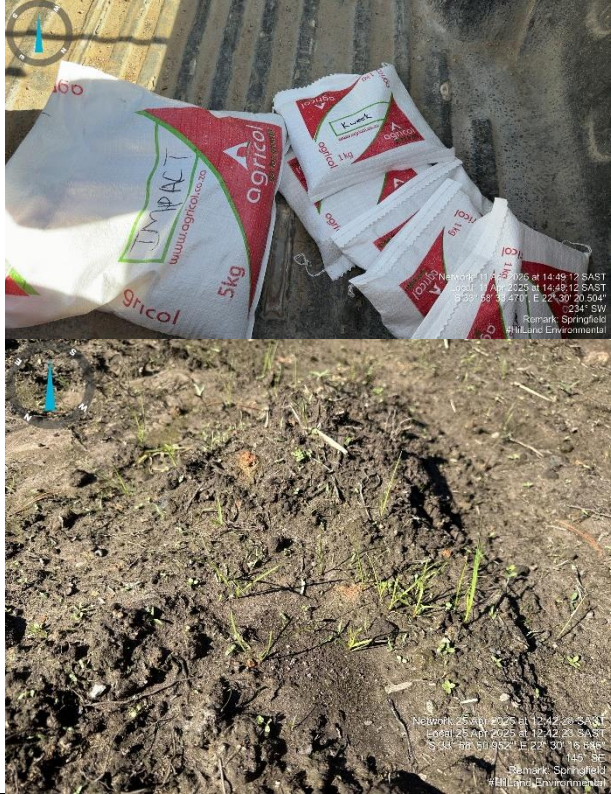
| | | | | <b>Topsoil of the stockpile areas were not rescued prior to stockpiling (on future erven).</b> |
|---|---|---|---|---|
| Soil excavated for installation of services must be placed to the side of the trench, with topsoil on one side and subsoil on the other side and replaced in the same sequence once done. | <b>Yes</b> | | | Rehabilitation of the sewer line in progress.<br><br> |

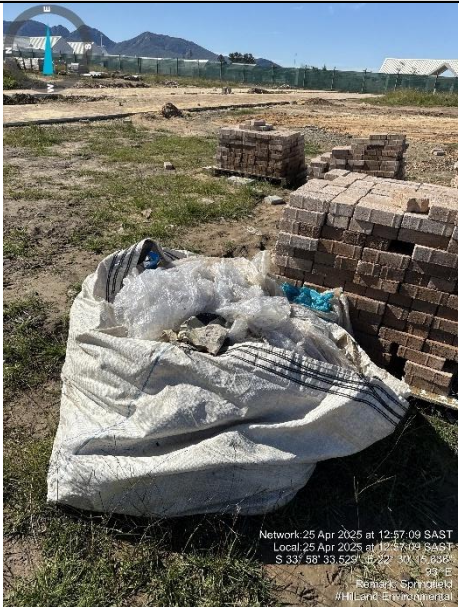
| No work may commence in a phase until the required hay bale protective screen has been installed along the buffer area. | | | N/A | Not applicable to this phase in the northern section of the development. May only be applicable in the areas near the watercourse and the road 3 construction. |
|---|---|---|---|---|
| The contractor must ensure that there are sufficient waste disposal facilities (bins/skips etc.) on site. | Ongoing | | | <p>Ongoing litter picking to be done as part of the snags process.</p> |

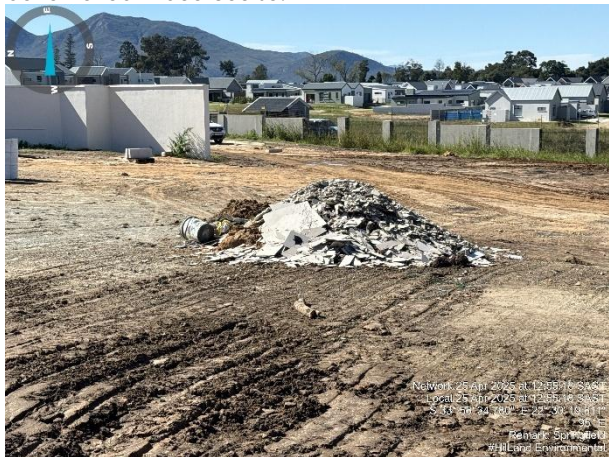
| No work may commence in a phase until the required hay bale protective screen has been installed along the buffer area. | | | N/A | Not applicable to this phase in the northern section of the development. May only be applicable in the areas near the watercourse and the road 3 construction. |
|---|---|---|---|---|
| <p>All waste must be disposed of at suitable facilities. No dumping on or off site is permitted.</p> <p>Solid waste may be temporarily stored on-site in a designated area, and it must be removed on a weekly basis.</p> | Yes | | | <p>Small rubble stockpile – not considered as dumping, this will be removed in due course.</p> |

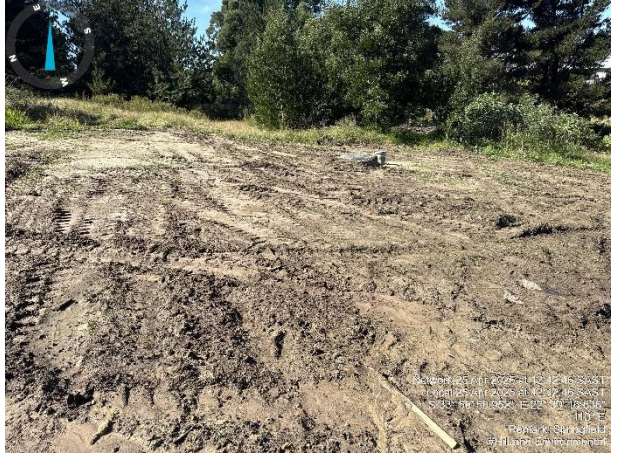
| All disturbed areas will require stabilization on completion of the work by the contractor. | Ongoing | | | Landscaping of private gardens has commenced.<br><br>Site camp and construction material area to be rehabilitated when the site camp has been removed.<br><br>Sewer line rehabilitation in process.<br><br><br>Road verges Jasmine Ave still to be completed (currently busy with paving).<br>See notes above. |
