**ENVIRONMENTAL MONITORING REPORT NO. 41  
FOR  
HARTLAND ON  
PORTION 11 OF FARM VAALE VALLEY 219, MOSSEL BAY**

**MOS24/1027/69**

**December 2024 & January 2025**

## ENVIRONMENTAL MONITORING REPORT NO. 41 – DECEMBER 2024 AND JANUARY 2025

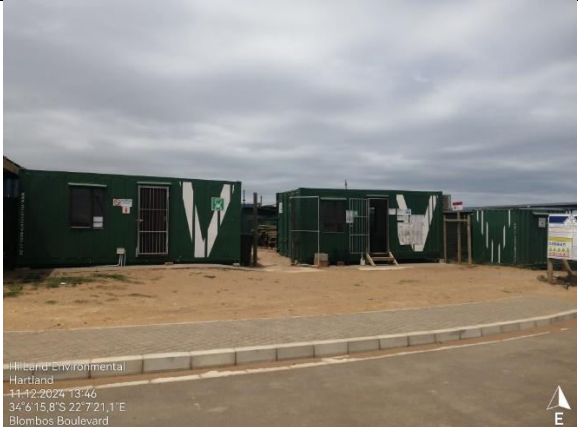
| EMPr requirements | Level of compliance | Comments / Findings | Photos (if applicable) |
|---|---|---|---|
| The site camp must be set up prior to the start of construction and clearly demarcated to illustrate NO-GO areas. | Compliant | The same site camp is being used, located in the development zone and complies with the requirements and recommendations. | <p>HillLand Environmental<br/>Hartland<br/>11/12/2024 13:46<br/>34°15'8"S 22°7'21.1"E<br/>Blombos Boulevard</p> |

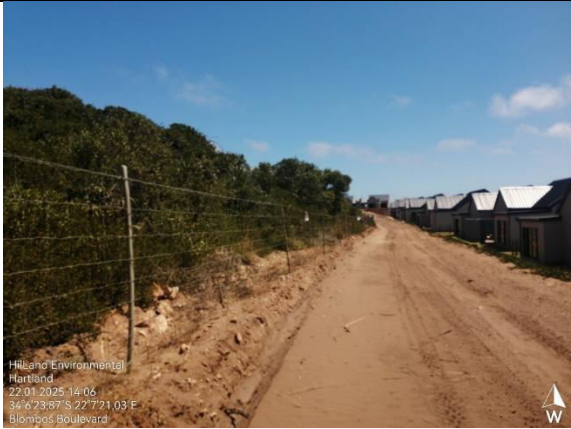
| <p>All sensitive areas, which must not be disturbed, must be demarcated using a 1.2m high fence constructed of shade cloth netting (<b>or similar product</b>), staked at regular intervals. Where a fence is considered impractical No- Go signs should be erected at frequent intervals along the edge of the no-go areas in consultation with the ECO.</p> | <p>Compliant</p> | <p>The working zone is pegged by the surveyor before construction starts</p> <p>The conservation area/natural vegetation adjacent to the Retirement village is demarcated with a suitable fence.</p> <p>Right-turn Lane sensitive areas (road reserve) have been pointed out to the contractor.</p> | <p>Showing the conservation area fenced off</p> |

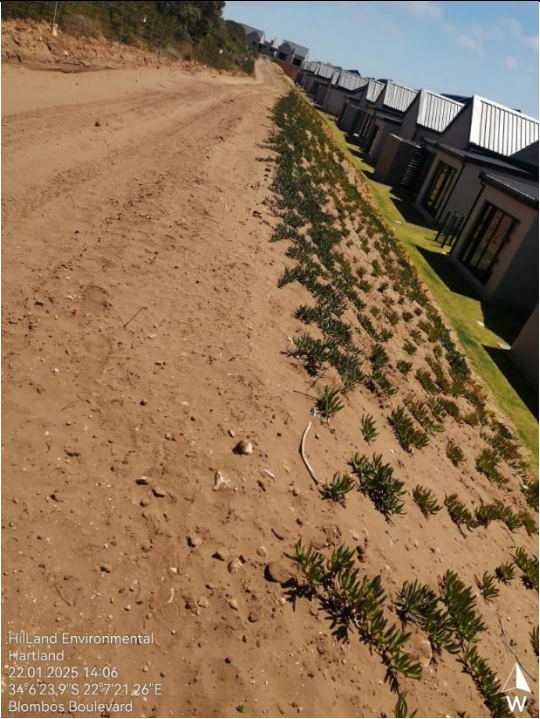
| Fauna and Flora | | | |
|---|---|---|---|
| Plant identification must be done whereby they must be rescued and relocated to an appropriate location for later use in rehabilitation. | Compliant & ongoing | <p>Development zone is the historic agricultural fields, mainly grass.</p> <p>Geophytes are to be rescued -they must be used in rehabilitation.</p> <p>Ongoing – record to be kept of the plants that are rescued and submitted to the ECO for record keeping.</p> | <p>HillLand Environmental<br/>Hartland<br/>22.01.2025 14:06<br/>34°6'23.9"S 22°7'21.26"E<br/>Blombos Boulevard</p> <p>Replanted geophytes in the Retirement Village</p> |

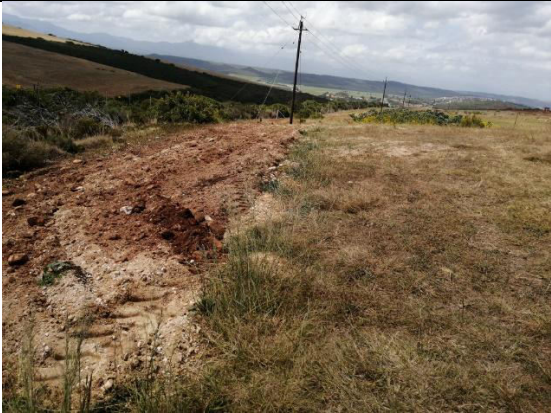
| Blanket clearing of vegetation must be limited to the approved development footprint, and the area to be cleared must be demarcated before any clearing and grubbing commences. | Compliant & ongoing | <p>All clearing is done within the demarcated footprint that is pegged out by the surveyor.</p> <p>No environmental issues noted.</p> | |

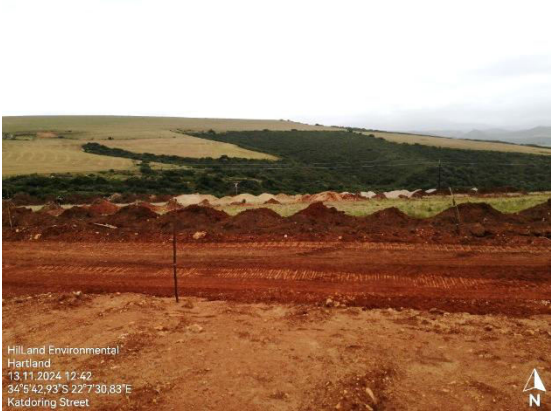
| Topsoil must be neatly removed and stored away without contamination. It is also to be used in rehabilitation once construction is complete. | Compliant & ongoing | <p>Topsoil is placed next to open trenches (windrow) for use during rehabilitation.</p> <p>Bulk topsoil stockpile sites for Retirement village and Fynbos Heuwels were approved by the ECO – internal open space of the retirement village.</p> <p>Subsoil will be stockpiled according to the earthworks master plan.</p> | <p>Hill and Environmental<br/>Hartland<br/>13.11.2024 12:42<br/>34°54'29"S 22°7'30.83"E<br/>Kaldorring Street</p> |

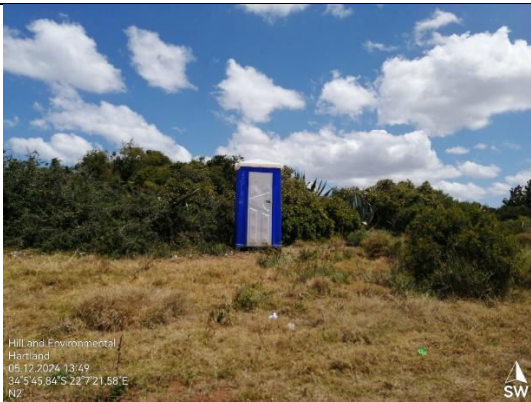
| CONSTRUCTION PHASE | | | |
|---|---|---|---|
| Chemical toilets must be kept at the site camp, on a level surface and secured from blowing over. | Compliant & ongoing | There is adequate ablution facilities located throughout the site and at the site camp – no environmental issues noted during this reporting period. | <p>Hilland Environmental<br/>Hartland<br/>05.12.2024 13:49<br/>34°54'58.84"S 22°7'21.58"E<br/>N2</p> <p>SW</p> |

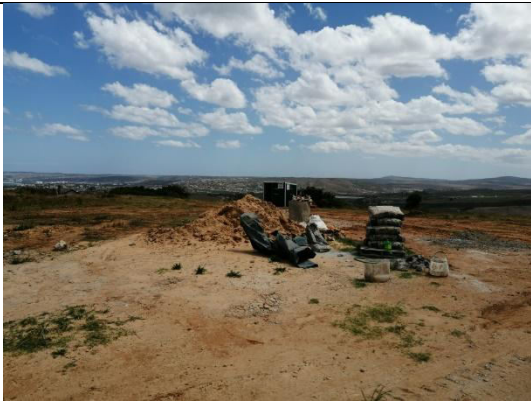
| CONSTRUCTION PHASE | | | |
|---|---|---|---|
| Cement batching must take place on an impermeable surface large enough to retain any slurry or cement water run-off. | Ongoing | <p>Cement batching is done on development areas (platforms), in wheelbarrows (as required) or on impermeable surfaces (wooden boards).</p> <p>The cement batching area in Phase H2 needs to be bunded – contract is near completion – the area must be fully rehabilitated – remove contaminated soil and replace topsoil (grass seed mix if required).</p> | <p>Cement batching in Phase H2</p> |

- The green zone adjacent to the Retirement living: Phase 1 development area has been demarcated with a wire fence and no entry sign boards.
- The cement batching area needs to be bunded with sandbags or a small berm.
- Indigenous trees have been planted along the entrance road into the Retirement village.
- Building rubble in/on the topsoil stockpile must be removed asap.

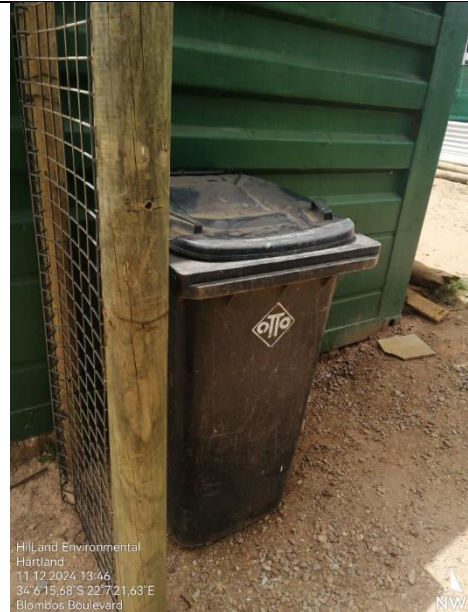
| <b>Soil erosion mitigation</b> | | | |
|---|---|---|---|
| Dedicated waste bins or skips must be provided on site and kept in a demarcated area on an impermeable surface. | Compliant & ongoing | Suitable waste bins are available at the site camp. It should be noted that the housing contractor is also busy in the same phase and therefore it is the housing contractor's obligation to ensure they have sufficient bins or skips on site. | <p>Hilland Environmental<br/>Hartland<br/>11.12.2024 13:46<br/>34° 2' 15.68" S 22° 7' 21.63" E<br/>Blombos Boulevard</p> |

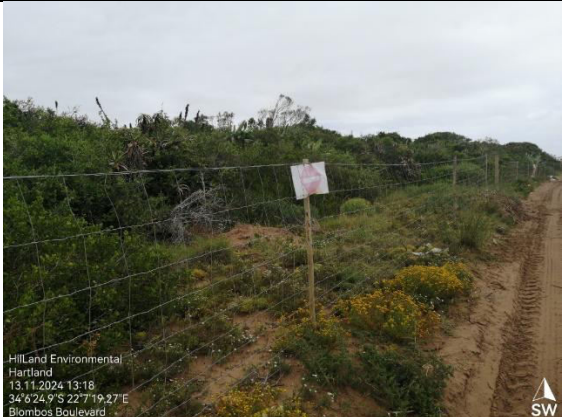
| EMPr requirements | Level of compliance | Comments / Findings | Photos (if applicable) |
|---|---|---|---|
| <p>All sensitive areas, which must not be disturbed, must be demarcated using a 1.2m high fence constructed of shade cloth netting (<b>or similar product</b>), staked at regular intervals. Where a fence is considered impractical No- Go signs should be erected at frequent intervals along the edge of the no-go areas in consultation with the ECO.</p> | Ongoing | <p>Housing construction sites that border sensitive areas are demarcated.</p> <p>Fynbos Heuwels and the Retirement Village are demarcated with wire fences.</p> | <p>HillLand Environmental<br/>Hartland<br/>13/11/2024 13:18<br/>34°6'24.9"S 22°7'19.27"E<br/>Blombos Boulevard</p> <p>SW</p> |

- Continue demarcating the sites bordering the conservation/sensitive areas.
- Ensure cement mixing on impermeable surfaces and remove cement contaminated soil and rehabilitate accordingly.
- Do regular litter picking with focus on the green zones.

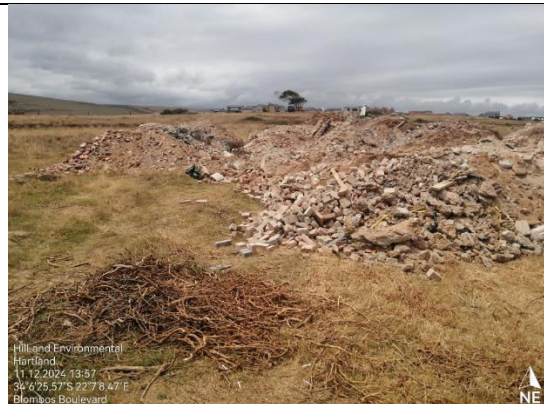
| Fauna and Flora | | | |
|---|---|---|---|
| Topsoil must be neatly removed and stored away without contamination. It is also to be used in rehabilitation once construction is complete. | Ongoing & Non-compliance | <p>Topsoil is stockpiled for rehabilitation and landscaping use.</p> <p>Topsoil is stored separately from any other material (no contamination).</p> <p>The retirement village topsoil stockpile must be kept free from invasive alien plants – <i>Datura</i>.</p> <p><b>Non-compliance - Building rubble has been dumped near the Retirement Village topsoil stockpile – as was reported to the contractor. This must be removed ASAP.</b></p> | <p>Hilland Environmental<br/>Hartland<br/>11.12.2024 13:57<br/>34° 6' 25.57" S 27° 7' 6.47" E<br/>Blomkops Boulevard</p> |

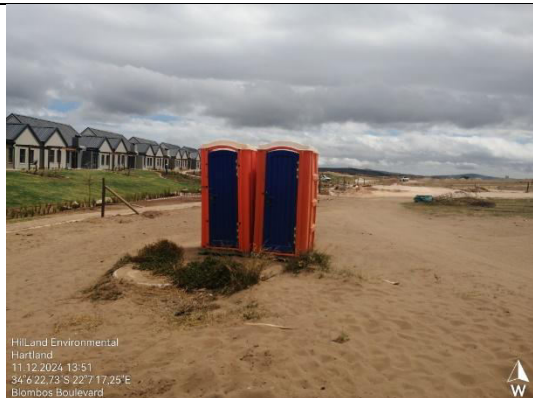
| CONSTRUCTION PHASE | | | |
|---|---|---|---|
| Chemical toilets must be kept at the site camp, on a level surface and secured from blowing over. | Compliant | <p>There are several portable toilets throughout the development zone.</p> <p>No complaints or environmental issues noted or reported to the ECO.</p> | <p>HillLand Environmental<br/>Hartland<br/>11.12.2024 13:51<br/>34°6'22.73"S 22°7'17.25"E<br/>Blombos Boulevard</p> |

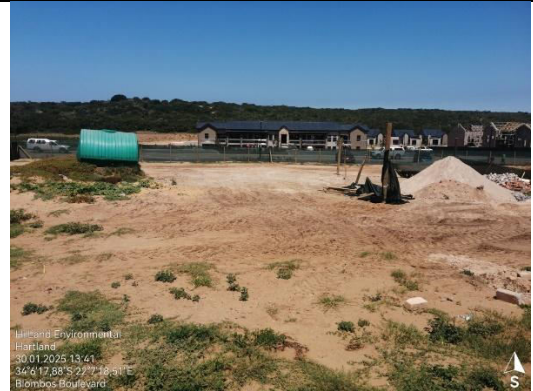
| CONSTRUCTION PHASE | | | |
|---|---|---|---|
| Cement batching must take place on an impermeable surface large enough to retain any slurry or cement water run-off. | Ongoing | <p>There are currently many houses under construction in various development phases.</p> <p>The contractor is requested to ensure that cement mixing is always conducted on an impermeable surface or permanent disturbance area. There are several construction sites that make use of an impermeable wooden sheet or in the driveway, however runoff contaminated water must be confined to the mixing area, i.e., appropriate bunding to be installed (small brick berm / wooden mixing box etc.)</p> <p>The cement mixing for the house construction in the Retirement Village is done on a future development zone. The batching area is not bunded – it is important to ensure that no cement water contaminates the surrounding area.</p> | <p>HillLand Environmental<br/>Hartland<br/>30.01.2025 13:41<br/>34°6'17.88"S 22°7'18.91"E<br/>Blombos Boulevard</p> <p>Cement batching</p> |

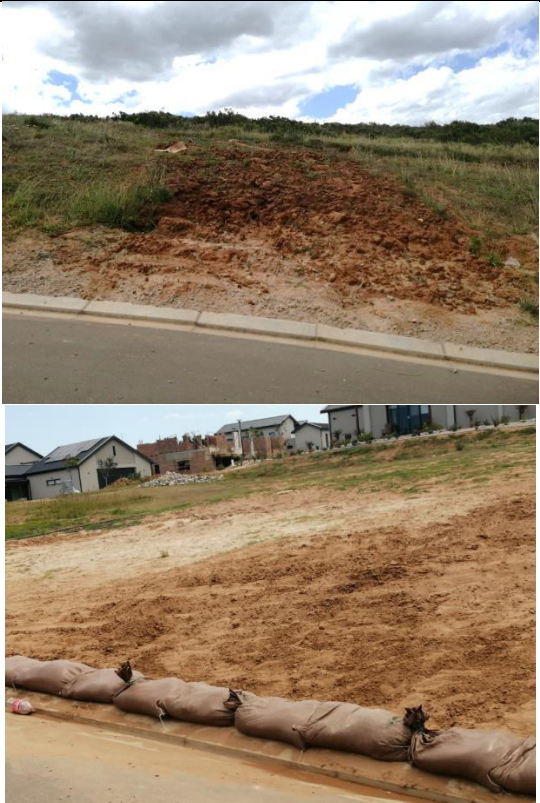
| Erosion control measures including silt fences, low soil berms and/or shutter boards must be put in place around the stockpiles to limit sediment runoff from stockpiles. | Ongoing | <p>Level erven is complaint and does not generally have silt or erosion issues.</p> <p>The steep erven will require silt protection, either sandbags or low bidim silt fence.</p> <p>Stormwater inlets must be protected – no silt or construction site wash must enter the stormwater system. This will silt up the stormwater outlets, many of which are in the conservation area.</p> | |

Sandbags below a steep erf (05.12.2024).

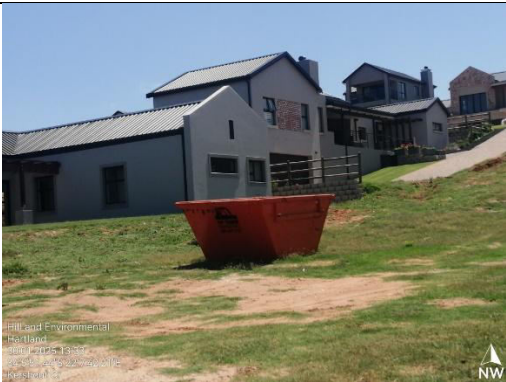
| <b>Waste and pollution management</b> | | | |
|---|---|---|---|
| Dedicated waste bins or skips must be provided on site and kept in a demarcated area on an impermeable surface. | Ongoing | <p><b>Compliant</b> - The contractor placed additional waste bins at each construction site which are emptied weekly. Skips are placed strategically throughout the site and are demarcated with shade netting (to prevent wind from blowing litter).</p> <p><b>Ongoing and compliant</b> - Wind-blown litter remains an ongoing construction related problem. Therefore, the contractor has a dedicated litter picking team conducting weekly litter picking. The HOA has also appointed a dedicated litter picker.</p> | |

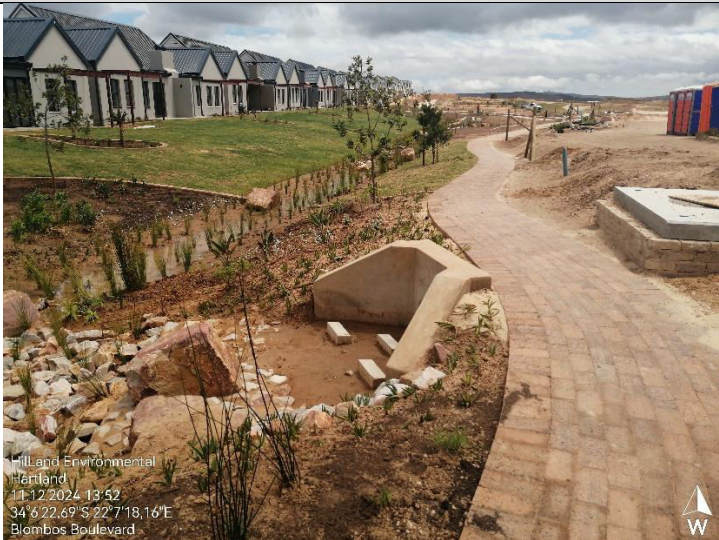
| OEMPr requirements | Level of compliance | Comments / Findings | Photos (if applicable) |
|---|---|---|---|
| Waste traps must be cleared of any obstructions monthly or when heavy rainfall has occurred. | Ongoing | Litter and silt wash have been removed from stormwater outlets and must be monitored by the HOA and management – ongoing activity that the HOA is managing. | <p>Hill and Environmental<br/>Hartland<br/>11-12-2024 13:52<br/>34°6'22.69"S 22°7'18.16"E<br/>Blombos Boulevard</p> <p>Retirement village stormwater management system</p> |

- Ongoing follow-up alien regrowth clearing.
- Ongoing maintenance of the stormwater outlets (silt and litter).
- Sandbags are being used along the southern fence to stop the (dune) erosion onto the fence and allow for security and maintenance monitoring within the firebreak – the sandbags will have to be covered with a Geojute to promote vegetation growth over the sandbags.
- Viewing deck and existing internal (green space) are maintained.

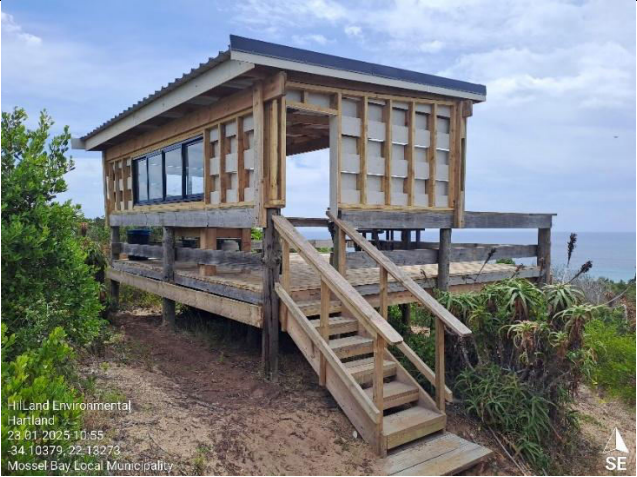
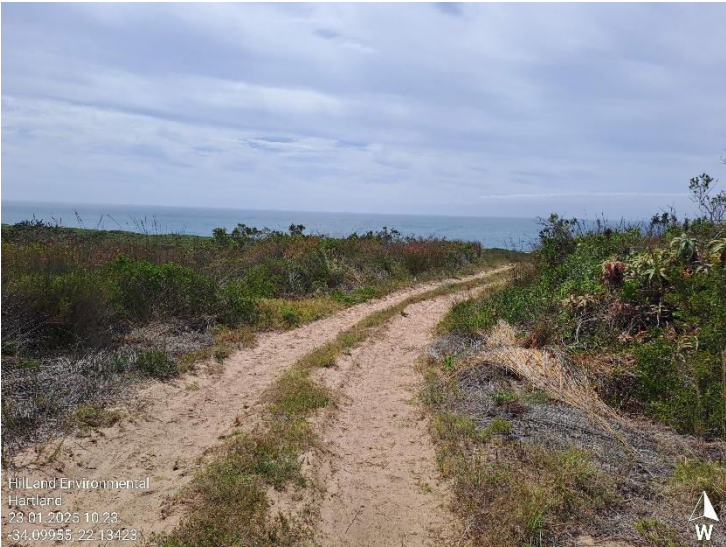
| MANAGEMENT OF NATURAL OPEN SPACES | | | |
|---|---|---|---|
| Natural open spaces must be managed properly to maintain ecological biodiversity and to provide limited and controlled recreational access to the residents living in this development. | Compliant and ongoing | <ul style="list-style-type: none"><li>Initial alien clearing is done. <b>Ongoing follow up clearing/eradication to be implemented.</b></li><li>A section of the <i>Thamnochortus insignis</i> in the natural open space is being maintained - bossiekap.</li><li>The existing tracks are being maintained as maintenance tracks and firebreaks (bossiekap).</li><li>Hiking/cycling tracks in the development area, conservation area and internal open spaces must be monitored for erosion and damage (by the HOA) and repaired immediately to avoid excessive environmental damage.</li><li>Viewing deck is maintained.</li><li>Perimeter firebreaks are in places and maintained – avoid bare surfaces to limit soil erosion risk. Wood chips/<i>carpobrotus</i> etc. can be used to cover bare soil.</li><li>Kweek lawns are installed at the newly completed houses.</li><li>Conservation area “rules” boards are in place.</li></ul> | <div><p>HillLand Environmental<br/>Hartland<br/>23.01.2025 10:55<br/>34.10379, 22.13274<br/>Mossel Bay Local Municipality</p><p>SE</p></div> <p>Viewing deck</p> <div><p>HillLand Environmental<br/>Hartland<br/>23.01.2025 10:23<br/>34.09955, 22.13428</p><p>W</p></div> <p>Existing tracks are maintained and double as internal firebreaks</p> |

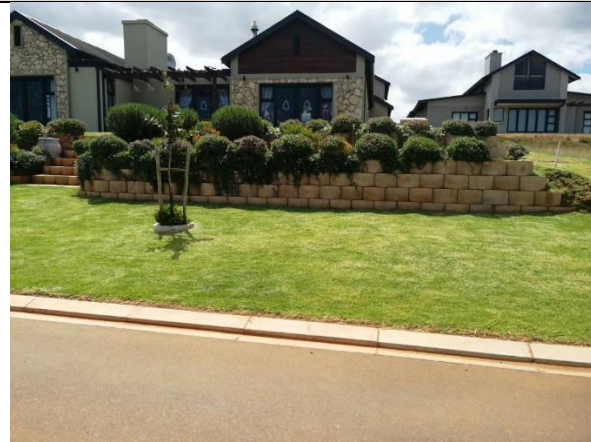
| FIRE MANAGEMENT | | | |
|---|---|---|---|
| Residents must propagate “water wise indigenous gardens” on their properties. | Compliant | Residents make use of rainwater tanks and indigenous vegetation. | |

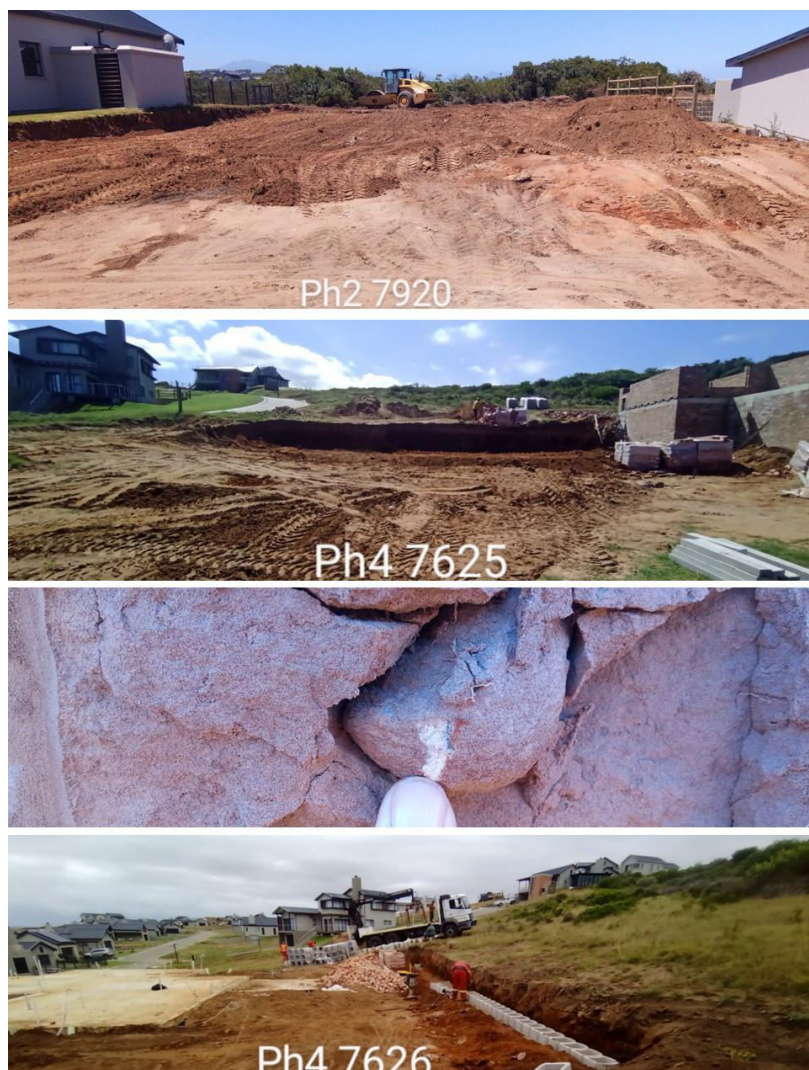
Erf 7920 was the only house platform completed in Phase 2 and no heritage resources were identified (Figure 1).

Figure 1. Hartland – Phases 2 and 4 – completed platforms and exposed manuport at Erf 7625.

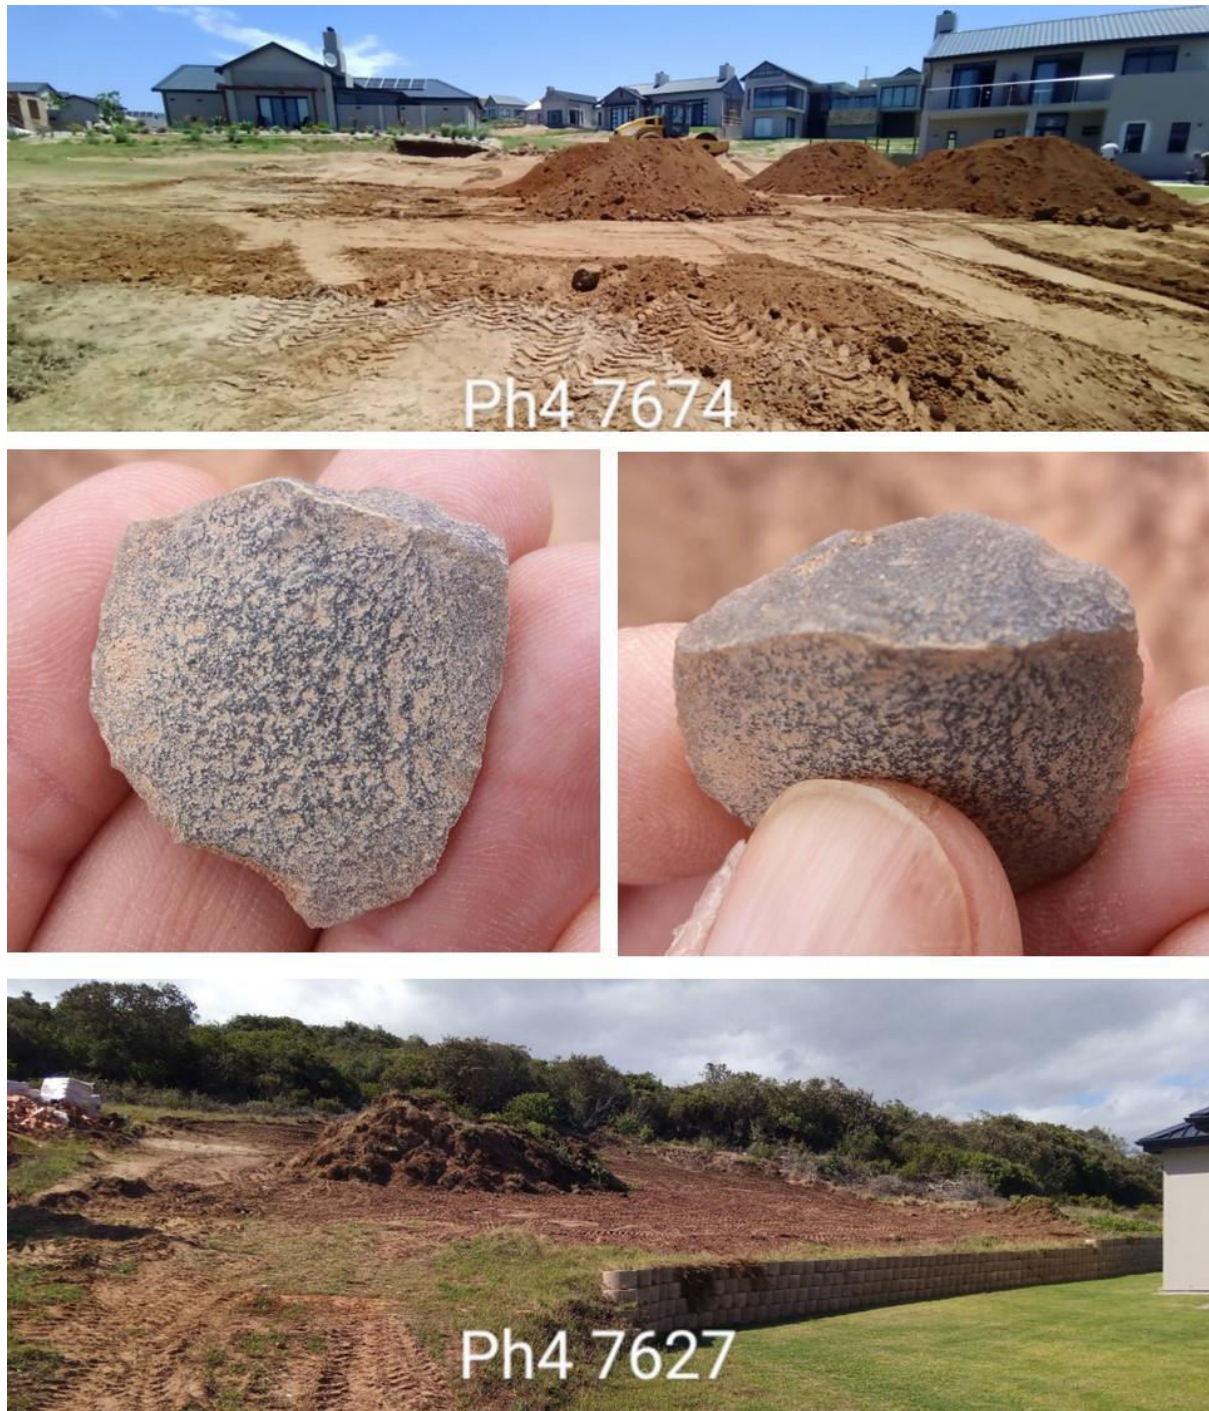
House platforms in Phase 4 included the completion of Erven 7625, 7626 and 7674 (Figures 1 & 2). Vegetation was cleared from Erf 7627, but no excavations were undertaken (Figure 2). A quartzite manuport exposed in the profile of aeolian sands was recorded at Erf 7625 (Figure 1) while a single quartzite flake with faceted striking platform was seen on exposed dune sands at Erf 7674 (Figure 2). Both artefacts are isolated and lack any associated organic or cultural remains. As such they are rated as Not Conservation Worthy (NCW) and require no further mitigation or management.

Figure 2. Hartland - Phase 4 – 7674 is complete, but excavation is outstanding for 7627. Stone Age flake with faceted platform seen at Erf 7674 (middle).

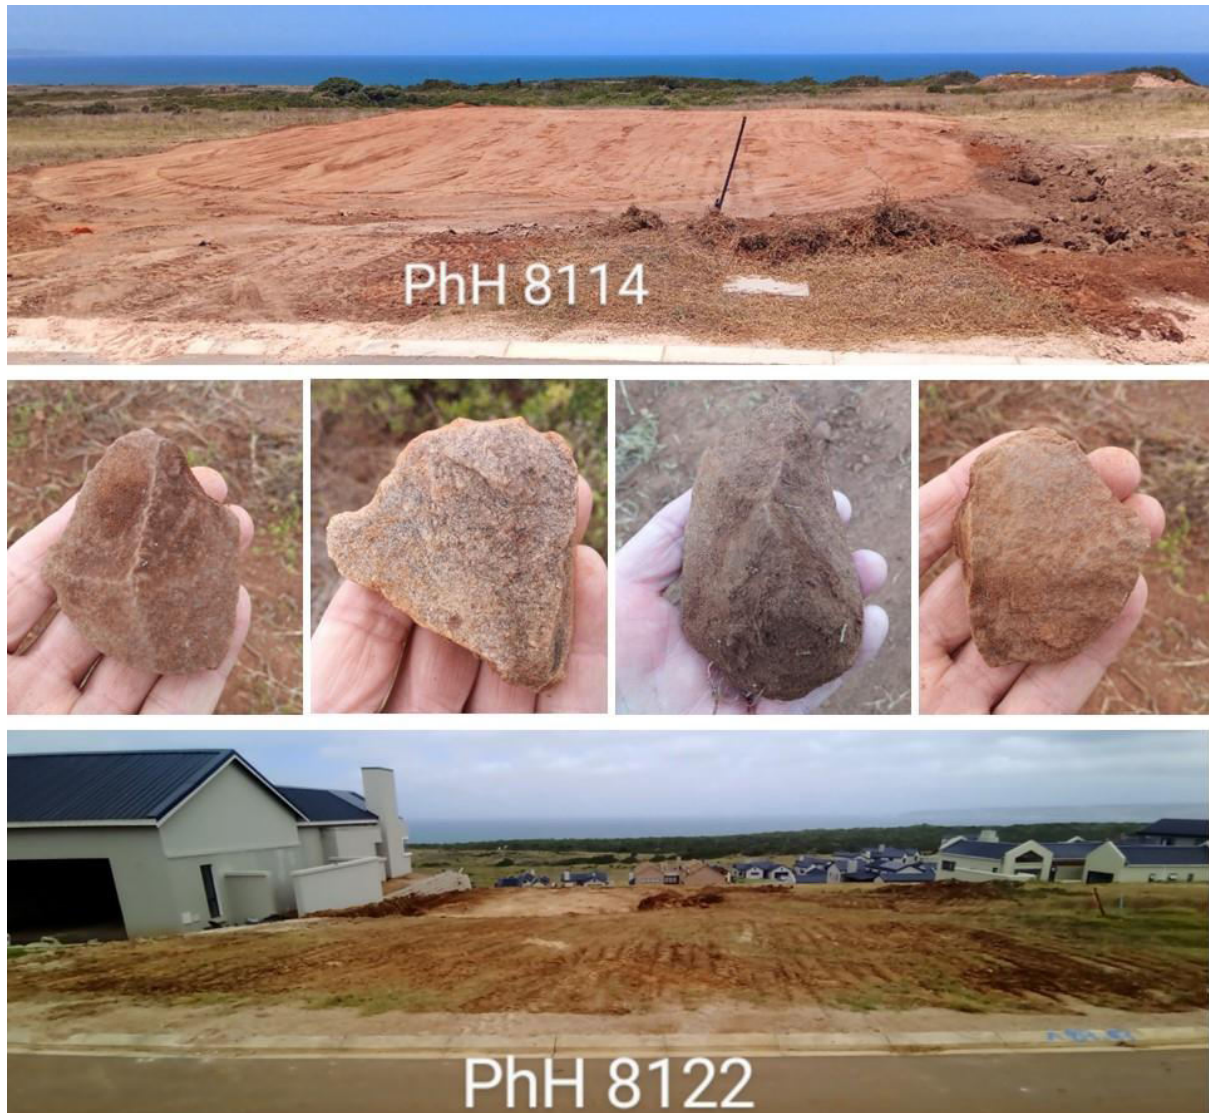
Excavations for house platforms in Phase H included the completion of Erven 8114 and 8122 (Figure 3). Identified artefacts are likely of Middle Stone Age origin and include flakes and flaked pieces in quartzite (Figure 3). Artefacts occur in isolation and are not associated with any other cultural or organic remains. They are rated NCW and require no further investigation, mitigation or management.

Figure 3. Hartland - Phase H – completed platforms and Stone Age artefacts recorded at 8122 (middle).

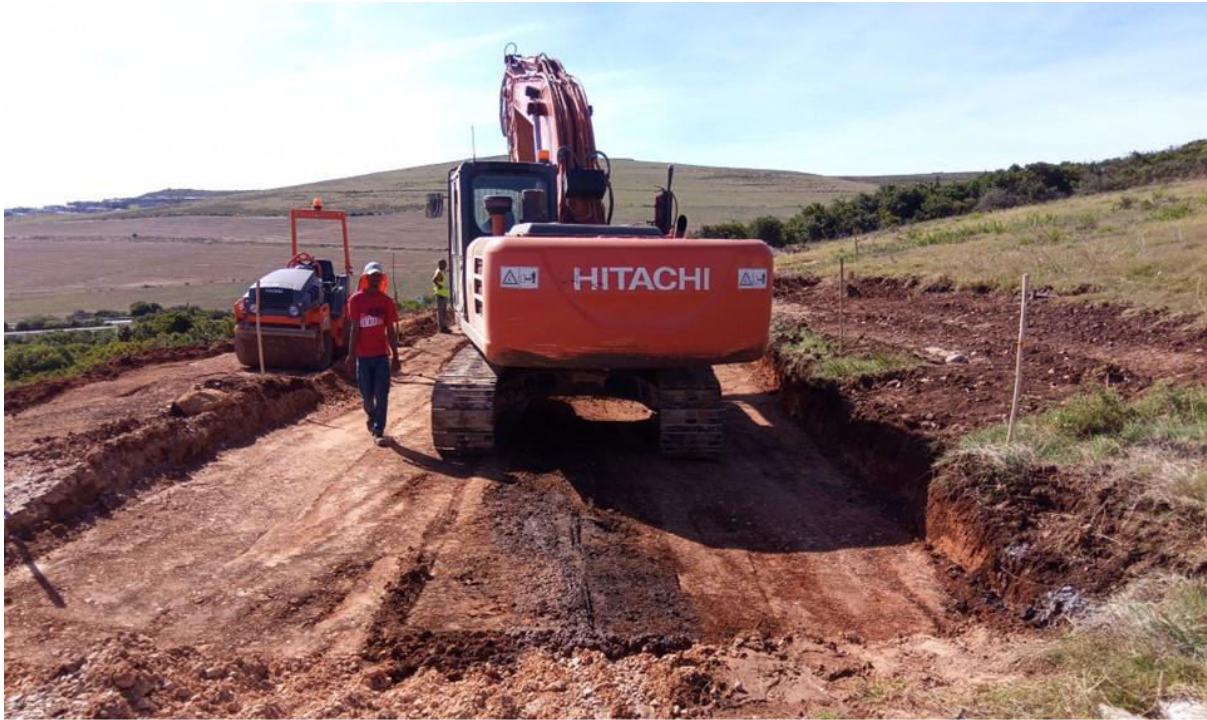
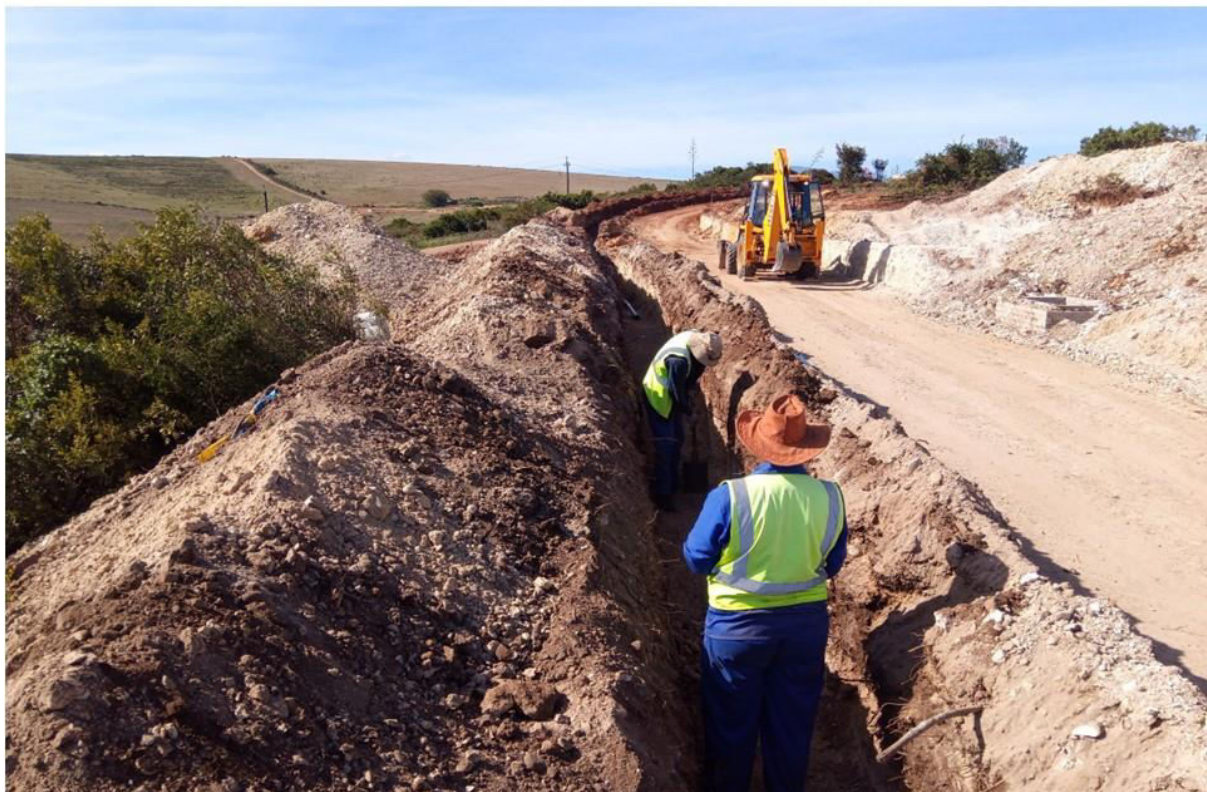
Earthworks involved road box cuts and verge shaping/trimming and the excavation of trenches for water and sewer pipelines (Figures 4, 5 & 6). No definitive heritage resources were identified.

Figure 4. Hartland – Phase H2 Civils – excavation of road box cuts and trenches in progress.

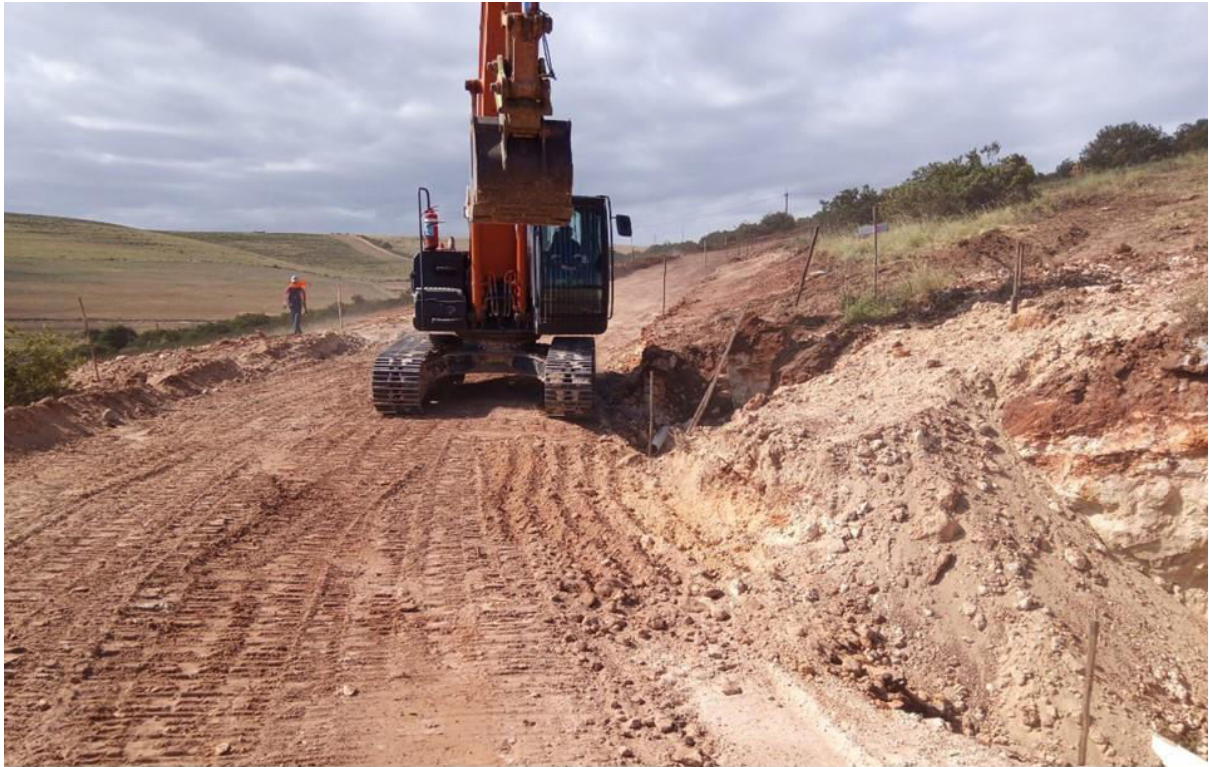
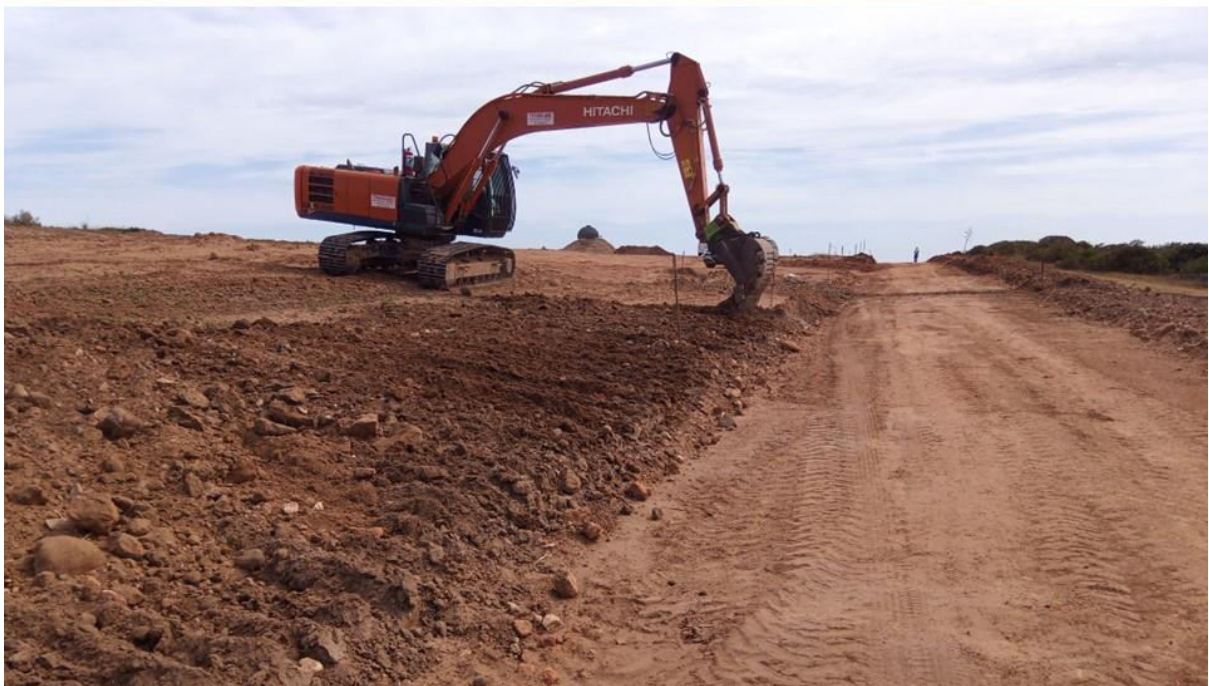
Figure 5. Hartland – Phase H2 Civils – road box cuts and verge “trimming” in progress.

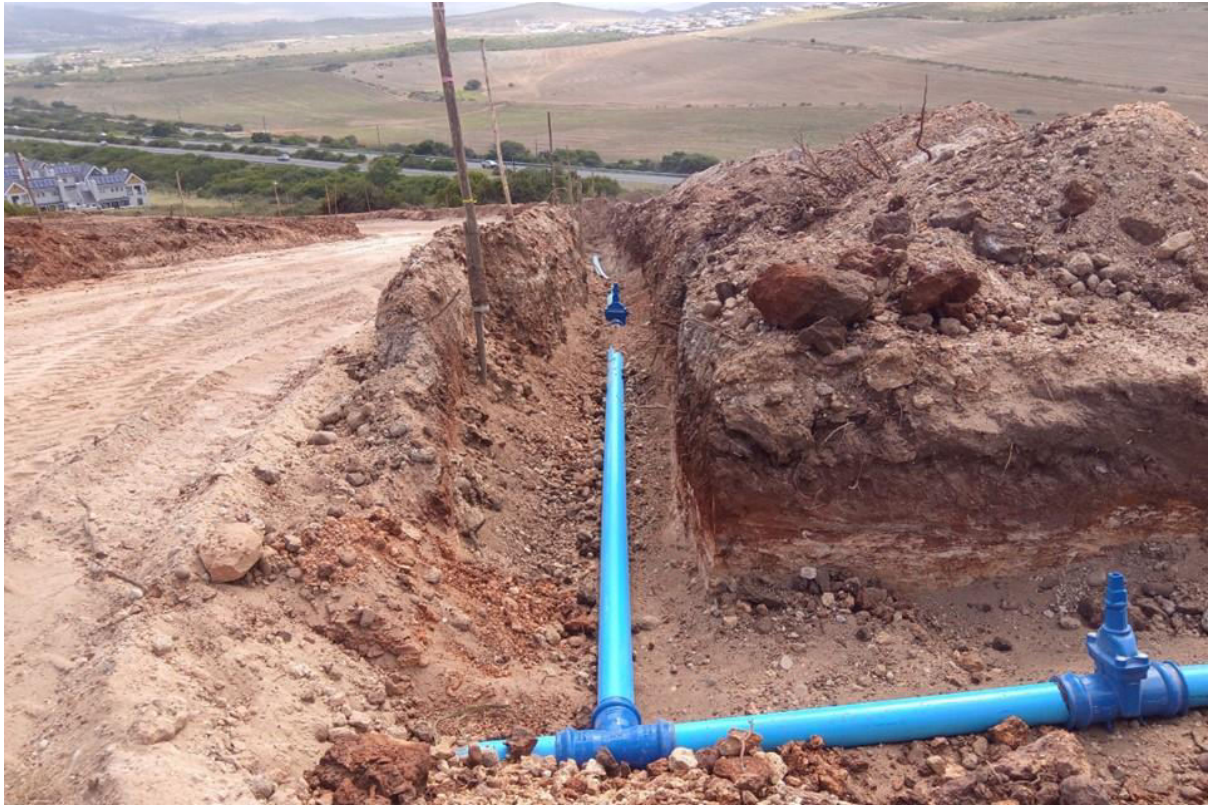
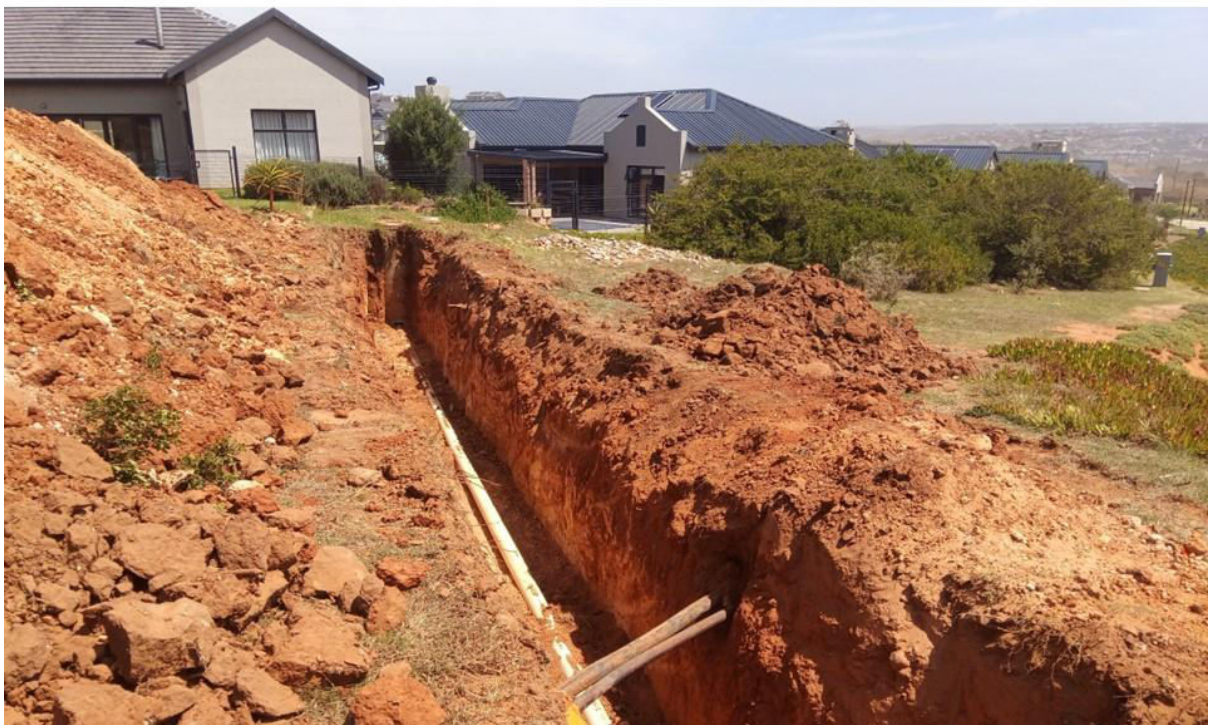
Figure 6. Hartland – Phase H2 Civils – water and sewer trenches.

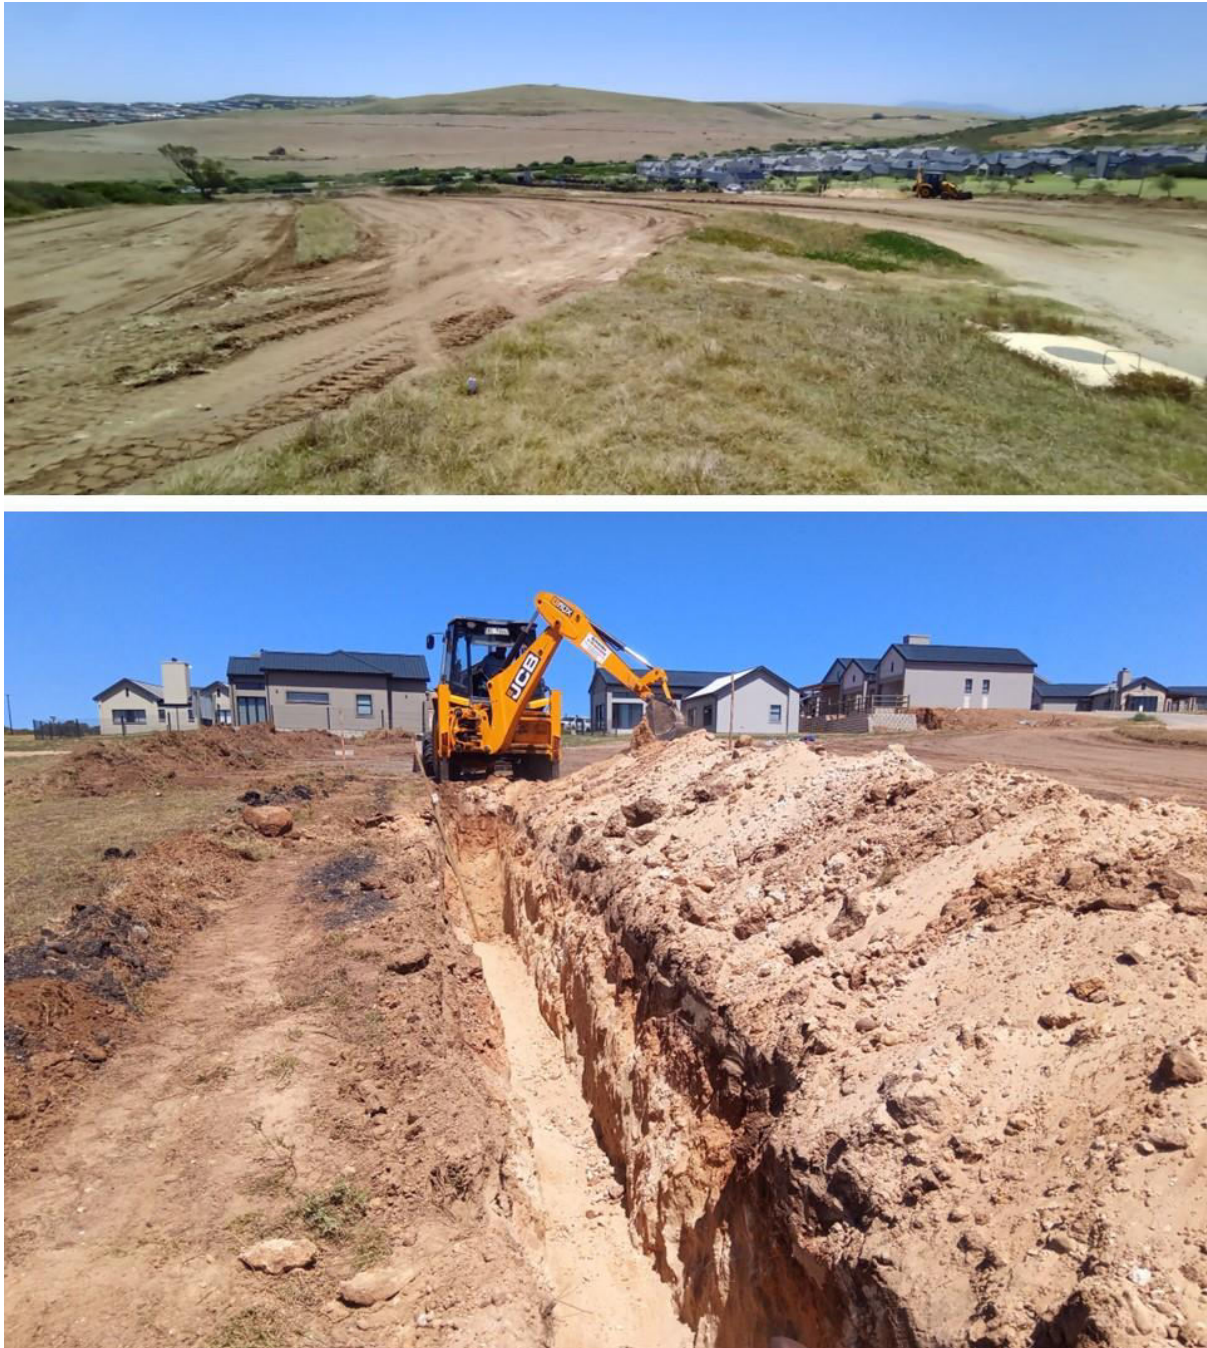
Works involved stripping of vegetation and grading as well as trench excavations for sewer pipes (Figures 7 & 8).

Figure 7. Hartland – Phase A – Klein Karoo Civils – vegetation stripping and excavations in progress.

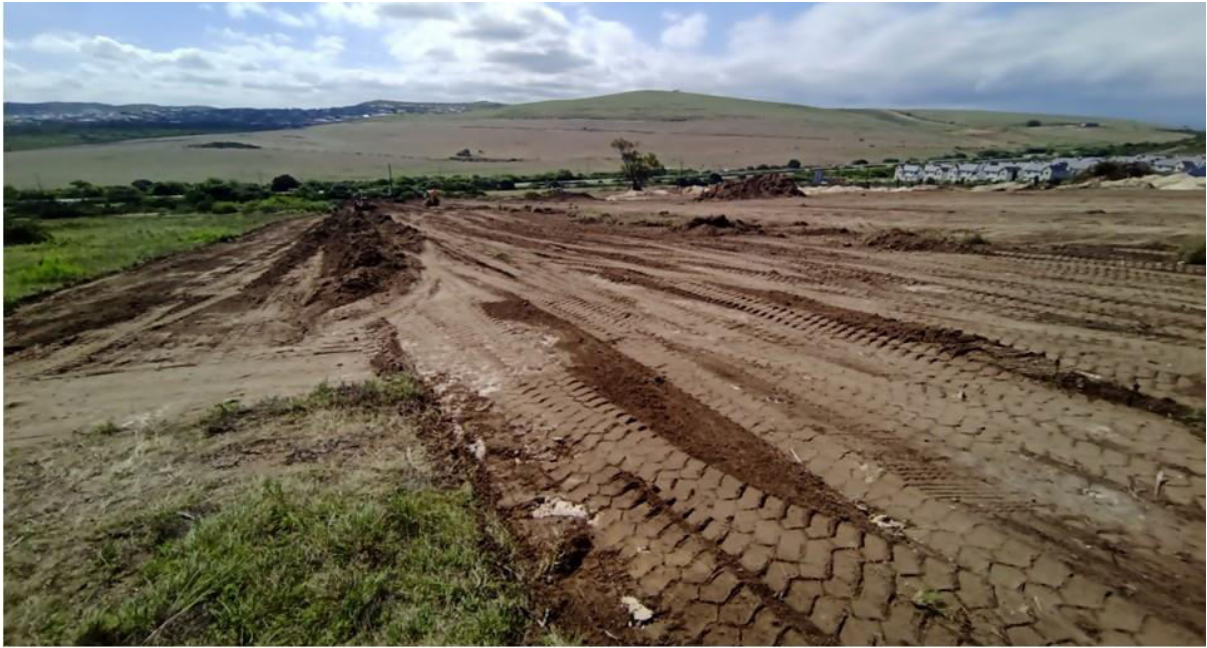
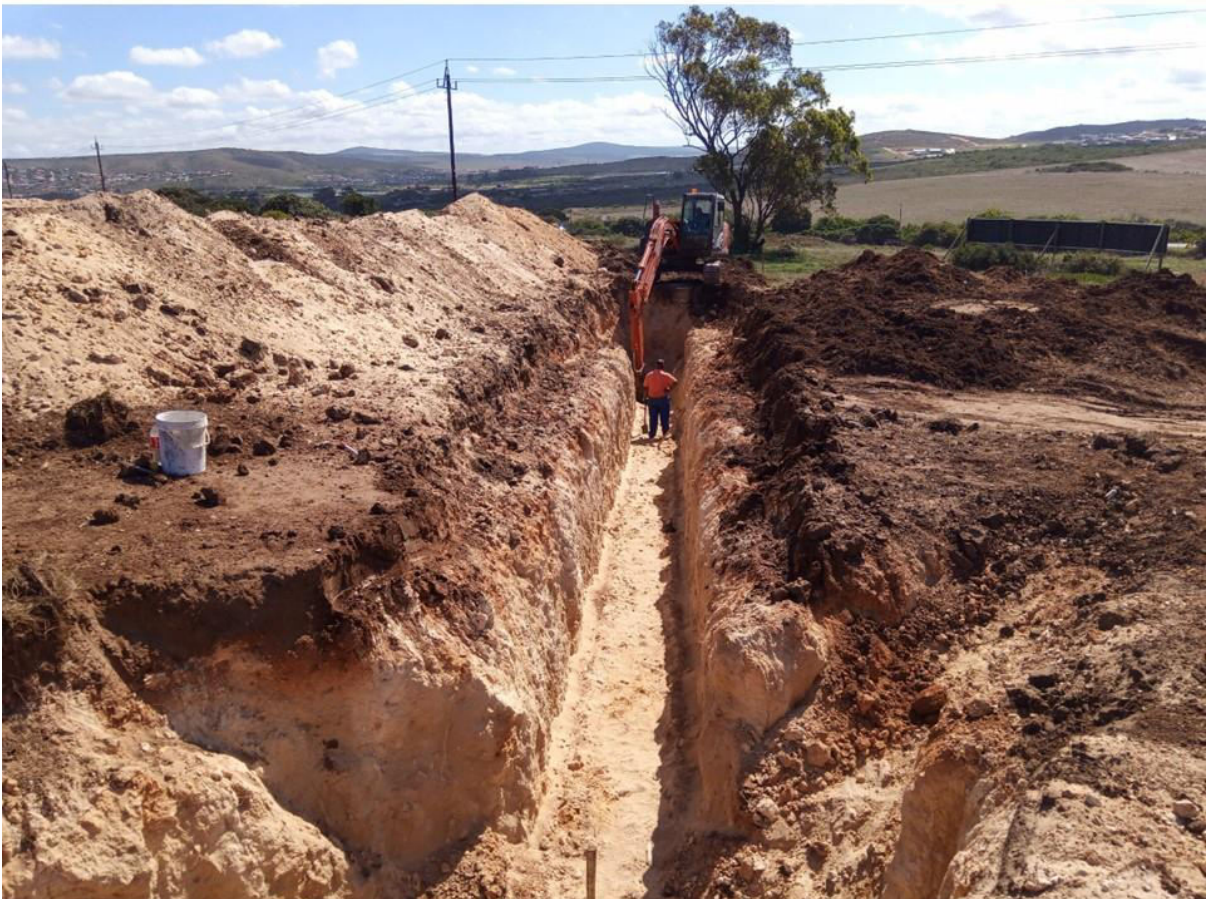
Figure 8. Hartland – Phase A – Klein Karoo Civils – vegetation stripping and excavations in progress.
