**ENVIRONMENTAL MONITORING REPORT NO. 41  
FOR  
HARTLAND ON  
PORTION 11 OF FARM VAALE VALLEY 219, MOSSEL BAY**

**MOS24/1027/69**

**December 2024 & January 2025**

## ENVIRONMENTAL MONITORING REPORT NO. 41 – DECEMBER 2024 AND JANUARY 2025

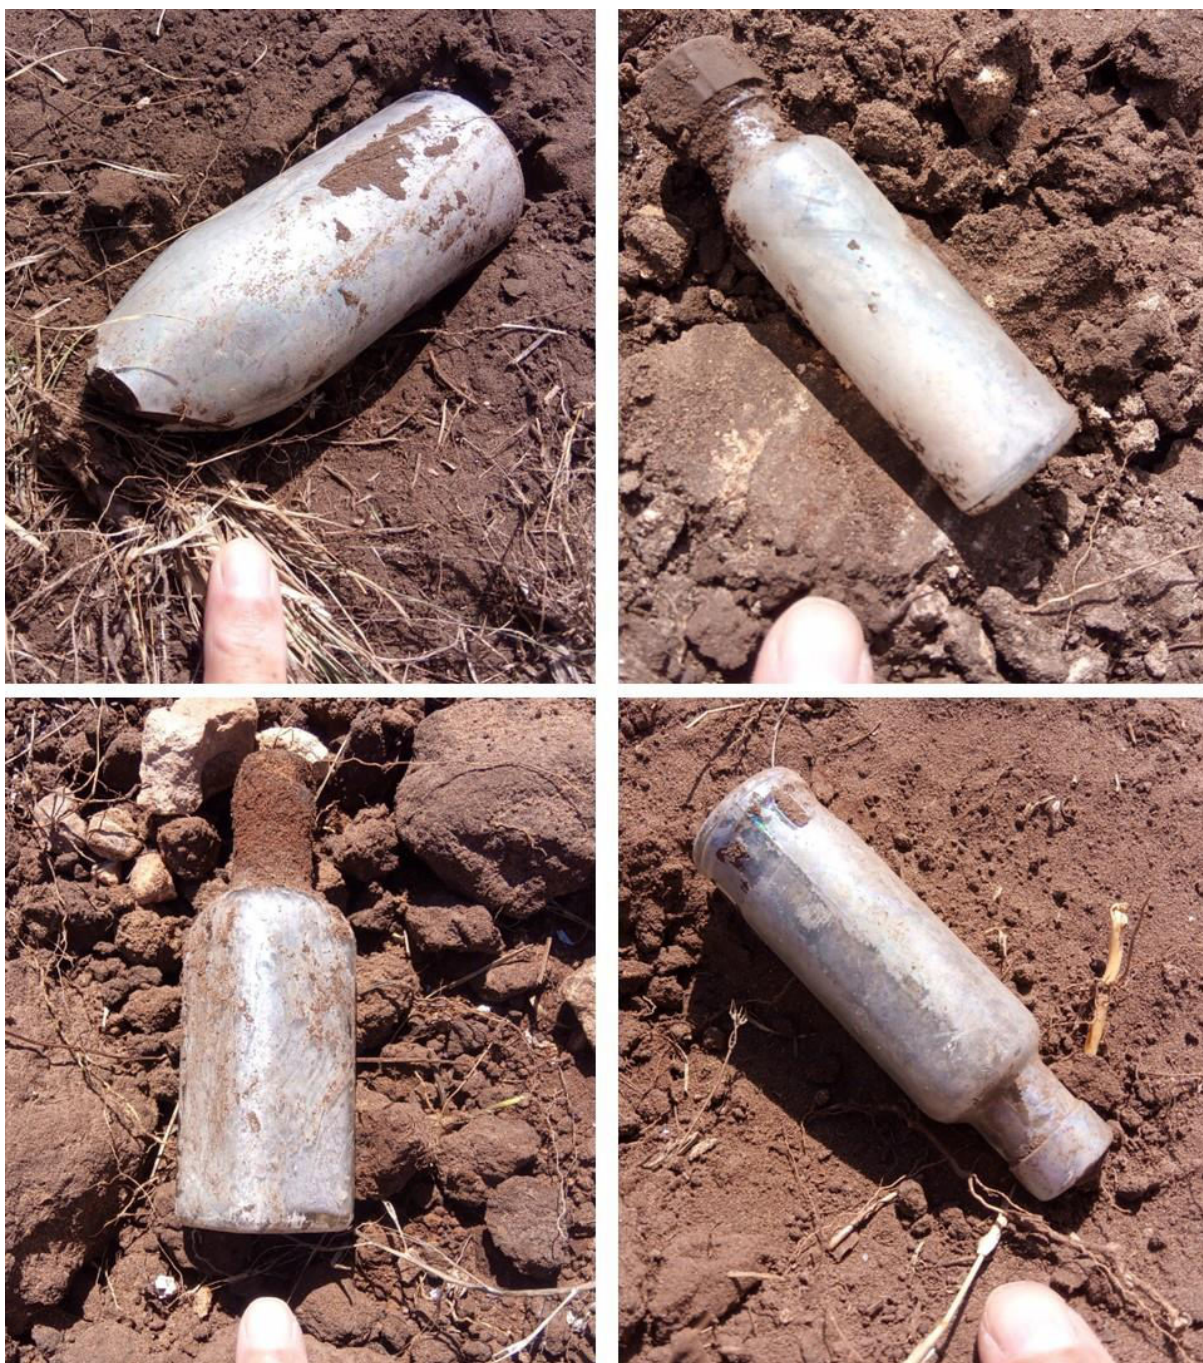
Identified heritage resources included modern/colonial period glass, ceramics and metal (Figure 9) and a few Stone Age specimens of indeterminate age including flakes and flaked quartzite cobble (Figure 10). The modern materials are NCW.

Figure 9. Hartland – Phase A – Klein Karoo Civils – examples of modern / colonial period glass bottles.

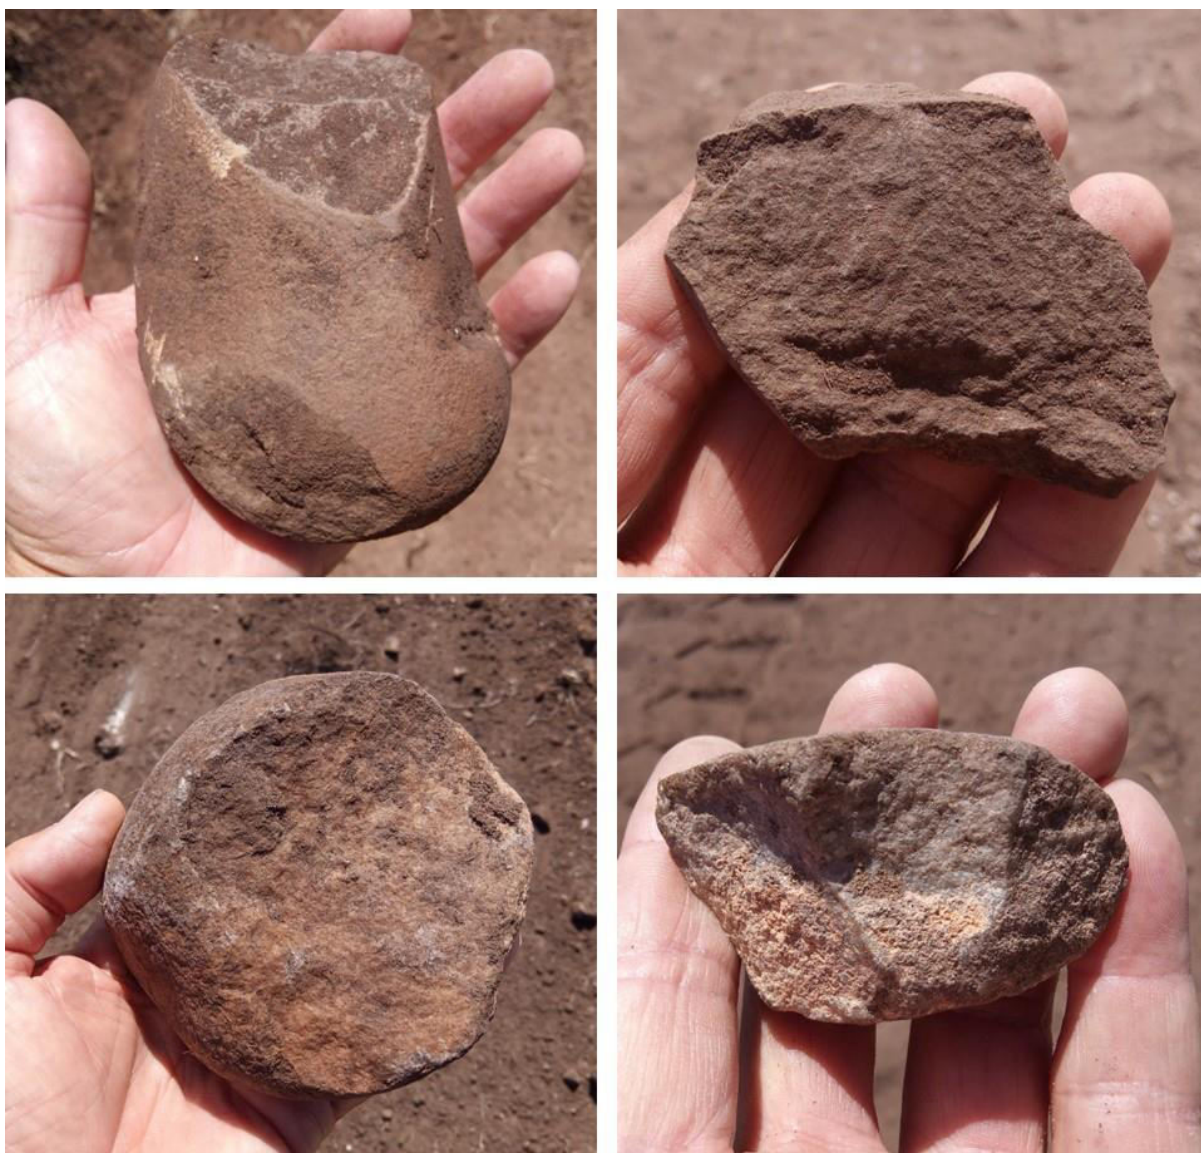
No definitive Early Stone Age pieces were recorded. Stone Age artefacts occur in isolation and are not associated with any other cultural or organic remains. They are rated NCW and require no further investigation, mitigation or management.

Figure 10. Hartland – Phase A – Klein Karoo Civils – examples of Stone Age stone artefacts.
