**ENVIRONMENTAL MONITORING REPORT NO. 42  
FOR  
HARTLAND ON  
PORTION 11 OF FARM VAALE VALLEY 219, MOSSEL BAY**

## ENVIRONMENTAL MONITORING REPORT NO. 42 – FEBRUARY 2025

**HARTLAND DEVELOPMENT- PORTION 11 OF FARM VAALE VALLEY 219, MOSSEL BAY****Conditions of report use:**

# Archaeological monitoring report for Hartland Lifestyle Estate

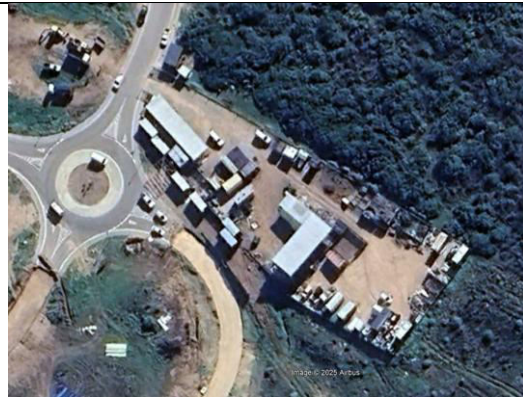
| EMPr requirements | Level of compliance | Comments / Findings | Photos (if applicable) |
|---|---|---|---|
| <p>The site camp must be set up prior to the start of construction and clearly demarcated to illustrate NO-GO areas.</p> | Compliant | <p>The same site camp is being used, located in the development zone and complies with the requirements and recommendations.</p> | <p>Google Earth</p> |

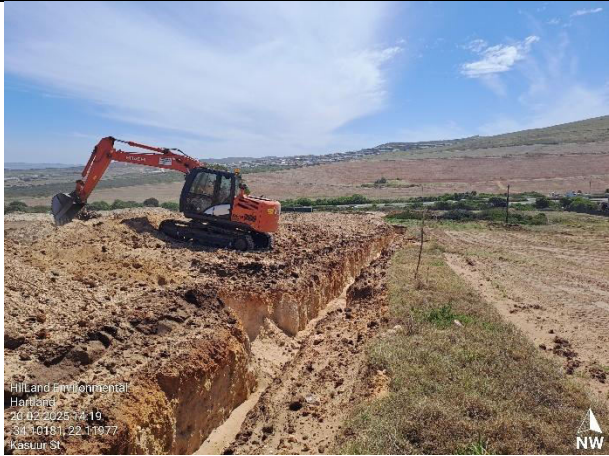
| <p>All sensitive areas, which must not be disturbed, must be demarcated using a 1.2m high fence constructed of shade cloth netting (<b>or similar product</b>), staked at regular intervals. Where a fence is considered impractical No-Go signs should be erected at frequent intervals along the edge of the no-go areas in consultation with the ECO.</p> | <p><b>Compliant</b></p> | <p>The working zone is pegged by the surveyor before construction starts</p> <p>The conservation area/natural vegetation adjacent to the Retirement village is demarcated with a suitable fence.</p> <p>Right-turn Lane sensitive areas (road reserve) have been pointed out to the contractor.</p> | |

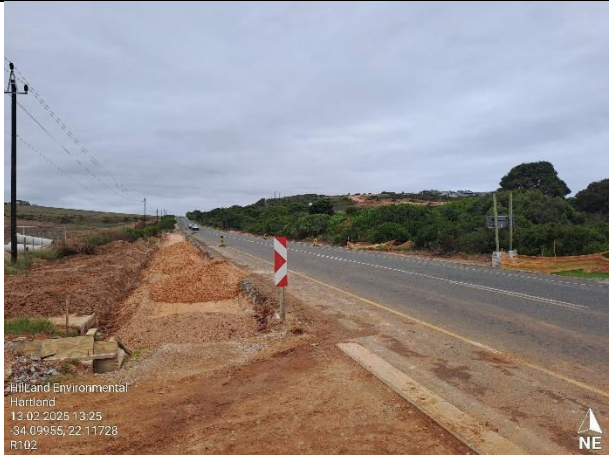
| No clearing outside of development and infrastructure footprint area to take place. | Compliant | Clearing takes place within the demarcated development footprint / pegged working area - the contractor is compliant with this requirement for phase H2 and Right-Turn Lane. | <p>Right-turn Lane</p> |

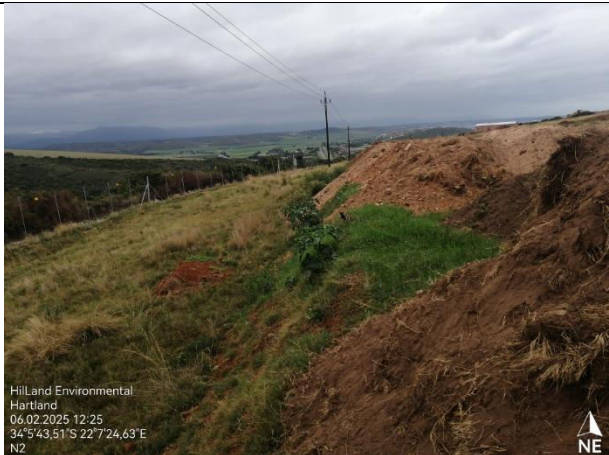
| Topsoil stripping | | | |
|---|---|---|---|
| Topsoil must be neatly removed and stored away without contamination. It is also to be used for rehabilitation once construction is complete. | Compliant & ongoing | <p>Topsoil is placed next to open trenches (windrow) for use during rehabilitation.</p> <p>Bulk topsoil stockpile sites for Retirement village and Fynbos Heuwels were approved by the ECO – internal open space of the retirement village.</p> <p>Subsoil will be stockpiled according to the earthworks master plan and covered with topsoil.</p> | <p>HillLand Environmental<br/>Hartland<br/>06.02.2025 12:25<br/>34°5'43.51"S 22°7'24.63"E<br/>N2</p> <p>Swale – topsoil cover</p> |

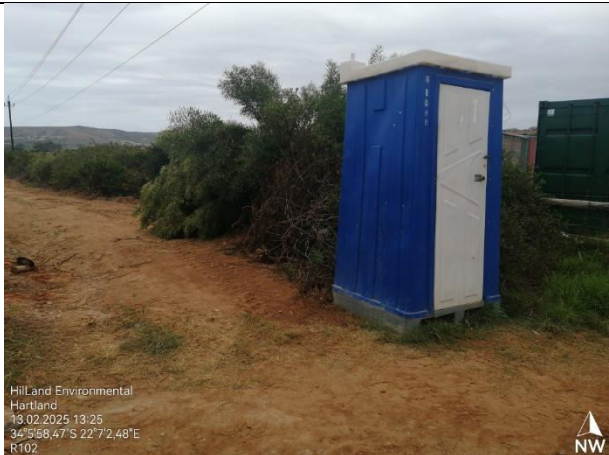
| Topsoil stripping | | | |
|---|---|---|---|
| Chemical toilets must be kept at the site camp, on a level surface and secured from blowing over. | Compliant & ongoing | There is adequate ablution facilities located throughout the site and at the site camp – no environmental issues noted during this reporting period. | <p>HillLand Environmental<br/>Hartland<br/>13.02.2025 13:25<br/>34°5'58.47"S 22°7'2.48"E<br/>R102</p> <p>Right-turn Lane</p> |

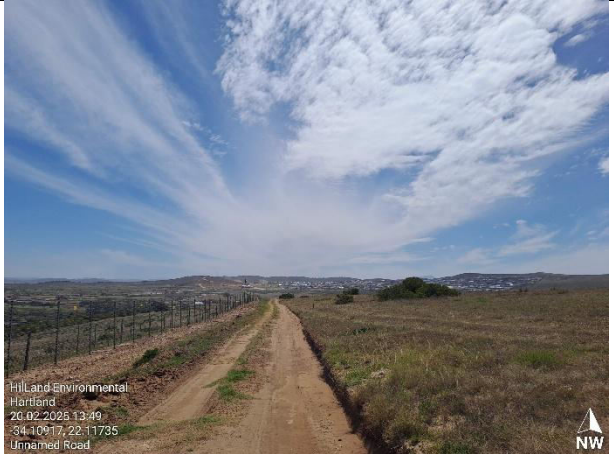
| All construction vehicles need to adhere to traffic laws. The speed of construction vehicles and other heavy vehicles must be strictly controlled to avoid dangerous conditions for other road users. As far as possible care should be taken to ensure that the local traffic flow pattern is not significantly disrupted. | Compliant & ongoing | No environmental issues to report. Construction vehicle movement is in general confined to the existing roads and/or construction haul roads. | <p>Hilland Environmental<br/>Hartland<br/>20.02.2026 13:49<br/>34.10917, 22.11735<br/>Unnamed Road</p> <p>NW</p> |

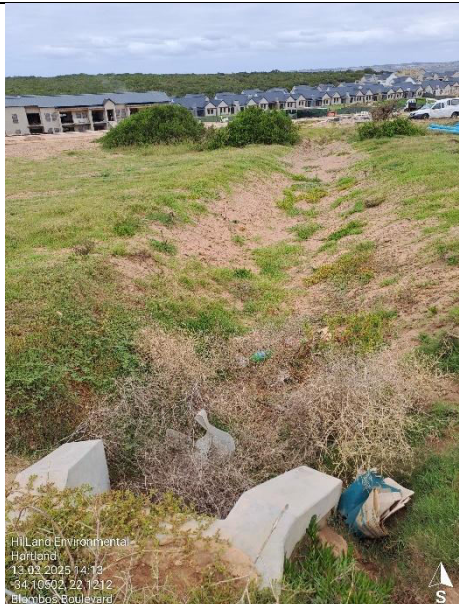
| <b>Soil erosion mitigation</b> | | | |
|---|---|---|---|
| Erosion control measures including silt fences, low soil berms and/or shutter boards must be put in place around the stockpiles to limit sediment runoff from stockpiles. | Ongoing | <p>Currently no erosion protection is required for the current construction period.</p> <p>It is recommended to install silt fences to capture silt runoff once the stormwater outlets have been construction.</p> | <p>Hilland Environmental<br/>Hartland<br/>13.03.2025 14:13<br/>34.10501 22.1212<br/>Blenbois Boulevard</p> |

| <b>Soil erosion mitigation</b> | | | |
|---|---|---|---|
| Areas which have been covered with topsoil from the stockpiles, and which may be subject to erosion should be stabilized. | Ongoing | Rehabilitation follows the construction phase. Road verges are covered with topsoil and the steeper sections will require erosion protection (silt fences or sandbags). This will be necessary for Phase H2. | |

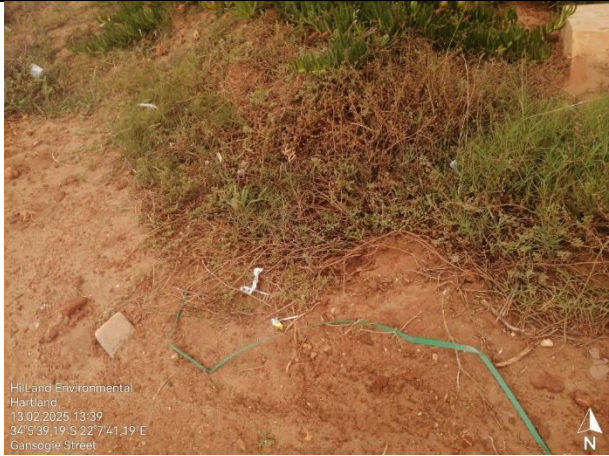
| Construction workers must be instructed not to litter and to place all waste in the appropriate waste bins provided on site. | Ongoing | <p>No environmental issues to report.</p> <p>Regular litter picking is being done by the HOA. Civil and building contractor to ensure their working areas are litter free (<b>all phases</b>).</p> | <p>Hilland Environmental<br/>Hartland<br/>13.02.2025 13:39<br/>34°5'39.19"S 22°7'41.19"E<br/>Gansobie Street</p> <p>Ongoing litter picking to be done</p> |

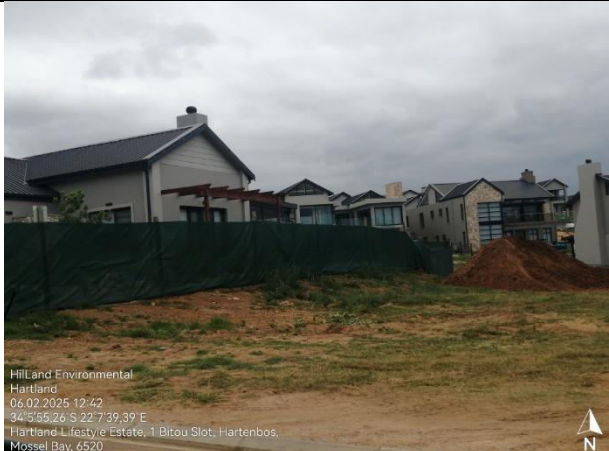
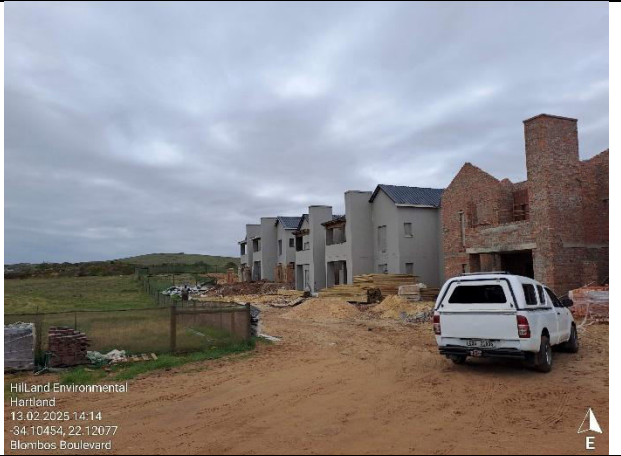
| EMPr requirements | Level of compliance | Comments / Findings | Photos (if applicable) |
|---|---|---|---|
| <p>All sensitive areas, which must not be disturbed, must be demarcated using a 1.2m high fence constructed of shade cloth netting (<b>or similar product</b>), staked at regular intervals. Where a fence is considered impractical No-Go signs should be erected at frequent intervals along the edge of the no-go areas in consultation with the ECO.</p> | Ongoing | <p>Housing construction sites that border sensitive areas are demarcated.</p> <p>Fynbos Heuwels and the Retirement Village are demarcated with wire fences.</p> | <p>Hilland Environmental<br/>Hartland<br/>06.02.2025 12:42<br/>34°55'26"S 22°7'39.39"E<br/>Hartland Lifestyle Estate, 1 Bitou Slot, Hartenbos,<br/>Mossel Bay, 6520</p> |

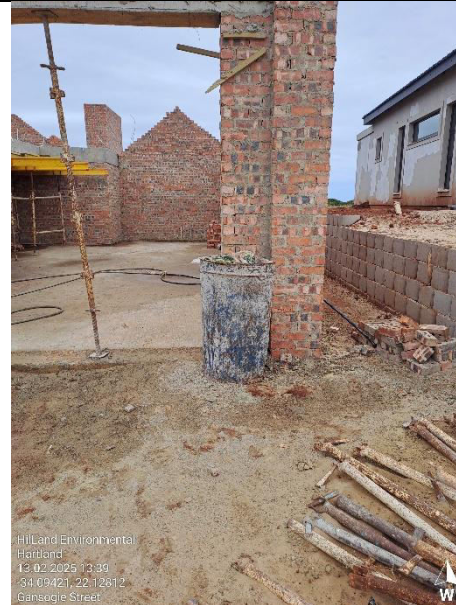
| Dedicated waste bins or skips must be provided on site and kept in a demarcated area on an impermeable surface. | Ongoing | <p><b>Compliant</b> - The contractor placed additional waste bins at each construction site which are emptied weekly. Skips are placed strategically throughout the site and are demarcated with shade netting (to prevent wind from blowing litter).</p> <p><b>Ongoing and compliant</b> - Wind-blown litter remains an ongoing construction related problem. Therefore, the contractor has a dedicated litter picking team conducting weekly litter picking. The HOA has also appointed a dedicated litter picker.</p> | <p>Hilland Environmental<br/>Hartland<br/>13.02.2025 12:39<br/>34.69421, 22.12812<br/>Gansugie Street</p> |

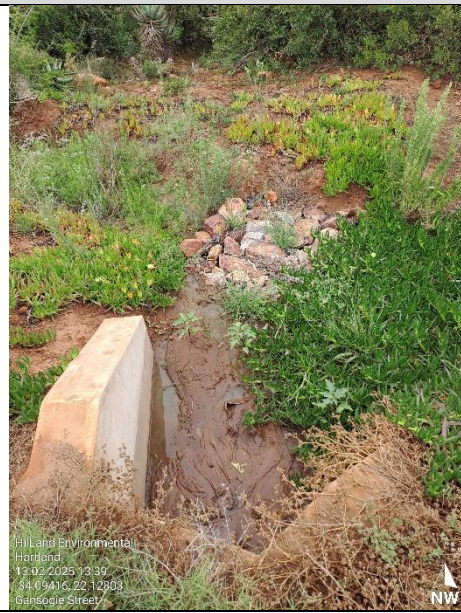
| OEMPr requirements | Level of compliance | Comments / Findings | Photos (if applicable) |
|---|---|---|---|
| Waste traps must be cleared of any obstructions monthly or when heavy rainfall has occurred. | Ongoing | Litter and silt wash have been removed from stormwater outlets and must be monitored by the HOA and management – ongoing activity that the HOA is managing. | |

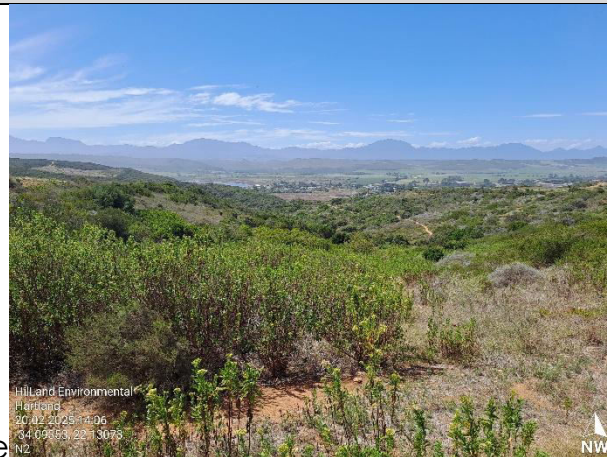
| MANAGEMENT OF NATURAL OPEN SPACES | | | |
|---|---|---|---|
| Natural open spaces must be managed properly to maintain ecological biodiversity and to provide limited and controlled recreational access to the residents living in this development. | Compliant and ongoing | <ul style="list-style-type: none"> <li>Initial alien clearing is done. <b>Ongoing follow up clearing/eradication to be implemented.</b></li> <li>A section of the <i>Thamnochortus insignis</i> in the natural open space is being maintained - bossiekap.</li> <li>The existing tracks are being maintained as maintenance tracks and firebreaks (bossiekap).</li> <li>Hiking/cycling tracks in the development area, conservation area and internal open spaces must be monitored for erosion and damage (by the HOA) and repaired immediately to avoid excessive environmental damage.</li> <li>Viewing deck is maintained.</li> <li>Perimeter firebreaks are in places and maintained – avoid bare surfaces to limit soil erosion risk. Wood chips/<i>carpobrotus</i> etc. can be used to cover bare soil.</li> <li>Kweek lawns are installed at the newly completed houses.</li> <li>Conservation area “rules” boards are in place.</li> <li><i>Conyza</i> sp. in the valleys can be managed by brush cutting with a solid blade only – no herbicide. Extreme care must be taken when cutting the <i>conyza</i> to not cut or damage any indigenous vegetation within the valley. Ideally the <i>conyza</i> must be removed by hand pulling while it is still small and before it flowers – produce seed.</li> </ul> | <p>e<br/>Conyza in valleys</p> |

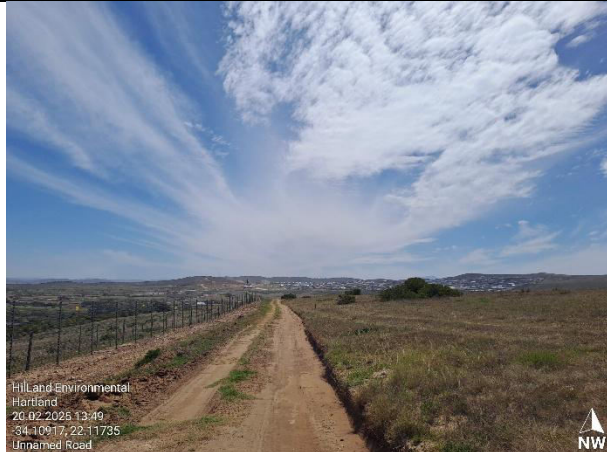
| Firebreaks surrounding and within the development must be managed properly. | Compliant | <b>No herbicides or “skoffeling”</b> must be used to maintain firebreaks. Make use of handheld operating equipment to maintain firebreak and minimize environmental risk. | <p>Hilland Environmental<br/>Hartland<br/>20.02.2025 13:49<br/>34.10417, 22.11735<br/>Unnamed Road</p> <p>NW</p> <p>Fence/firebreak to be managed by brush cutting only</p> |

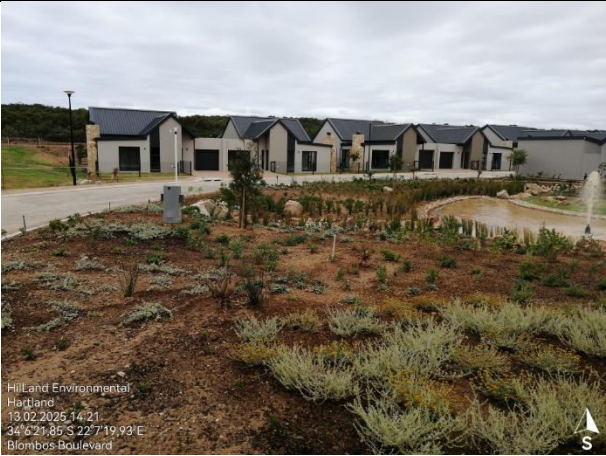
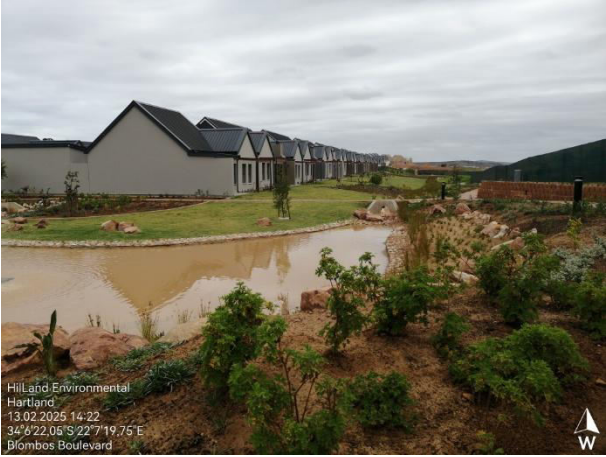
| | | | <div><p>HillLand Environmental<br/>Hartland<br/>13.02.2025 14:21<br/>34°6'21.85"S 22°7'19.93"E<br/>Blombos Boulevard</p></div> <p>Retirement village landscaping</p> <div><p>HillLand Environmental<br/>Hartland<br/>13.02.2025 14:22<br/>34°6'22.06"S 22°7'19.75"E<br/>Blombos Boulevard</p></div> <p>Retirement village stormwater management</p> |

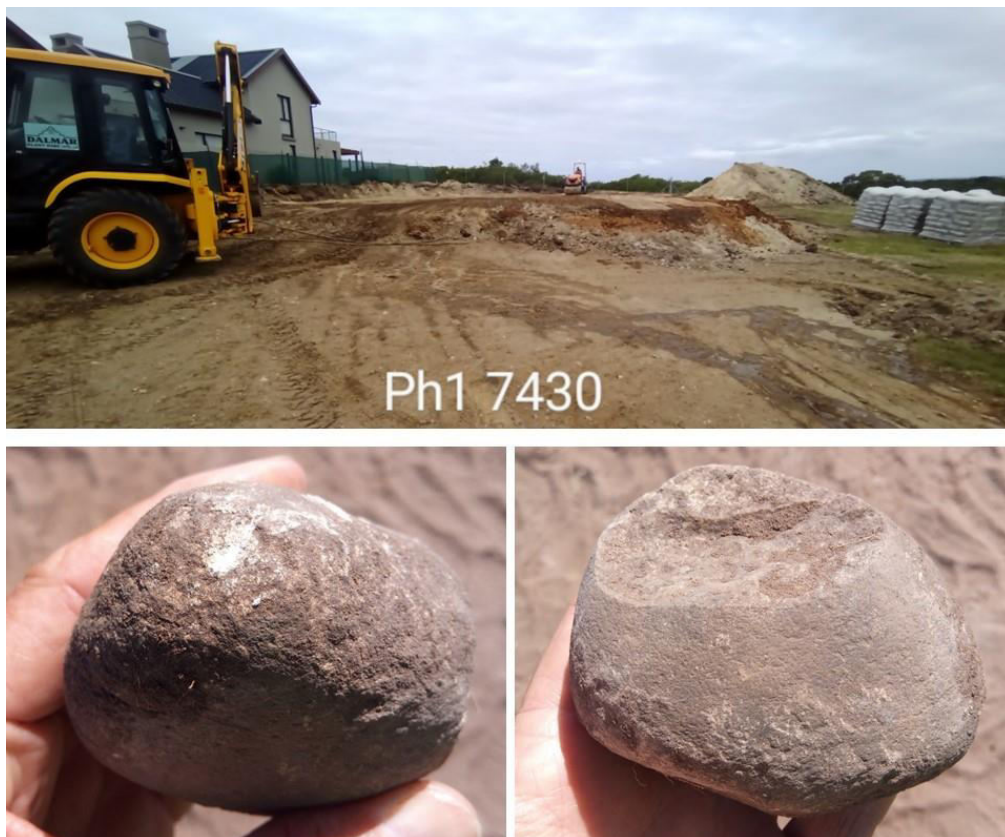
Erf 7640 (not notified) was the only house platform completed in Phase 1. A single combination hammerstone / grindstone in quartzite was (Figure 1). Due to its isolated nature and the entire absence of associated organic or cultural remains, the find is rated Not Conservation Worthy (NCW) and requires no further study, mitigation or management.

Figure 1. Hartland – Phase 1 – completed platform and hammerstone/grindstone.

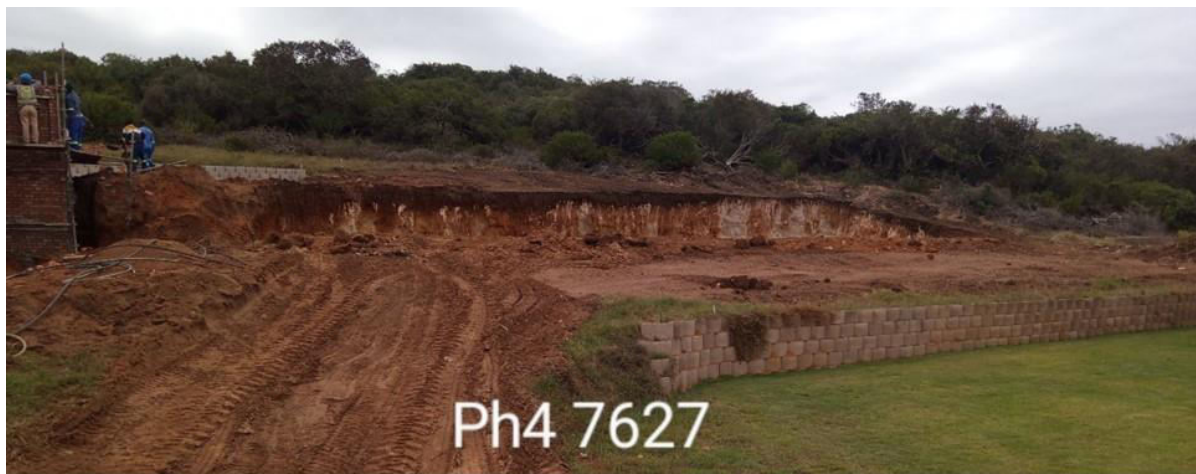
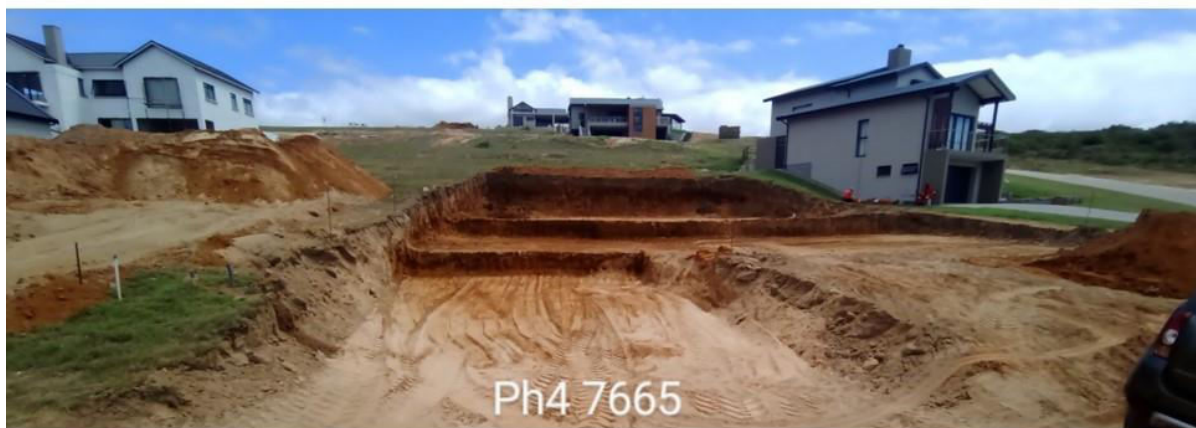
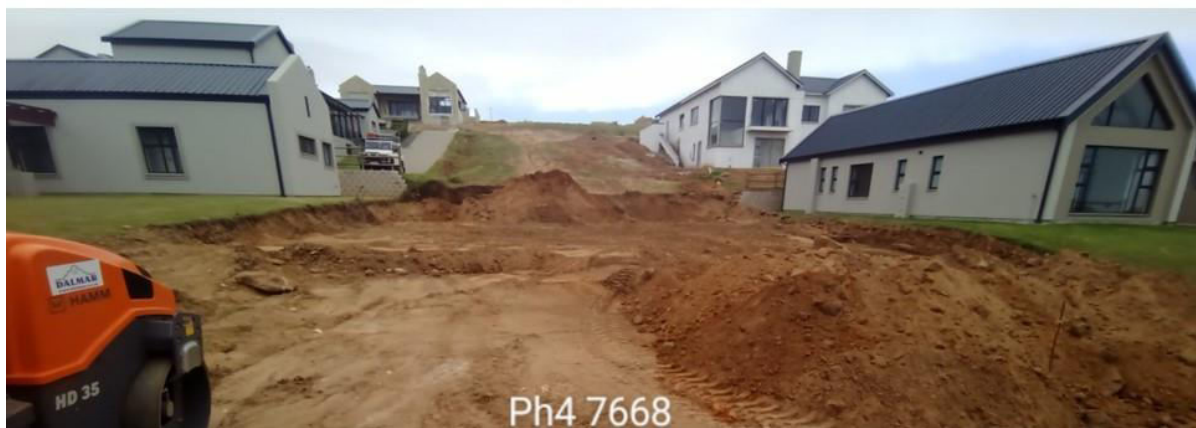
House platforms in Phase 4 included the completion of Erven 7627, 7665 (not notified), 7635 and 7647 while excavation at Erf 7668 continues, (Figures 2 & 3). A single Stone Age piece of flaked

Figure 2. Hartland - Phase 4 – completed house platforms except for 7668.

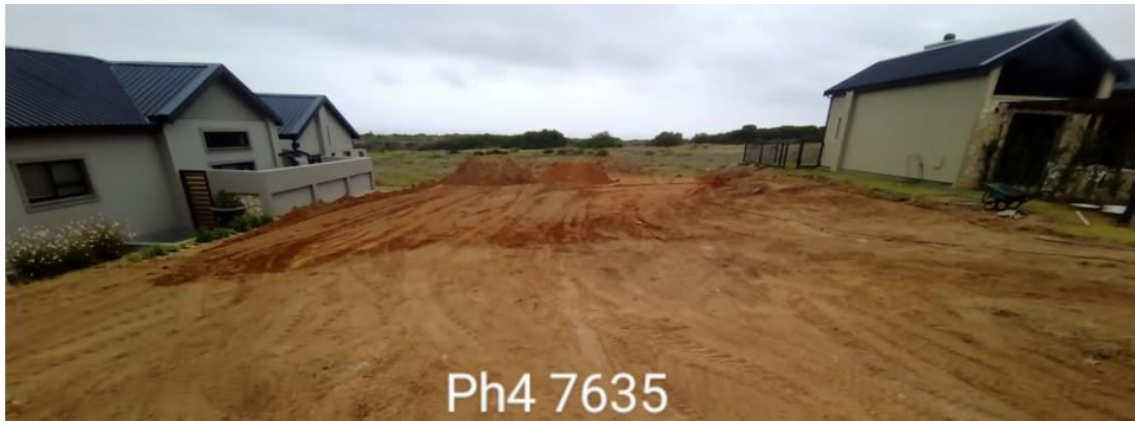
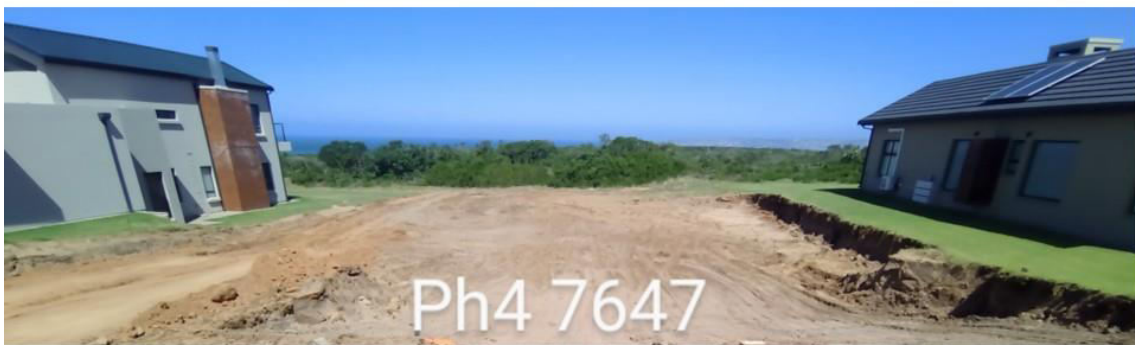
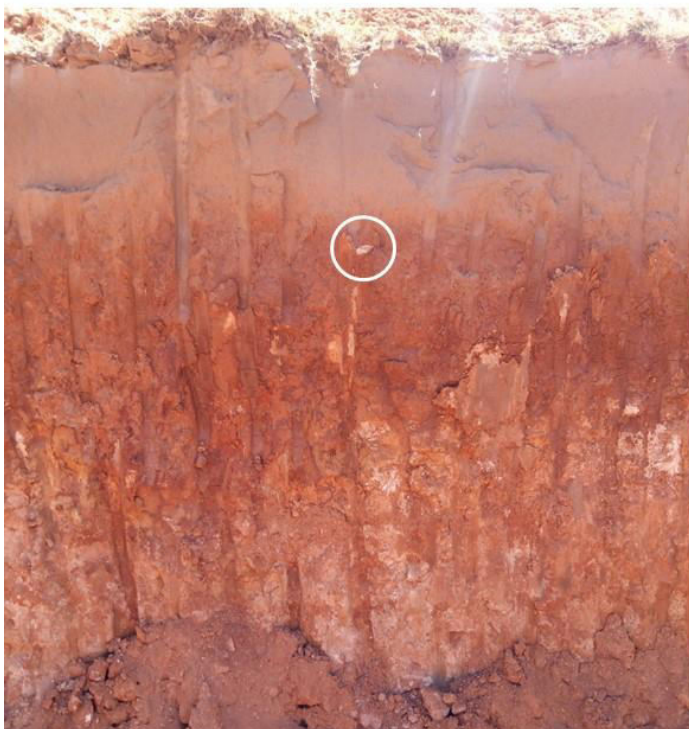
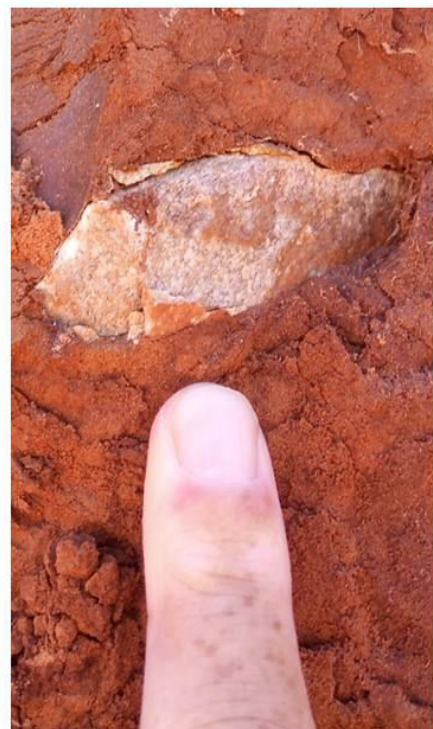
quartzite was seen in the exposed profile at Erf 7665 (Figure 3). Due to its isolated nature, the absence of an anthropogenic horizon and no associated organic or cultural remains, the find is rated as NCW and requires no further study, mitigation or management.

Figure 3. Hartland - Phase 4 – completed house platforms and in situ Stone Age piece at Erf 7665.

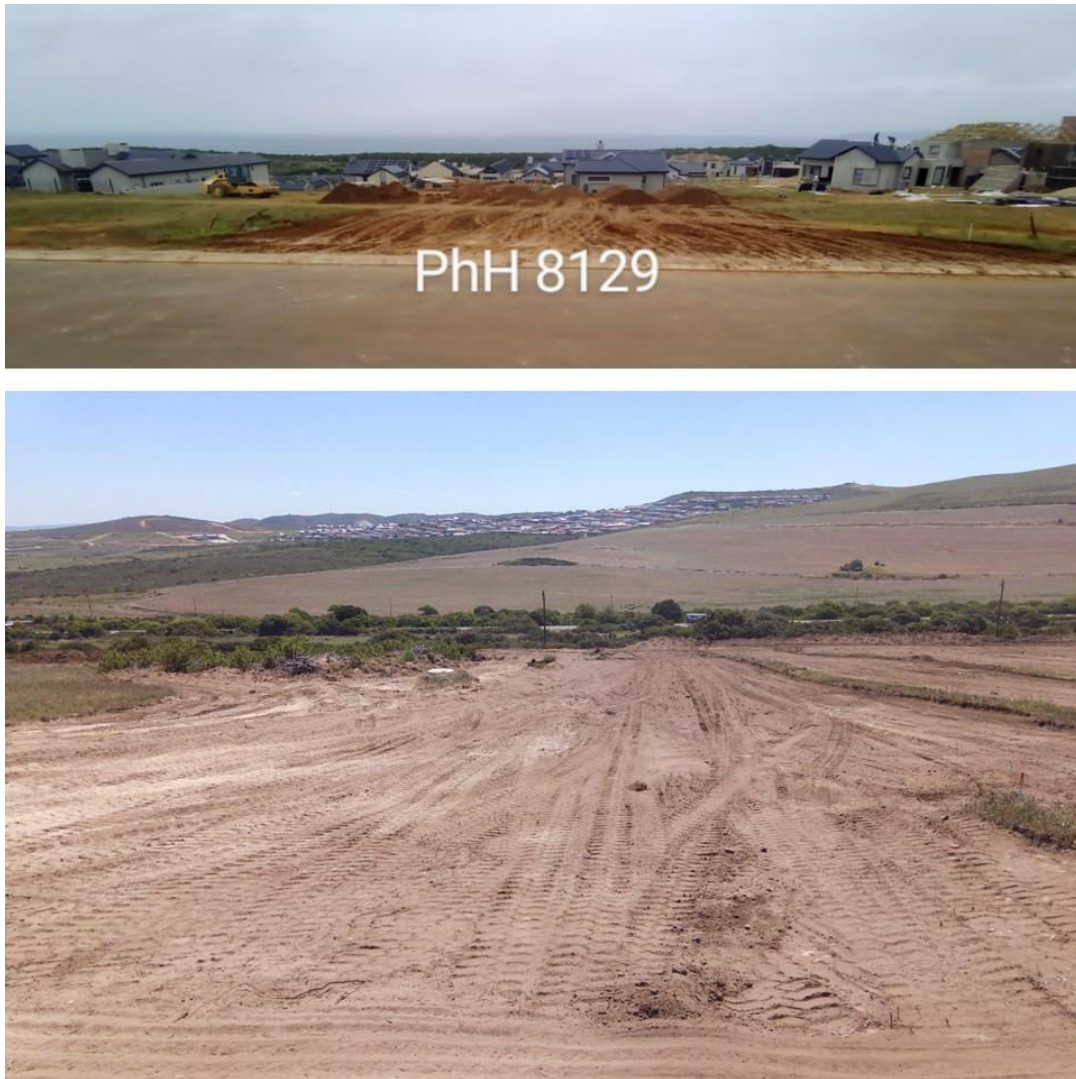
Excavations for house platforms in Phase H included the completion of Erven 8110 and 8115 (not notified & construction started). Vegetation and topsoil clearance is complete at Erf 8129 (not notified), but excavations are outstanding (Figure 4). No heritage resources were identified.

Figure 4. Hartland - Phase H, Erf 8129 cleared (top) and Phase A – Klein Karoo Civils, clearance of vegetation and topsoil (bottom).

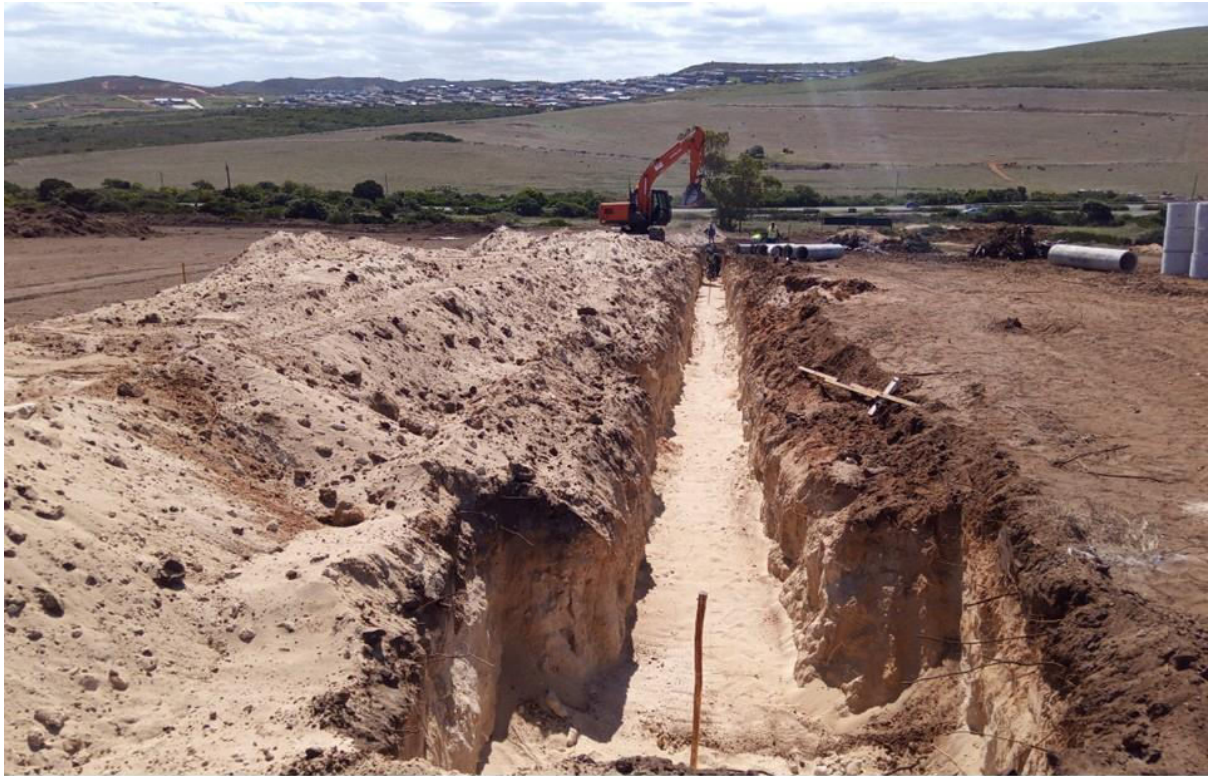
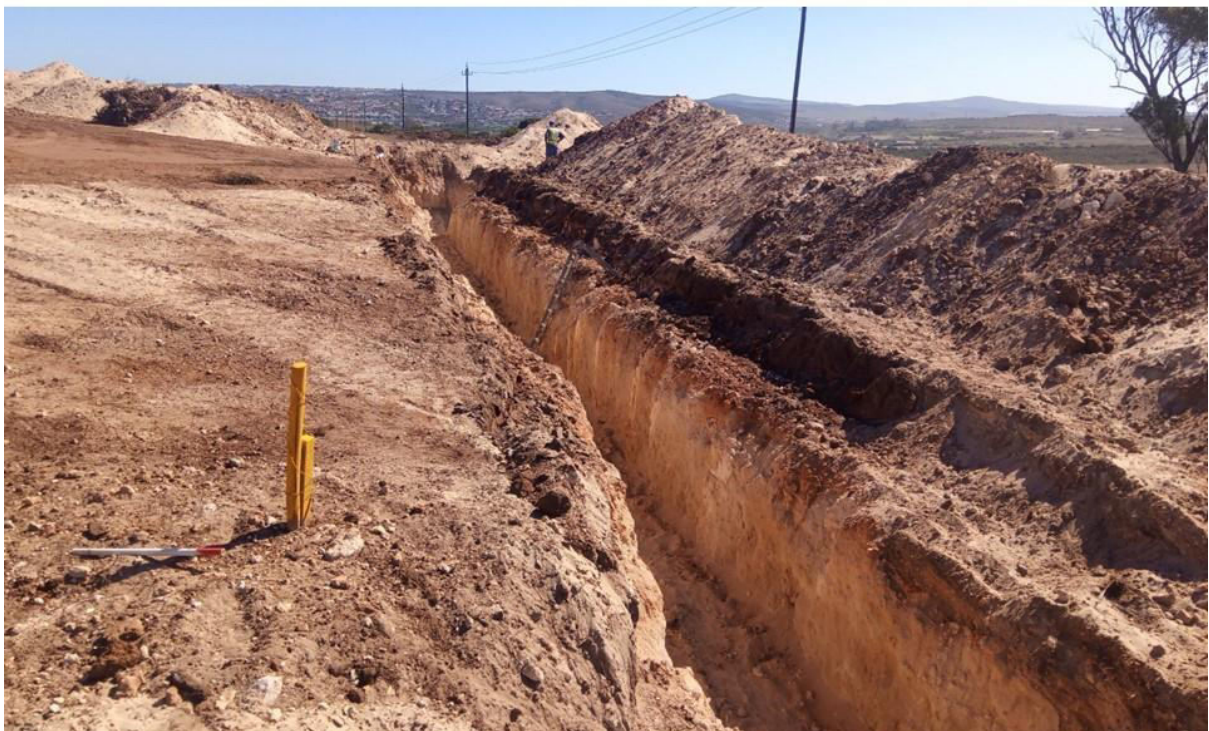
Figure 5. Hartland – Phase A – Klein Karoo Civils – storm water trench excavations in progress.

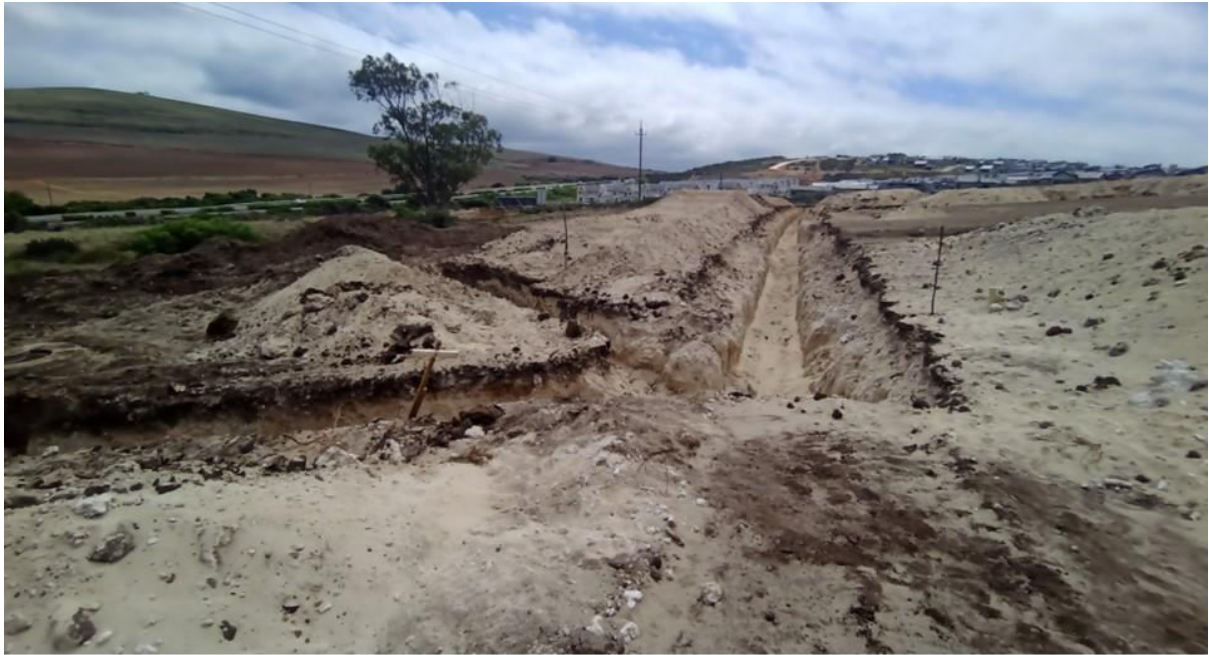
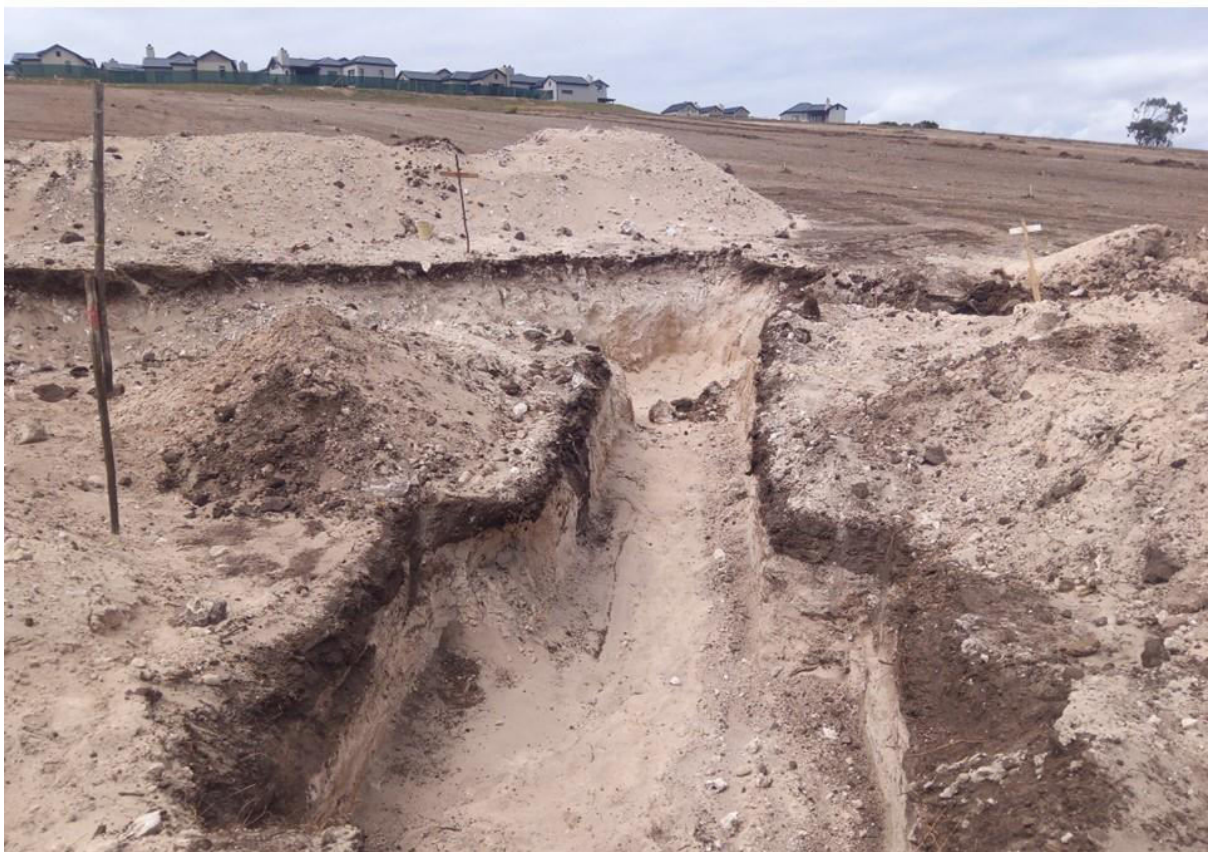
Figure 6. Hartland – Phase A – Klein Karoo Civils – storm water trench excavations in progress.

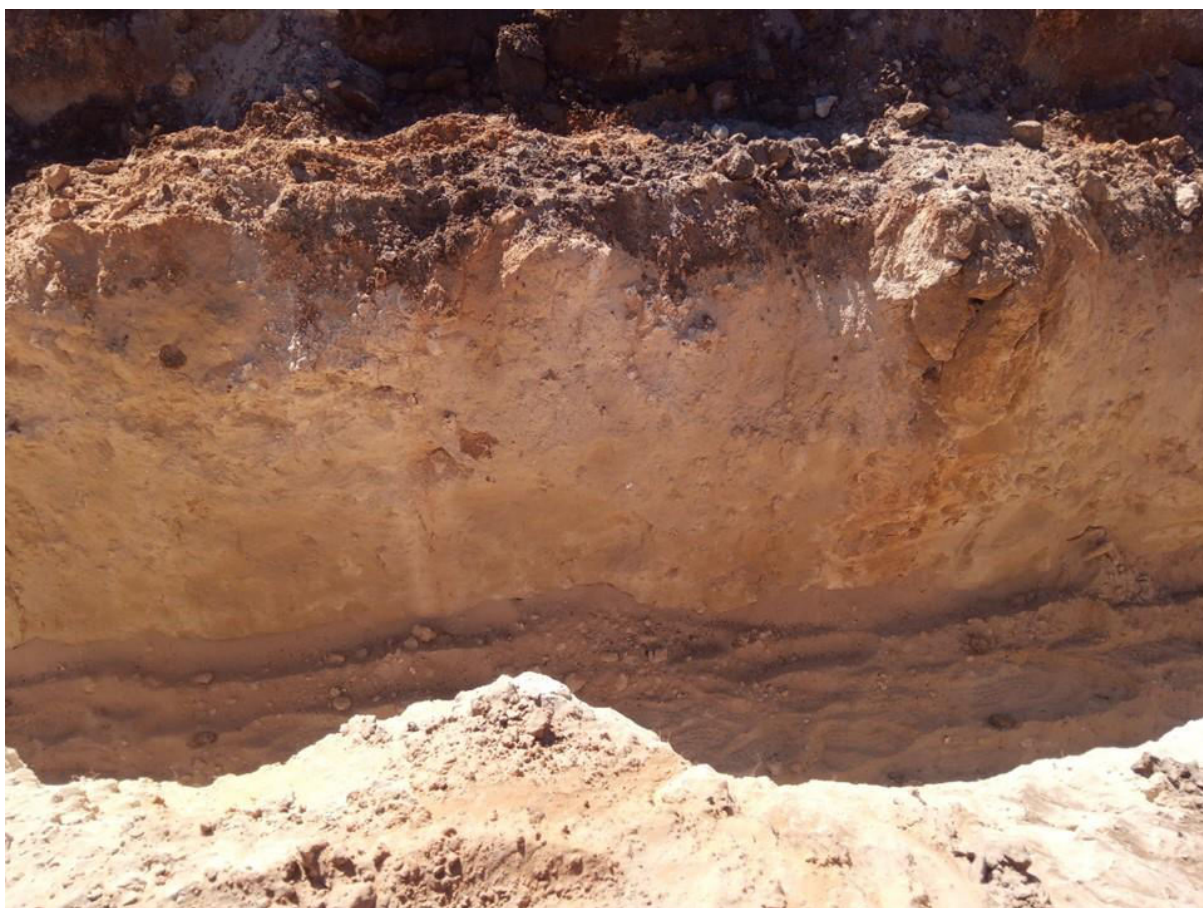
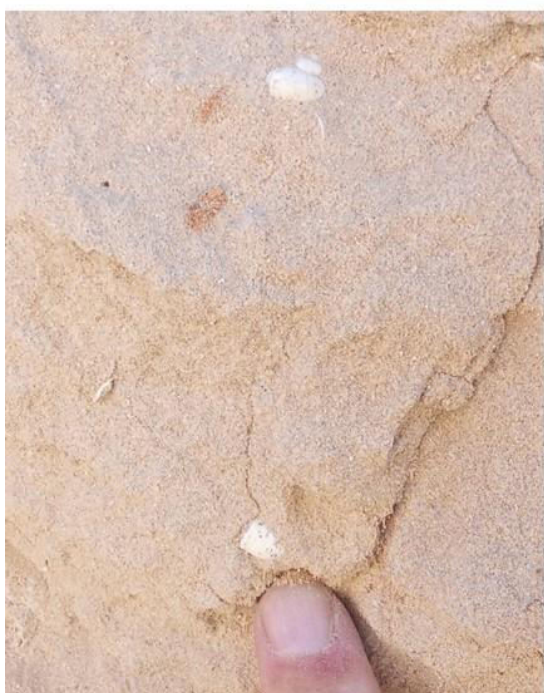
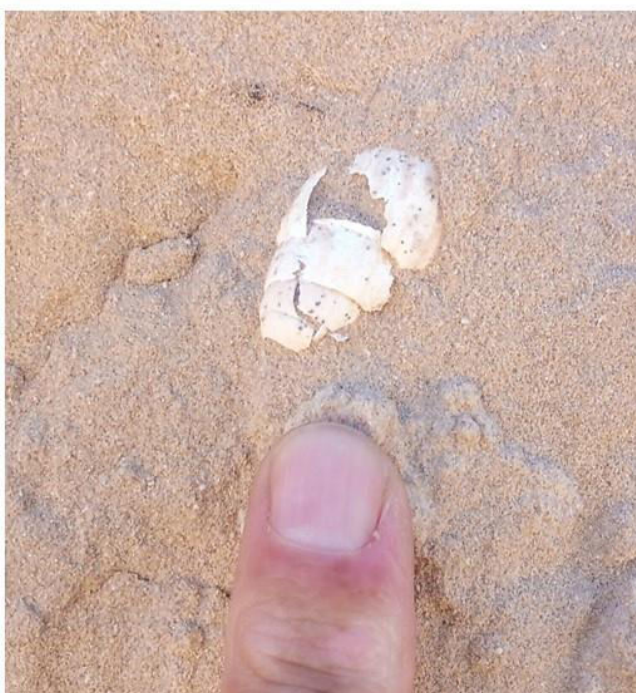
Identified heritage resources included a few fossilised land snails (Figure 7) of low palaeontological significance that are rated as NCW, modern/colonial period glass, ceramics and metal, a Stone Age combination hammerstone / grindstone of indeterminate age and a Middle Stone Age blade in quartzite with faceted striking platform (Figure 8). The modern materials are rated NCW and require no further action in terms of the NHRA.

Figure 7. Hartland – Phase A – Klein Karoo Civils – examples of fossil land snails in exposed profiles.

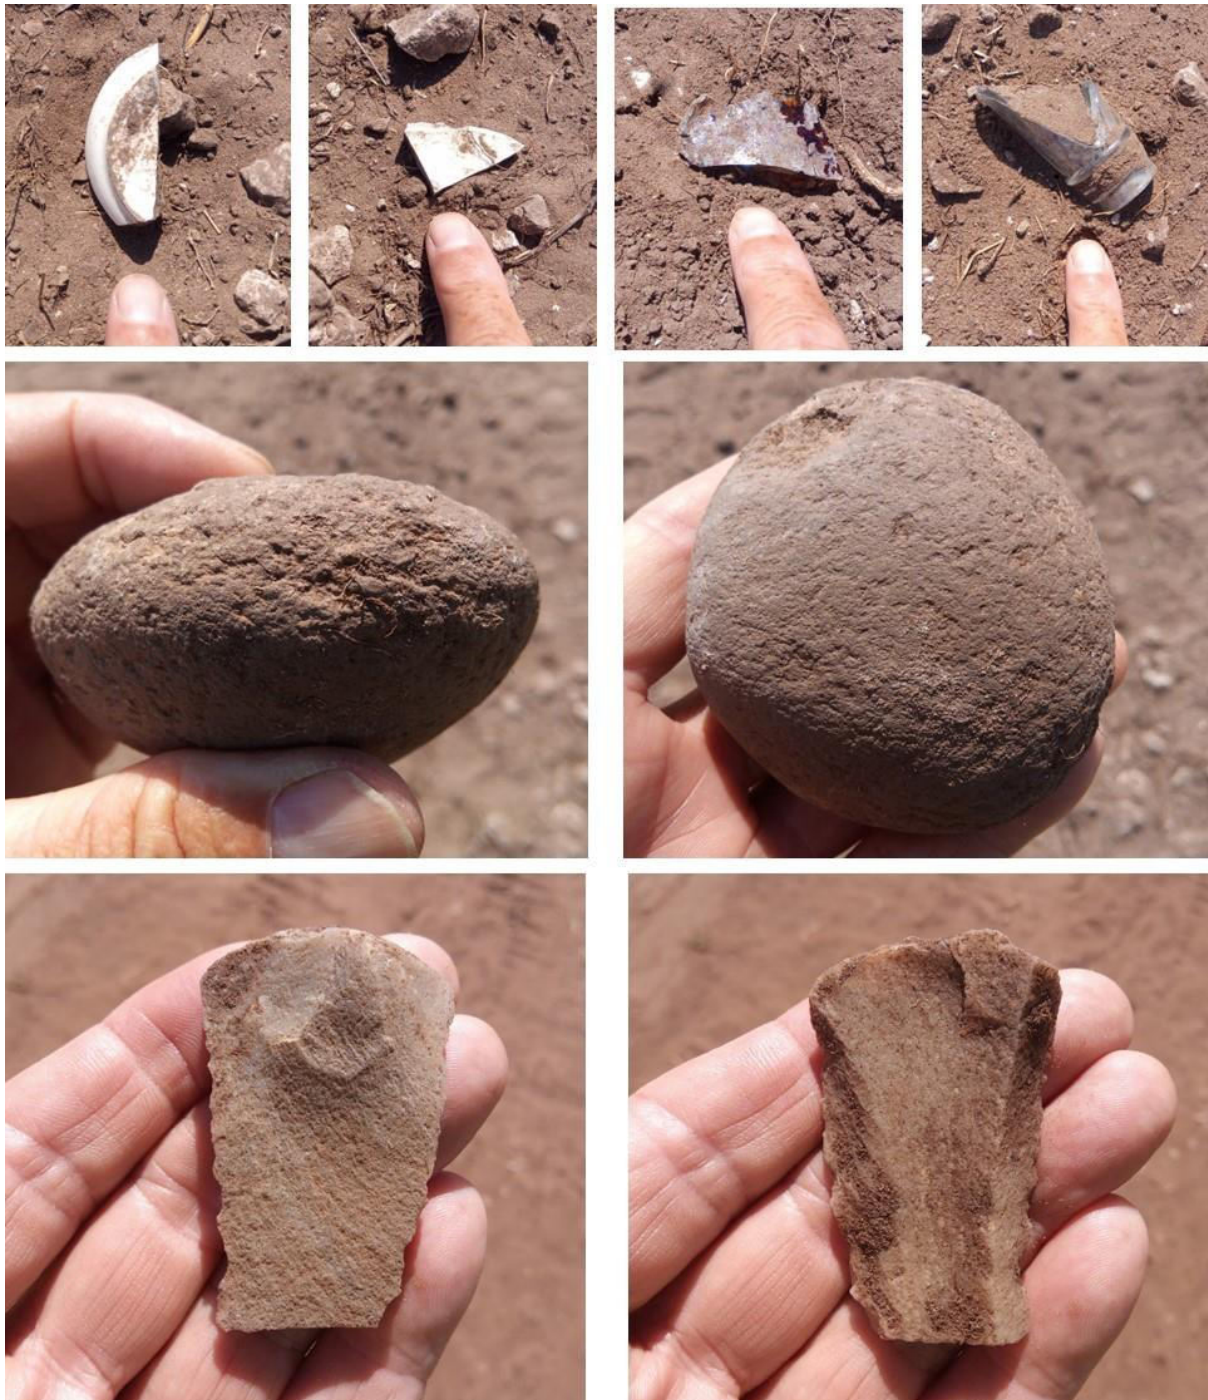
Identified Stone Age artefacts occur in isolation and are not associated with any other cultural or organic remains. They are rated NCW and require no further investigation, mitigation or management.

Figure 8. Hartland – Phase A – Klein Karoo Civils – examples of modern / colonial period glass and ceramic (top) and Stone Age stone artefacts (middle and bottom).
