**ENVIRONMENTAL MONITORING REPORT NO. 43  
FOR  
HARTLAND ON  
PORTION 11 OF FARM VAALE VALLEY 219, MOSSEL BAY**

**MOS25/1027/71**

**March 2025**

## ENVIRONMENTAL MONITORING REPORT NO. 43 – MARCH 2025

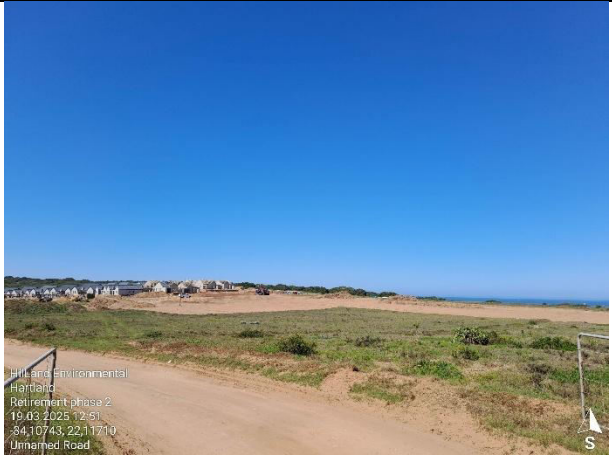
| <p>Blanket clearing of vegetation must be limited to the approved development footprint, and the area to be cleared must be demarcated before any clearing and grubbing commences.</p> | <p>Compliant &amp; ongoing</p> | <p>All clearing is done within the demarcated footprint that is pegged out by the surveyor.</p> <p>No environmental issues noted.</p> | <p>Retirement village phase 2</p> |

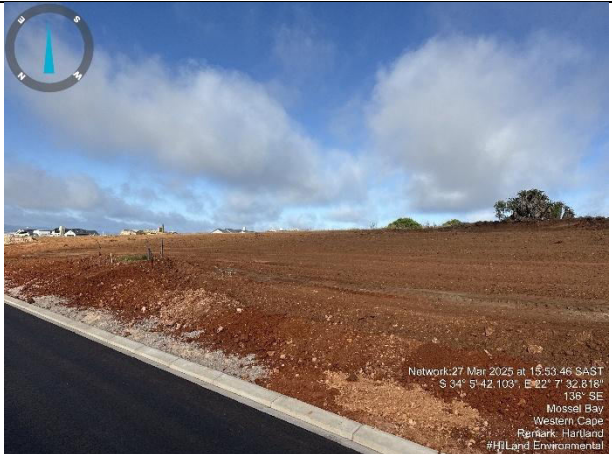
| <p>Topsoil must be neatly removed and stored away without contamination. It is also to be used for rehabilitation once construction is complete.</p> | <p>Compliant &amp; ongoing</p> | <p>Topsoil is placed next to open trenches (windrow) for use during rehabilitation.</p> <p>Bulk topsoil stockpile sites for Retirement village and Fynbos Heuwels were approved by the ECO – internal open space of the retirement village.</p> <p>Subsoil will be stockpiled according to the earthworks master plan and covered with topsoil – ongoing alien clearing on the swale required.</p> | <p>Phase H2 – topsoil replaced on road verges and haul routes (in process)</p> |

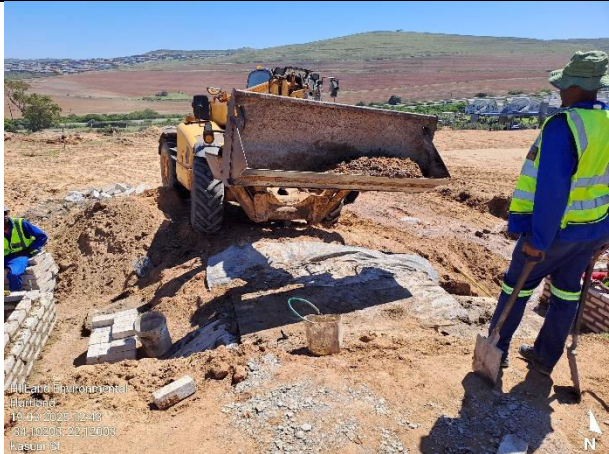
| CONSTRUCTION PHASE | | | |
|---|---|---|---|
| Cement batching must take place on an impermeable surface large enough to retain any slurry or cement water run-off. | Ongoing | <p>Cement batching is done on development areas (platforms), in wheelbarrows (as required) or on impermeable surfaces (wooden boards).</p> <p>Cement mixing area must be rehabilitated (all phases) to the satisfaction of the ECO – remove contaminated soil and replace topsoil (grass seed mix if required).</p> | <p>Phase A – cement mixing on wood sheet</p> |

- Continue demarcating the sites bordering the conservation/sensitive areas.
- Ensure cement mixing on impermeable surfaces and remove cement contaminated soil and rehabilitate accordingly.
- Do regular litter picking with focus on the green zones and undeveloped stands.

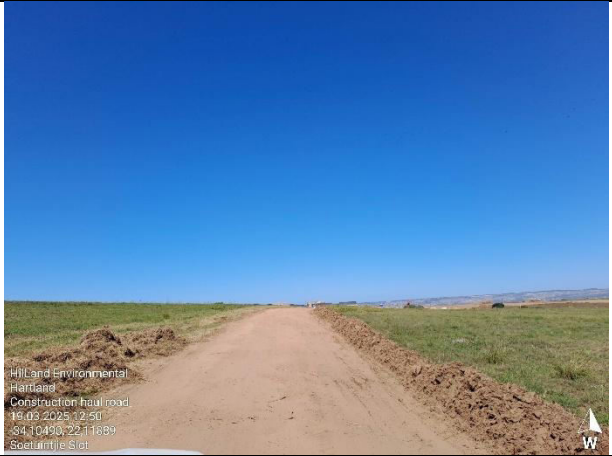
| <p>All construction vehicles need to adhere to traffic laws. The speed of construction vehicles and other heavy vehicles must be strictly controlled to avoid dangerous conditions for other road users. As far as possible care should be taken to ensure that the local traffic flow pattern is not significantly disrupted.</p> | <p>Compliant &amp; ongoing</p> | <p>No environmental issues to report.</p> <p>Construction vehicle movement is in general confined to the existing roads and/or construction haul roads.</p> | <p>Hilland Environmental<br/>Hartland<br/>Construction haul road<br/>16.03.2025 12:50<br/>34.10490, 22.11689<br/>Soelentjie Str.</p> |

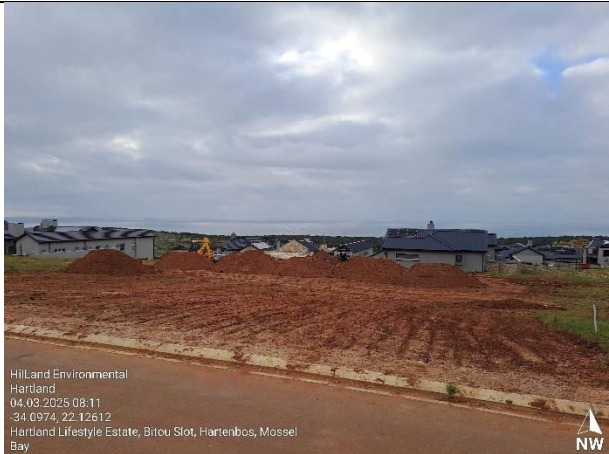
| No clearing outside of development and infrastructure footprint area to take place. | Ongoing | <p>Only development areas and working zones are cleared.</p> <p>The contractor consults with the ECO to assist with No-Go demarcation identification (sensitive areas) when necessary.</p> | <p>Hilland Environmental<br/>Hartland<br/>04.03.2025 08:11<br/>-34.0974, 22.12612<br/>Hartland Lifestyle Estate, Bitou Slot, Hartenbos, Mossel Bay</p> |

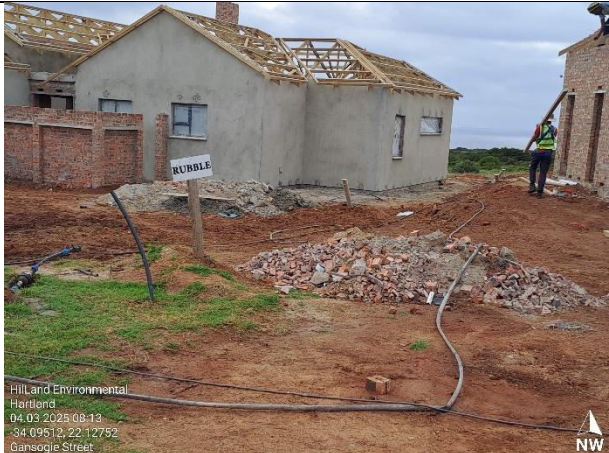
| Topsoil must be neatly removed and stored away without contamination. It is also to be used for rehabilitation once construction is complete. | Ongoing | <p>Topsoil is stockpiled for rehabilitation and landscaping use.</p> <p>Topsoil is to be stored separately from any other material (no contamination).</p> <p>Building rubble has been dumped near the Retirement Village topsoil stockpile – as was reported to the contractor. This must be removed ASAP.</p> <p>Building rubble signs to be placed at the dedicated building rubble stockpile to avoid confusion between the topsoil and building rubble stockpiles</p> <p>The retirement village and Fynbos Heuwels topsoil stockpile must be kept free from invasive alien plants – <i>Datura</i>.</p> | <p>Hilland Environmental<br/>Hartland<br/>04.03.2025 08:13<br/>-34.09512, 22.12752<br/>Gansogies Street</p> <p>Rubble sign at some of the stockpile areas</p> |

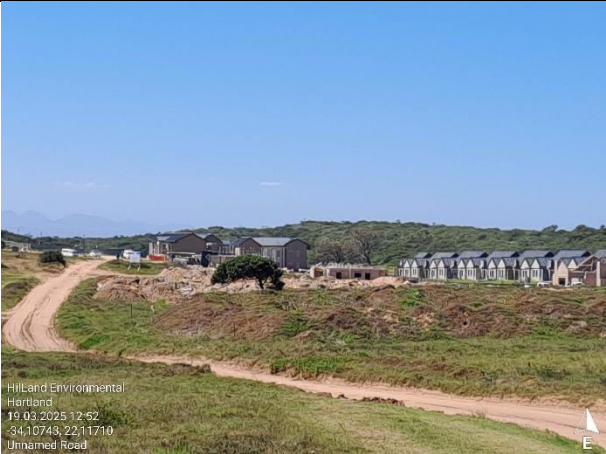
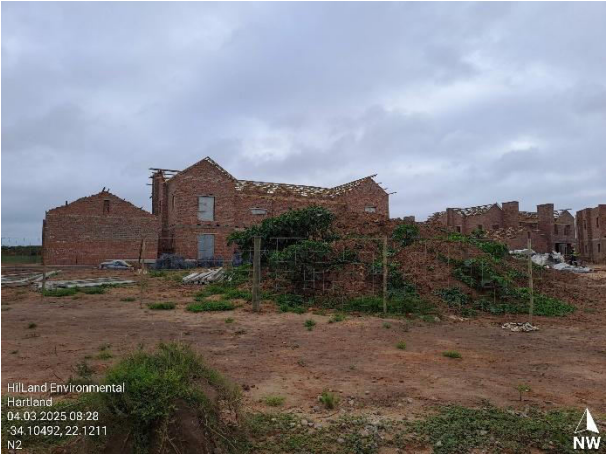
| | | | <div><p>HiLand Environmental<br/>Hartland<br/>19.03.2025 12:52<br/>34.10743, 22.11710<br/>Unnamed Road</p><p>Building rubble close to the topsoil stockpile – to be removed</p></div> <div><p>HiLand Environmental<br/>Hartland<br/>04.03.2025 09:28<br/>34.10492, 22.1211<br/>N2</p><p>Fynbos Heuwels topsoil stockpile – remove invasive plants</p></div> |

- The green zone adjacent to the Retirement living: Phase 1 development area is demarcated with a wire fence and no entry sign boards. This zone is well away from Retirement village phase 2.
- The cement batching area **needs to be** bunded with sandbags or a small berm.
- Indigenous trees and vegetation have been planted along the entrance road into the Retirement village.
- **Building rubble in/on the topsoil stockpile must be removed asap.**

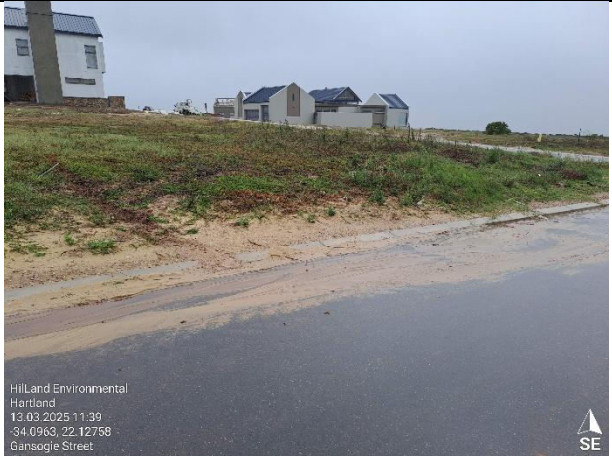
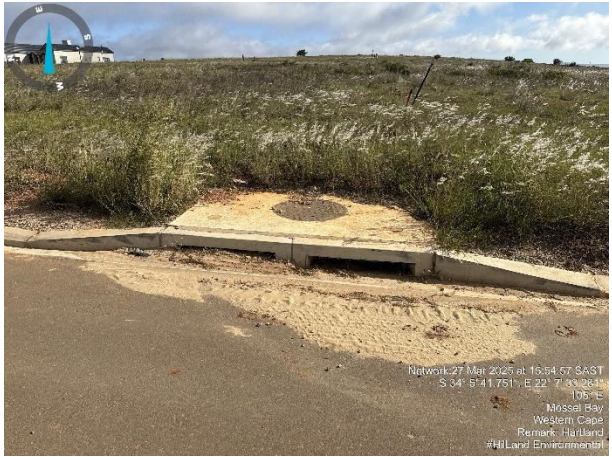
| Soil erosion mitigation | | | |
|---|---|---|---|
| Erosion control measures including silt fences, low soil berms and/or shutter boards must be put in place around the stockpiles to limit sediment runoff from stockpiles. | Ongoing | <p>Level erven is complaint and does not generally have silt or erosion issues.</p> <p>The steep erven will require silt protection, either sandbags or low bidim silt fence.</p> <p>Stormwater inlets must be protected – no silt or construction site wash must enter the stormwater system. This will silt up the stormwater outlets, many of which are in the conservation area.</p> | <div><p>HillLand Environmental<br/>Hartland<br/>13.03.2025 11:39<br/>34.0963, 22.12758<br/>Gansogle Street</p><p>SE</p><p>Slope/road verge protection required to prevent silt washing onto the roads and stormwater infrastructure.</p></div> <div><p>Network: 27 Mar 2025 at 16:54:57 SAST<br/>S 34° 5'41.751" E 22° 7'03.264"<br/>105° E<br/>Mossel Bay<br/>Western Cape<br/>Remark: Hartland<br/>HillLand Environmental</p><p>Stormwater inlets must be protected to prevent silt build-up</p></div> |

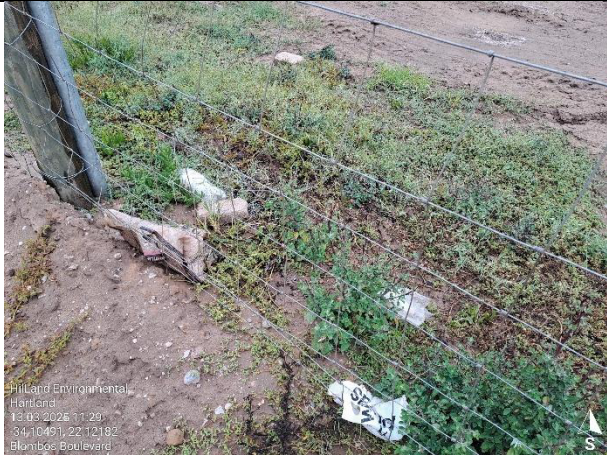
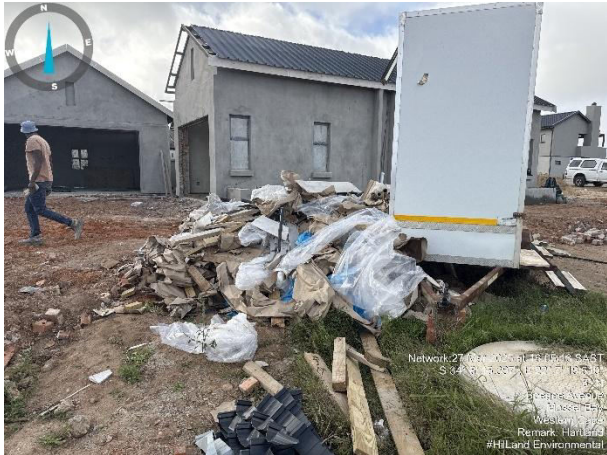
| Waste and pollution management | | | |
|---|---|---|---|
| Dedicated waste bins or skips must be provided on site and kept in a demarcated area on an impermeable surface. | Ongoing | <p><b>Compliant</b> - The contractor placed additional waste bins at each construction site which are emptied weekly. Skips are placed strategically throughout the site and are demarcated with shade netting (to prevent wind from blowing litter).</p> <p><b>Ongoing and compliant</b> - Wind-blown litter remains an ongoing construction related problem. Therefore, the contractor has a dedicated litter picking team conducting weekly litter picking. The HOA has also appointed a dedicated litter picker.</p> | |

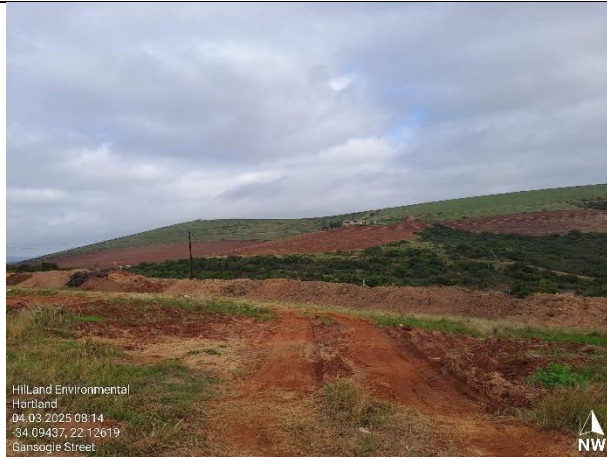
| OEMPr requirements | Level of compliance | Comments / Findings | Photos (if applicable) |
|---|---|---|---|
| Any concentrated flows of stormwater should, where possible, be dissipated to avert any erosion. | Compliant | Stormwater is generally dissipated and diverted into the naturally vegetated open space as per the engineering design and ECO guidance. Swales in terms of the earthworks master plan. | <p>Stormwater swale</p> |

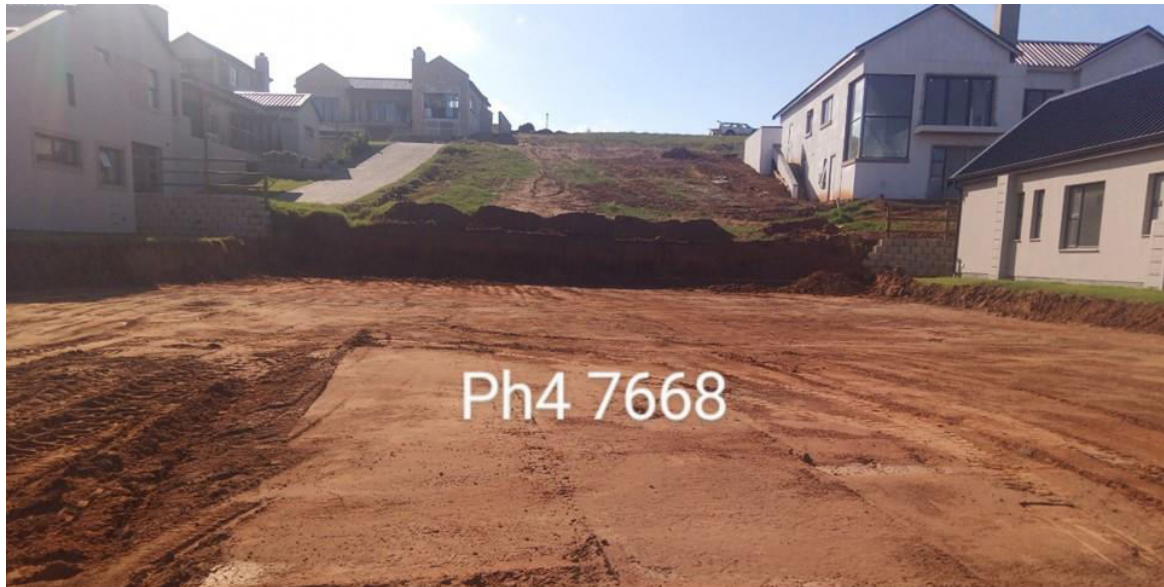
Figure 1. Hartland – Phase 4 – completed platform and flaked quartzite in exposed profile (excuse poor image).

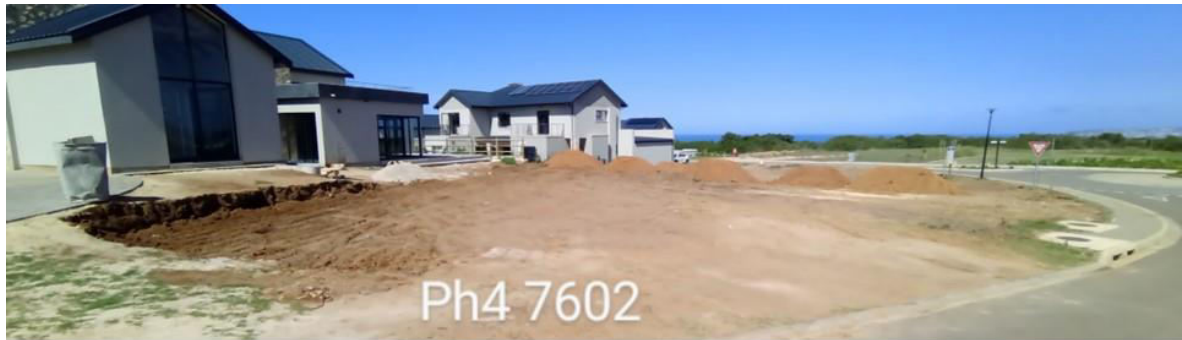
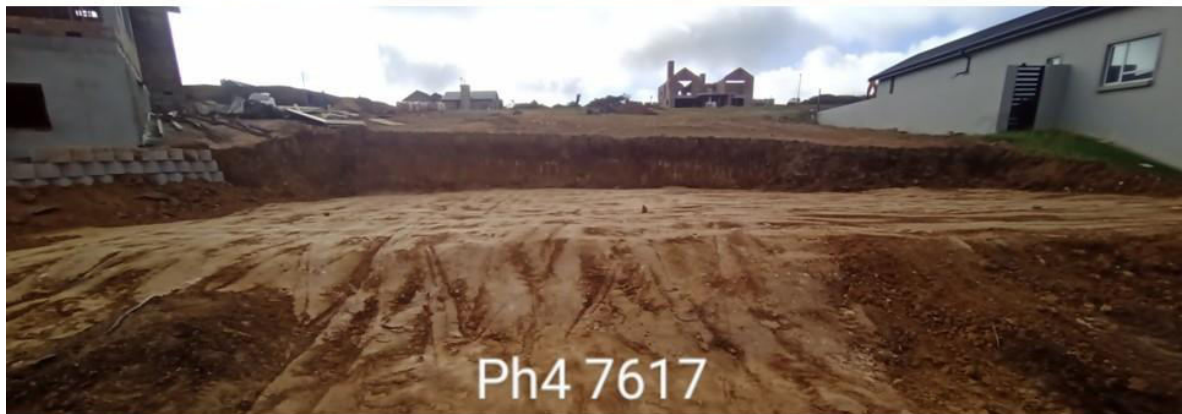
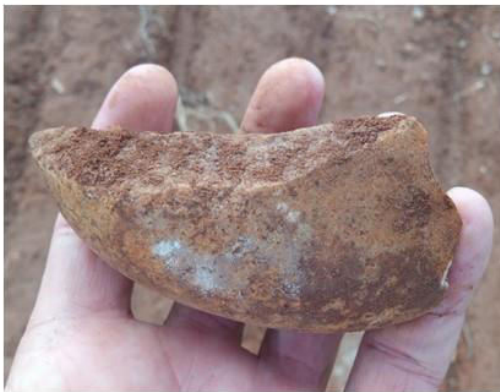
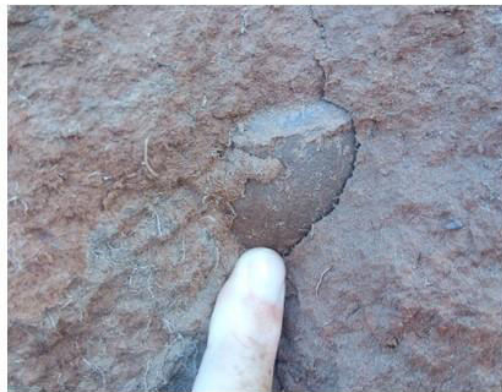
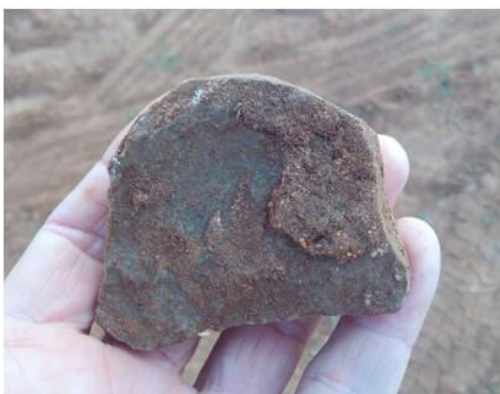
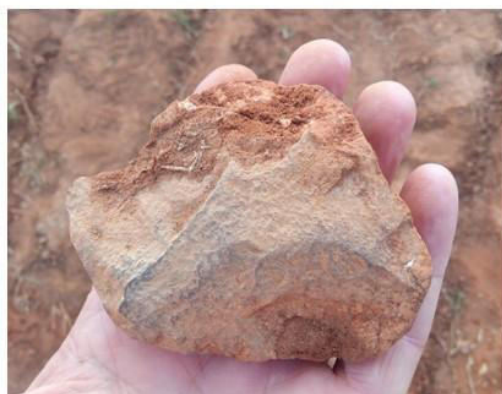
Figure 2. Hartland – Phase 4 – completed platforms and quartzite artefacts at 7617.

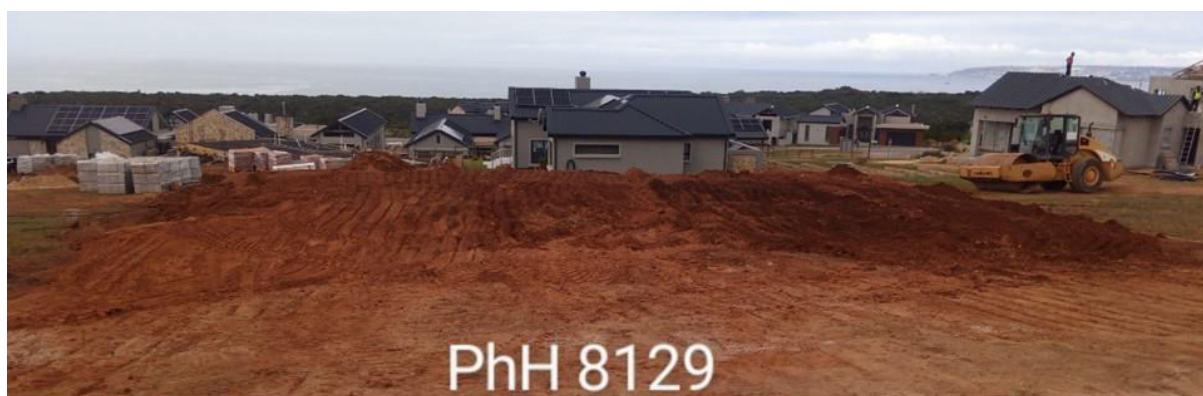
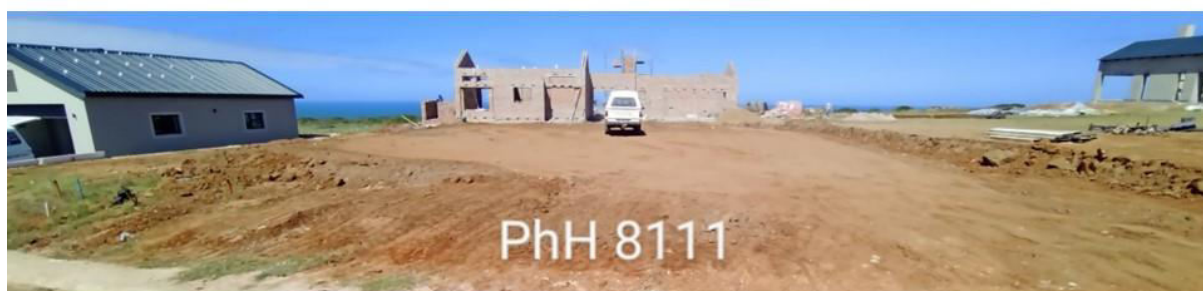
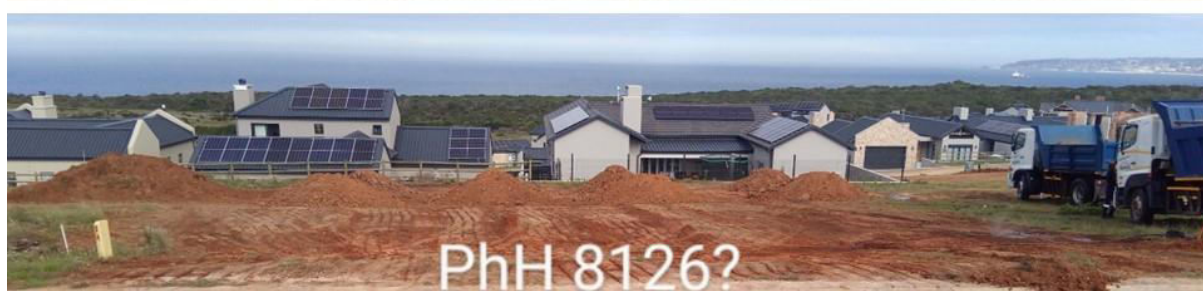
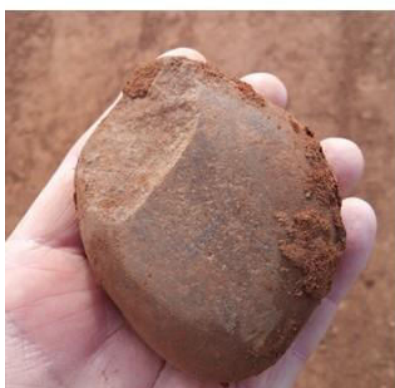
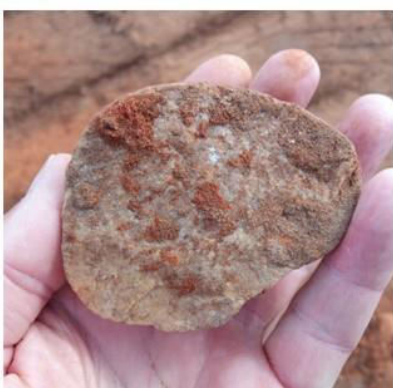
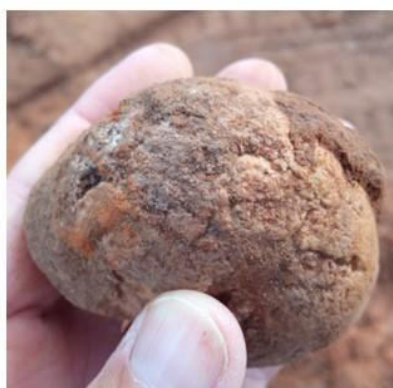
Figure 3. Hartland - Phase H, completed platforms and Stone Age pieces recorded at 8126?.

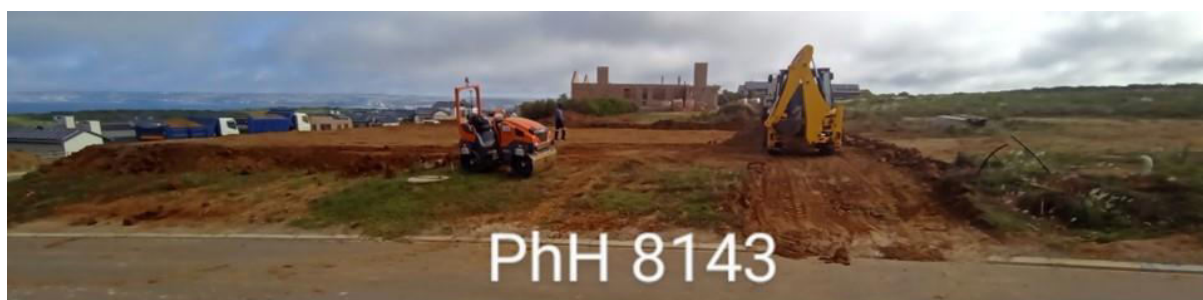
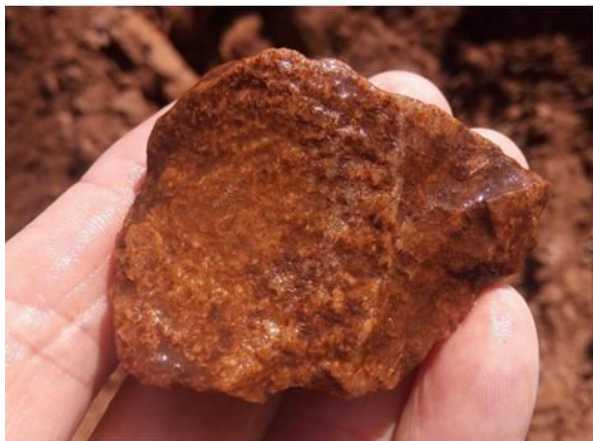
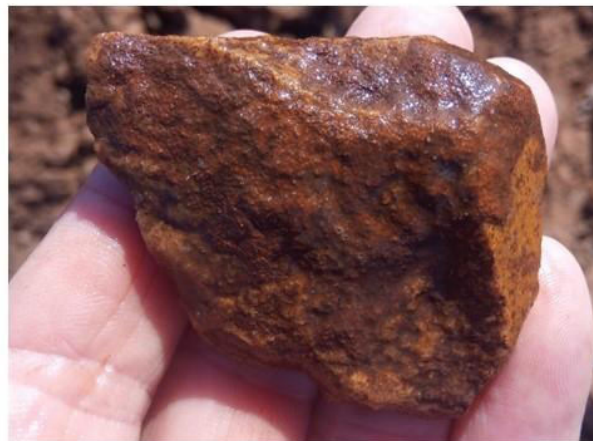
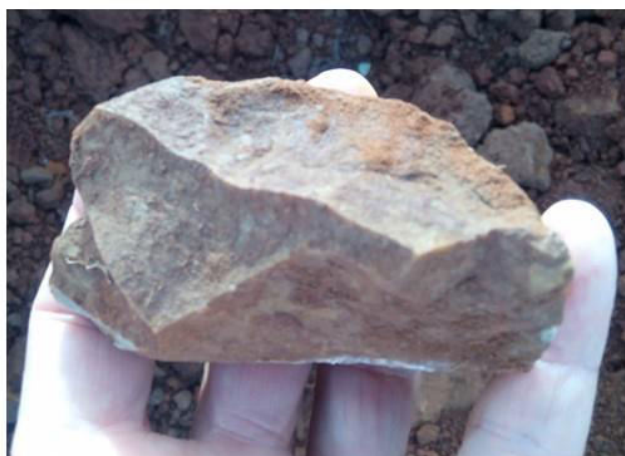
Figure 4. Hartland - Phase H, completed platform and Stone Age pieces recorded at 8143.

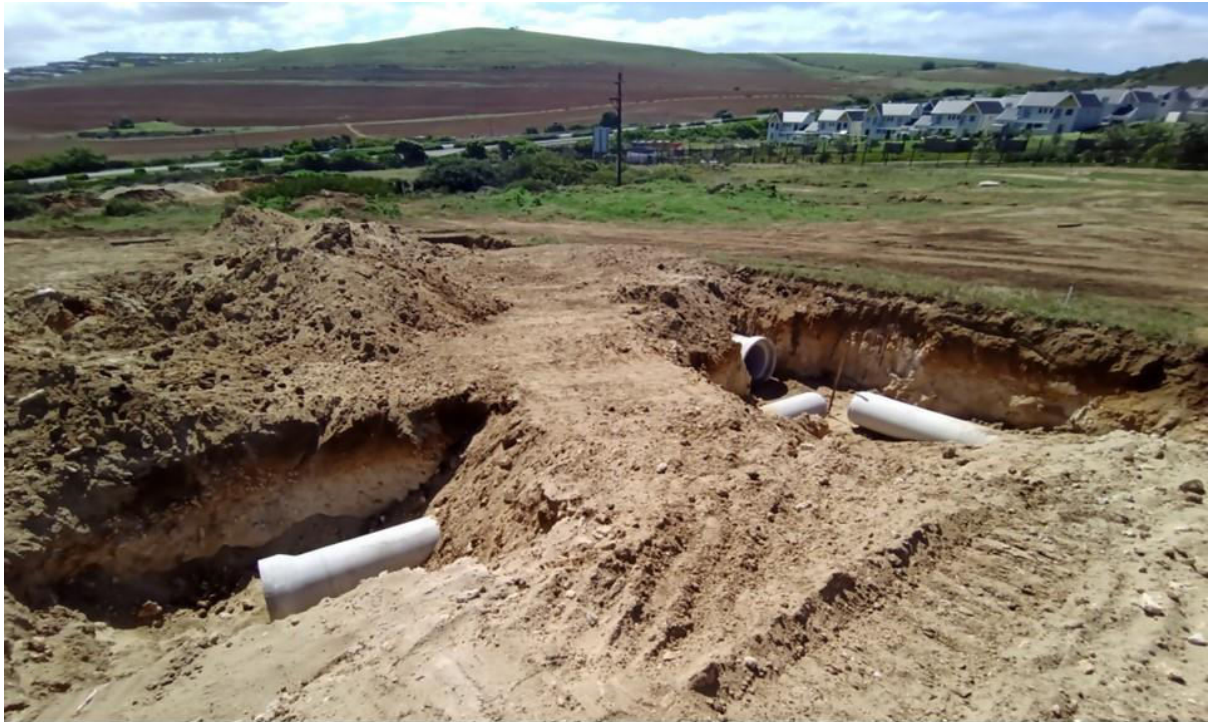
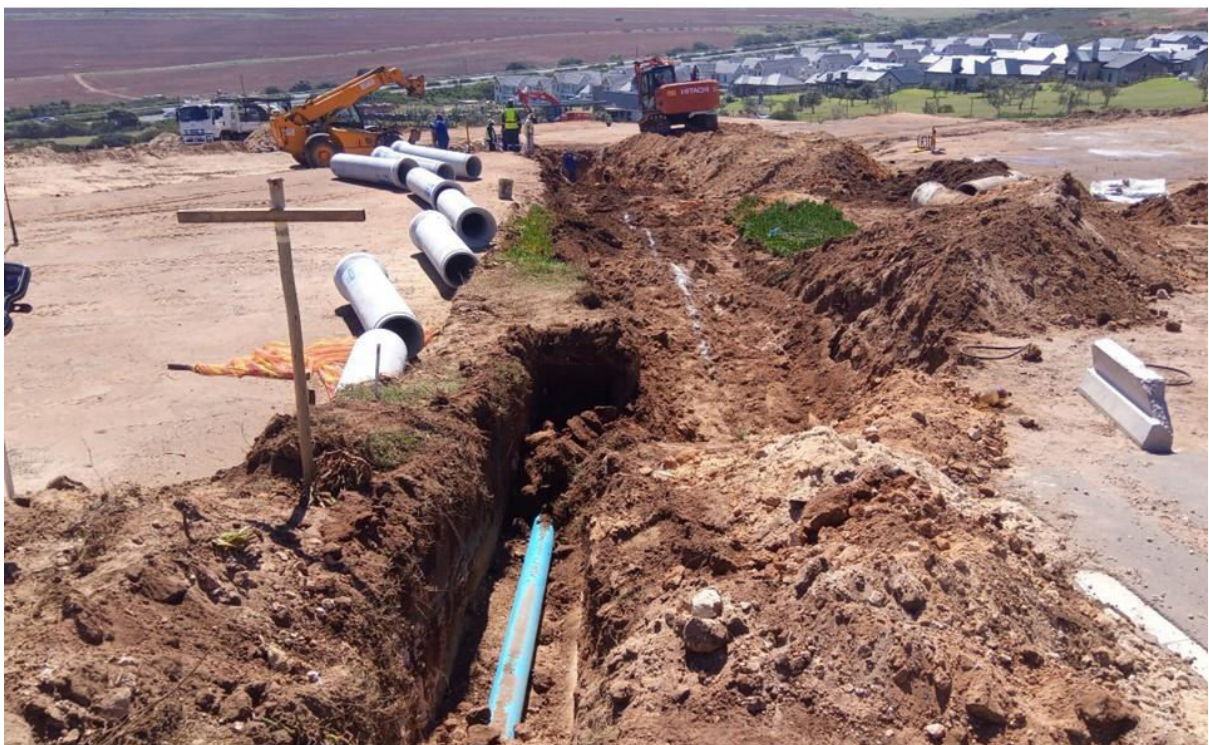
Figure 5. Hartland – Phase A – Klein Karoo Civils – water and storm water trench excavations in progress.

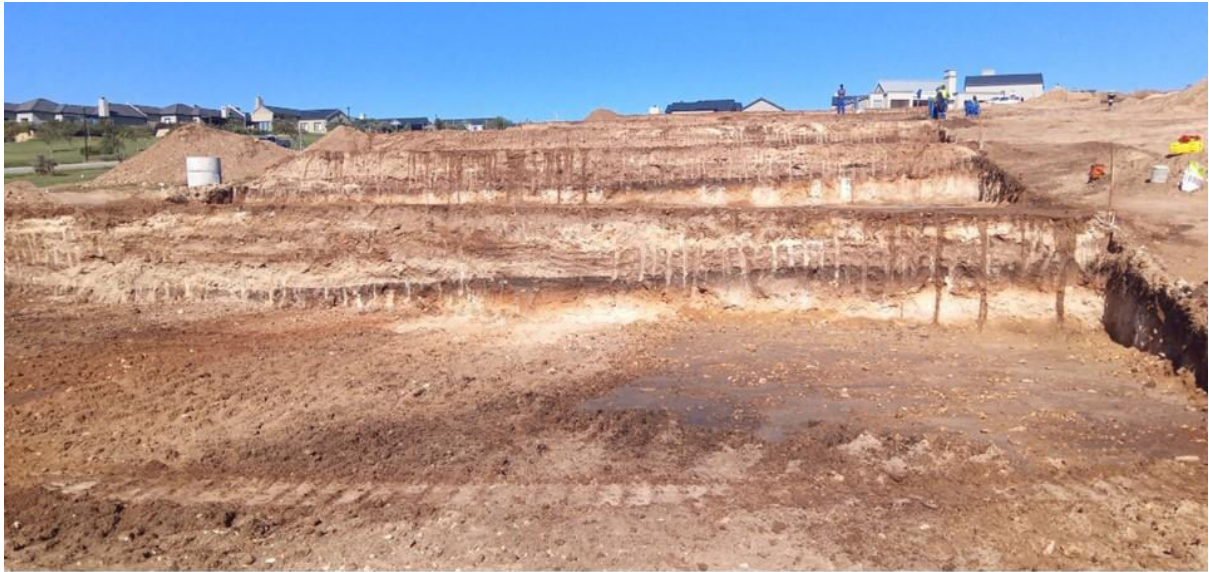
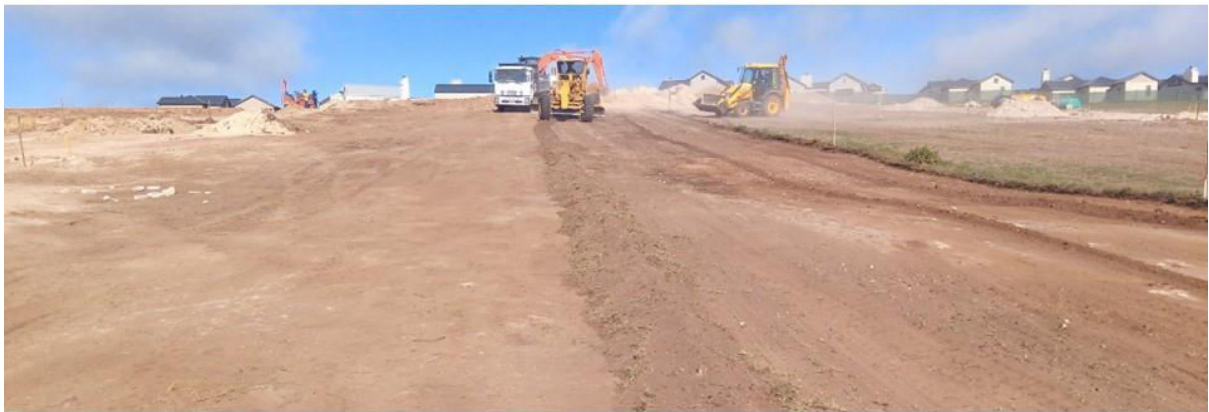
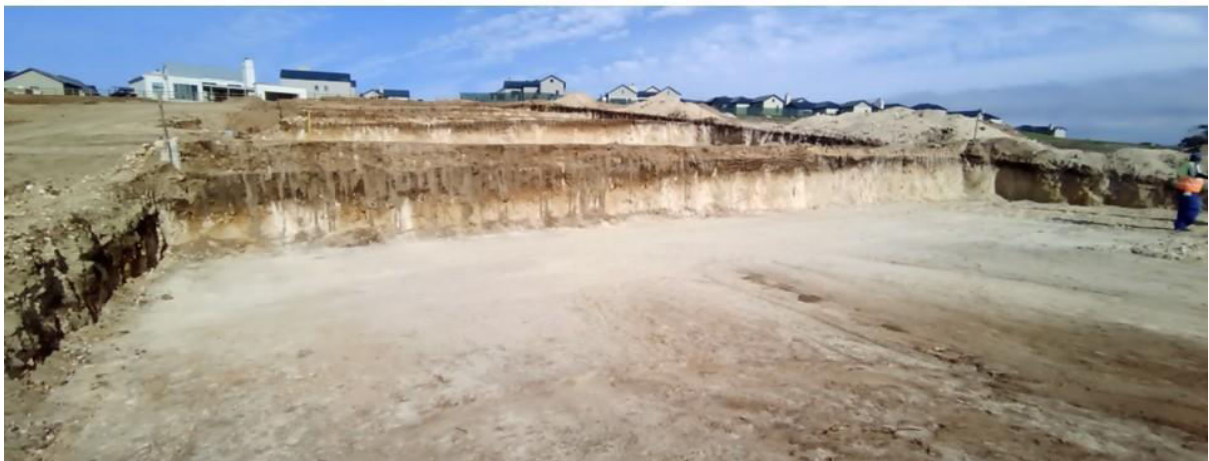
Figure 6. Hartland – Phase A – Klein Karoo Civils – platform / terracing excavations and grading in progress.

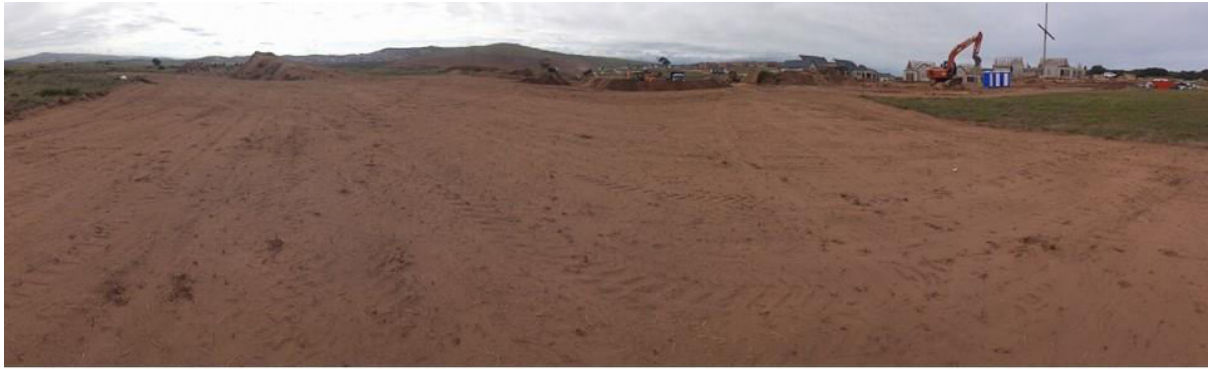
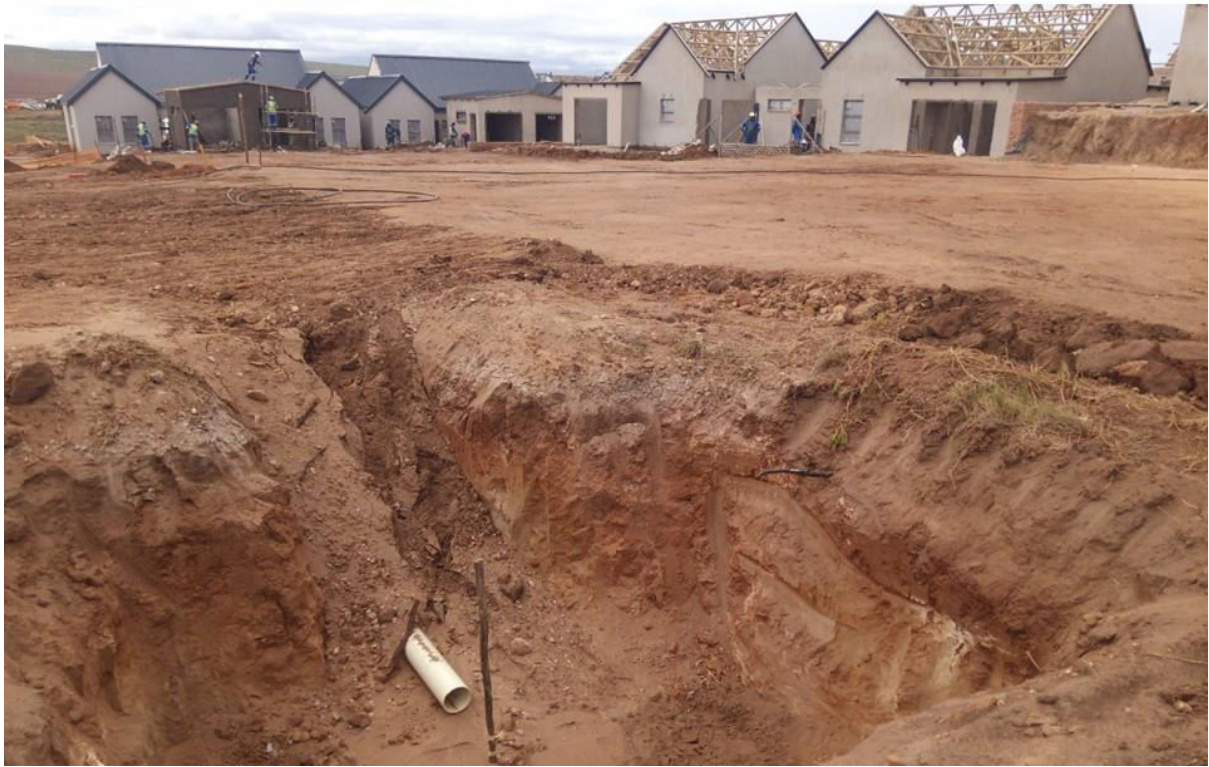
Works included vegetation clearing and topsoil stripping, road box cut, sewer trenching and platform excavations (Figures 7, 8 & 9). A few Stone Age pieces were identified in the large, cleared area, but given their low densities and the absence of organic and cultural remains, these finds are rated as NCW and require no further action in terms of the NHRA.

Figure 7. Hartland – HRV-Ph2 – cleared area and sewer trenching.

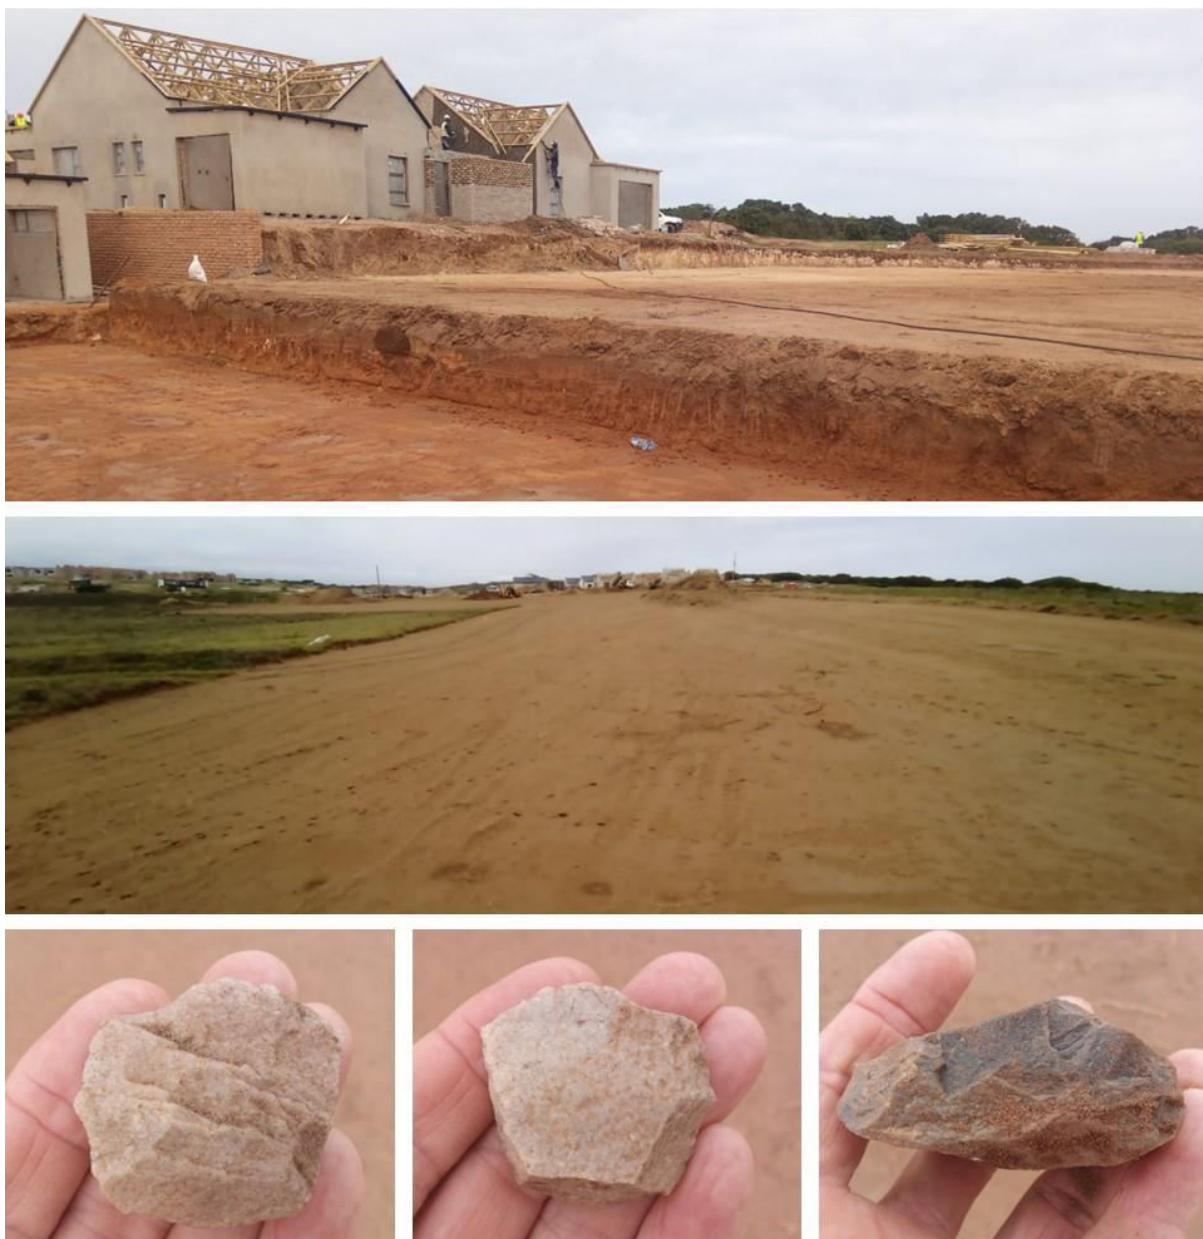
Figure 8. Hartland – HRV-Ph2 – platform excavations and cleared area with a few Stone Age pieces.

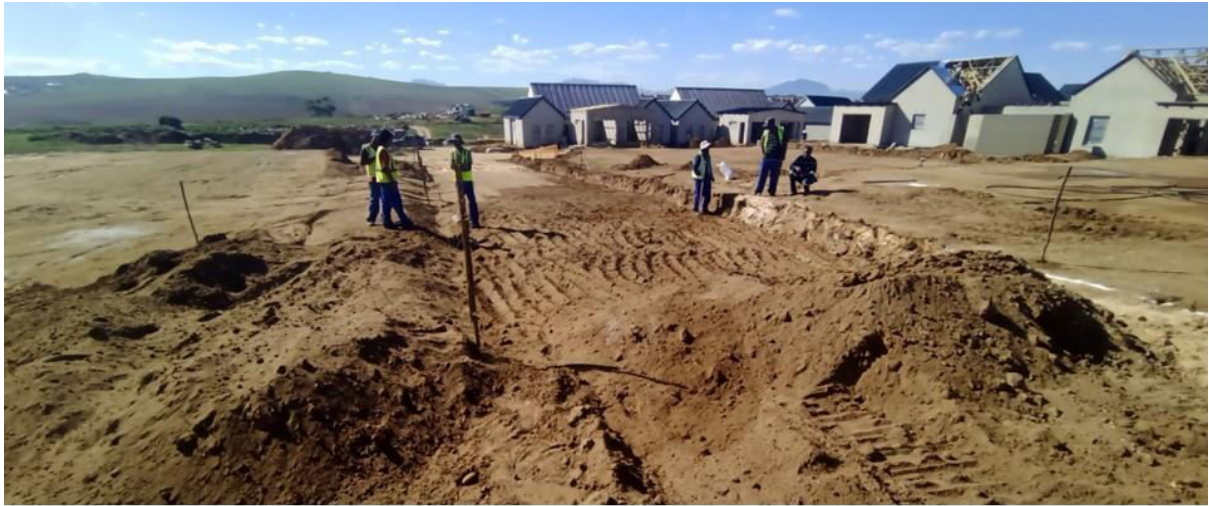
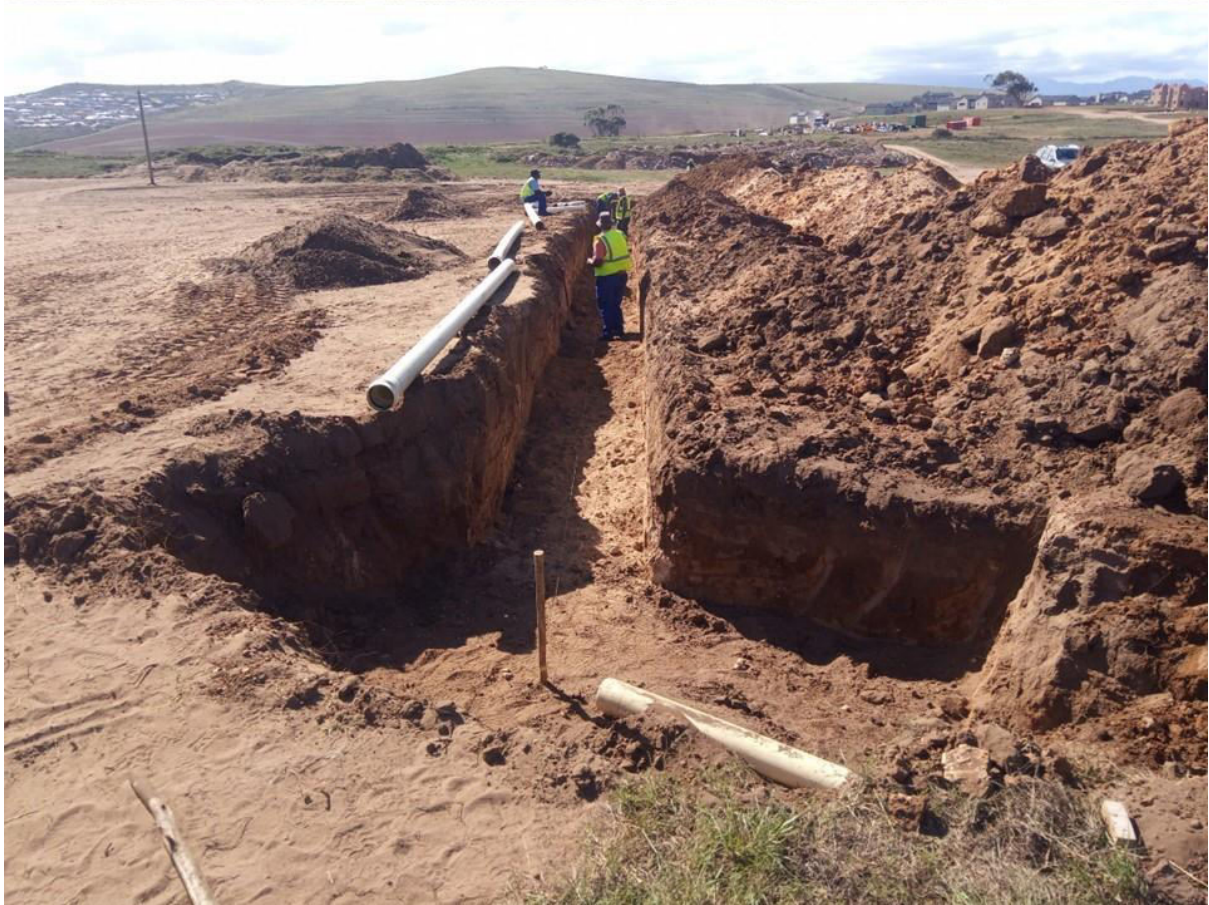
Figure 9. Hartland – HRV-Ph2 – road box cut and sewer trench excavations.

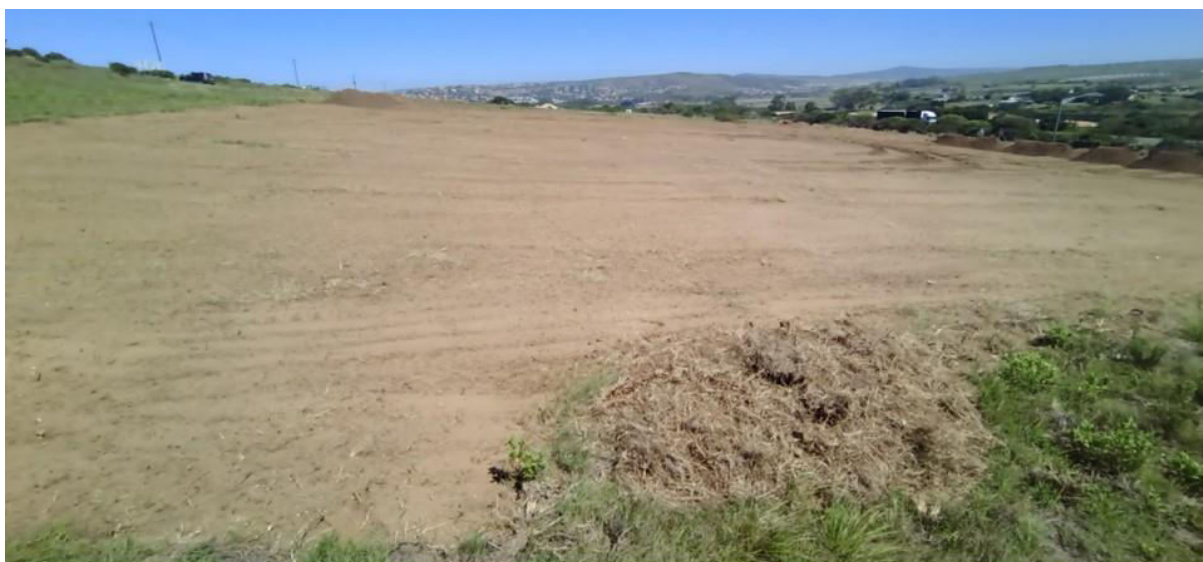
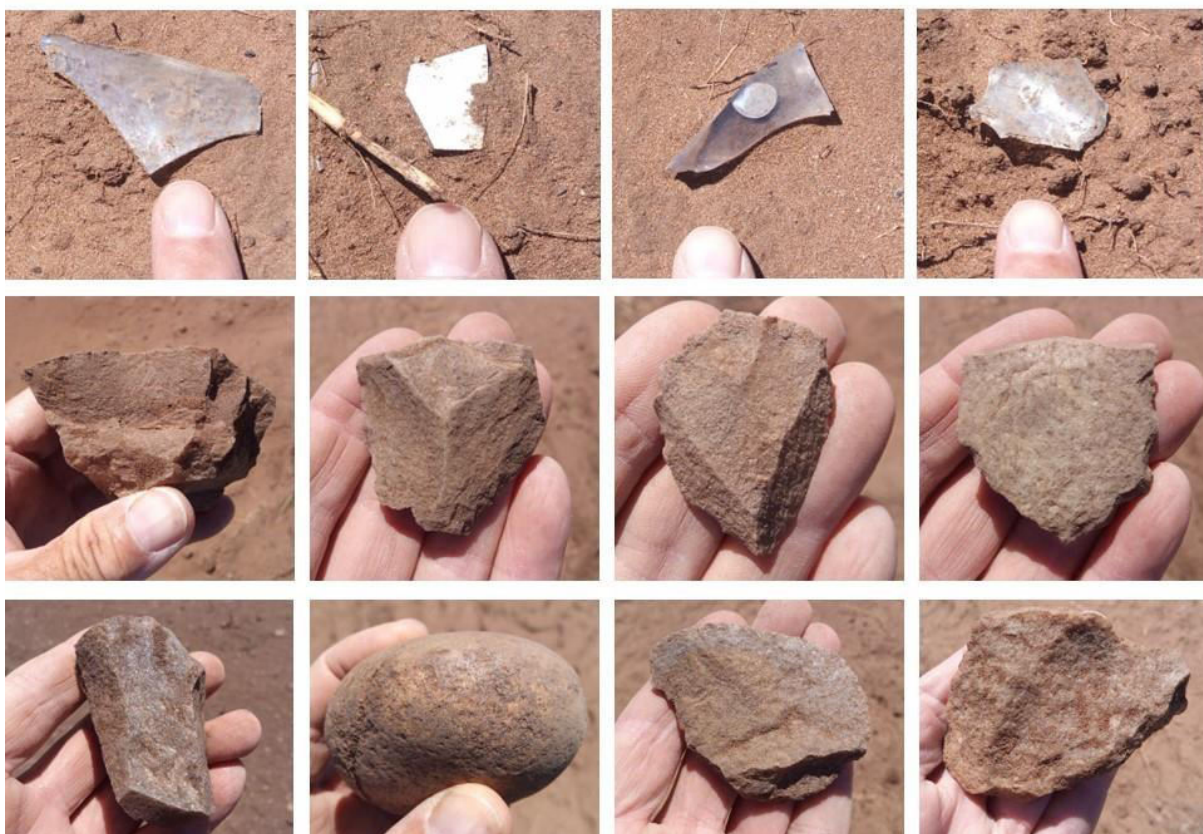
Works included the clearing of an area for stockpiles that involved the stripping of vegetation and topsoil, as well as the opening of roads through grading (Figures 10 & 11). Several fragments of ceramic and glass of modern / colonial period origin were seen as well as several Stone Age implements. Due to their low densities, temporal mixing, and the absence of organic and cultural remains, these finds are rated NCW and require no further action in terms of the HRA.

Figure 10. Hartland Development – cleared area and identified glass & ceramic fragments as well as Stone Age pieces.

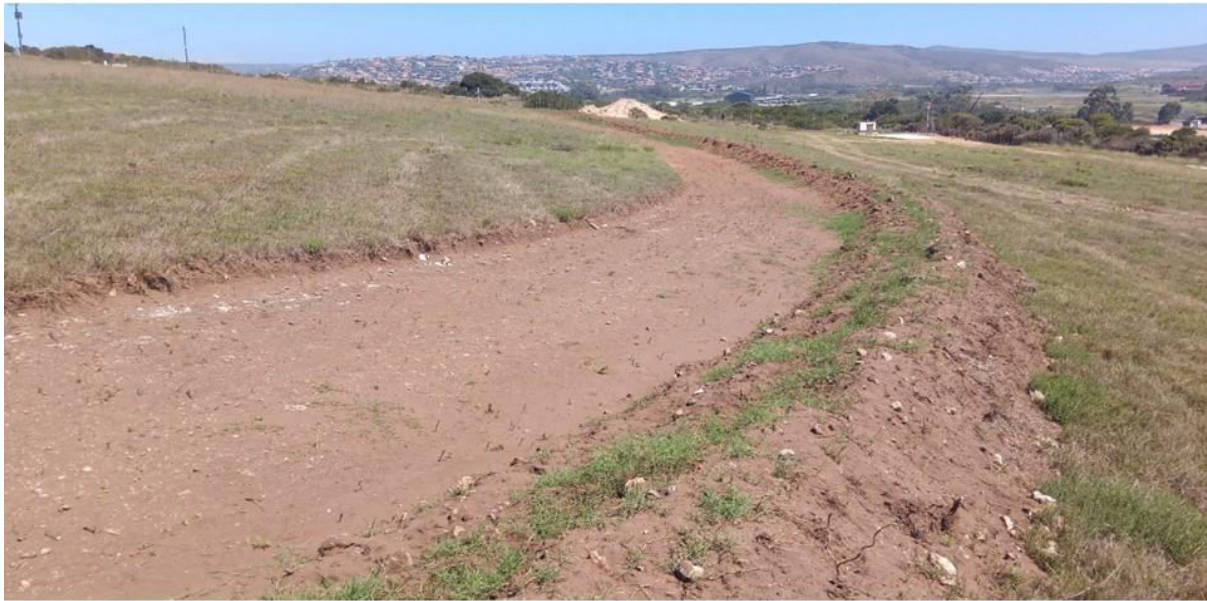
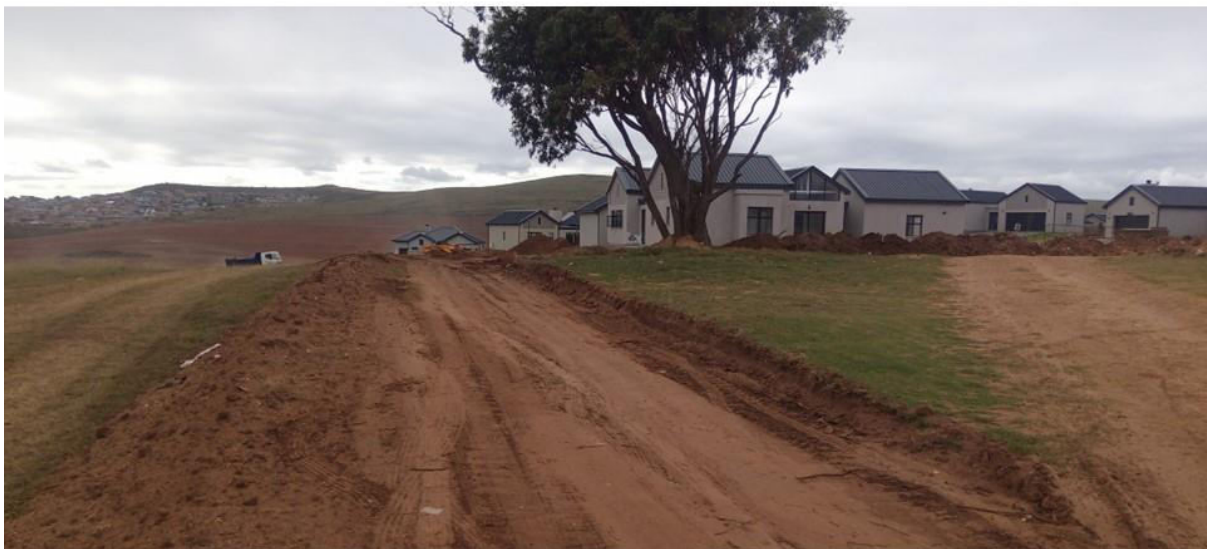
Figure 11. Hartland Development – opened / graded roads.
