**ENVIRONMENTAL MONITORING REPORT NO. 45  
FOR  
HARTLAND ON  
PORTION 11 OF FARM VAALE VALLEY 219, MOSSEL BAY**

**MOS25/1027/73**

## ENVIRONMENTAL MONITORING REPORT NO. 45 – MAY 2025

**HARTLAND DEVELOPMENT- PORTION 11 OF FARM VAALE VALLEY 219, MOSSEL BAY****Conditions of report use:**

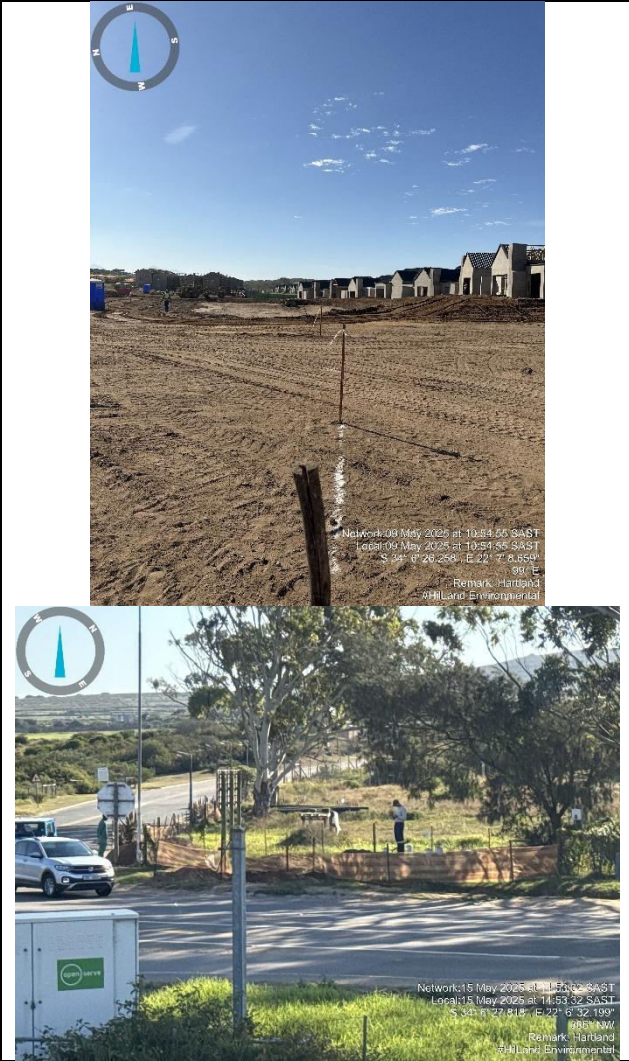
| <p>All sensitive areas, which must not be disturbed, must be demarcated using a 1.2m high fence constructed of shade cloth netting (<b>or similar product</b>), staked at regular intervals. Where a fence is considered impractical No-Go signs should be erected at frequent intervals along the edge of the no-go areas in consultation with the ECO.</p> | <p>Compliant</p> | <p>The working zone is pegged by the surveyor before construction starts - ongoing.</p> <p>The conservation area/natural vegetation adjacent to the Retirement village is demarcated with a suitable fence - ongoing.</p> <p>Indigenous hedgerow (southeast) of the school sport field to be surveyed – in terms of condition 20 of the EA existing hedgerows are to be retained.</p> <p>Right-turn Lane sensitive areas (road reserve) have been pointed out to the contractor - compliant.</p> <p>Bulk electrical – within the road reserve (R102/Monte Christo Road/SANRAL) – indigenous vegetation (aloes) is avoided. No other protected vegetation was noted.</p> | <p>Network: 09 May 2025 at 10:54:55 SAST<br/>Local: 09 May 2025 at 10:54:55 SAST<br/>S 241° 0' 26.258" E 221° 7' 0.650"<br/>98° 14'<br/>Remark: Hartland<br/>Hiland Environmental</p> <p>Network: 15 May 2025 at 11:53:32 SAST<br/>Local: 15 May 2025 at 11:53:32 SAST<br/>S 345° 12' 0.118" E 221° 5' 32.138"<br/>98° 14' NW<br/>Remark: Hartland<br/>Hiland Environmental</p> |

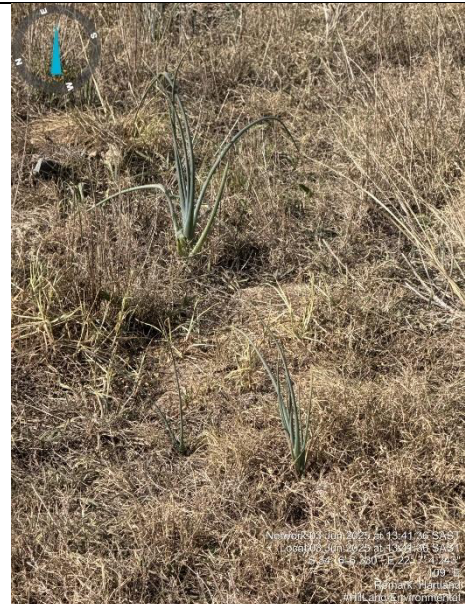
| Fauna and Flora | | | |
|---|---|---|---|
| Plant identification must be done whereby they must be rescued and relocated to an appropriate location for later use in rehabilitation. | Ongoing | <p>Development zone is the historic agricultural fields, <i>mainly grass</i>. <b>Geophytes are to be rescued</b> -they must be used in rehabilitation - ongoing.</p> <p>Ongoing – record to be kept of the plants that are rescued and submitted to the ECO for record keeping – <i>no record received during this reporting period</i>.</p> | <p>Network: 21 May 2025 at 13:41:49 SAST<br/>Local: 21 May 2025 at 13:41:49 SAST<br/>S 34° 6' 6.809" E 22° 7' 7.745"<br/>116° SE<br/>Remark: Hartland<br/>#Hiland Environmental</p> |

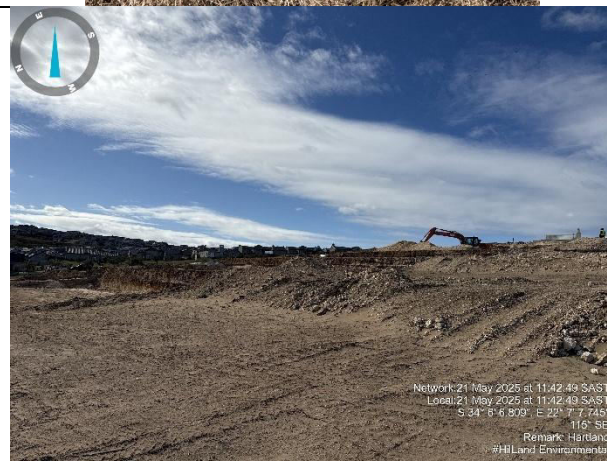
| Fauna and Flora | | | |
|---|---|---|---|
| No clearing outside of development and infrastructure footprint area to take place. | Compliant | Clearing takes place within the demarcated development footprint / pegged working area. | <p>Network: 21 May 2025 at 11:42:49 SAST<br/>Local: 21 May 2025 at 11:42:49 SAST<br/>S 34° 6' 6.809" E 22° 7' 7.745"<br/>116° SE<br/>Remark: Hartland<br/>#Hiland Environmental</p> <p>Phase A</p> |

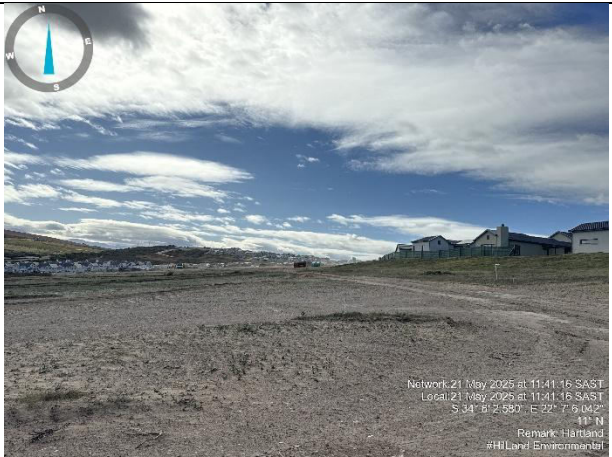
| Blanket clearing of vegetation must be limited to the approved development footprint, and the area to be cleared must be demarcated before any clearing and grubbing commences. | Compliant & ongoing | All clearing is done within the demarcated footprint that is pegged out by the surveyor.<br><br>No blanket clearing outside of the immediate/current development area noted. | <div><p>Network: 21 May 2025 at 11:41:16 SAST<br/>Local: 21 May 2025 at 11:41:16 SAST<br/>S: 34° 51' 2.550" E: 22° 7' 5.042"<br/>UTM<br/>Remark: Hartland<br/>#HilandEnvironmental</p></div> <p>Phase A</p> |

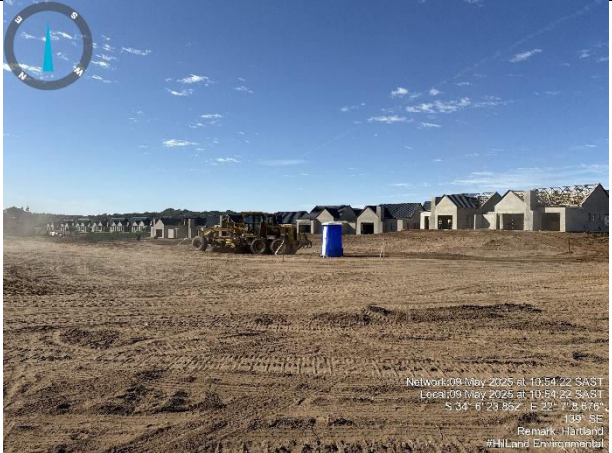
| CONSTRUCTION PHASE | | | |
|---|---|---|---|
| Chemical toilets must be kept at the site camp, on a level surface and secured from blowing over. | Compliant & ongoing | There is adequate ablution facilities located throughout the site and at the site camp – no environmental issues noted during this reporting period. | <p>Network: 09 May 2025 at 10:54:22 SAST<br/>Location: 09 May 2025 at 10:54:22 SAST<br/>5 34° 0' 23.892" E 32° 1' 39.151" S<br/>Remark: Hartland<br/>#Hiland Environmental</p> |

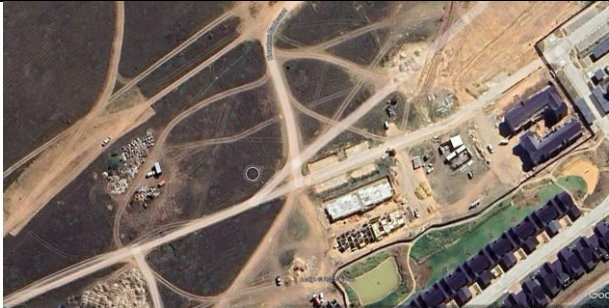
| <p>All construction vehicles need to adhere to traffic laws. The speed of construction vehicles and other heavy vehicles must be strictly controlled to avoid dangerous conditions for other road users. As far as possible care should be taken to ensure that the local traffic flow pattern is not significantly disrupted.</p> <p>Use existing construction haul routes.</p> | Ongoing | <p>Construction vehicle movement is in general confined to the roads and/or construction haul roads.</p> <p><b>Haul routes to be demarcated to prevent unnecessary off-road driving or creating new haul routes.</b></p> <p>All construction haul routes must be rehabilitated to the satisfaction of the ECO and developer at completion of the phase.</p> | <p>Google Earth (March 2025)</p> |

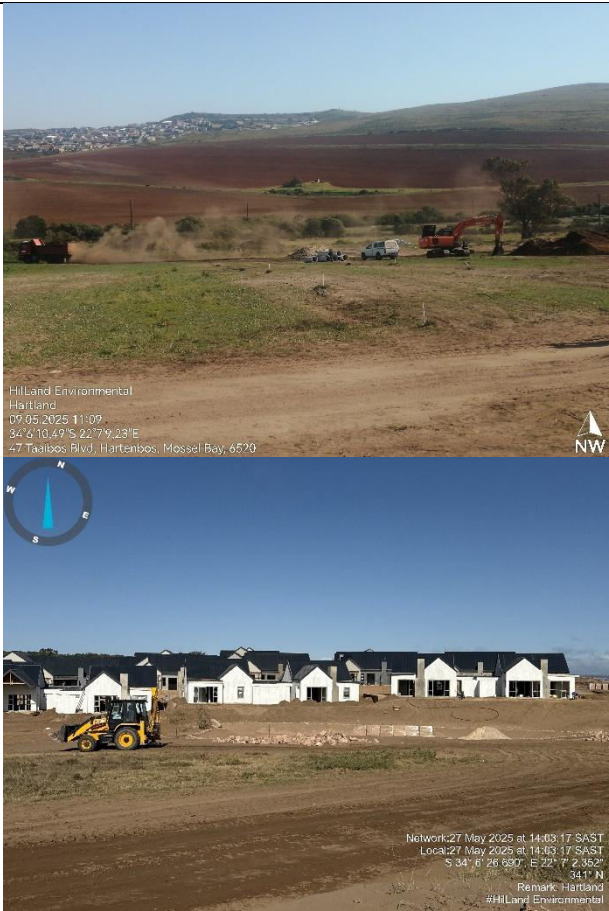
| Waste and pollution management | | | |
|---|---|---|---|
| <p>Dedicated waste bins or skips must be provided on site and kept in a demarcated area on an impermeable surface.</p> <p>Construction workers must be instructed not to litter and to place all waste in the appropriate waste bins provided on site.</p> <p>Suitable dust suppression to be implemented.</p> | Compliant & ongoing | <p>Suitable waste bins are available at the site camp. It should be noted that the housing contractor is also busy in the same phase(s) and therefore it is the housing contractor's obligation to ensure they have sufficient bins or skips on site.</p> <p><b>Ongoing litter picking for both civil services installation and house building contractor.</b></p> <p>Regular litter picking is being done by the HOA. Civil and building contractors to ensure their working areas are litter free (<b>all phases</b>).</p> <p>Dust suppression – dust noted on haul route during ECO inspection – ongoing dust suppression to be implemented (as noted during ECO site visit)</p> | <p>Hilland Environmental<br/>Hartland<br/>09.05.2025 11:09<br/>34° 10' 49" S 22° 7' 23" E<br/>47 Taalbos Blvd, Hartenbos, Mossel Bay, 6570</p> <p>Network: 27 May 2025 at 14:03:17 SAST<br/>Local: 27 May 2025 at 11:03:17 SAST<br/>S 34° 6' 28.500" E 22° 7' 2.352"<br/>34.1° N<br/>Remark: Hartland<br/>#Hilland Environmental</p> |

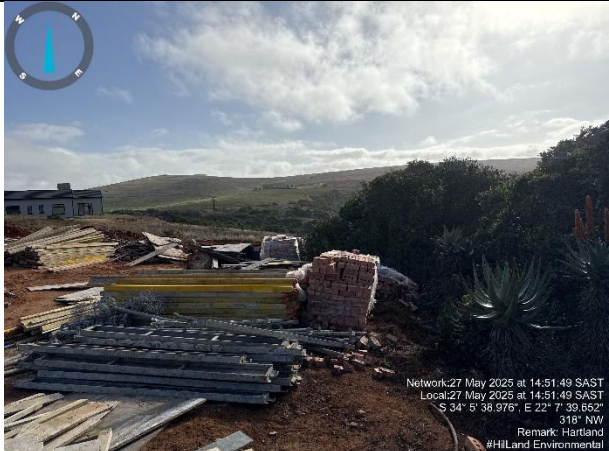
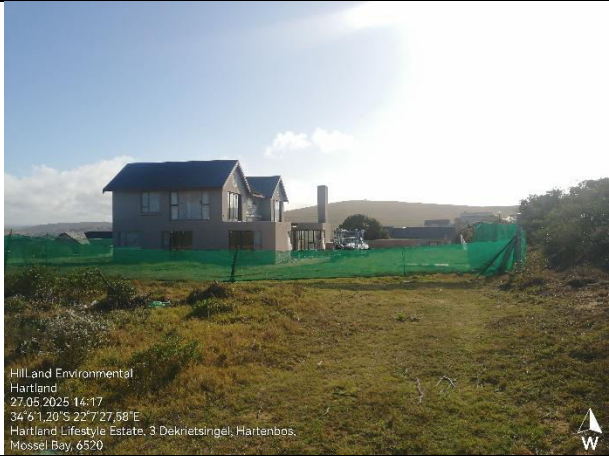
| EMPr requirements | Level of compliance | Comments / Findings | Photos (if applicable) |
|---|---|---|---|
| <p>All sensitive areas, which must not be disturbed, must be demarcated using a 1.2m high fence constructed of shade cloth netting (<b>or similar product</b>), staked at regular intervals. Where a fence is considered impractical No-Go signs should be erected at frequent intervals along the edge of the no-go areas in consultation with the ECO.</p> | Ongoing | <p>Housing construction sites that border sensitive areas are demarcated. The site (8104/8105) must be demarcated.</p> <p>Fynbos Heuwels and the Retirement Village are demarcated with wire fences.</p> <p>Other construction sites are demarcated with wire fence or shade netting.</p> | <p>Network: 27 May 2025 at 14:51:49 SAST<br/> Local: 27 May 2025 at 14:51:49 SAST<br/> S 34° 5' 38.976" E 22° 7' 39.652"<br/> 318° NW<br/> Remark: Hartland<br/> #Hiland Environmental</p> |

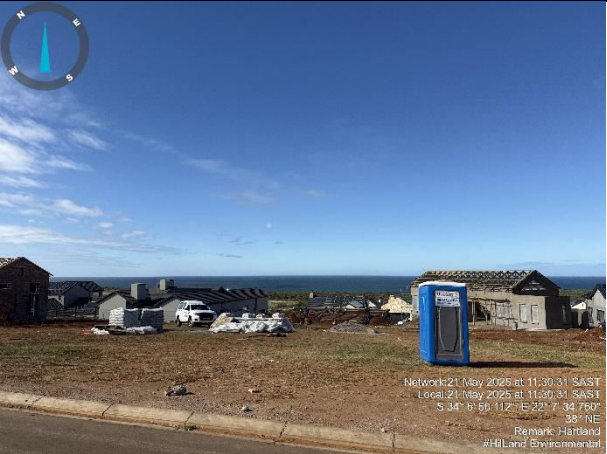
| Chemical toilets must be kept at the site camp, on a level surface and secured from blowing over. | Compliant | <p>There are several portable toilets throughout the development zone.</p> <p>Toolbox talk to be done with construction staff. Natural veld may not be used for ablution activities.</p> | <p>Network: 21 May 2025 at 11:39:31 SAST<br/>Local: 21 May 2025 at 11:39:31 SAST<br/>S: 34° 1' 49.112" E: 22° 7' 34.768"<br/>38° NE<br/>Remark: Hartland<br/>HillLand Environmental</p> |

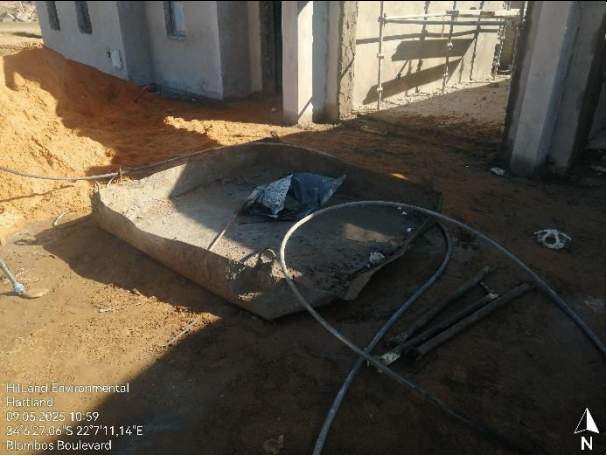
| <p>Cement batching must take place on an impermeable surface large enough to retain any slurry or cement water run-off.</p> | <p>Ongoing</p> | <p>There are currently several houses under construction in various development phases.</p> <p>The contractor is requested to ensure that cement mixing is always conducted on an impermeable surface or permanent disturbance area. There are several construction sites that make use of an impermeable wooden sheet or in the driveway, however runoff contaminated water must be confined to the mixing area, i.e., appropriate bunding to be installed (small brick berm / wooden mixing box etc.)</p> <p>The cement mixing for the house construction in the Retirement Village is done on a future development zone.</p> | <p>Hill and Environmental<br/>Hartland<br/>09/05/2025 10:59<br/>34°42'06"S 22°7'11.14"E<br/>Blaribos Boulevard</p> |

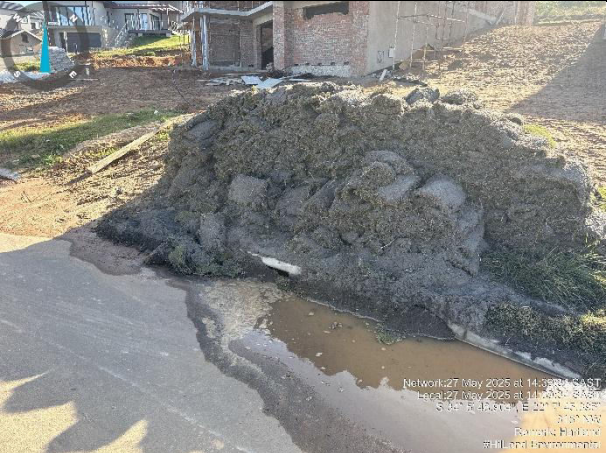
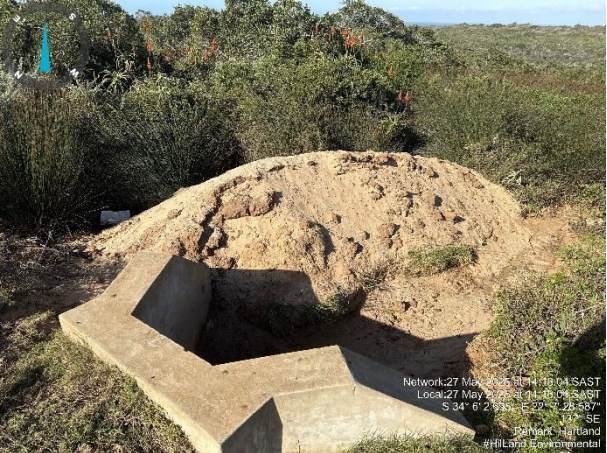
| Soil erosion mitigation | | | |
|---|---|---|---|
| Erosion control measures including silt fences, low soil berms and/or shutter boards must be put in place around the stockpiles to limit sediment runoff from stockpiles. | Ongoing | <p>Level erven is complaint and does not generally have silt or erosion issues.</p> <p>The steep erven will require silt protection, either sandbags or low bidim silt fence.</p> <p>Stormwater inlets must be protected – no silt or construction site wash must enter the stormwater system. This will silt up the stormwater outlets, many of which are in the conservation area.</p> | <div><p>Network:27 May 2025 at 14:33:37 SAST<br/>Local:27 May 2025 at 11:00:00 SAST<br/>S 34° 14' 42.83" E 02° 12' 12.15" E<br/>Datum: Hartland<br/>Hilland Environmental</p></div> <p>Stormwater inlets must be protected to prevent silt build-up</p> <div><p>Network:27 May 2025 at 14:19:04 SAST<br/>Local:27 May 2025 at 11:00:00 SAST<br/>S 34° 07' 21.98" E 02° 12' 28.53" E<br/>Datum: Hartland<br/>Hilland Environmental</p></div> <p>Example of the amount of silt in the stormwater network that was removed recently. Silt protection at the curb-inlets is crucial.</p> |

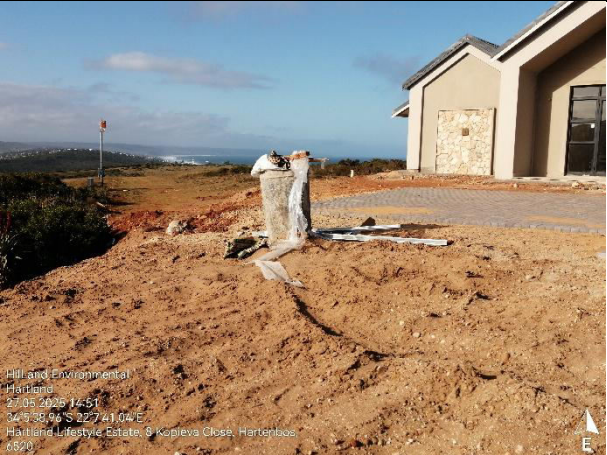
| Waste and pollution management | | | |
|---|---|---|---|
| <p>Dedicated waste bins or skips must be provided on site and kept in a demarcated area on an impermeable surface.</p> <p>Construction workers must be instructed not to litter and to place all waste in the appropriate waste bins provided on site.</p> | Ongoing | <p><b>Compliant</b> - The contractor placed additional waste bins at each construction site which are emptied weekly. Skips are placed strategically throughout the site and are demarcated with shade netting (to prevent wind from blowing litter).</p> <p><b>Ongoing</b> - Wind-blown litter remains an ongoing construction related problem. Therefore, the contractor has a dedicated litter picking team conducting weekly litter picking.</p> <p>Either the bins must be cleaned out more frequently or the workers must be briefed on waste and litter weekly.</p> <p>The HOA has also appointed a dedicated litter picker.</p> | |

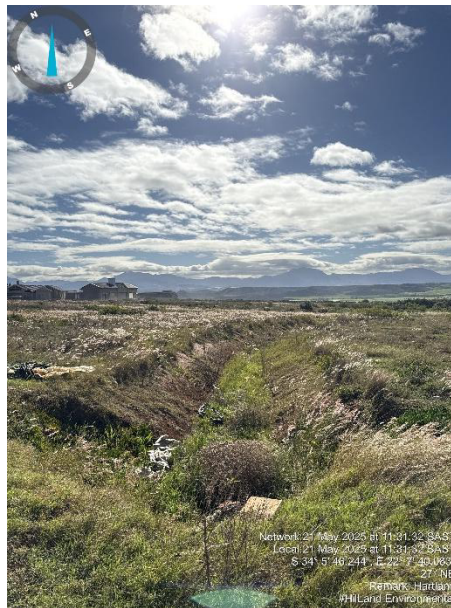
Rehabilitation progress of the stormwater outlets

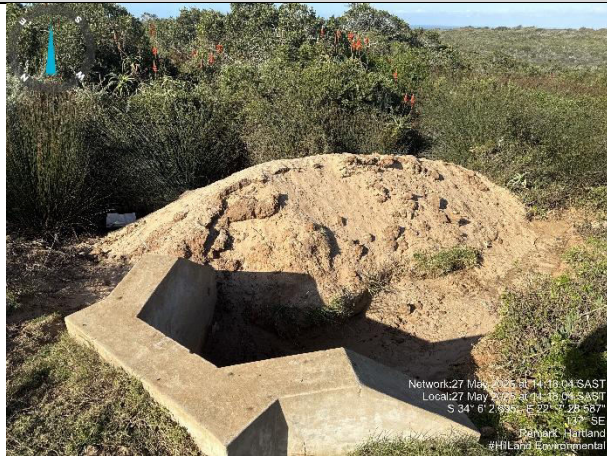
| OEMPr requirements | Level of compliance | Comments / Findings | Photos (if applicable) |
|---|---|---|---|
| Waste traps must be cleared of any obstructions monthly or when heavy rainfall has occurred. | Ongoing | Litter and silt wash are being removed from stormwater outlets and must be monitored by the HOA and management – ongoing activity that the HOA is assisting and managing. | <p>Network: 27 May 2023 14:19:04 SAST<br/> Local: 27 May 2023 14:19:04 SAST<br/> S: 34° 0' 2.955\"</p> |

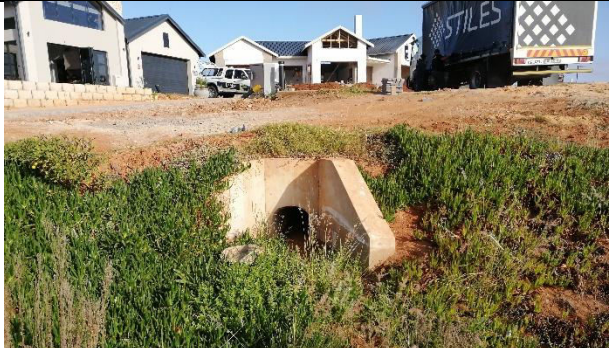
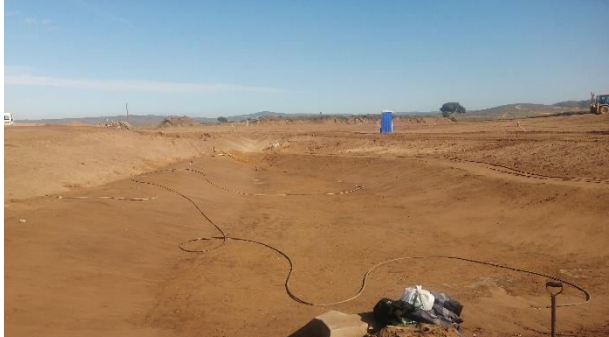
Stormwater outlet was recently cleaned out (silt build up). It is important that the silt is removed from the outlet (by hand – no machines)

| | | | <div data-bbox="1565 193 2172 651"><p>HillLand Environmental<br/>Hartland<br/>27.05.2025 14:51<br/>34°5'38.96"S 22°7'40.98"E<br/>Hartland Lifestyle Estate, 8 Kopleys Close, Hartenbos,<br/>6520</p></div> <div data-bbox="1565 683 2172 1141"><p>HillLand Environmental<br/>Hartland<br/>09.05.2025 11:00<br/>34°6'26.52"S 22°7'10.98"E<br/>Blombos Boulevard</p></div> <div data-bbox="1579 1141 2161 1204"><p>Stormwater retention ponds in the retirement village.</p></div> |

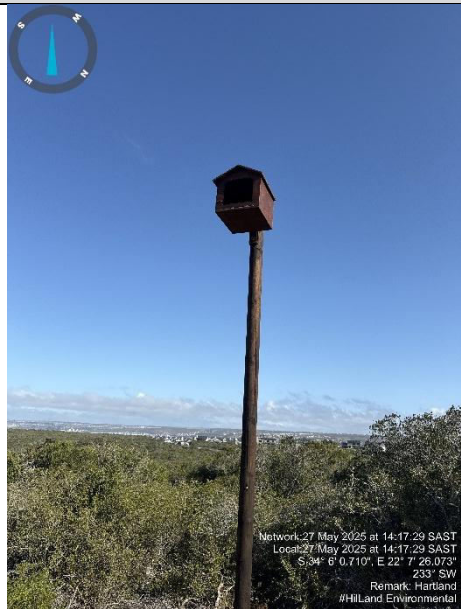
| MANAGEMENT OF NATURAL OPEN SPACES | | | |
|---|---|---|---|
| Natural open spaces must be managed properly to maintain ecological biodiversity and to provide limited and controlled recreational access to the residents living in this development. | Compliant and ongoing | <ul style="list-style-type: none"> <li>Initial alien clearing is done. <b>Ongoing follow up clearing/eradication to be implemented.</b></li> <li>A section of the <i>Thamnochortus insignis</i> in the natural open space is maintained - bossiekap.</li> <li>The existing tracks are being maintained as maintenance tracks, firebreaks (bossiekap) and security patrols.</li> <li>Hiking/cycling tracks in the development area, conservation area and internal open spaces must be monitored for erosion and damage (by the HOA) and repaired immediately to avoid excessive environmental damage.</li> <li>Viewing deck is maintained.</li> <li>Perimeter firebreaks are in places and maintained – avoid bare surfaces to limit soil erosion risk. Wood chips/<i>carpobrotus</i> etc. can be used to cover bare soil.</li> <li>Kweek lawns are installed at the newly completed houses.</li> <li>Conservation area “rules” boards are in place.</li> <li>Owl boxes were installed in the conservation area.</li> </ul> | <p>Network: 27 May 2025 at 14:17:29 SAST<br/> Location: 27 May 2025 at 14:17:29 SAST<br/> S: 34° 0' 0.710", E: 22° 7' 26.073"<br/> Z33° SW<br/> Remark: Hartland<br/> #Hiland Environmental</p> |

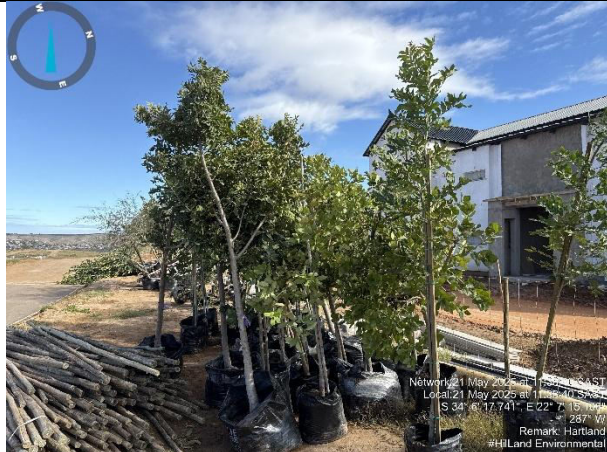
| No gardening allowed in the natural open spaces / conservation areas. | Compliant | No gardening in natural open spaces (conservation area and natural bush). Internal open spaces are maintained for the residential use – landscaped area. | <p>Indigenous trees are planted in the internal open spaces – in line with the NFA permit condition for the Hartland Western access.</p> |

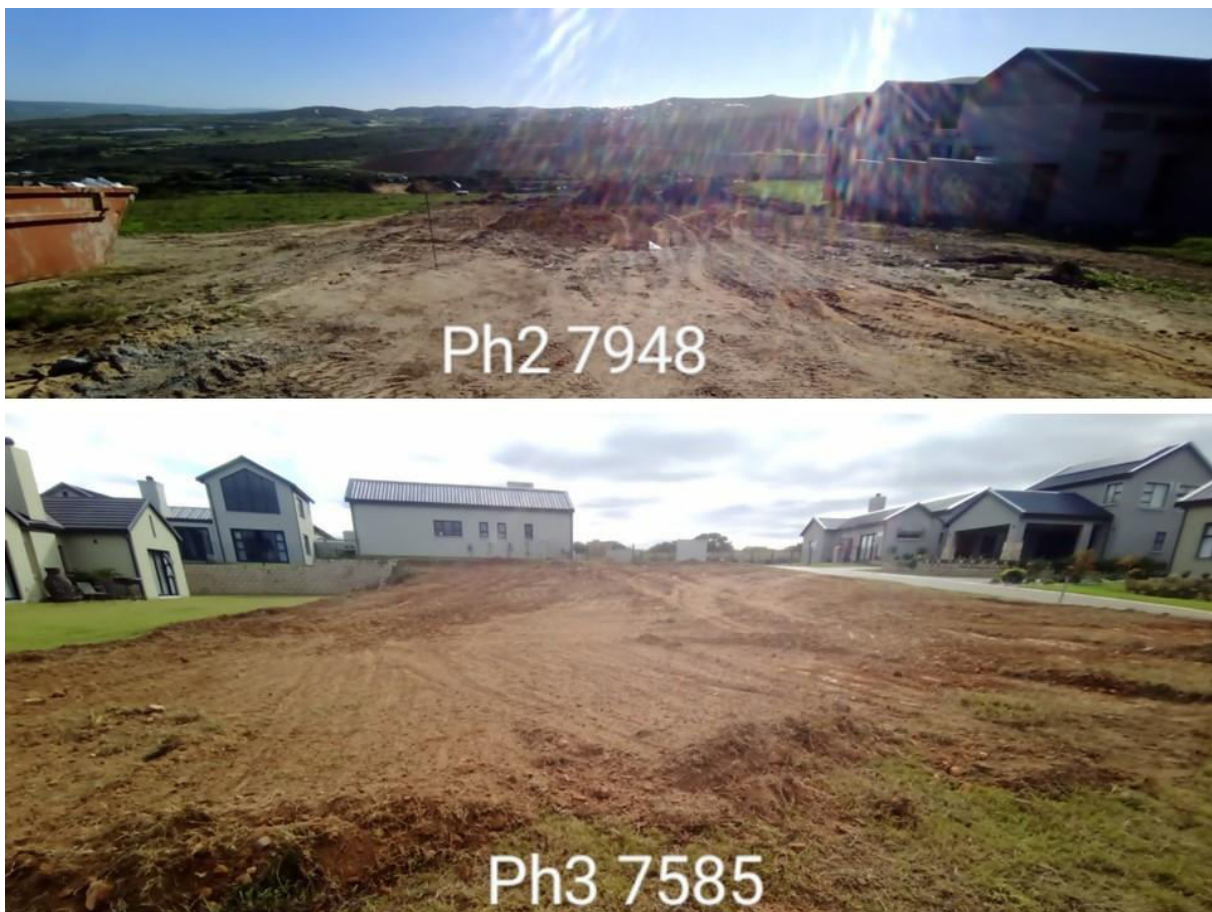
Figure 1. Hartland – Phases 2 and 3 – 7948 is cleared, filled and complete while 7585 is cleared but not excavated or complete.

Erf 7948 is the only house platform completed in Phase 2 (Figure 1). The site was cleared and filled without any excavation. No heritage resources were identified.

Erf 7585 was cleared but no excavations to date (Figure 1). Erf 7587 is till on hold. No heritage resources were identified.

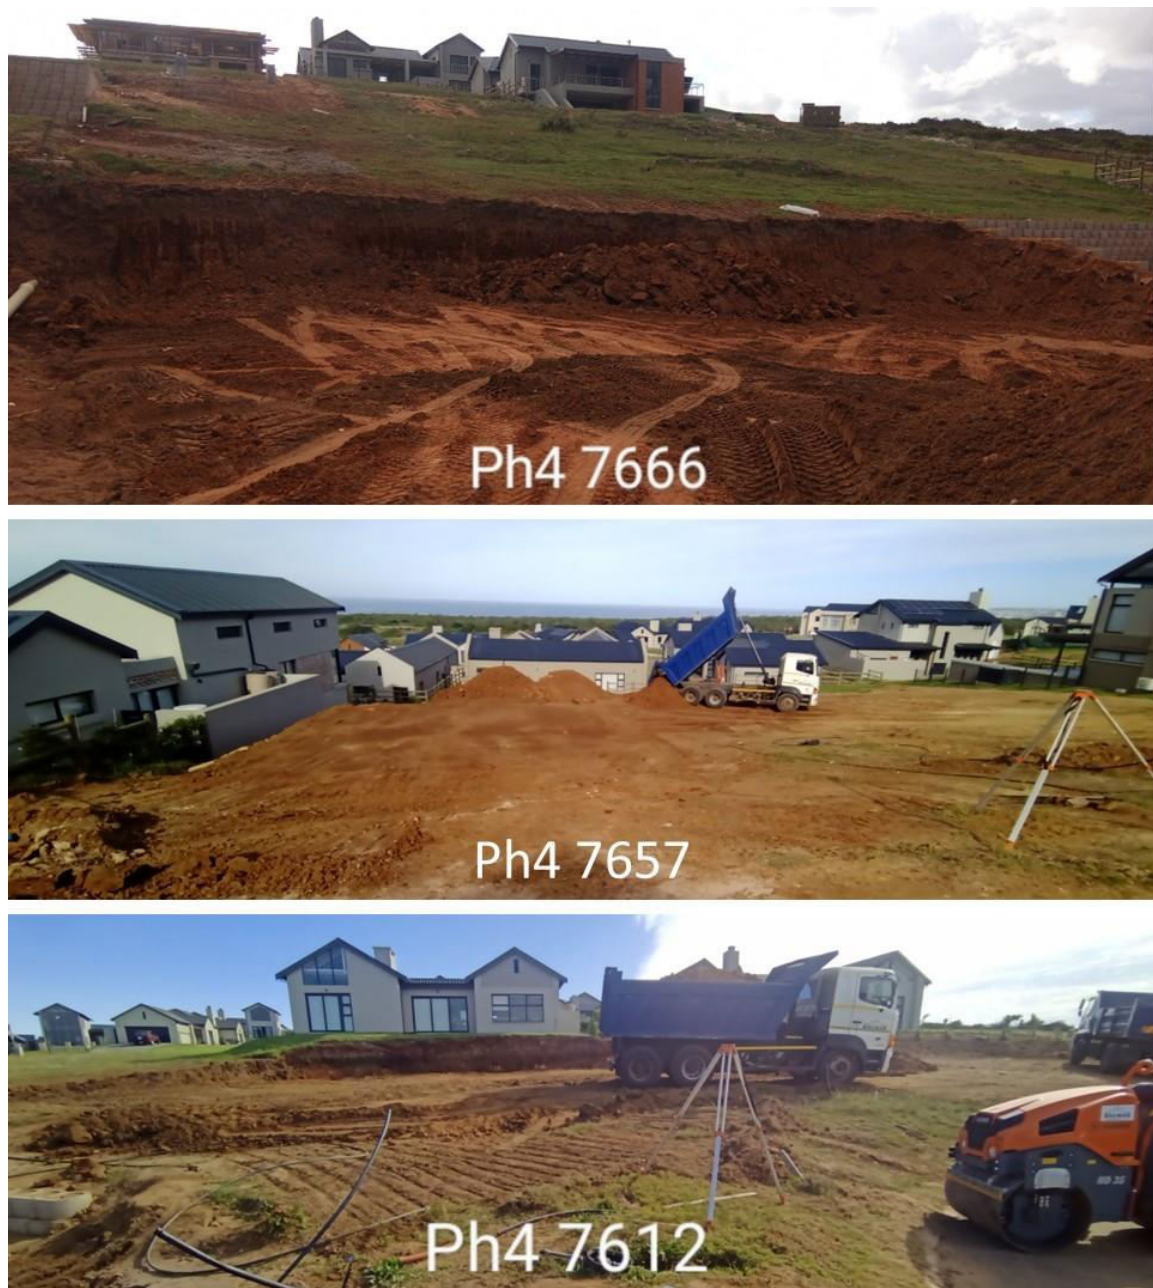
House platforms at Erven 7666, 7657, 7612 (Figure 2) and the upper level of Erf 7617 (first reported previously) are complete, while those at Erven 7622 and 7643 are still in progress. To date, no heritage resources were identified at these sites.

Figure 2. Hartland – Phase 4 – completed house platforms.

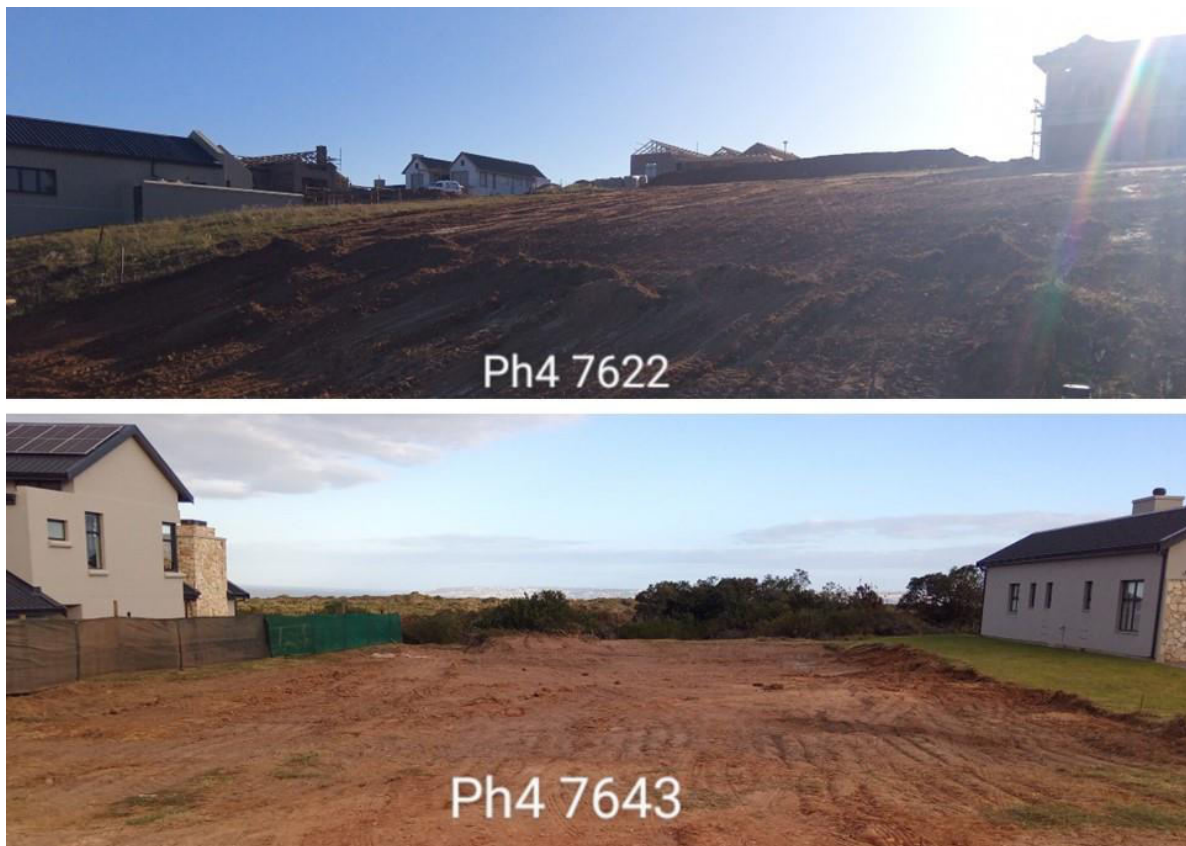
Figure 3. Hartland – Phase 4 – incomplete house platforms.

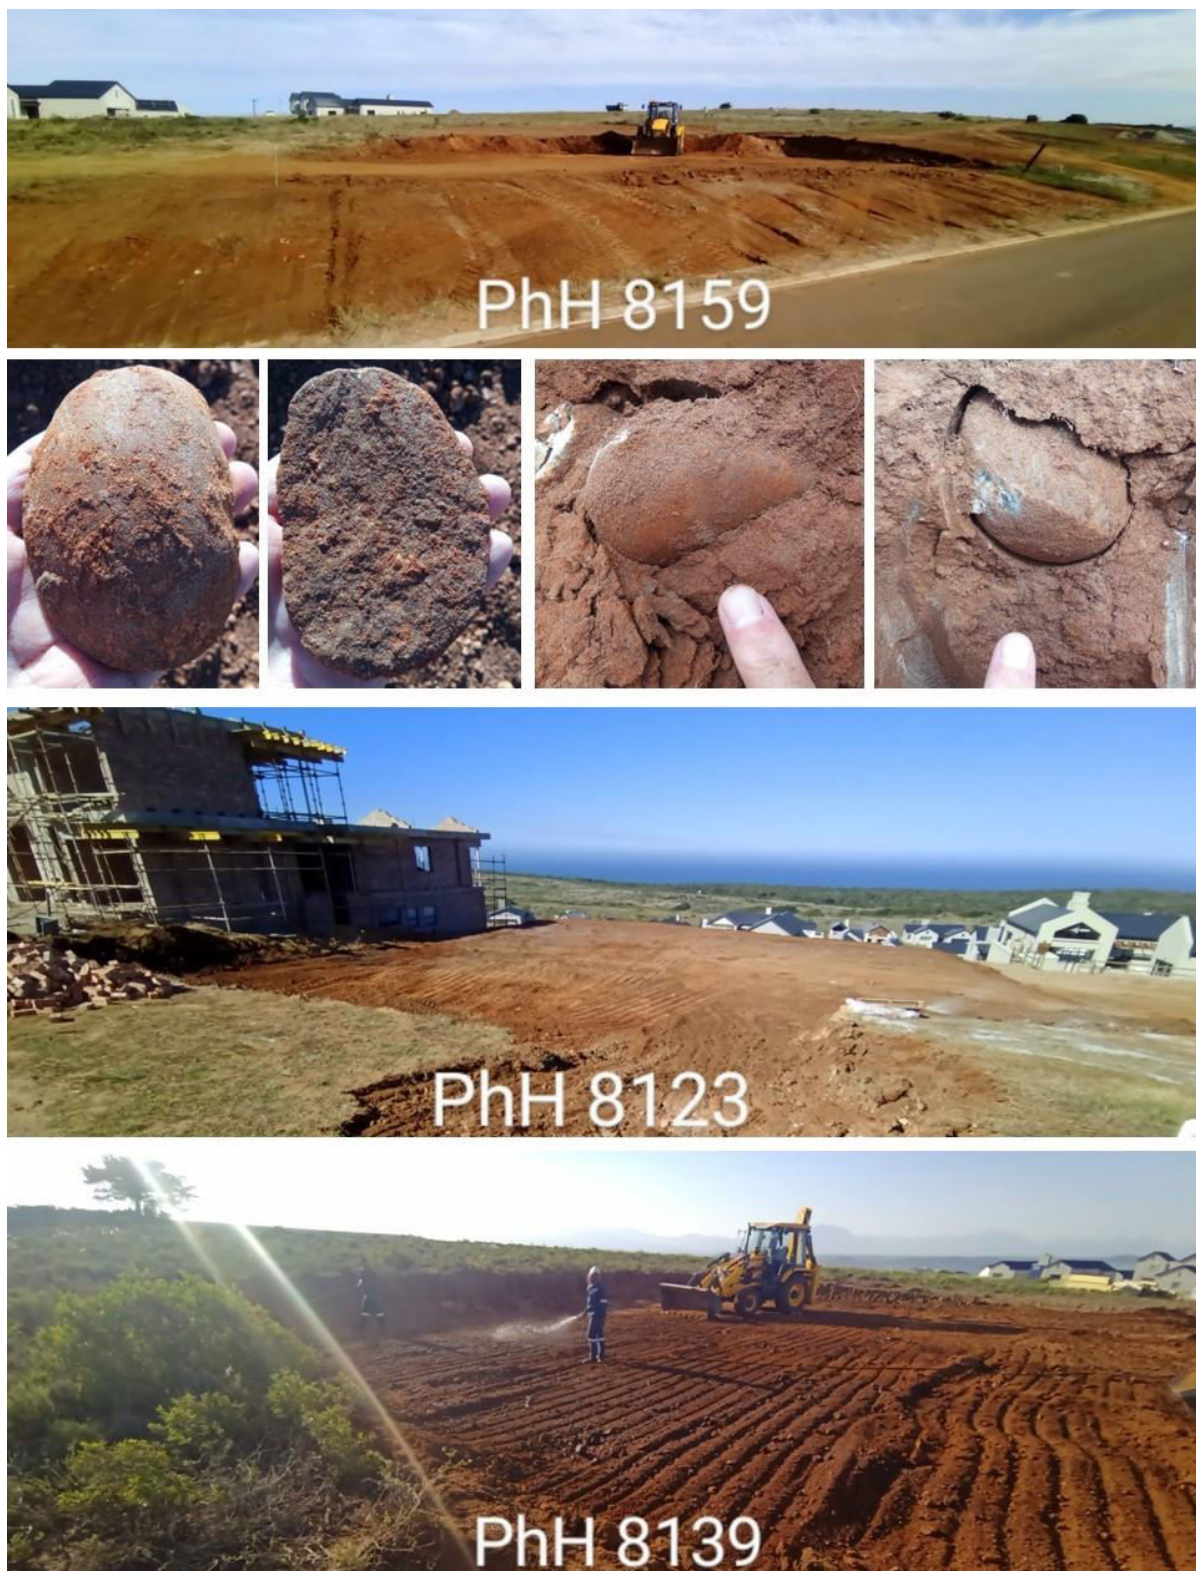
House platforms in Phase H included the completion of Erven 8159, 8123 and 8139 where Stone Age specimens were identified at Erven 8159 and 8139 (Figures 4 & 5). Artefacts are in quartzite and include flakes, flaked cobbles, hammer stones and a bifacial cutting tool of late Early Stone Age or early Middle Stone Age origin. Due to their low densities, temporal mixing, the absence of anthropogenic strata, and the absence of associated cultural and organic remains, these find are rated Not Conservation Worthy and require no further action in terms of the NHRA.

Figure 4. Hartland – Phase H – completed platforms and Stone Age pieces in quartzite recorded at Erf 8159.

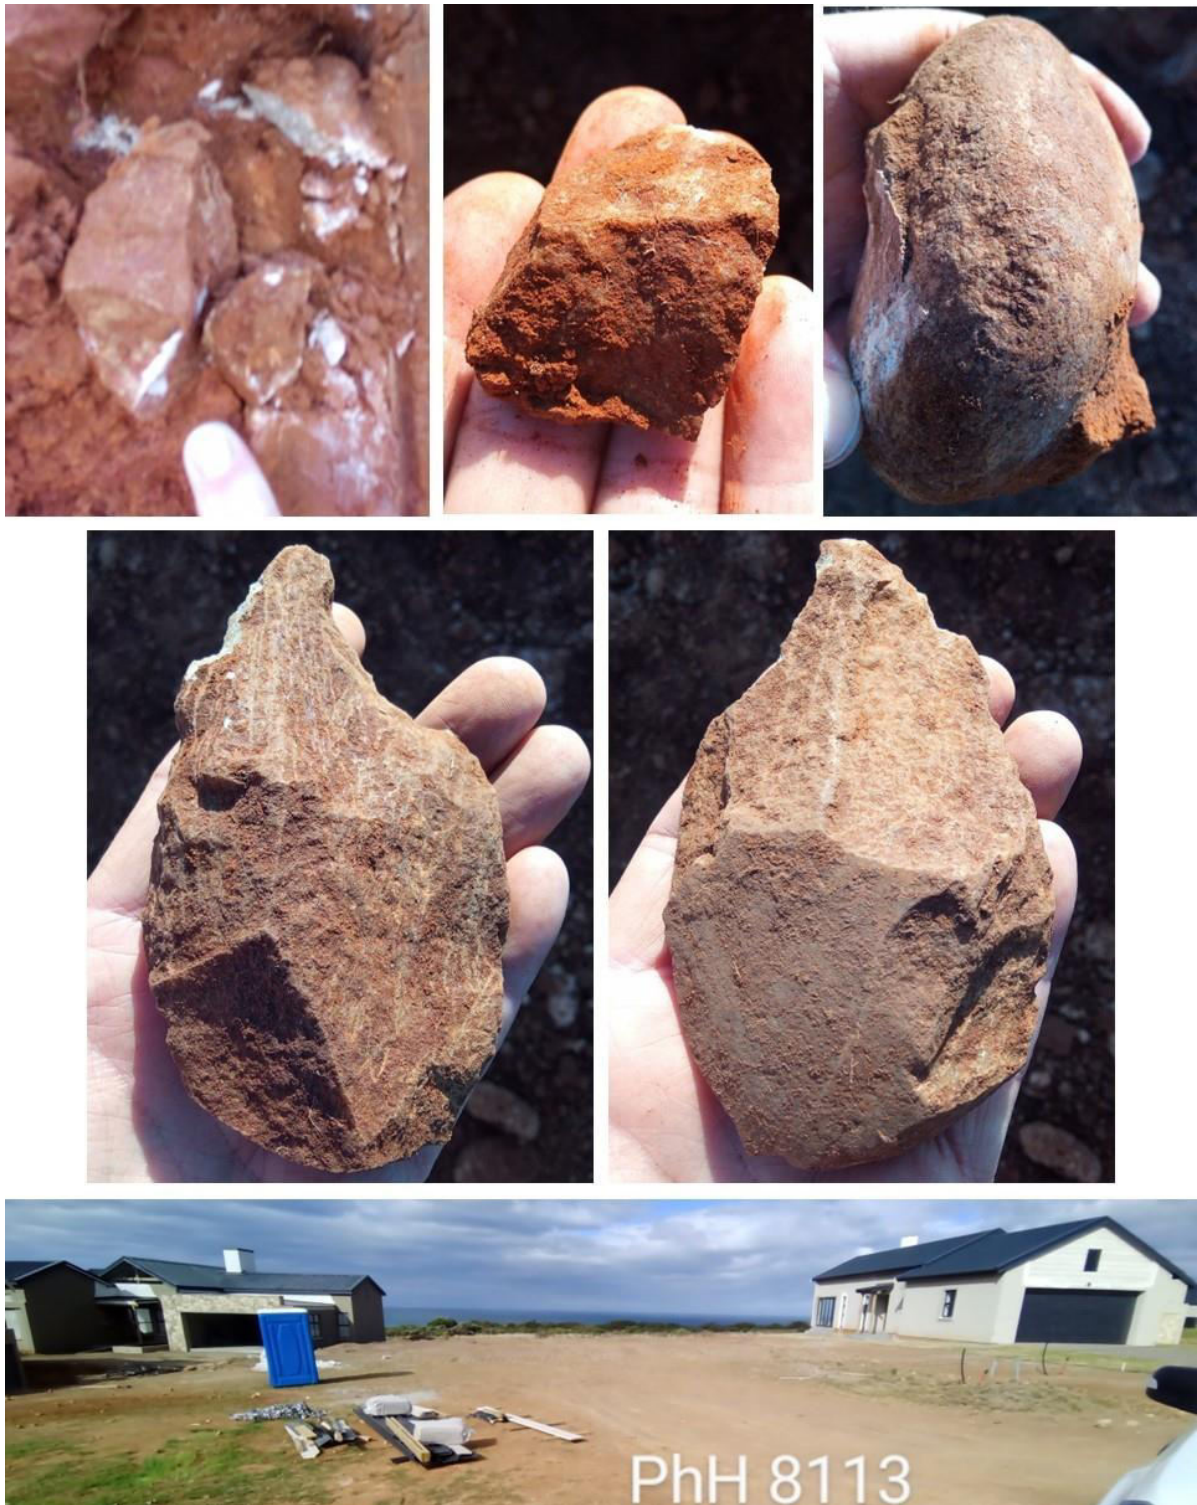
Earthworks for Erven 8113 (Figure 5) and 8105 are still outstanding.

Figure 5. Hartland – Phase H – Stone Age implements recorded at Erf 8139 and incomplete platform at Erf 8113.

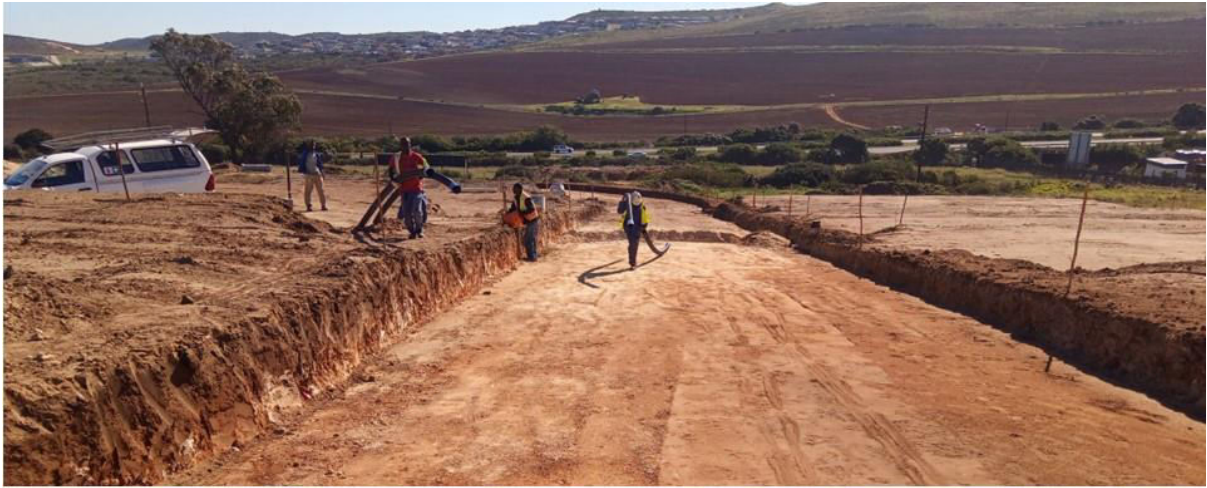
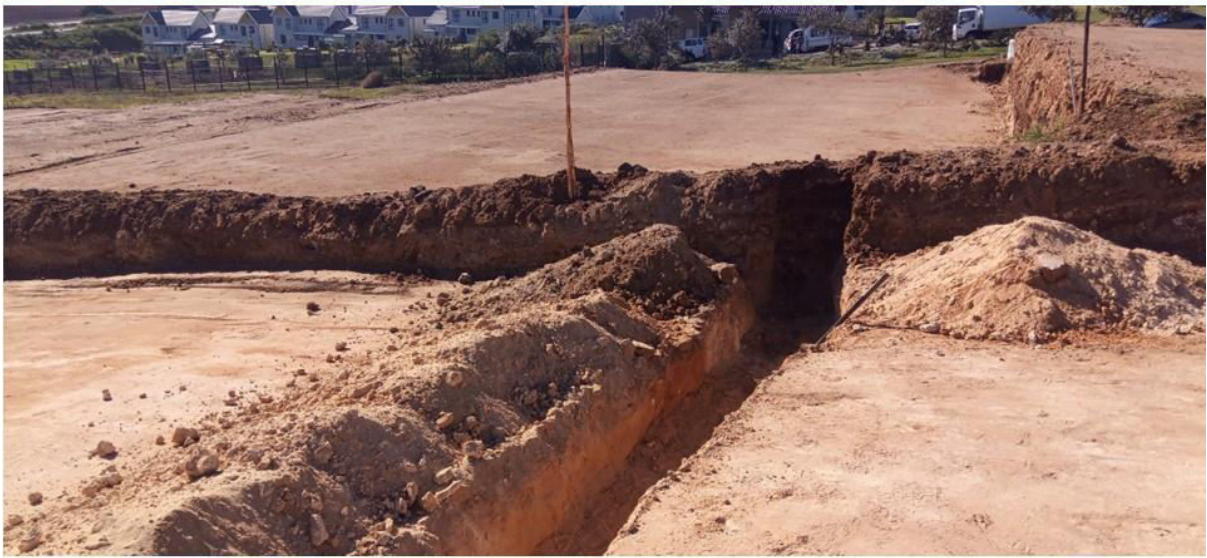
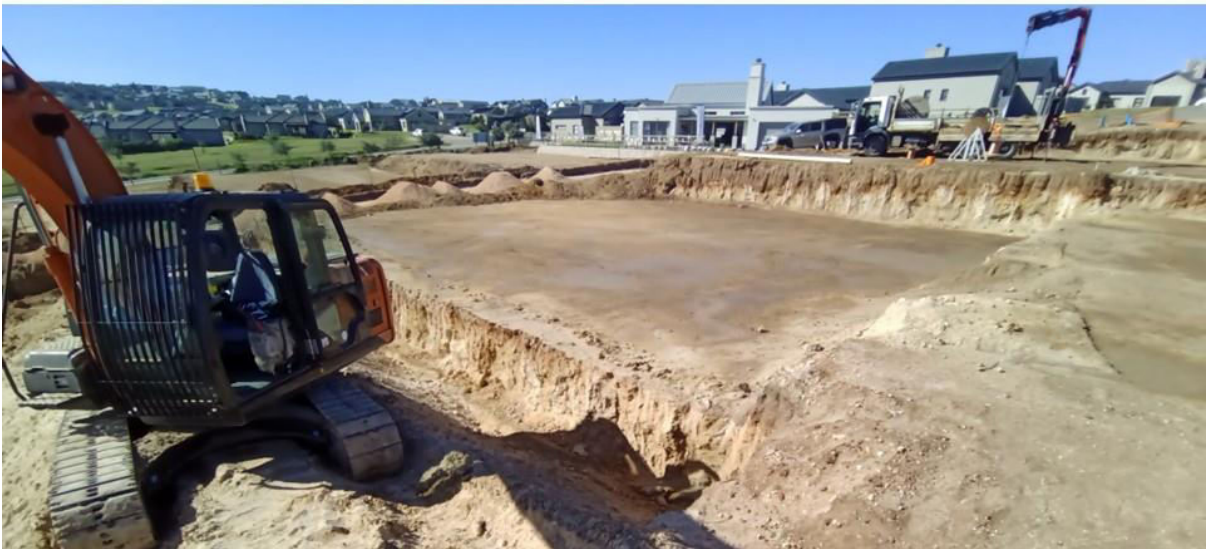
Works included road box cuts, road crossings and terrace repairs (Figure 6). No heritage resources were identified.

Figure 6. Hartland – Phase A – Klein Karoo Civils – road box cuts, road crossings and terrace repairs in progress.

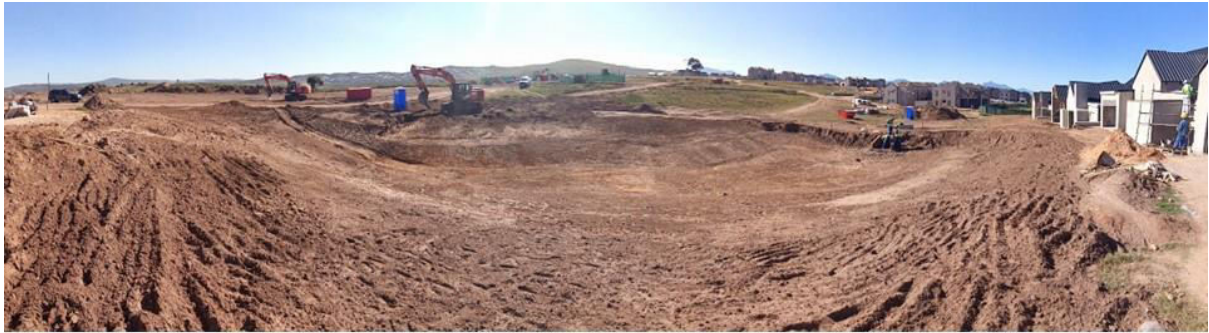
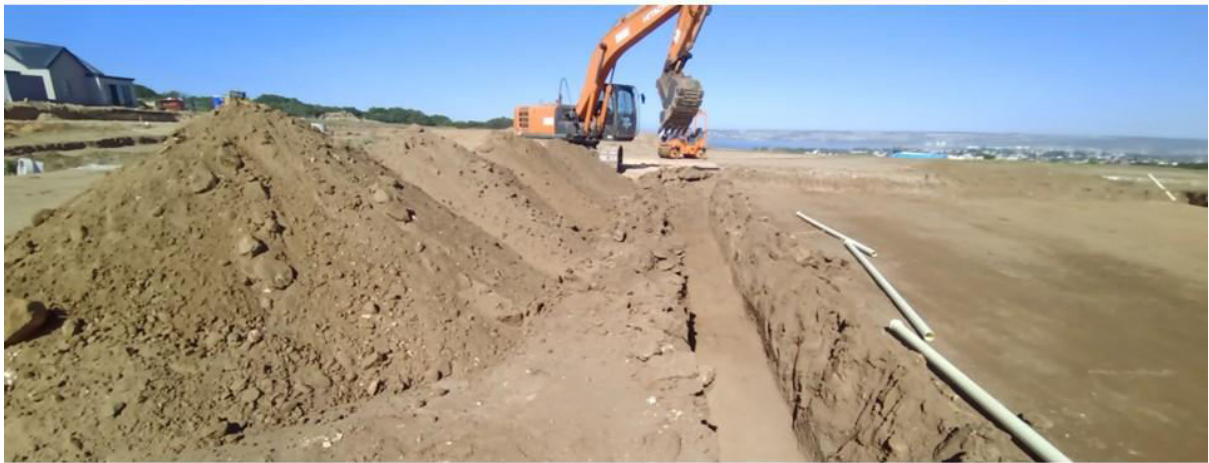
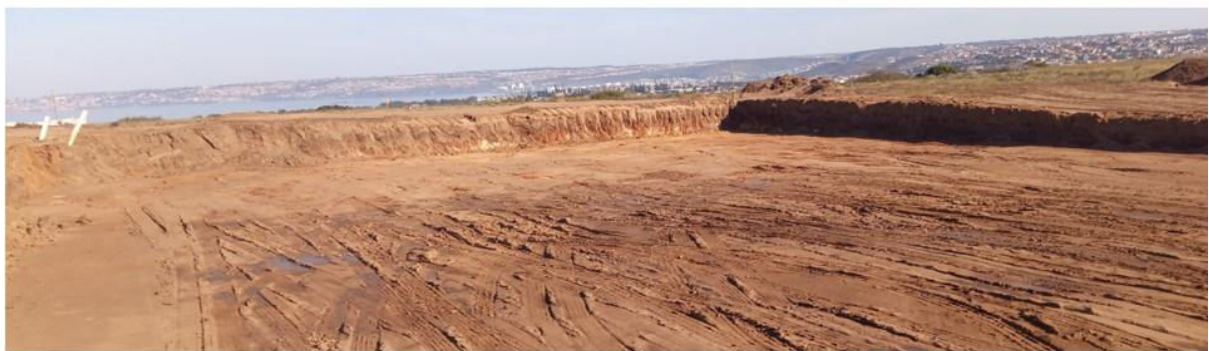
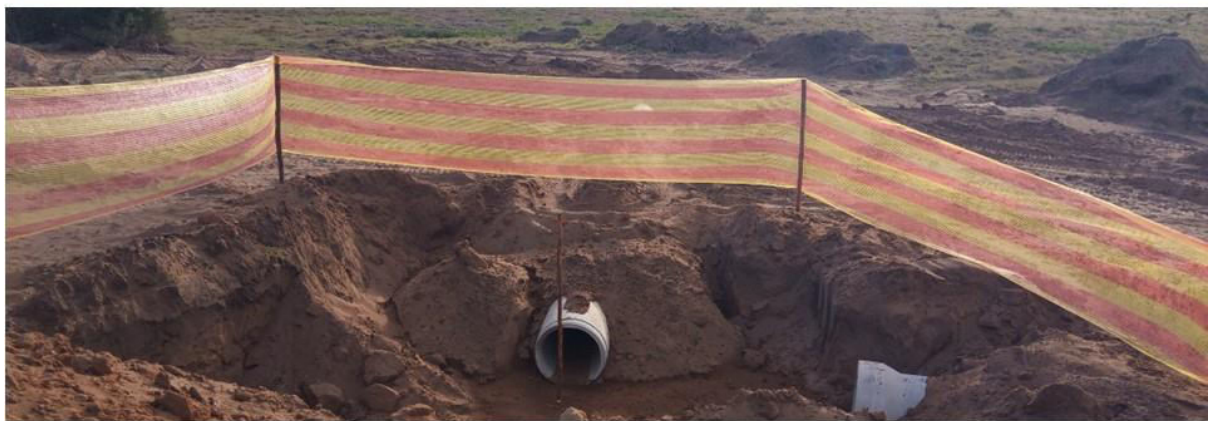
Figure 7. Hartland – HRV-Ph2 – earthworks in progress.
