**ENVIRONMENTAL MONITORING REPORT NO. 45  
FOR  
HARTLAND ON  
PORTION 11 OF FARM VAALE VALLEY 219, MOSSEL BAY**

**MOS25/1027/73**

## ENVIRONMENTAL MONITORING REPORT NO. 45 – MAY 2025

**HARTLAND DEVELOPMENT- PORTION 11 OF FARM VAALE VALLEY 219, MOSSEL BAY****Conditions of report use:**

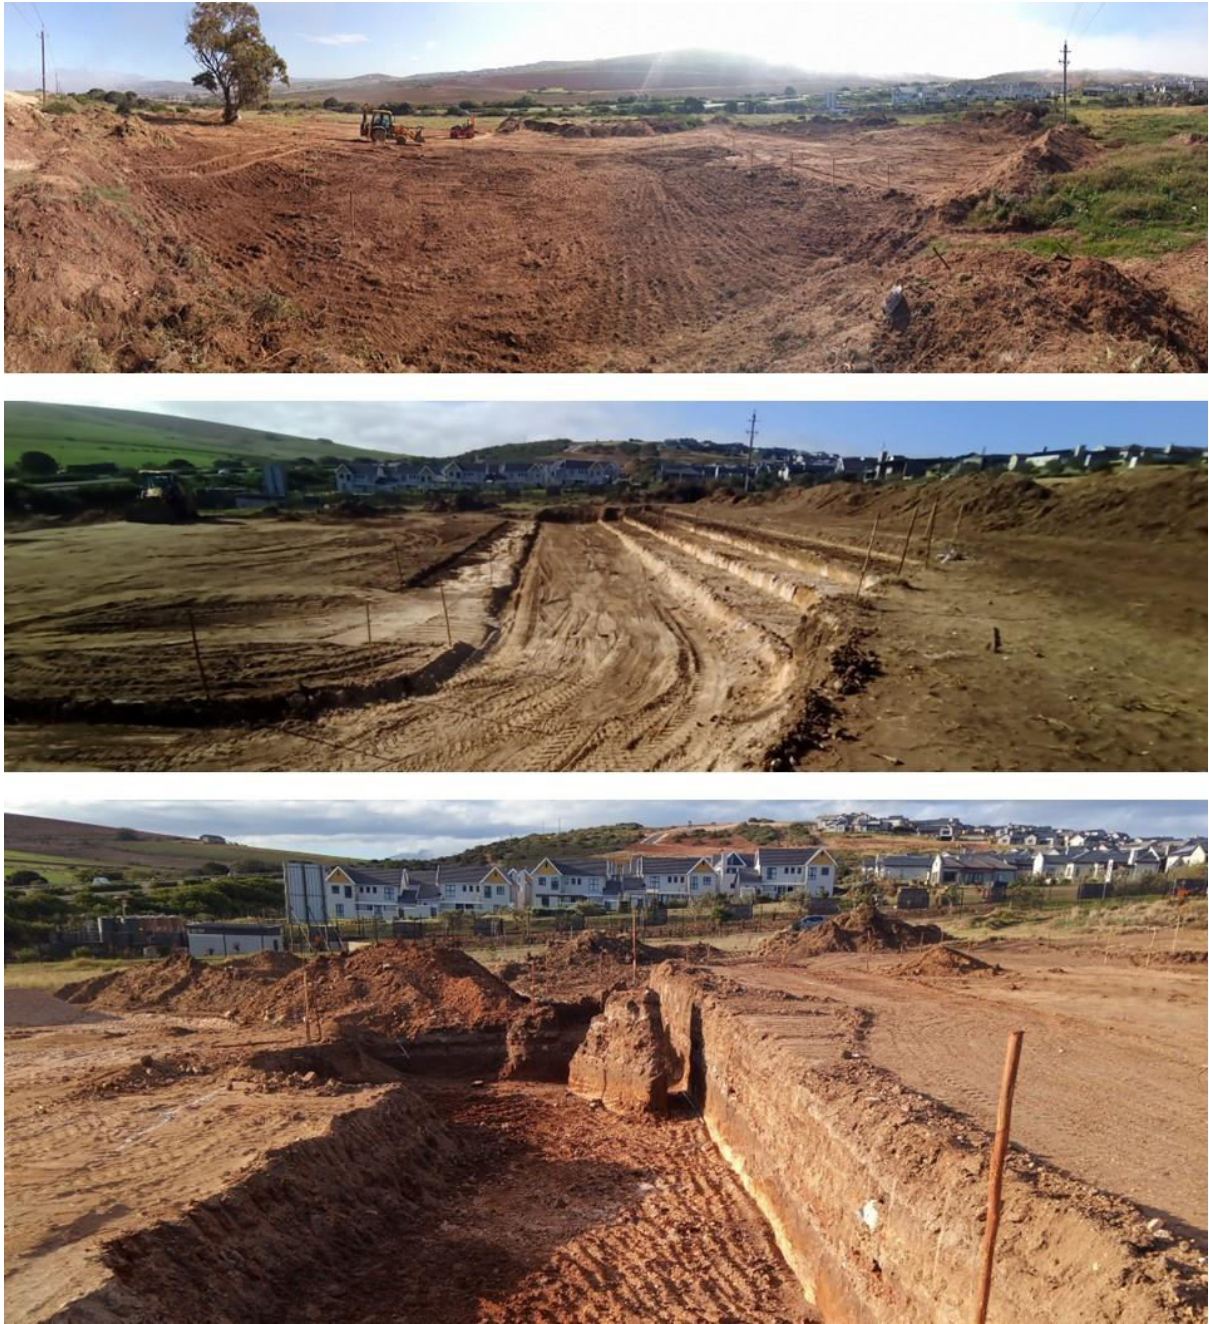
Works involved vegetation & topsoil stripping and structural / foundation excavations as well as mini terraces (Figure 8). No heritage resources were identified.

Figure 8. Hartland Development– future school site – earthworks in progress.
