# ENVIRONMENTAL MONITORING REPORT

## HARTENBOS LANDGOED PHASE 2 DEVELOPMENT ON A PORTION OF THE REMAINDER OF THE FARM VAALEVALLEY 219, MOSSEL BAY

**DATE:** 6<sup>th</sup> August 2019

**REPORT NR:** EMR/HBLG/MSB/01/19  
**DEADP REF NR** EG12/2/1 – AM18 – Farm Valle Valley 219/10 (5382)

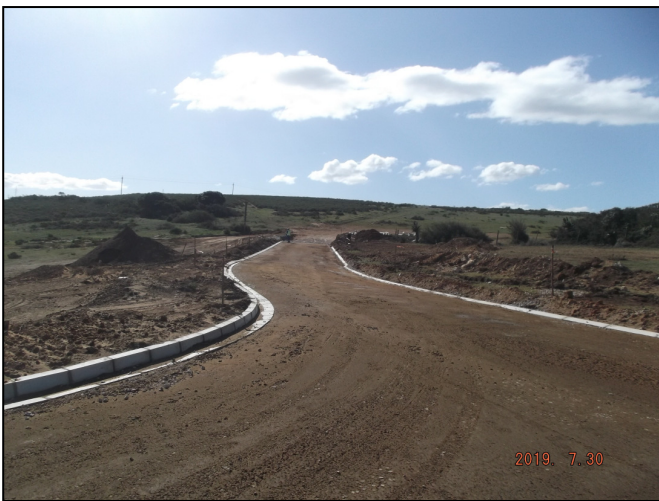
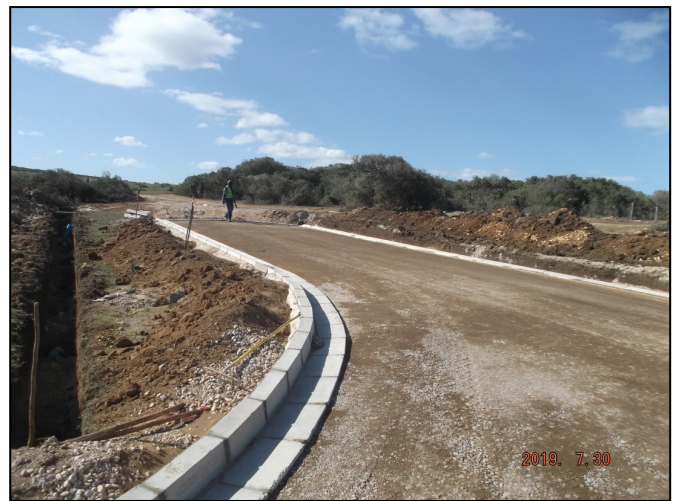
- Land clearing activities were undertaken on site
- An internal road network is being established within the development site (Images 1 and 2)
- Blue water pipes have been installed within the excavated trenches as seen from Image 3
- Stormwater inlets and sewerage cesspits have been installed on site, as seen from Images 4 and 5
- In addition, lamp posts were also installed on site, as seen from Image 6.
- Excavated material is being stockpiled in the South Eastern edge of the development area.

**Images 1 & 2: Road network and installed kerbing within the development site**

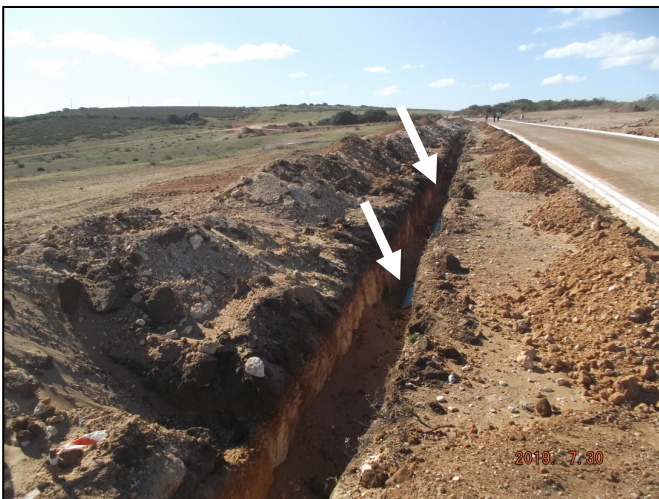
**Image 3: Arrows indicating installed water pipes within the excavated trenches**

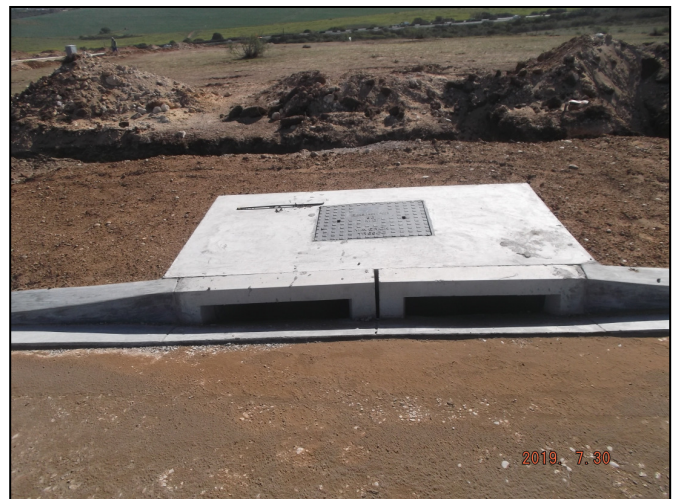
**Image 4: Installed stormwater inlet within the development site**

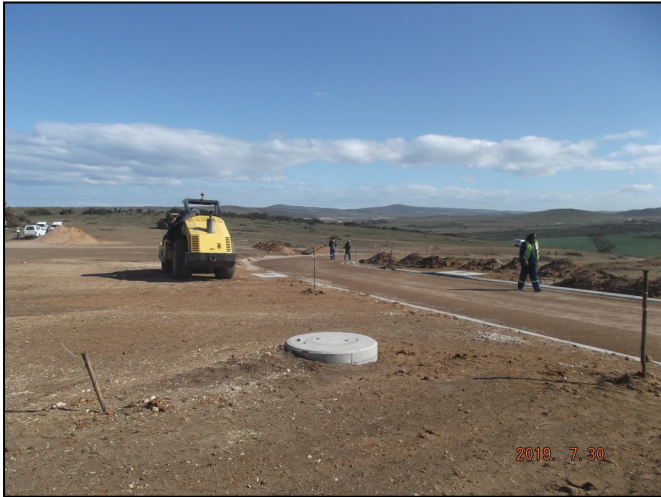
**Image 5: Installed sewerage cesspit within the development site**

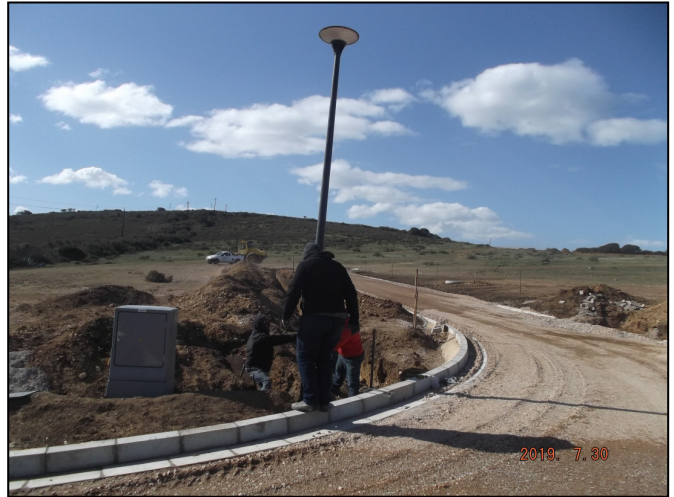
**Image 6: Installation of new lamp posts within the development site**

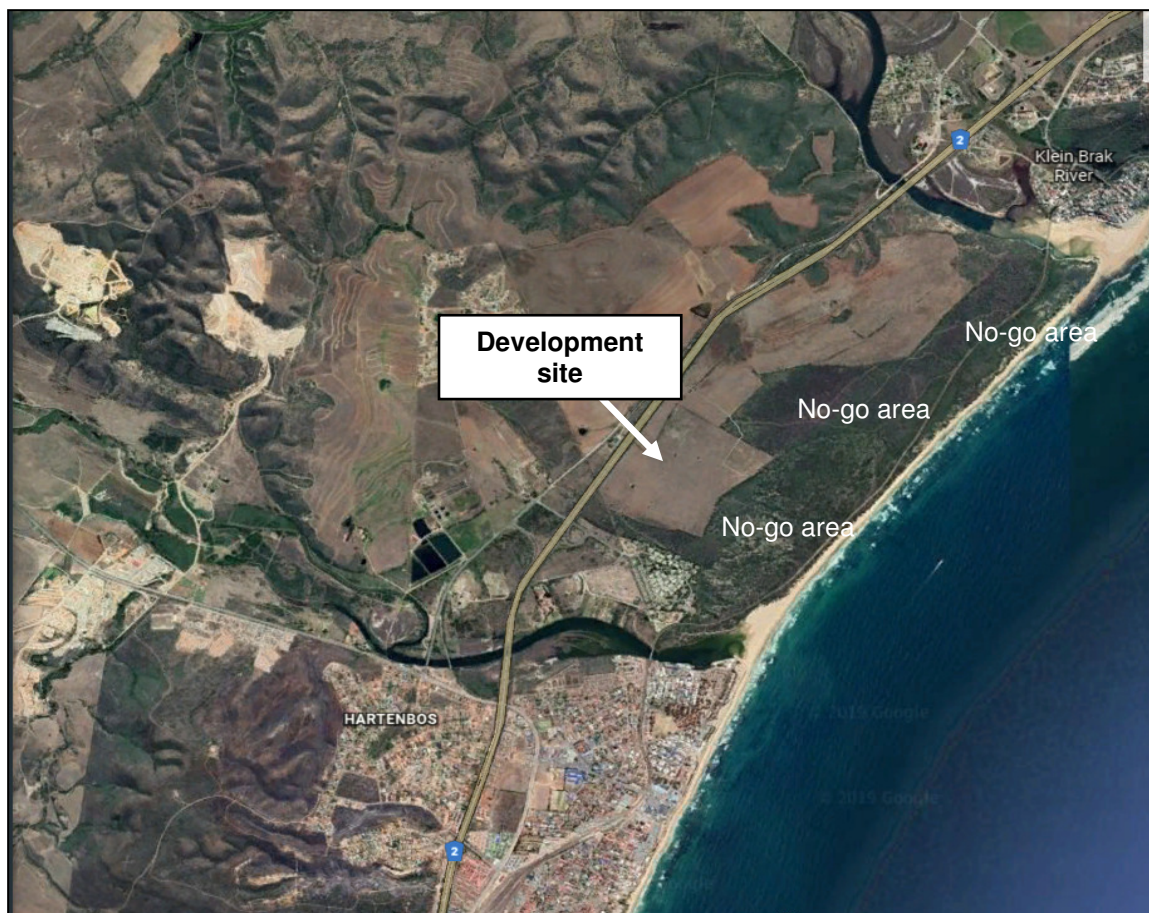
**Figure 2: Google earth Image showing “No-go” areas and development site**

Demarcation must be put in place using 1.2m high fence of shade cloth netting. In addition, “No-go” signs should be put in place to ensure that these areas are not disturbed by the construction team. Please refer to Figure 2 for the “No-go” areas.

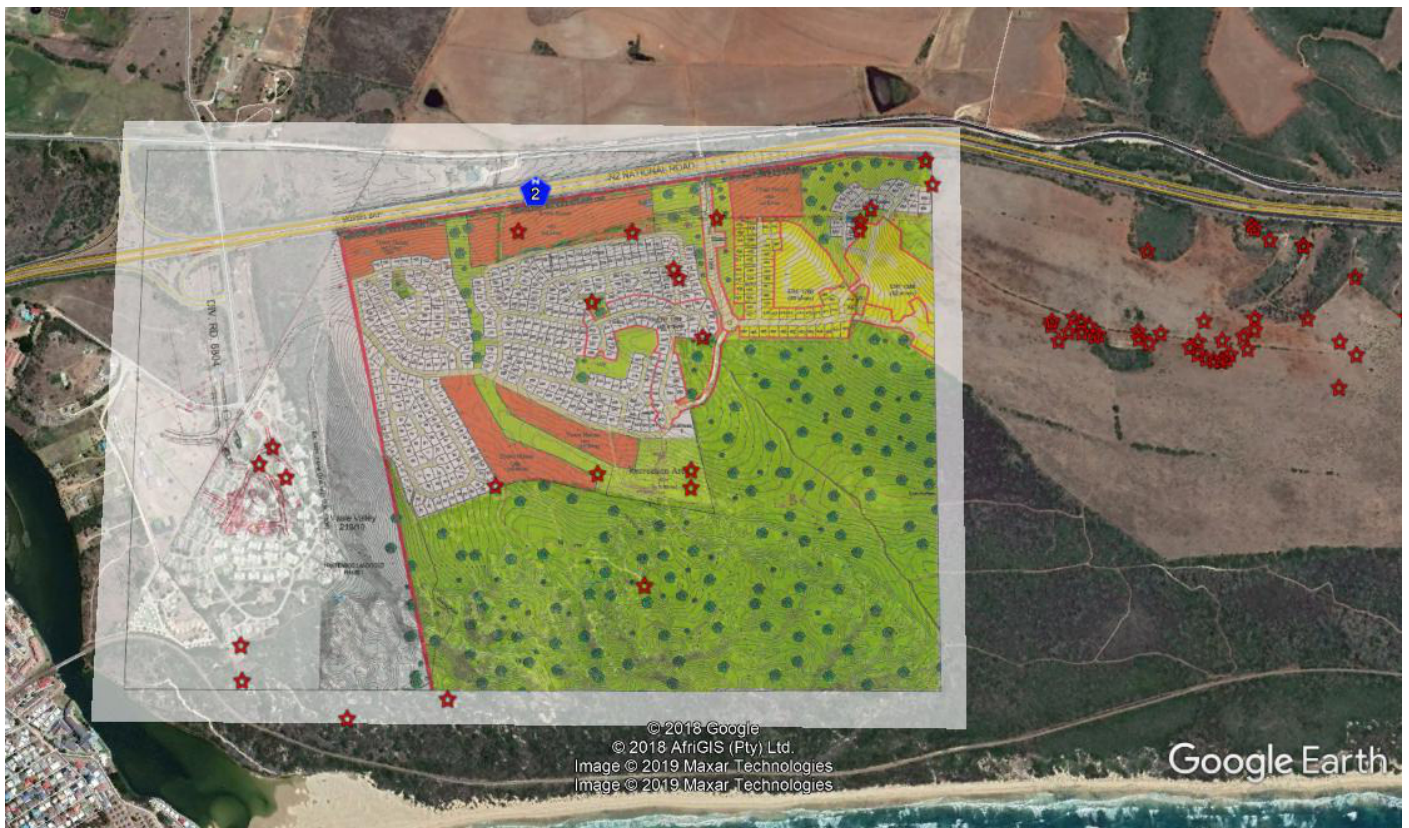
No permits have been obtained from Heritage Western Cape as stipulated in the Impact Assessment Report conducted by MAPCRM cc. Refer to Figure 3 for the archaeological of the Heritage Report compiled for the assessment of this development which have been overlain on a Google Earth Image of the site in addition to the most recent Site Development Plan.

Figure 3: Site map indicating areas of heritage interest

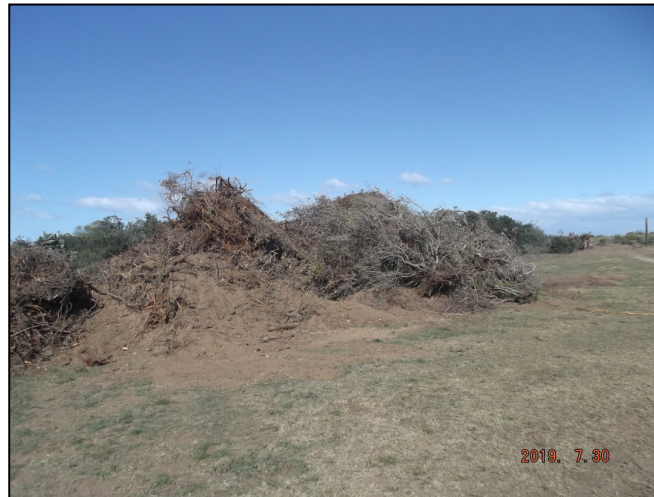
| Section<br>4 | COMPLIANCE WITH EA and EMPr | | |
|---|---|---|---|
| Housekeeping | No | Removed branches were noted near the site camp area. | The removed branches must be disposed of at an appropriate registered facility (Image 9). |

**Image 8: The branches must be removed from site and disposed of at an appropriate registered facility**

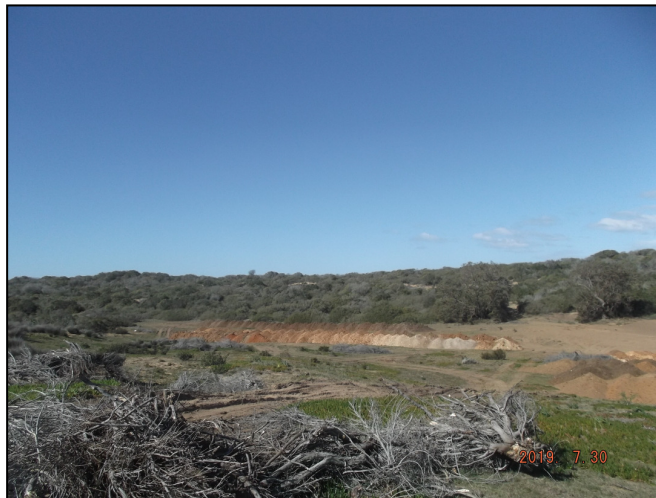
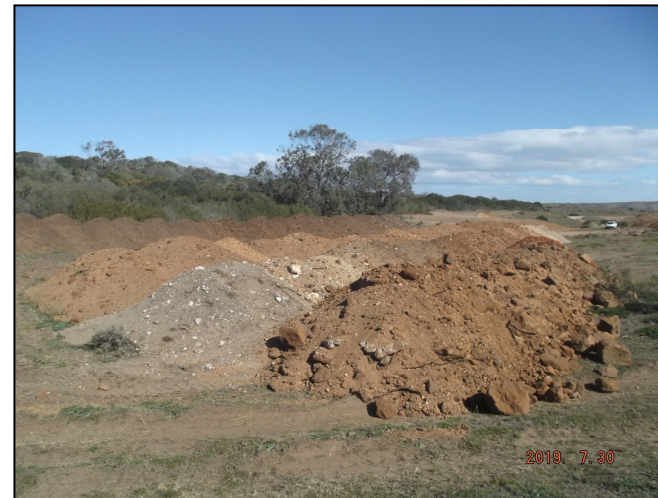
| Section<br>4 | COMPLIANCE WITH EA and EMPr | | |
|---|---|---|---|
| Sensitive areas | No | "No-go" areas were disturbed by the construction team. | The contractor is to ensure that the "No-go" areas are demarcated and appropriate signage are put in place on site to prevent the construction team from entering these areas. |

**Images 9 & 10: The stockpiles must be removed sensitively from the “No-go” areas and placed within the development site or a location upon consultation with the Environmental Control Officer**
