# **Review of earlier Archaeological Heritage Study and an Archaeological Site Inspection – Current Status and Way Forward**

**Hartland Development (Previously known as Hartenbos Landgoed  
II) - Residential Development on a Portion of the farm Vaalevalley  
219, Mossel Bay, Western Cape Province**

5 May 2021

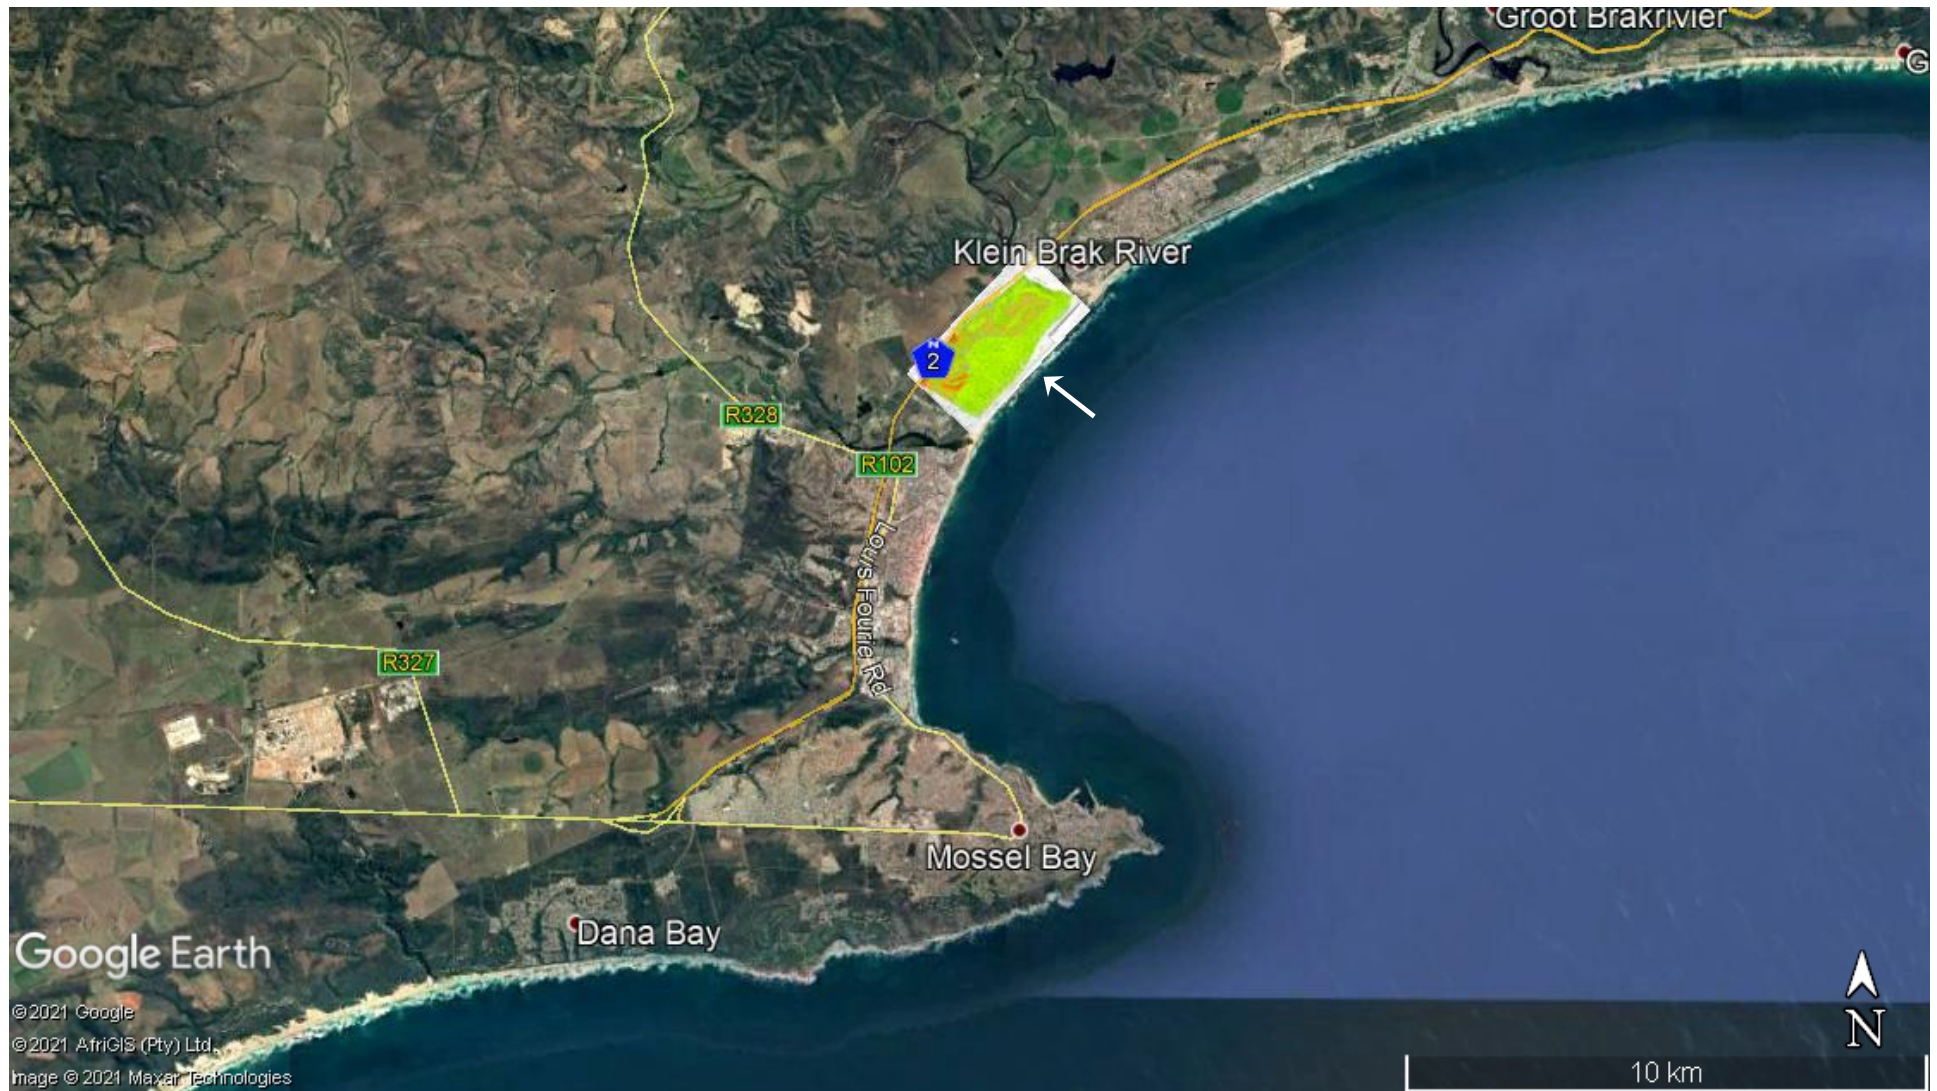
Figure 1. White arrow shows the location and extent of the Hartland Development relative to Mossel Bay and Klein Brak River in the Garden Route of the Western Cape Province. Courtesy of Dalmar Beleggings and Google Earth 2021 .

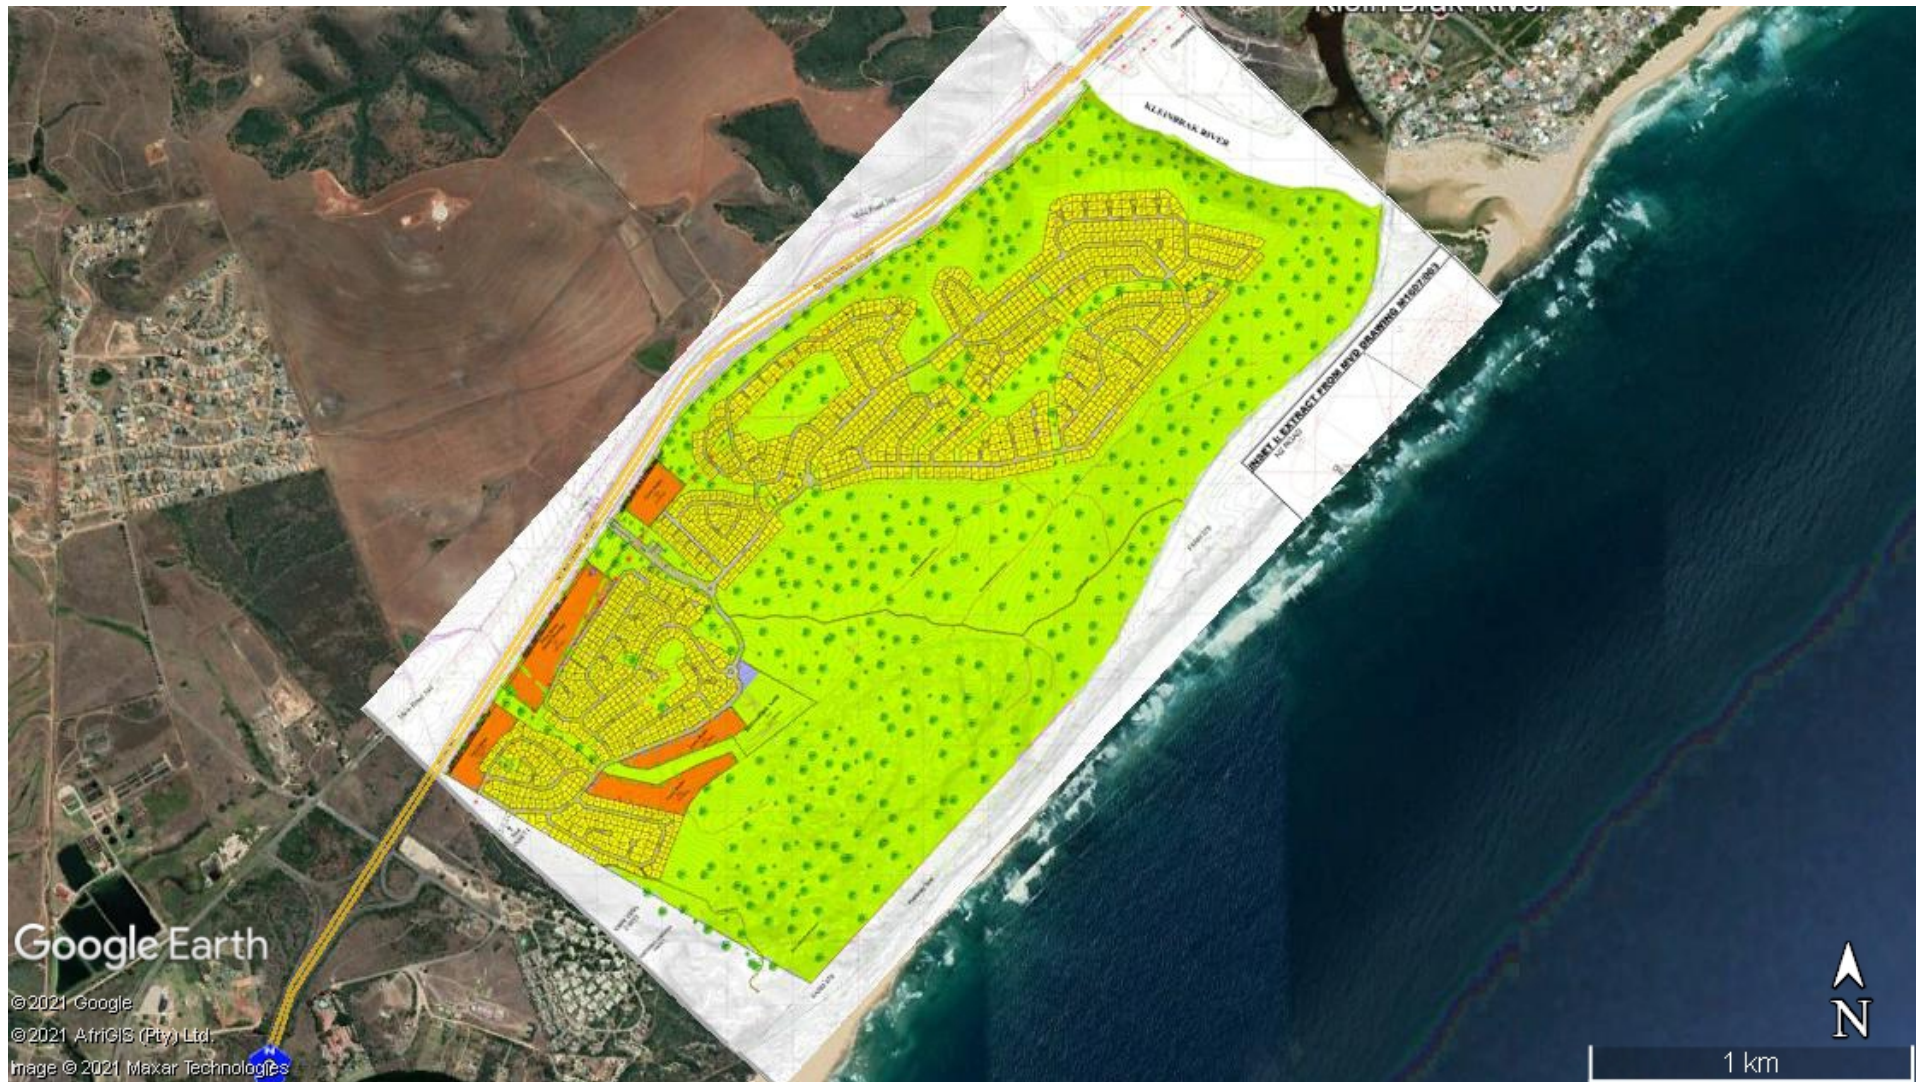
Figure 2. Area enlarged from Figure 1 with the Site Development Plan for the Hartland Development overlain on a Google Earth image with the Klein Brak River visible immediately to the NE. The N2 highway runs along the NW boundary of the development site. Courtesy of Dalmar Beleggings and Google Earth 2021.

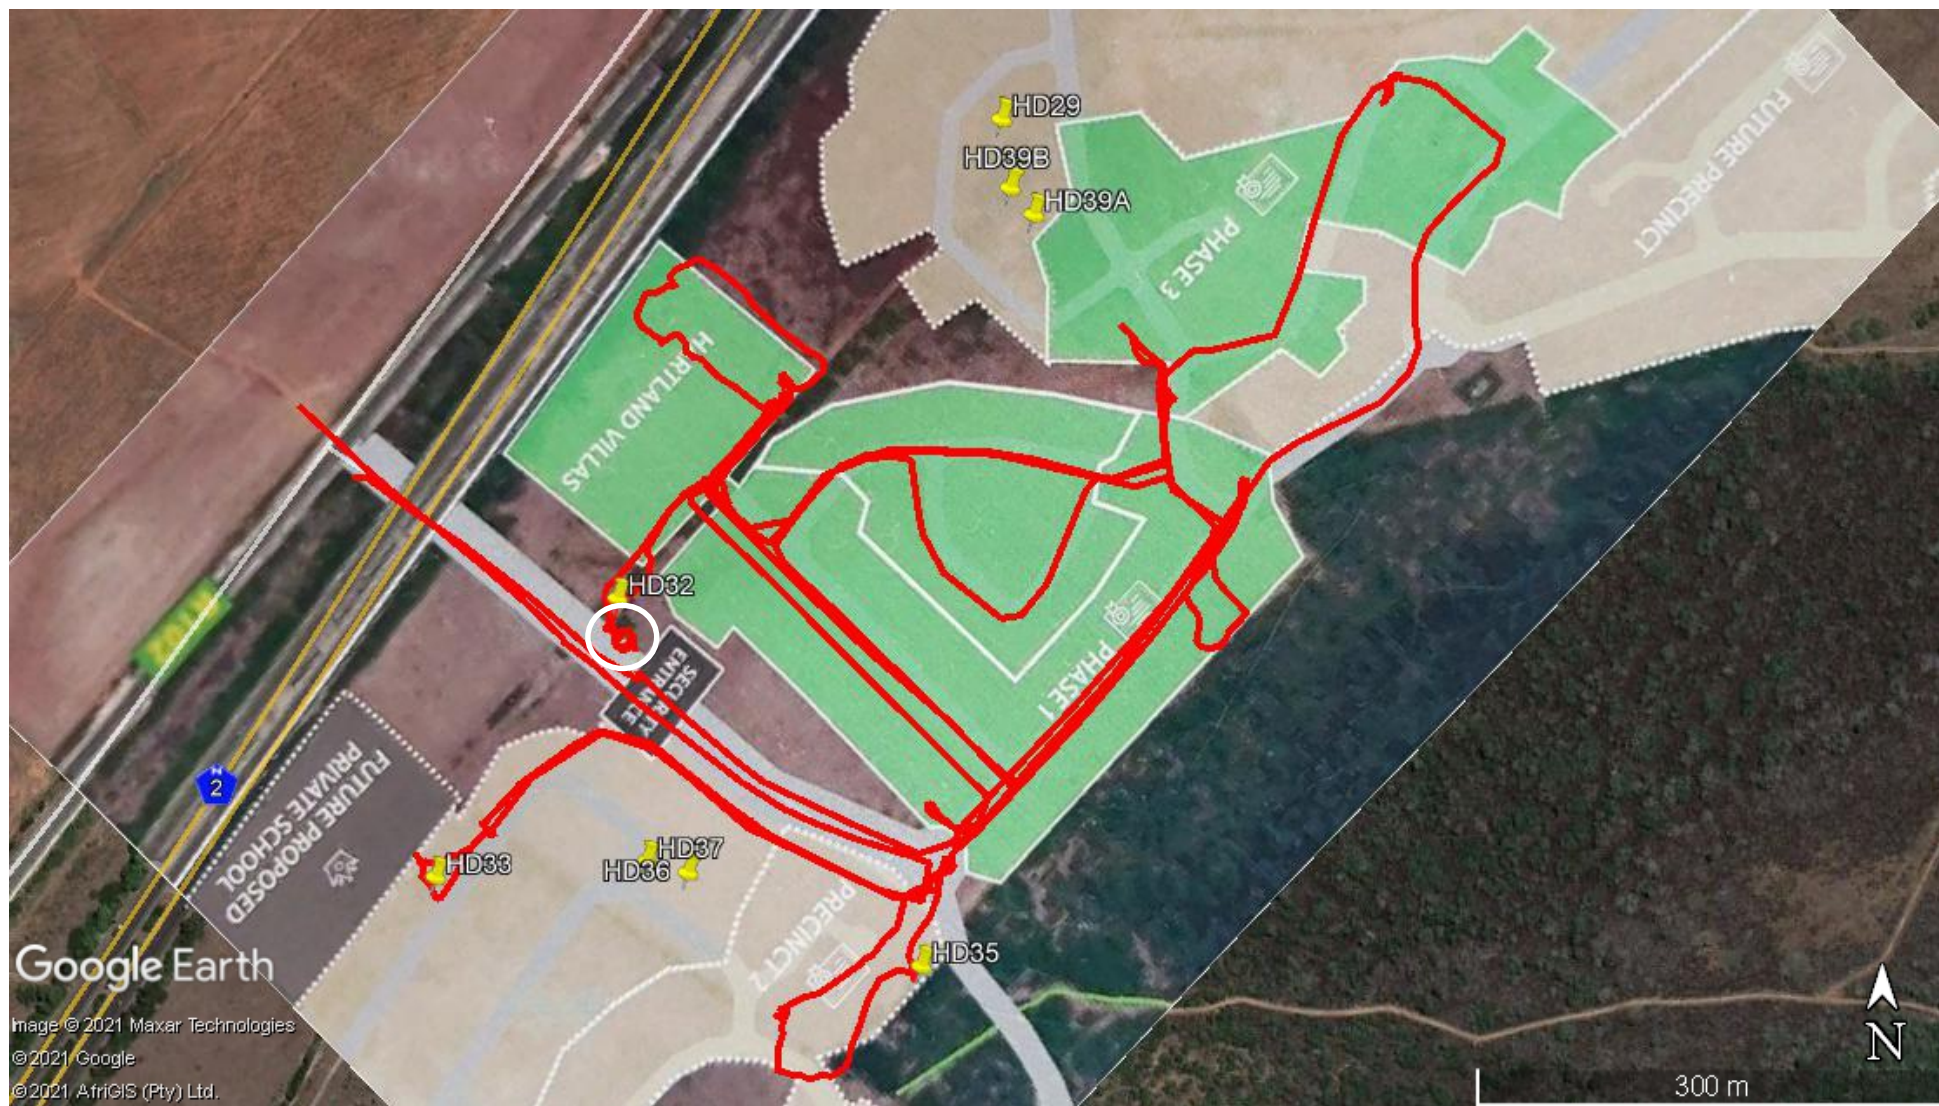
Figure 4. Enlarged from Figure 3 showing the current and imminent development phases in green (Hartland Villas, Phase 1 and Phase 3), GPS fixed tracks (red lines) of the archaeological foot survey and documented heritage resources (yellow markers, Nilssen 2005). Note that HD32 is approximately 20 meters NE of the actual location of the graves enclosed with a white circle (Plates 4 & 5). The labourers cottages were at waypoint HW33 (Plate 6). Courtesy of HilLand Environmental, Dalmar Beleggings and Google Earth 2021.

The northern portion of the Hartland Villas was in the process of a moderate scale cut-and-fill process (Figure 4, Plate 3). A walk along an approximately 250 meter long stretch of exposed profiles and excavated areas revealed a single isolated manuport (unmodified quartzite cobble) and a single isolated piece of flaked quartzite, both *ex situ* and of indeterminate age. Such very low density occurrences or isolated specimens of Stone Age origin are common in areas known for prehistoric occupation, especially within a few kilometres of the present shoreline. Such finds are considered to be of low to no significance and generally, apart from recording and documentation, are left in place and are not worthy of formal mitigation and collection under a permit from HWC. No artefacts were seen during a cursory inspection of a recently cleared plot at the eastern extent of Phase 1 (Figure 4 and Plate 3 bottom right).

The site of the previously recorded graves is indicated in Figures 3 and 4 (occurrence 32 is presented in full below). The original waypoint (Figure 4, HD32) taken in 2005 is

approximately 20 meters NNE of the actual grave site. GPS errors of 15 to 20 meters were acceptable back in 2005 whereas GPS coordinates can be accurate to within 3 meters today.

Fortunately, a review of the previous study undertaken in 2005 and results of the archaeological site inspection undertaken for this report have revealed that, apart from development activity in very close proximity to the previously recorded grave site, no significant heritage resources were damaged, disturbed or destroyed to date. Furthermore, for the current phase of development (Figure 4), no significant heritage resources are threatened by construction activities.

Because of their vulnerable context and in order to protect them in the short to medium term, it is strongly recommended that the graves at waypoint HD32 (Figure 4) should be fenced as soon as possible and that a buffer of at least 2 to 3 meters between the graves and the fence should be observed. A decision about the future of the graves should also be made as soon as possible. It is requested that Heritage Western Cape provides input as to the best way forward in terms of relocating the graves to a more suitable site on the property, or conserving the graves *in situ* with suitable measures for maintenance and protection. It is this author's opinion, pending results of research into living descendants or relatives of the deceased, that the former option of relocation may be preferable. This issue may require further discussion between all interested and affected parties and with consideration of Section 36 of the National Heritage Resources Act (Act No.25 of 1999).

Due to the scarcity of heritage resources - noted in both the Nilssen 2005 report and during the recent site inspection - in the area currently under development (Figure 4), it is recommended that full time archaeological monitoring is not necessary but that part time monitoring involving daily site inspections by a suitably accredited professional archaeologist should be implemented when bulk excavations and earthworks are in progress. Dalmar or a representative should inform the appointed archaeologist of their excavation and earthworks

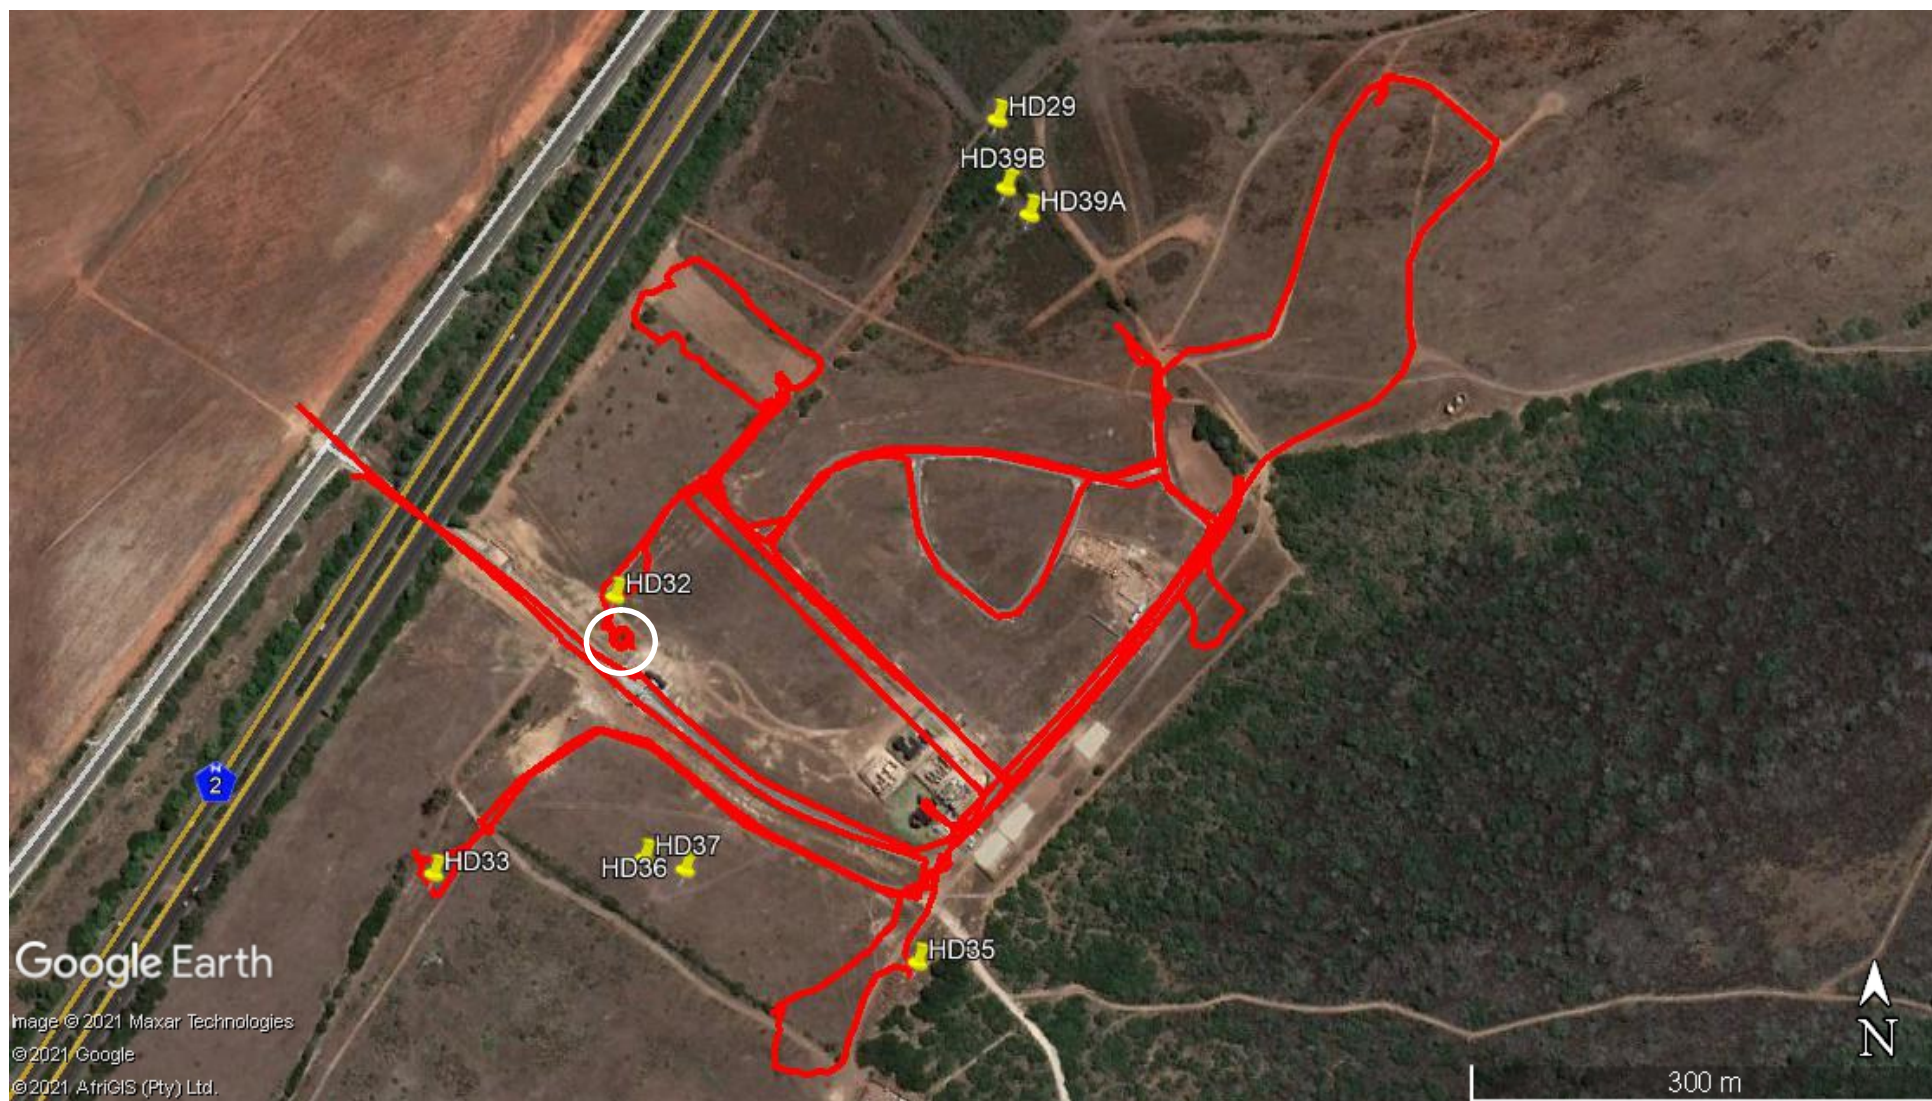
Figure 5. Same enlarged area as Figure 3, but excluding the development overlay. Existing development activities are clearly visible. Also shown are GPS fixed tracks (red lines) of the archaeological foot survey and documented heritage resources (yellow markers, Nilssen 2005).

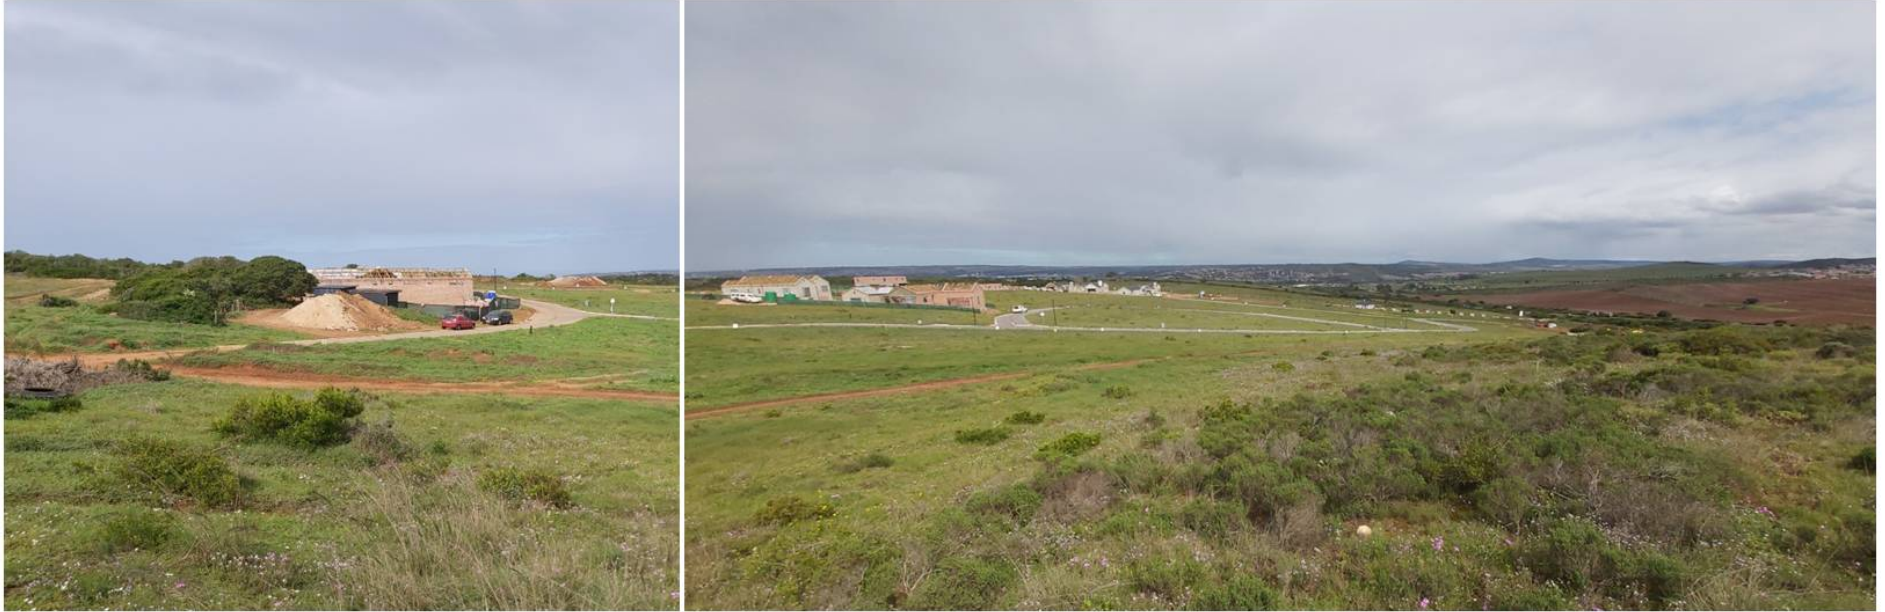
Plate 1. This view is roughly in a south-westerly direction, taken from Phase 3 and looking over the existing and future development area of Phase 1.

On 27 April 2021 this author met Mr Holiday at the marketing office of the Hartland Development site, which is situated between the Hartenbos and Kleinbrak Rivers north of Mossel Bay (Figures 1 through 4). Mr Holiday took me around site to point out the existing, current and imminent construction and development activities. Thereafter the site inspection was conducted independently. Figure 4 shows a close-up of the area currently under development with an overlay of the first three phases, documented heritage resources, and archaeological survey tracks. The area currently under development is shown in Plates 1 and 2.

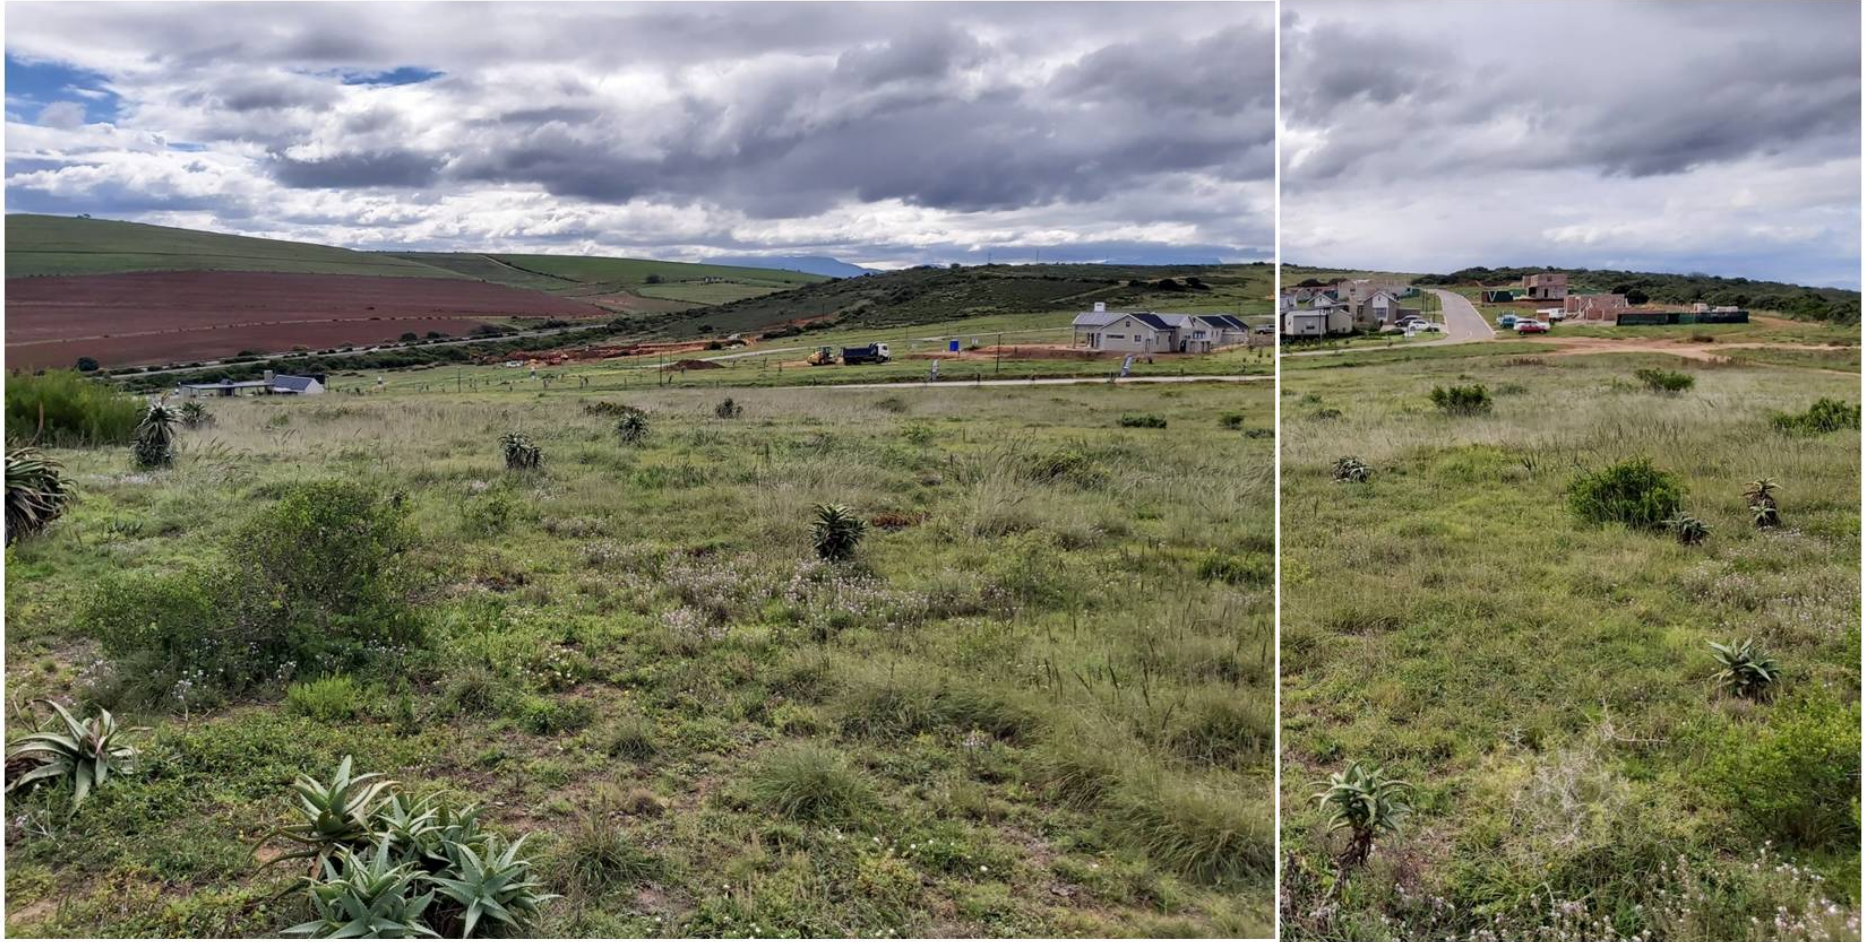
Plate 2. This view is roughly in a north-easterly direction, taken from the west of the main entrance road with the gate house to the left (N2 highway visible immediately above gate house), Hartland Villas in the distant middle-left (under earthworks and excavation), and Phase 1 in the right of the image.

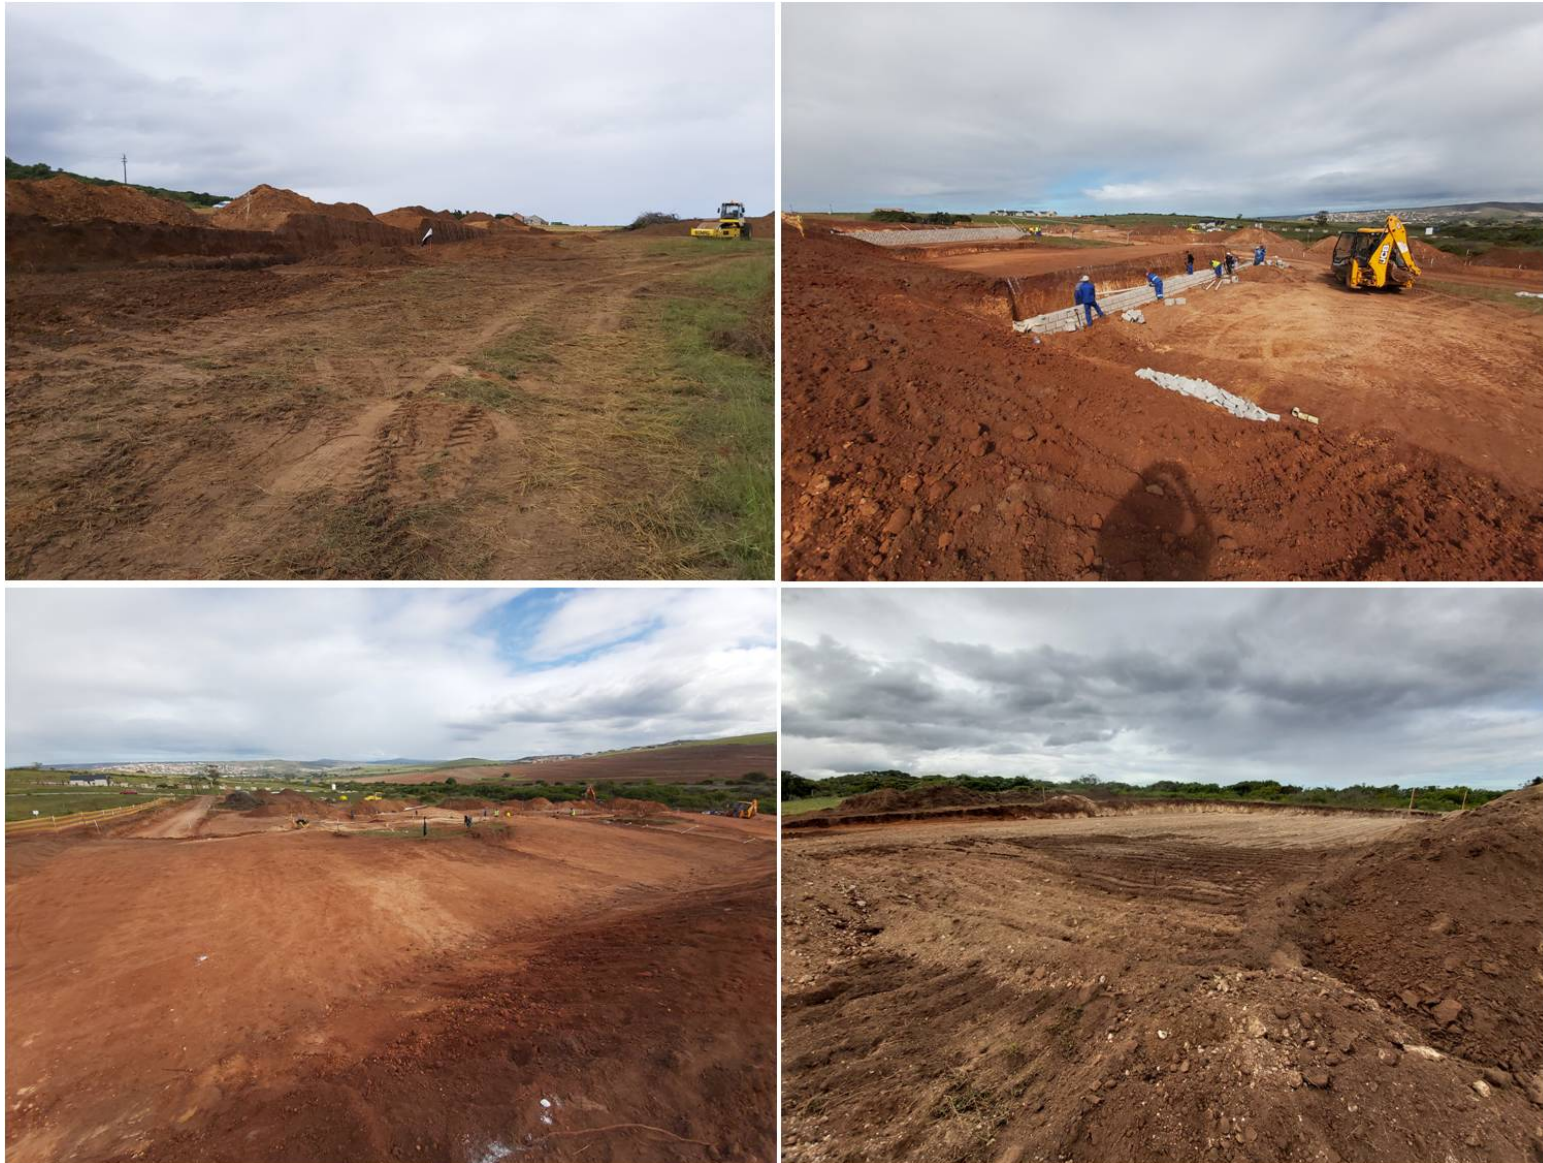
Plate 3. Excavations and earthworks in the north-eastern portion of the Hartland Villas phase, except for the bottom right image which shows a cleared plot at the north-eastern extent of Phase 1.

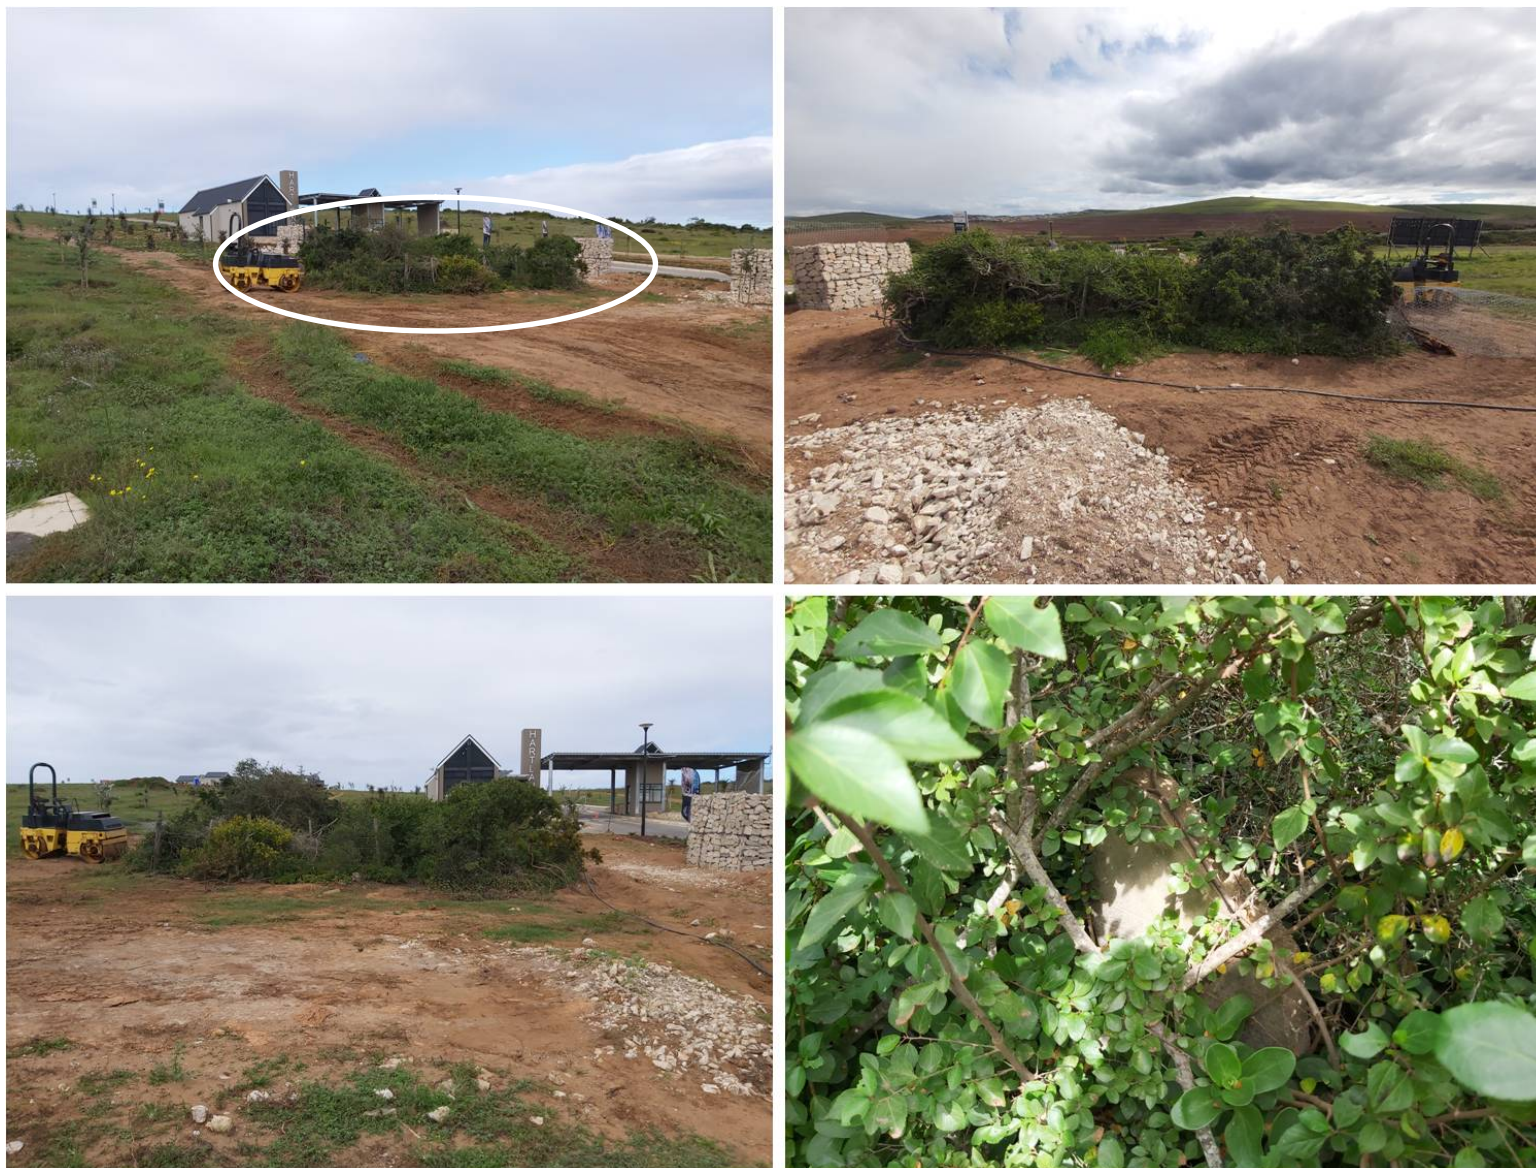
The current status of the area containing the 5 graves is shown in Plate 4. While a detailed investigation was not done, it appears that one of the headstones has been broken since the graves were documented in 2005. Only 3 of the headstones were partially visible due to thick vegetation cover. The context and condition of the graves in 2005 compared to the current situation is evident when comparing Plates 4 and 5. The area around the graves is cleared right up to the graves allowing almost no buffer between the graves and the cleared area (Plate 5). If the graves are to be conserved in their current position, then it is recommended that they are enclosed with a more suitable fence and that a buffer of at least 2 to 3 meters is allowed between the graves and the fence. A more appropriate option may be to relocate the graves to a more suitable and quieter location on the property, but this may require research into potential living descendants or relatives and their wishes, if any (see below from the Nilssen 2005 report).

Plate 4. Context and surroundings of the grave site (bushy area indicated with white ellipse in top left image) at waypoint HD32, showing the cleared area around the graves, the gate house, and the main access road. Note that one of the headstones (Plate 5 g) is barely visible through dense vegetation (bottom right). See the context and surroundings of the grave site in 2005 in Plate 5 below.

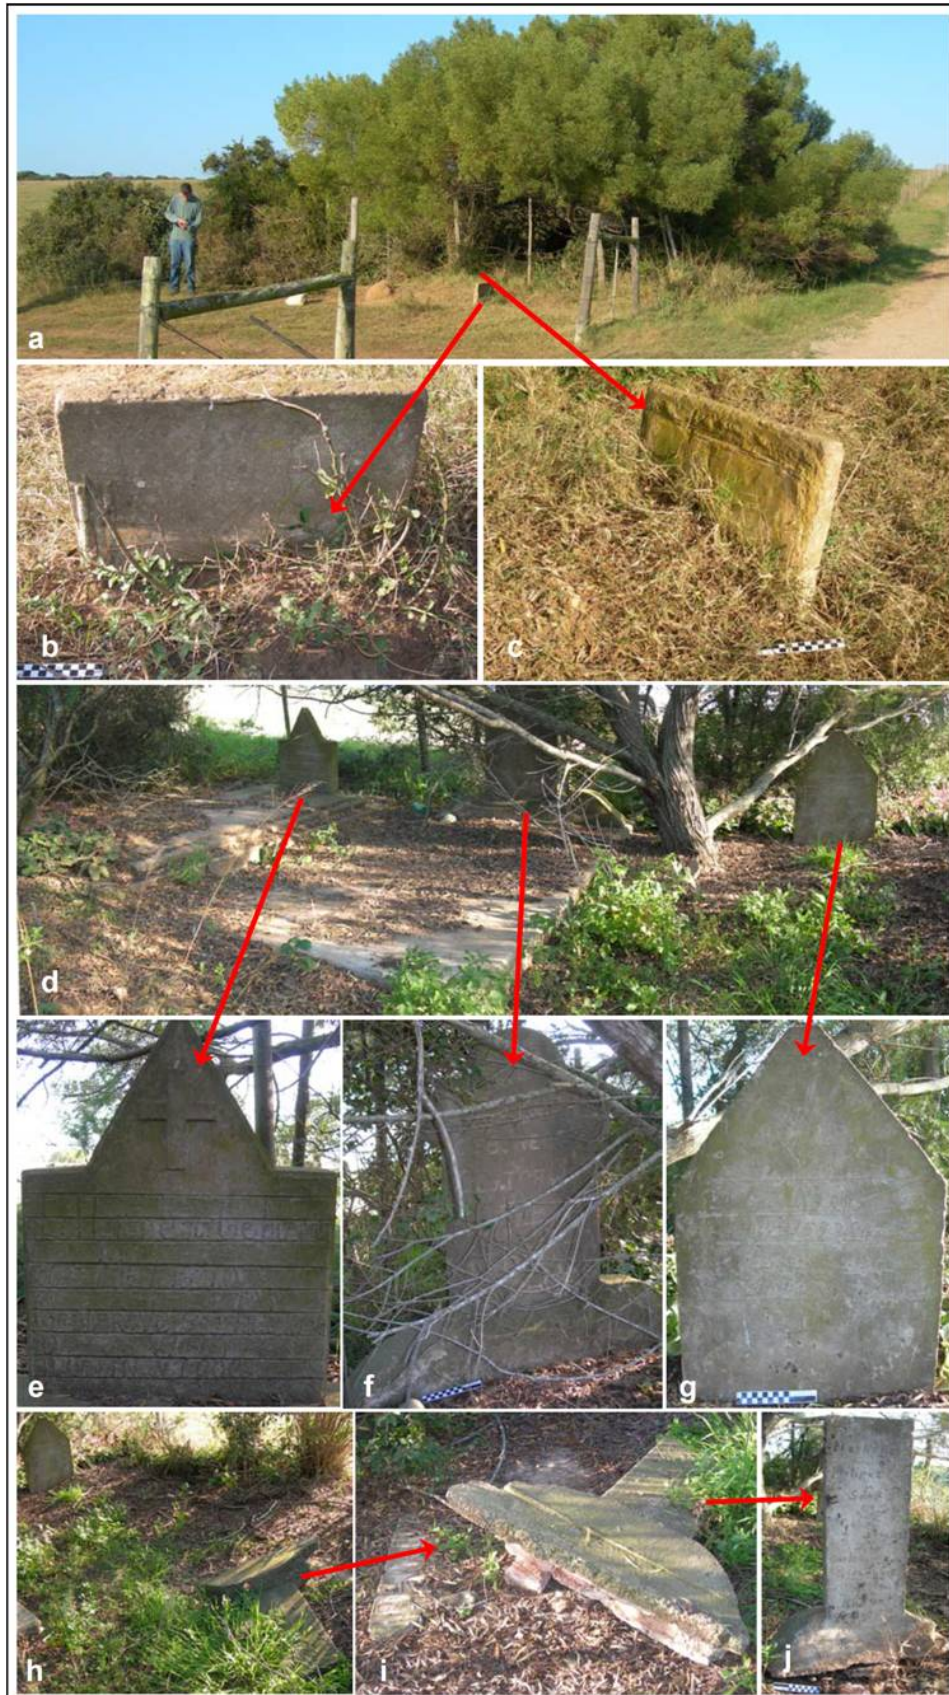
Some 200 meters east of the subway under the N2, along the main gravel road into the property are five graves situated under and next to a large Rooikranz bush on the north side of the road (see Plate 5). All graves have old concrete headstones that face in a north to northeasterly direction. Three graves are capped with concrete “beds” (Plate 33 e, f & i). The only materials associated with these graves are a modern wine bottle and a broken glass container.

Only four gravestones bear inscriptions (e, f, g & j), though the one depicted in Plate 33 (a, b & c) is somewhat overgrown with grass, which may be obscuring any inscription. The following was legible on gravestones in Plate 33 (e, f, g & j) and the format used below is as text appeared on the headstones;

Plate 5. "Graves in and adjacent to large Rooikranz bush at occurrence 32 (a). The gravestone to the west is not inscribed (a, b & c) while the remaining four bear inscriptions (e, f, g & j). Scale intervals are in cm" (Plate 33, Nilssen 2005, pg 46).

More information concerning occurrence 32 may be obtained via archival/historic/anthropogenic research that should be conducted during the mitigation phase. Through this research concerted efforts must be made to locate relatives of the above-named individuals and if they so require, a reburial of the above-named individuals will

be at the expense of the developer. If no relatives can be located, then the best option may be to leave the graves undisturbed" (Nilssen 2005, pg., 11 & 12).

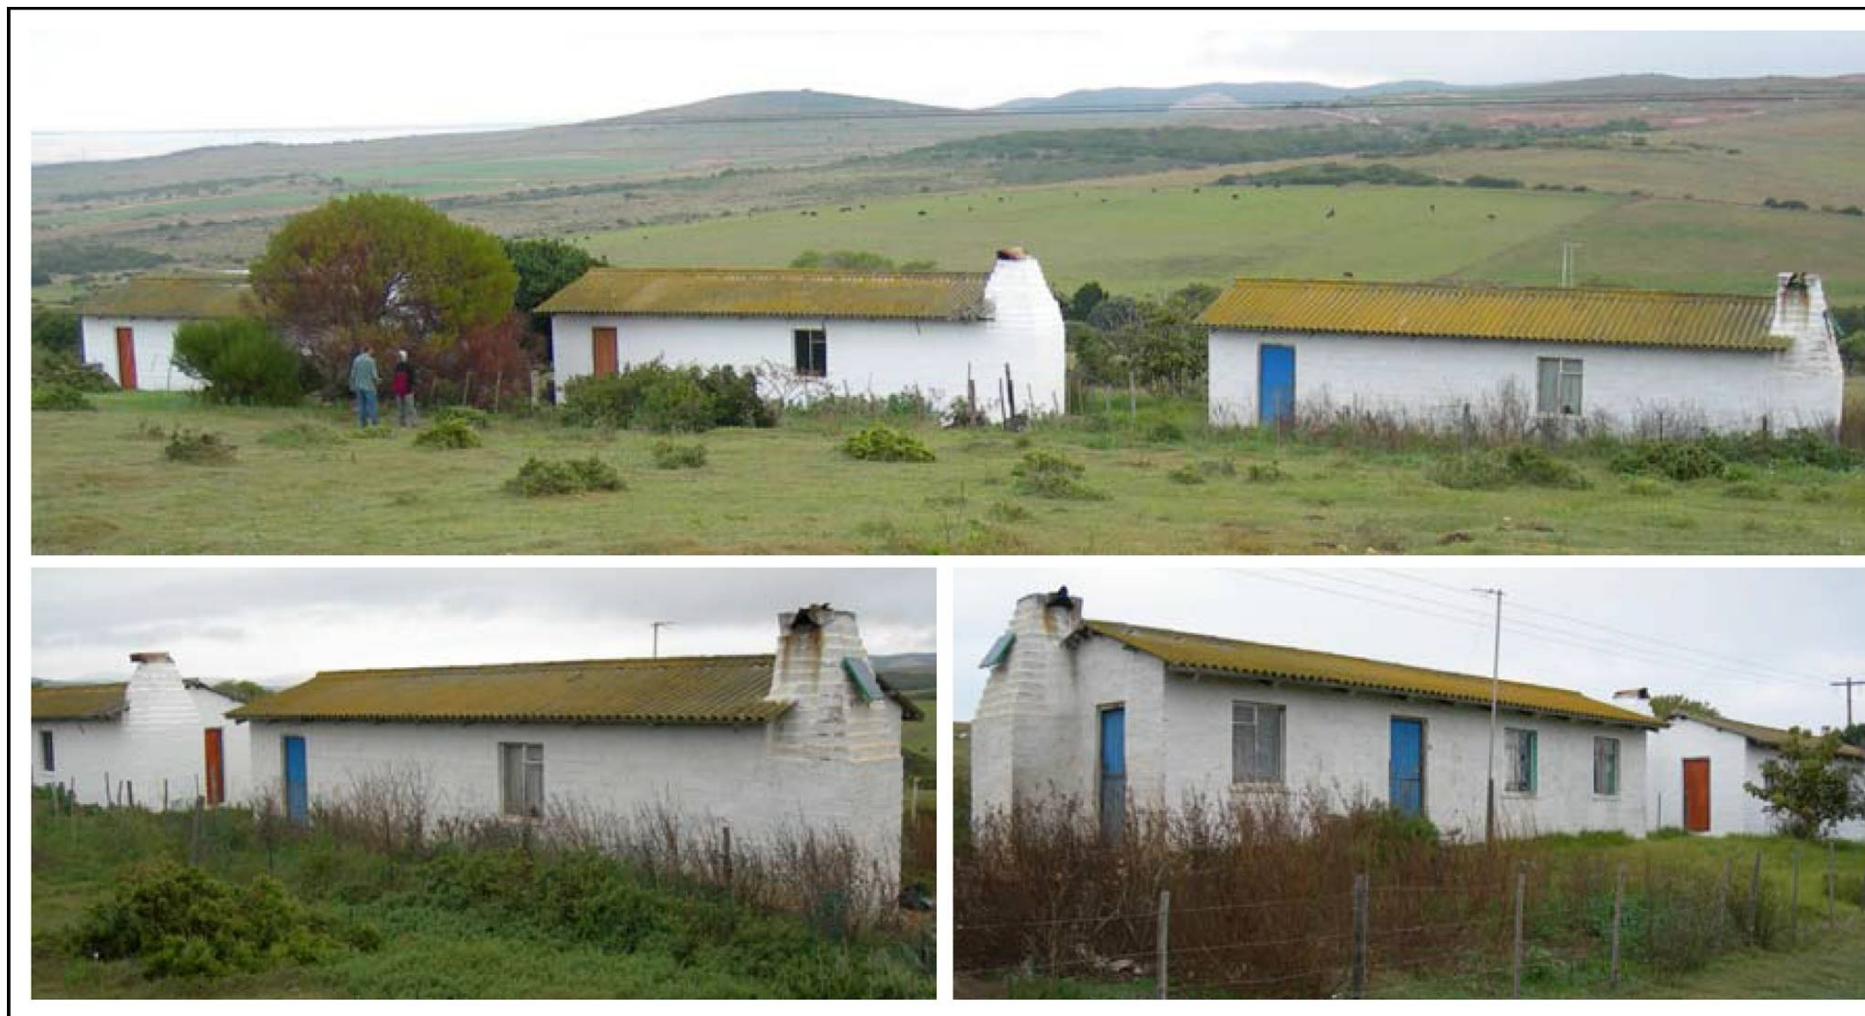
It was noted that the labourers cottages recorded at occurrence 33 (HD33 in Figure 4 and Plate 6) were demolished and it appears that most of the rubble was removed from site. The cottages were previously visible from the N2 highway. The below is copied verbatim from the Nilssen 2005 report.

These are fairly recent labourers cottages built of modern materials including large concrete bricks and the roof is of "big six" style roof plates in fiber cement. The houses are similar to "longhouses" that are common on the west coast of the southwestern Cape with fireplaces at the northern ends of the structures. A lot of modern litter is strewn around in the vicinity of the houses including many plastic containers and other 20th and 21st century materials" (Nilssen 2005, pg., 12).

Plate 6. "Modern labourer's cottages at occurrence 33 viewed from the east to northeast (top and bottom left), and from the north to northwest (bottom right)" (Plate 34, Nilssen 2005, pg 47). Waypoint 33 is marked as HD33 in Figures 4 & 5.

It was concluded that the labourers cottages were of low significance and that no mitigation was required (Nilssen 2015, Table 1, pg.15).
